CIDER BARN AT COURT BARTON, SILVER STREET,
THORVERTON, DEVON

Historic Building Appraisal

Mid Devon District Council planning reference
17/004567/HOUSE

Document No: ACD1611/2/0

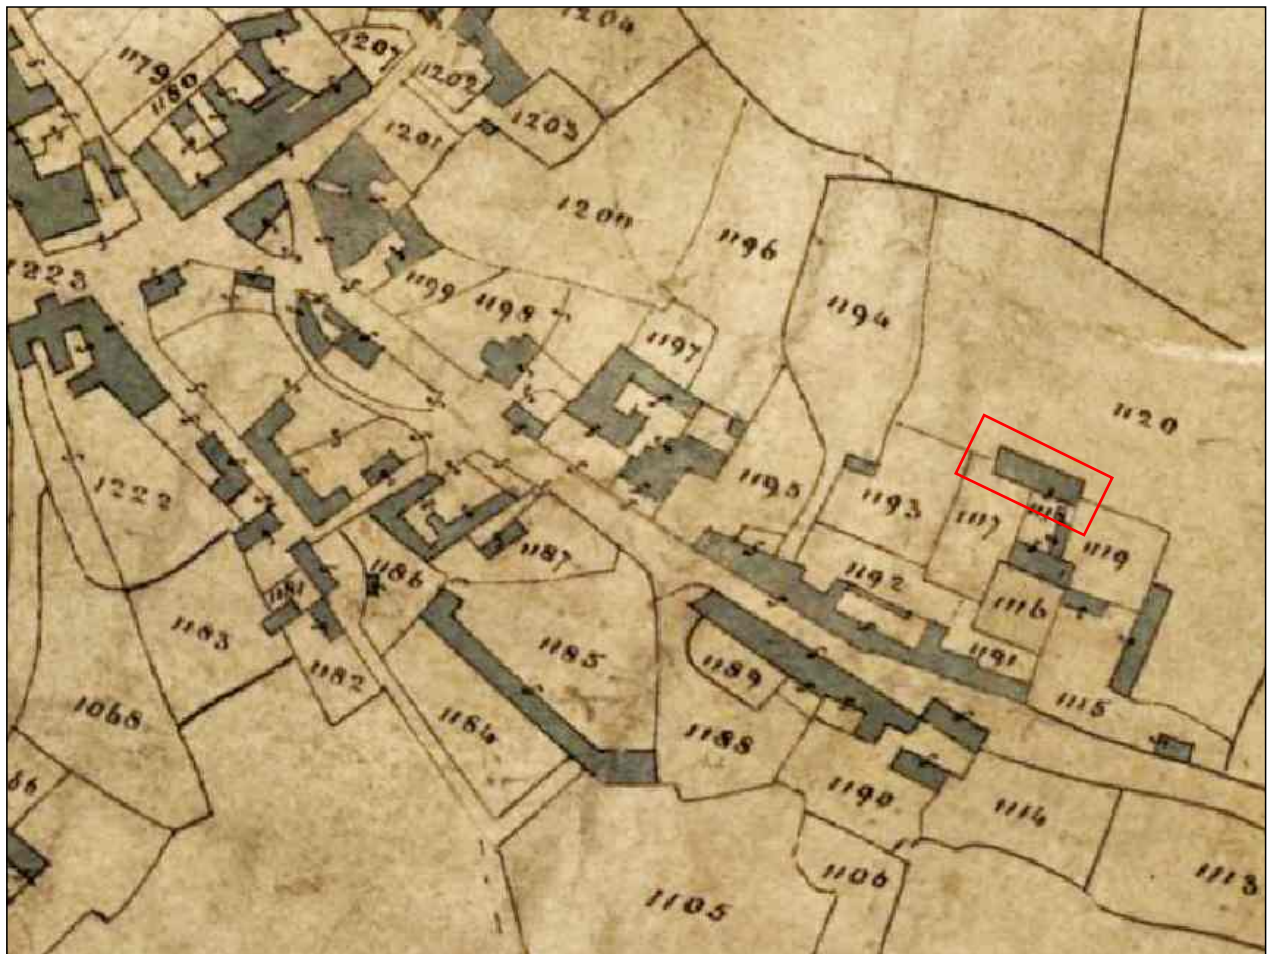
Fig. 2: Extract from the
Thorverton tithe map, 1841

4.3 The earliest identified map to depict the property is the 1841 Thorverton tithe map (Fig. 2). The property is recorded within Plot 1118 as *Houses and Court* forming part of Court Barton tenements; Table 1 below includes all the plots associated with Court Barton listed in the 1840 apportionment. The 20 plots are owned by the Dean and Chapter of Exeter, who leased the property to Yeoman Thomas Reynold senior who occupied the property along with his family, servant and agricultural workers. The farmstead is set back from the Silver Street, behind a row of cottages fronting the street and their gardens. No clear access to the farmstead is depicted but it seems likely that a path led from Silver Street to the northeast through plot 1115.

4.4 The farmhouse of the property is located along the south boundary of plot 1118, and aligned broadly southeast-northwest with a narrow, northeast-southwest aligned rear extension offset towards the east end of the house. There is an additional structure attached to the southeast corner of the farmhouse. The cider barn is

shown positioned along the north boundaries of plots 1117 and 1118 with the rear of the barn facing plot 1120, which was called *Back Orchard* suggestive that the barn was probably used as a cider barn at this time. The linhay recorded in the HER entry above is not depicted on the tithe map. The map shows an L-shaped wall (defining plot 1119) abutting the east side of the cider barn. Its east side terminates at a long northeast-southwest aligned building, to the southeast of which is a small building fronting Silver Street.

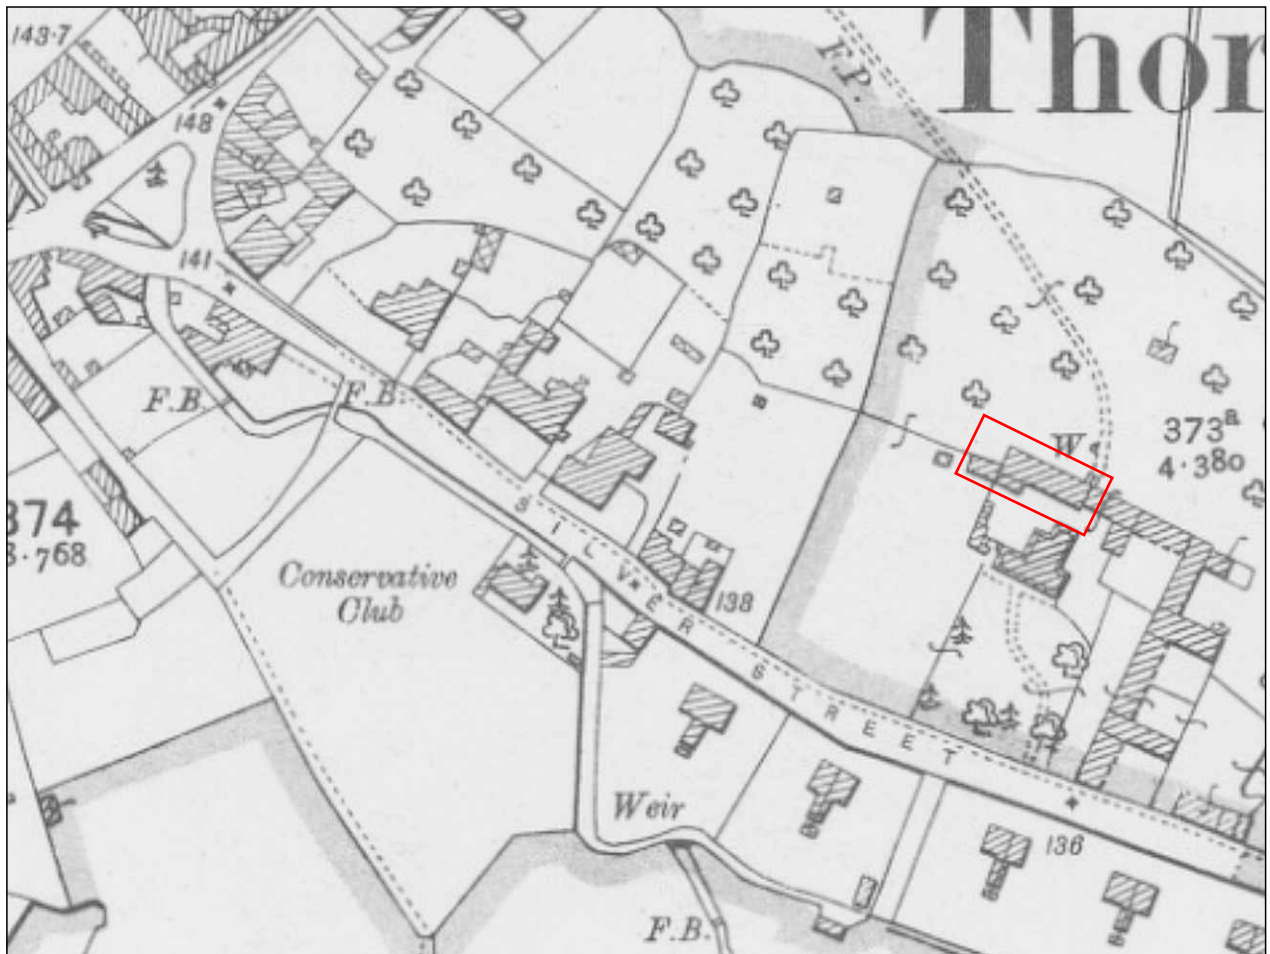
Fig. 4: Extract from the Second Edition
Ordnance Survey 25-inch map, 1905

- 4.7 The Second Edition 25-inch Ordnance Survey map of 1905 (Fig. 4) records that an additional building has been constructed at the south end of the C-shape range of buildings, and there is a further extension at the northeast corner of this range. In the inner yard a small stable block had been constructed against the building southeast of the cider barn. An additional extension has been added to the west end of the cider barn off-set to the south from the existing extension, whilst a further structure – probably the extant steps – are recorded at the southeast corner of the building. A well is recorded to the north, within the orchard.

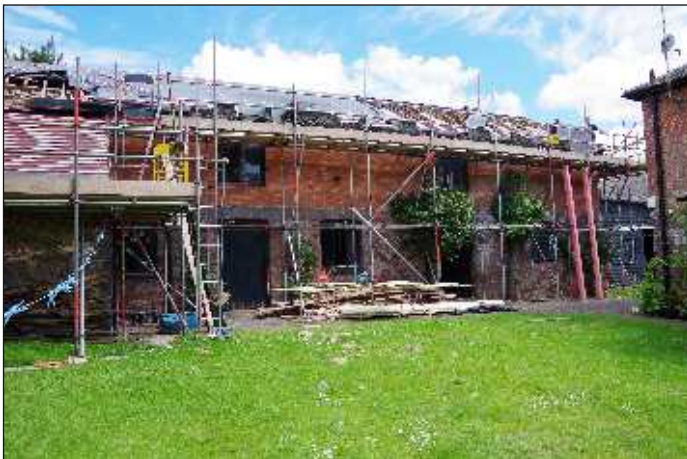
- 5.3 The building displays a mixture of construction materials, indicative of three phases of construction. The southeast end of the building extending to the external staircase along the northeast elevation is constructed of cob set on a Raddon stone plinth and, along with elements of the north range of the linhay and stable, is the earliest element of the agricultural buildings. This is abutted by rubble Raddon stone creating the footprint of the cider barn in its current form. At first-floor level, the front,

Plate 3: Southwest elevation of the cider barn, looking northeast. 1m scale

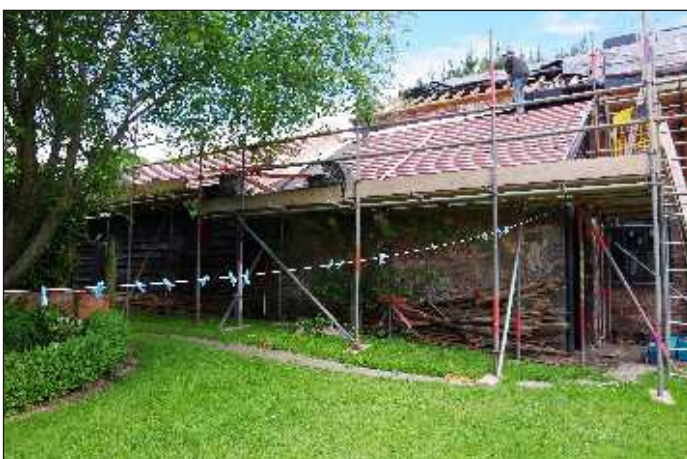
Plate 4: Northwest end of the southwest elevation, showing extensions, looking north. 1m scale

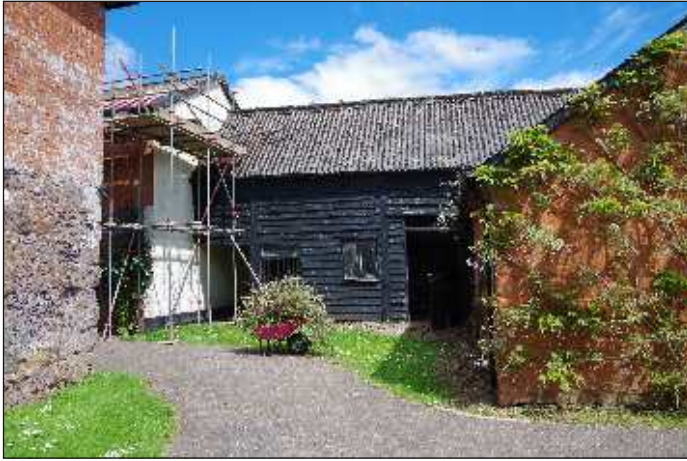
Plate 5: Southeast gable end of the cider barn abutted by the stable block of the linhay, looking northeast

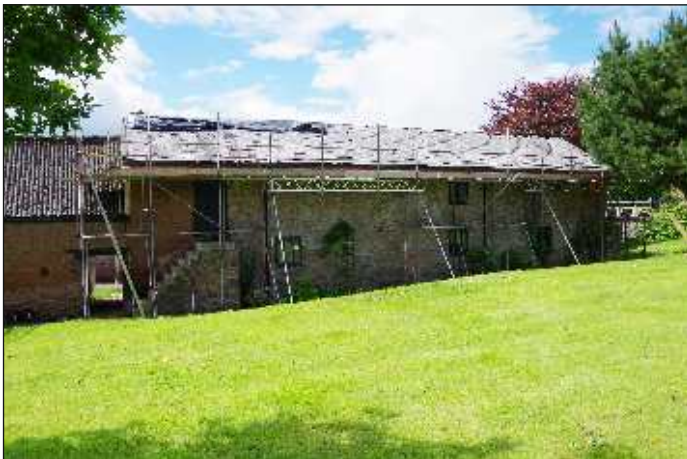
- 5.7** The northeast elevation has a doorway located at first-floor level accessed from the flight of granite steps within Raddon stone masonry. Although not shown on some 19th-century maps the staircase appears to be contemporary with the cider barn. The doorway has dressed Raddon stone voussoirs forming a very shallow arch which has been fitted with the same style of door as used in the front elevation.

Plate 6: Northeast elevation of the cider barn and the cob wall of the stable block within the linhay, looking southwest. 1m scale

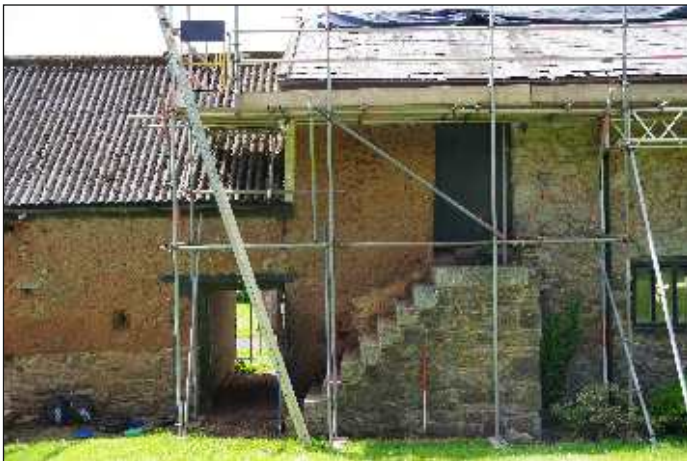
Plate 7: Close-up of the southeast end of the northeast elevation of the cider barn, showing the cob abutted by the Raddon stonework, looking southwest. 1m scale

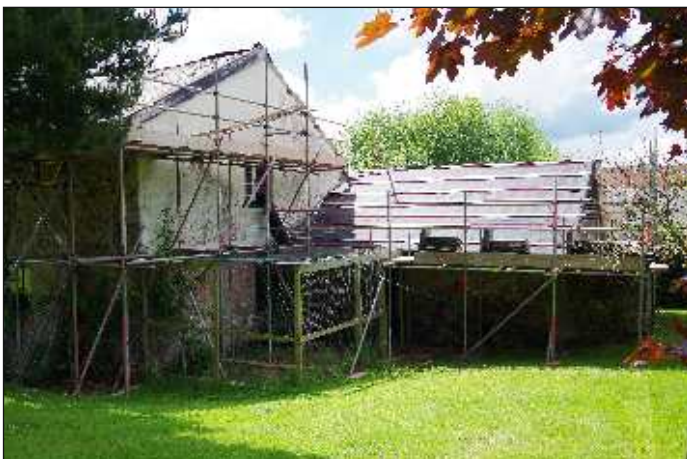
- 5.5** Against the northwest elevation, at the southwest end, of the cider barn and abutting the lean-to extension there is an early 20th-century extension constructed of Flemish garden wall bond brickwork on the northwest elevation and shiplap cladding set on a brick plinth along the southwest elevation. The northeast elevation is constructed of rubble Raddon stonework, which originally formed a garden wall dividing the rear orchard from the gardens to the front of the barn. The building is currently used as, and potentially was initially built as, a chicken coop. It has two small openings at the base of the rubble stone elevation providing access to a pen within the orchard against the northeast elevation of the barn.

Plate 8: Northwest elevation of the cider barn and the chicken coop extension, looking south-southeast

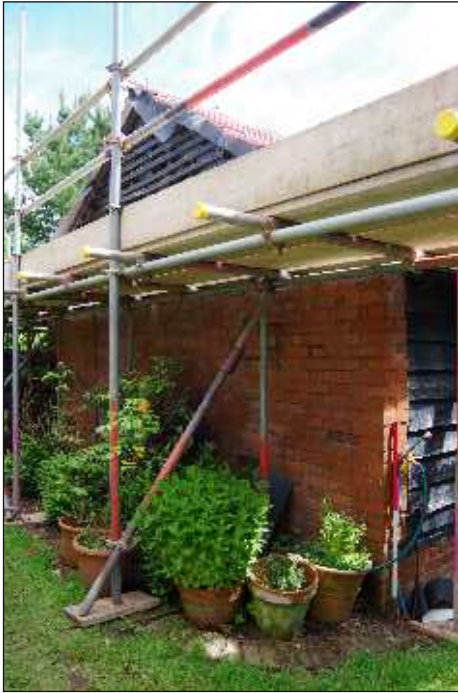
Plate 9: Northwest elevation of chicken coop, looking northeast. 1m scale

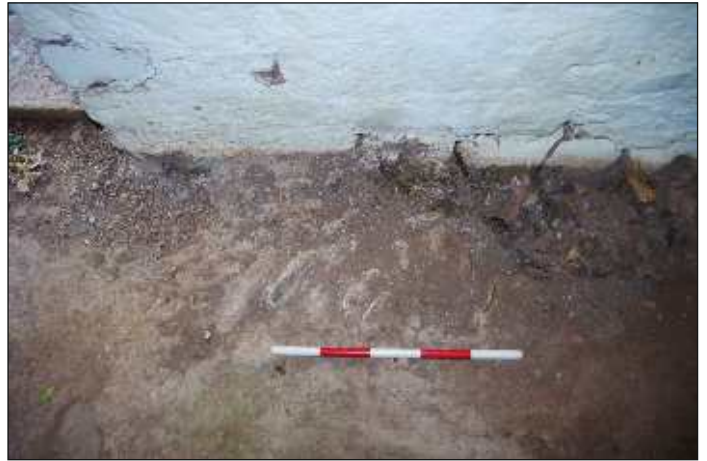
Plate 10: Example of cobbles *in situ*, to the northwest side of the cider press room entrance, looking southwest. 0.5m scale

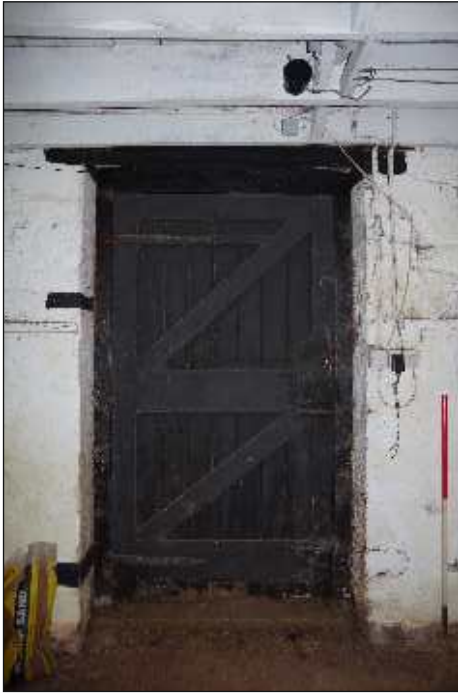
Plate 13: Plank and batten door with ledges and braces, leading to the exterior from the cider press room, looking southwest. 1m scale

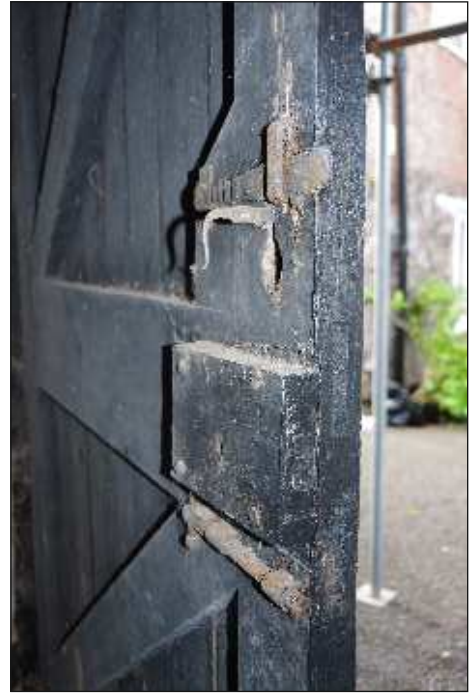
Plate 14: Detail of latch and lock case of the door leading to the exterior from the cider press room, looking south-southeast

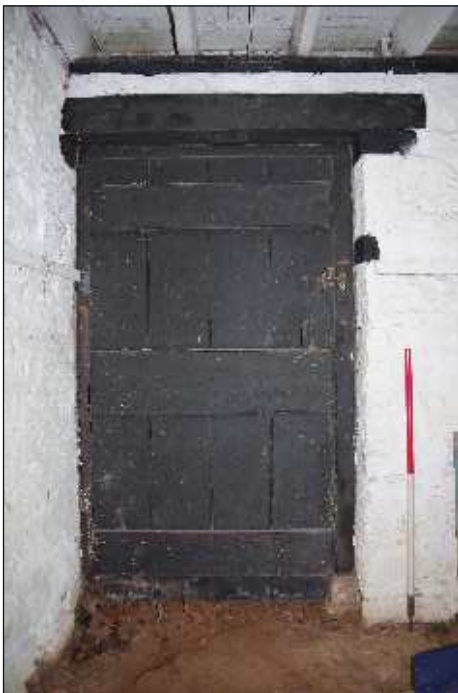
Plate 15: Plank and batten door, leading to the barrel/cask store room, looking northwest. 1m scale

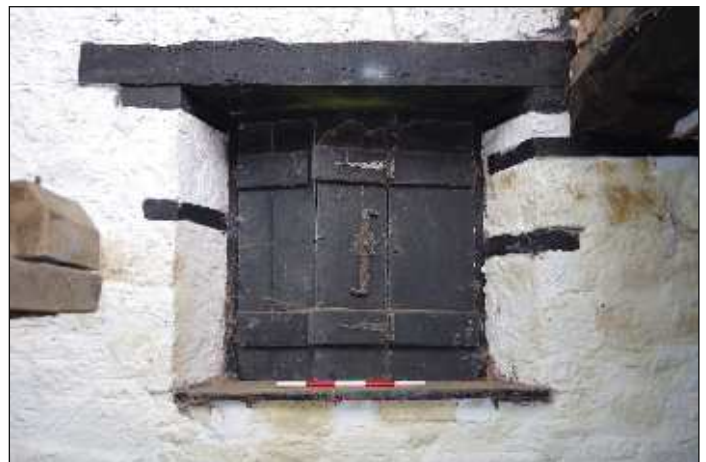
Plate 16: Window on the northeast elevation of the cider press room, with detail of the timber shutters, looking northeast. 0.5m scale

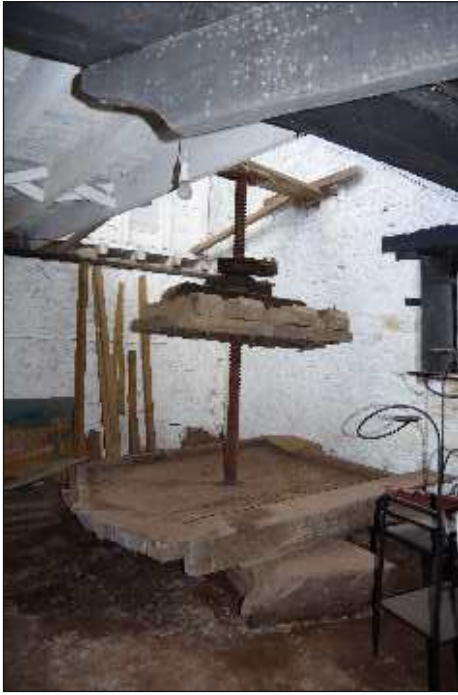
5.13 The cider press is located in the north corner of the room. It is a Devon central iron screw press (Quinion 1982) probably dating to the 19th century. The press is roughly square and comprises a press base and press block which were constructed of large chunky pieces of timber which appear to be oak. The press block has iron straps and large timber pegs and iron studs protruding out on its underside. The press base/bed has a spout centrally located along the southwest side with iron studs and timber dowel pegs around the top of the frame edge of the base. The press is a central cast iron screw design, with the large narrow screw rising out of the middle of the press base with the press block above operated by a ratchet mechanism. There are two additional timber fixtures on the ceiling of the cider room close to the cider press that were probably utilised along with the ratchet mechanism of the press. The press is positioned on top of a section of tree trunk raising it slightly above the ground level. There is no trough *in situ* with current floor levels not allowing space for a trough or barrel/cask to be positioned. The ground

underfoot in this area was fairly soft suggesting a loose backfill in the area, possibly signifying a semi-sunken collecting receptacle was once positioned here.

Plate 17: The cider press, looking north

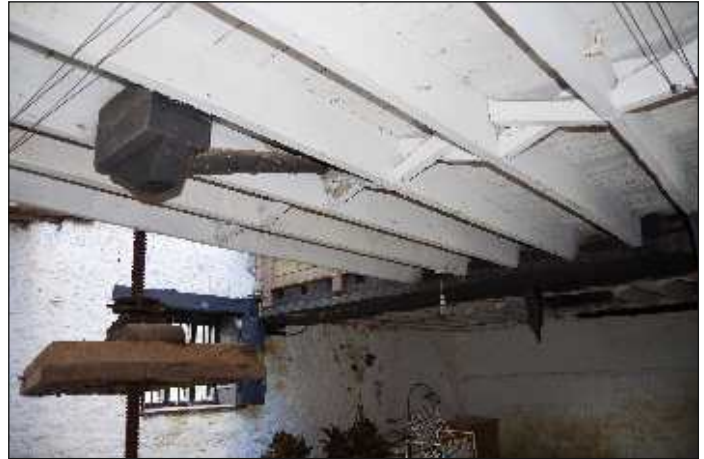
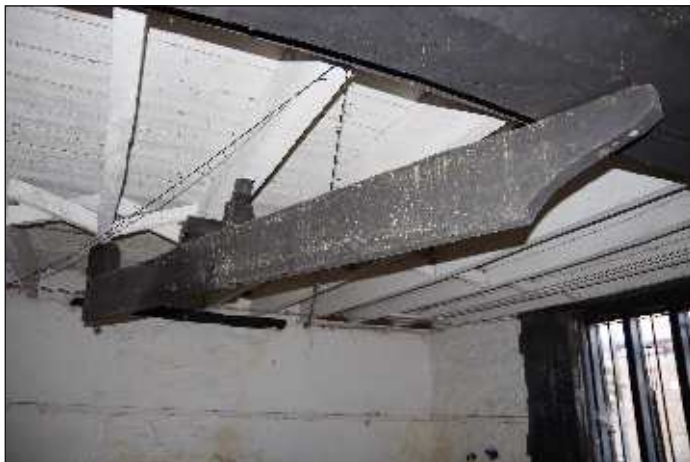
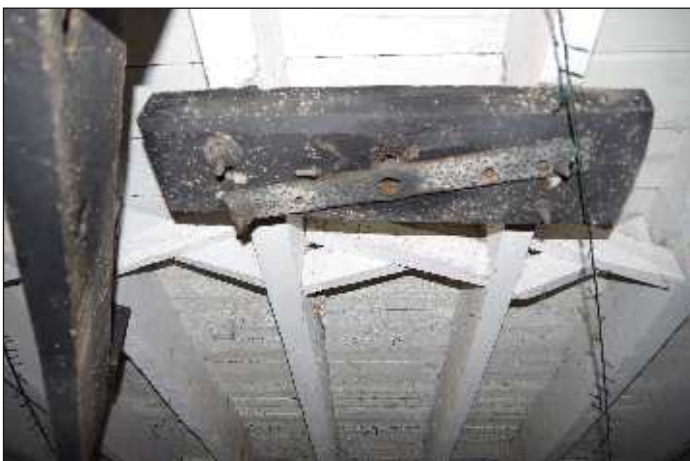
Plate 18: Fixtures on the ceiling to the southwest of the cider press, associated with the ratchet mechanism of the cider press, looking northeast

Plate 19: Fixtures on the ceiling to the south of the cider press, associated with the ratchet mechanism of the press, looking south

Plate 20: Fixtures on the ceiling to the south of the cider press, associated with the ratchet mechanism of the press, looking northwest

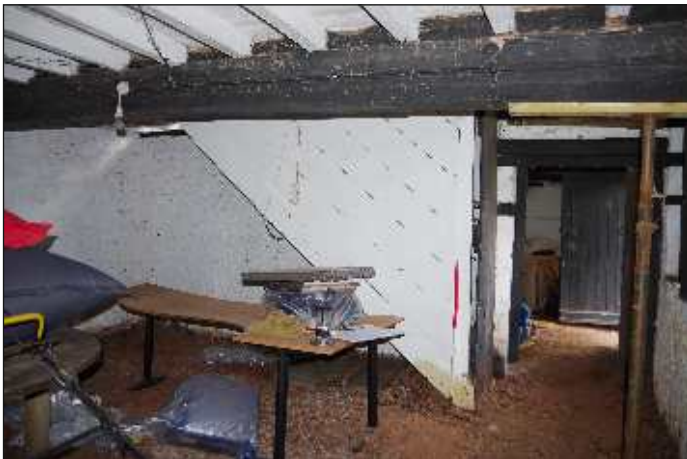
- 5.16** The enclosed staircase appears to be a late 19th-century insertion, and it is not clear if there originally was a staircase positioned here. The wide timber planks with beading along one edge are likely to be re-used. Under the stairs there is some writing, but has faded too far to decipher. The door hung at the bottom of the staircase appears to be contemporary with the other internal doors of the building but was probably re-hung in this position when the stairs were inserted.

Plate 22: General view to the southeast end of the barrel/cask store room, showing the enclosed staircase, looking east. 1m scale

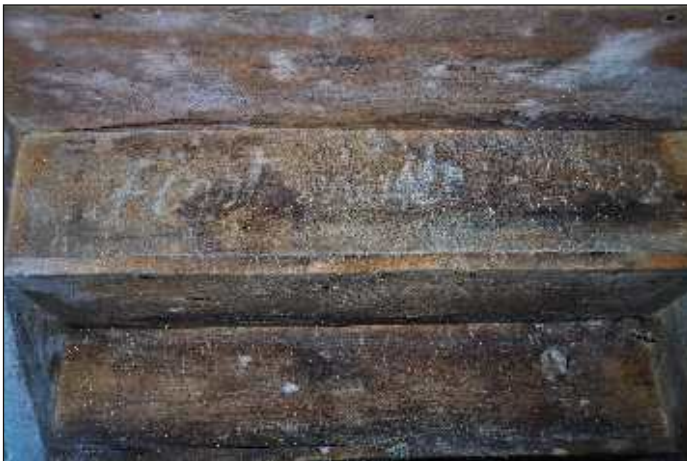
Plate 23: Detail of writing under the staircase, looking southeast

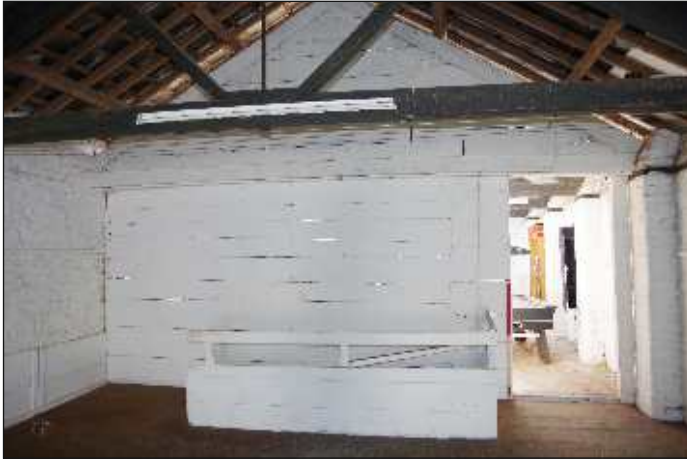
Plate 25: The first-floor partition wall, looking southeast. 1m scale

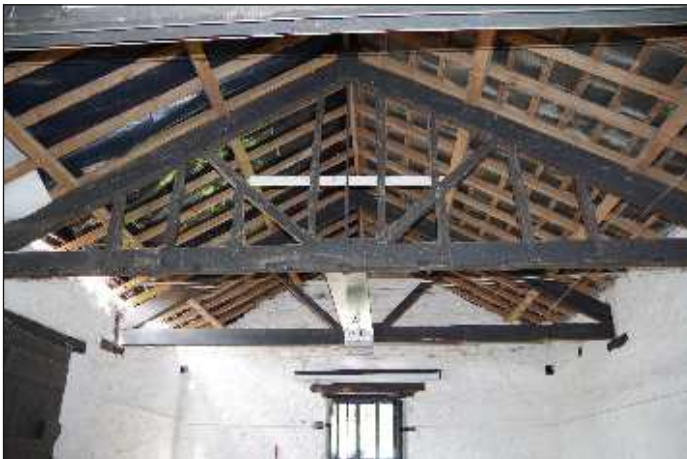
- 5.20** The floor is constructed of floorboards of a probable late 19th-century date and the room is open to the rafters. As described earlier the room has a five-bay roof. The second truss from the northwest end displays features similar to the truss over and within the internal partition, namely studs above the tie beam. It also contains sockets in the base for removed studs, and was therefore on the line of a partition.

Plate 26: Detail of the truss with evidence for a former partition located towards the northwest end of the first-floor northwest room, looking northwest
