STOKE COTTAGE, HIGH STREET, STOKE CANON, DEVON

Results of Archaeological Trench Evaluation and Historic Building Appraisal

Report No: ACD1617/2/0

Date: July 2017

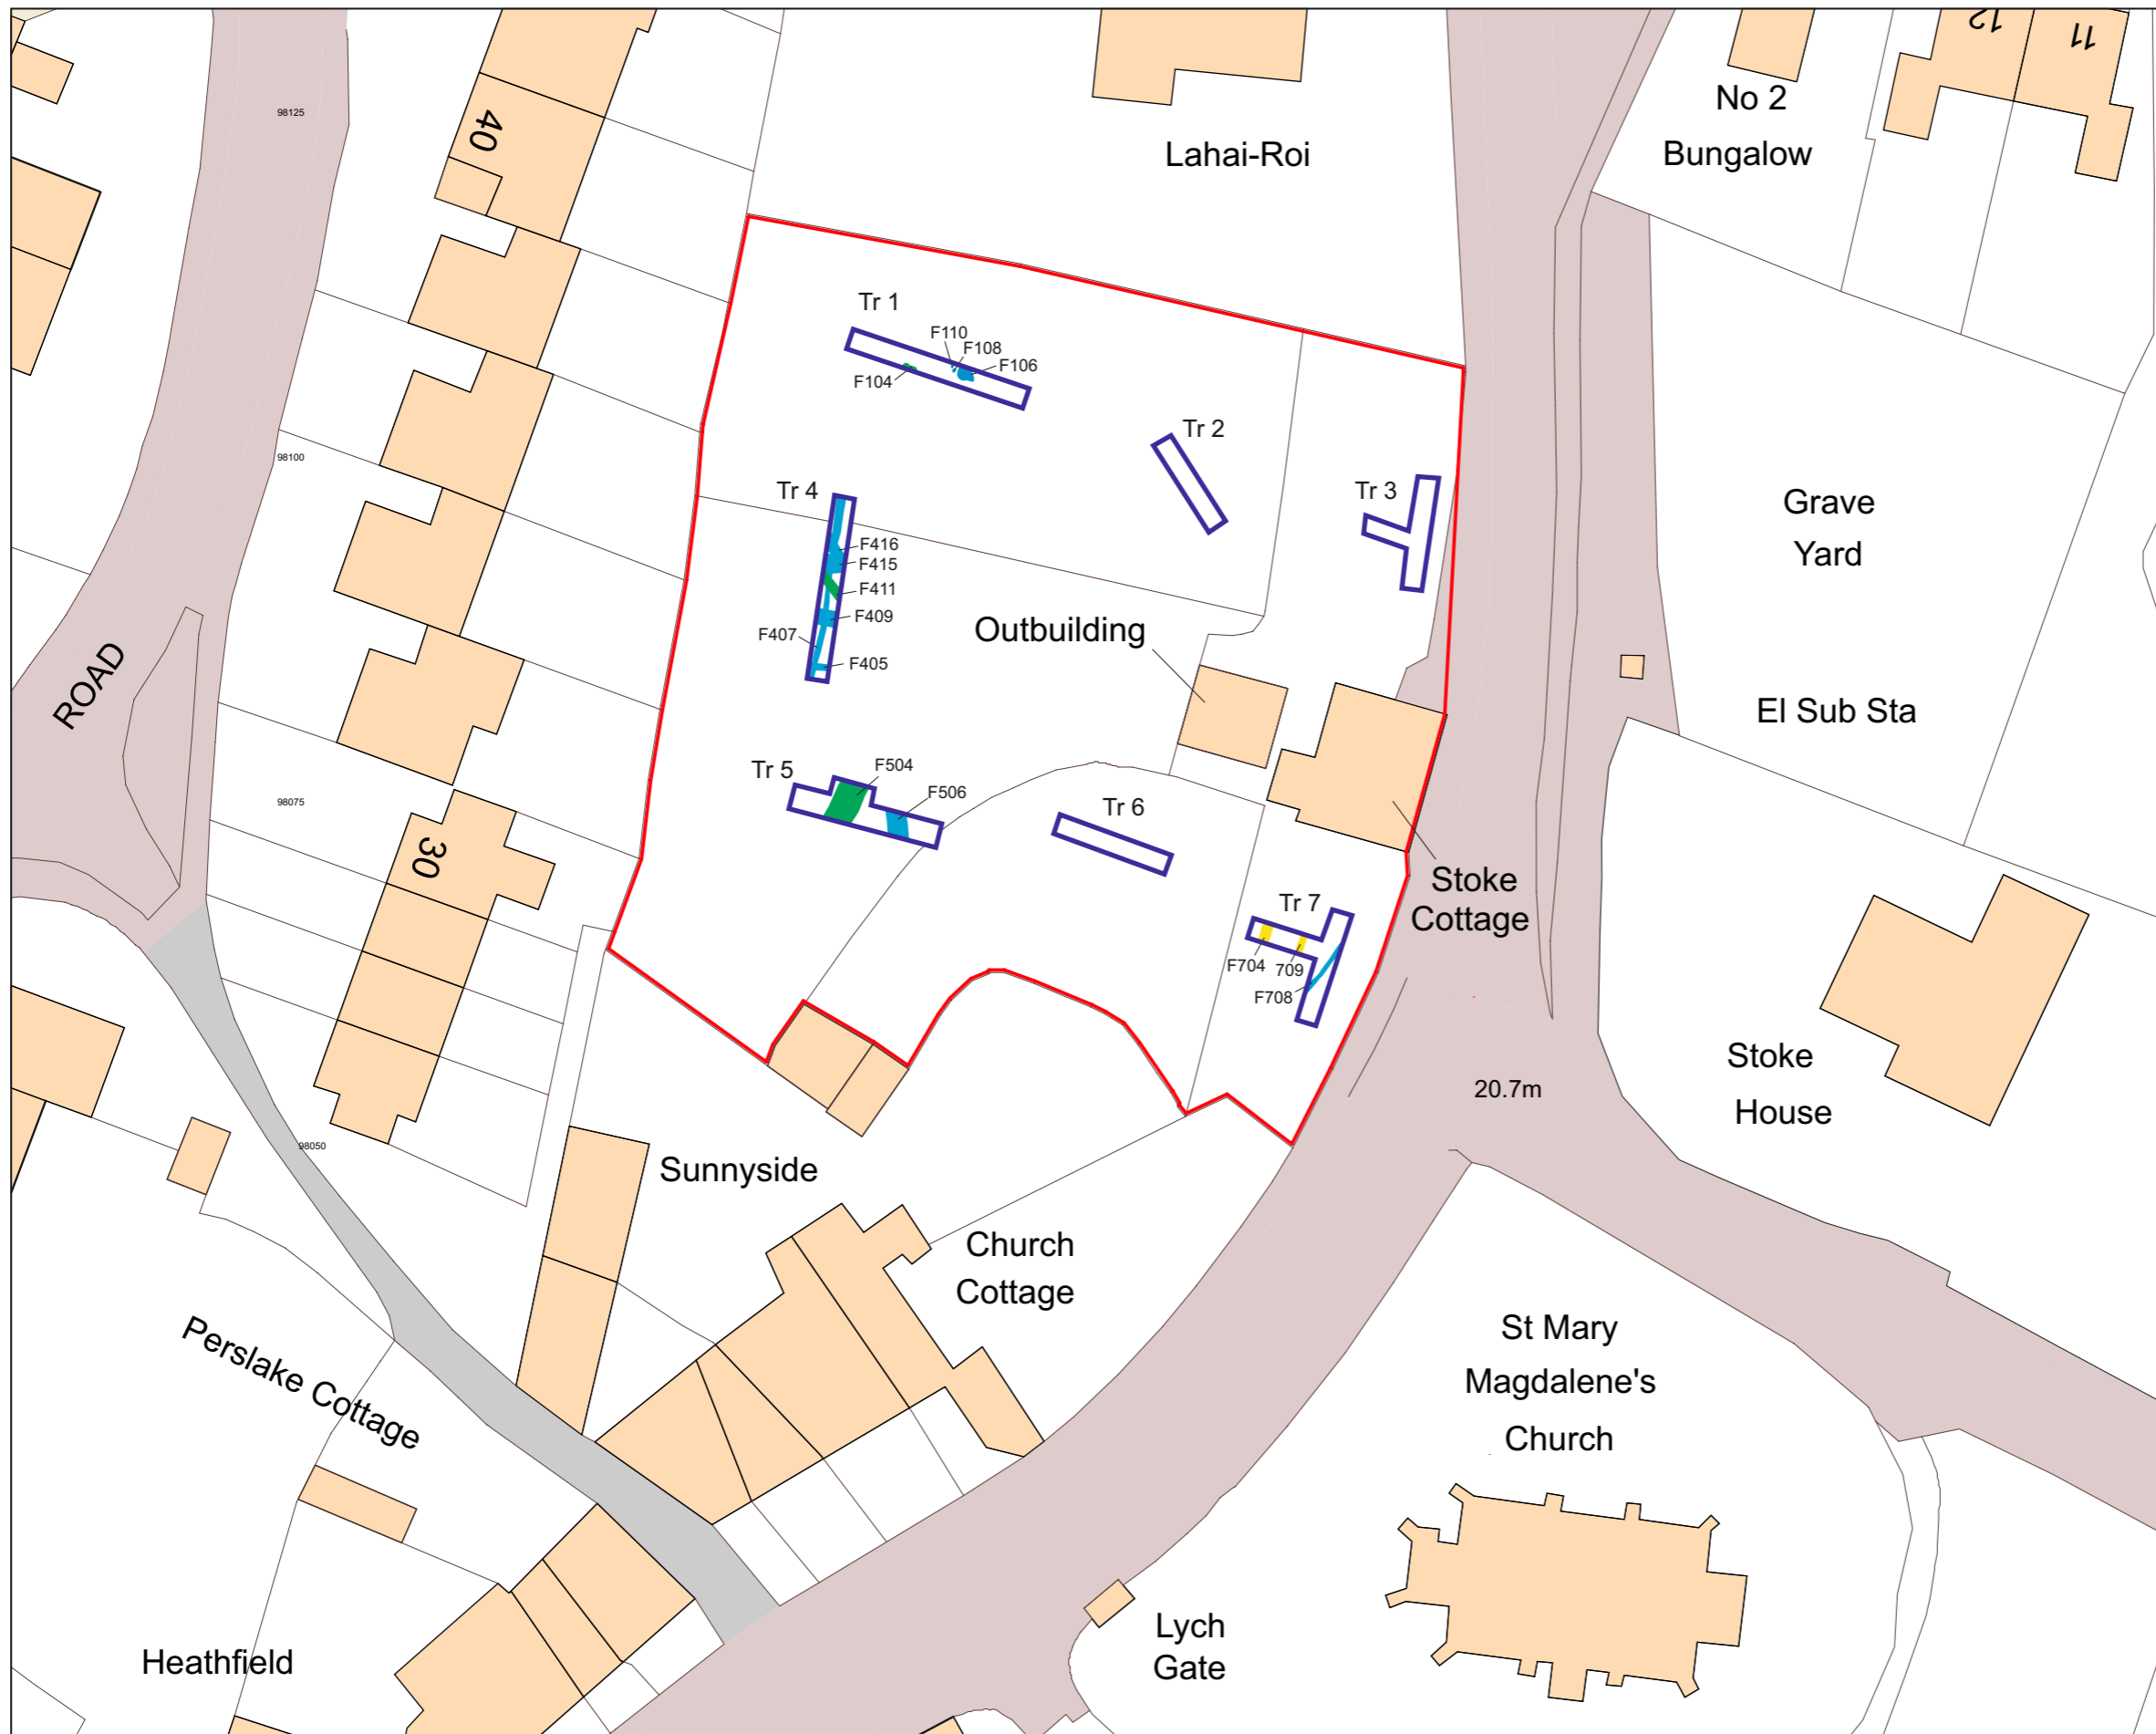
- Application area
- Trial trench with archaeological features shown
- Prehistoric
- Medieval
- Post-Medieval

- 4.1 The trial trench evaluation was undertaken in accordance with the Chartered Institute for Archaeologists' document *Standards and Guidance for Field Evaluation* (revised December 2014). It comprised the machine-excavation of seven trenches totaling 72m in length and with each trench 1.5m wide. These were positioned to provide sample coverage of available areas of the site (Fig. 5).

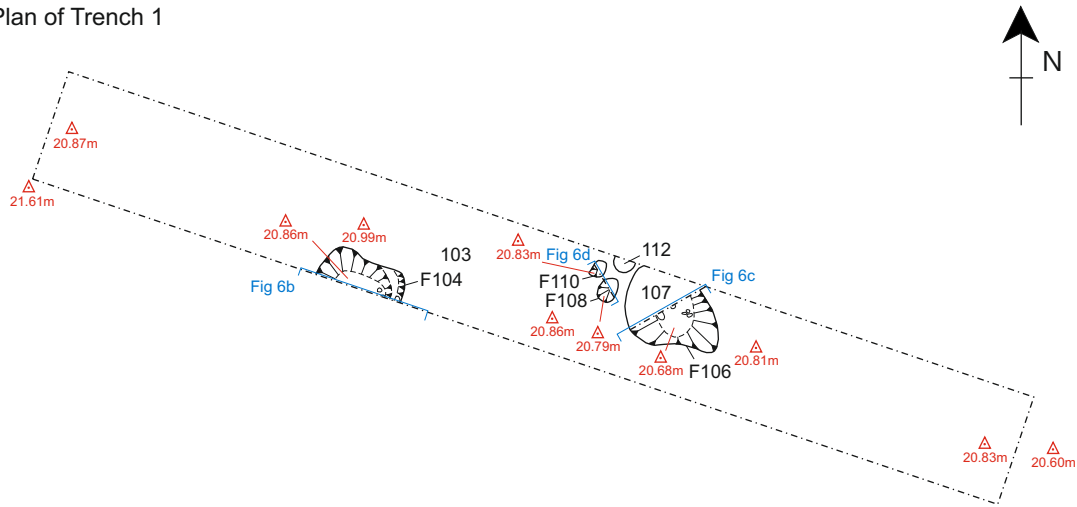
b) Section of pit F104

Pit F104 measured 1.25m across and 0.2m deep with moderately-steep sloping sides and a gentle concave base. It contained a mid reddish-brown silty-clay fill (105) from which a sherd of possible Middle Neolithic pottery was recovered.

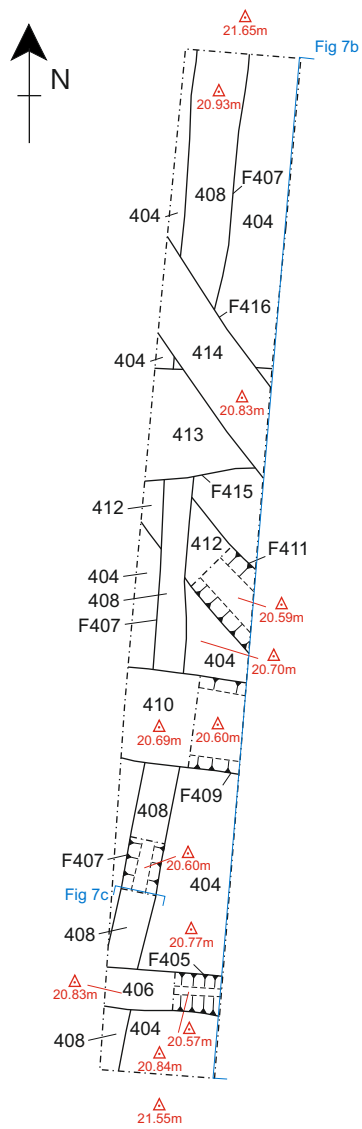
b) Section of ditches F405, F409, F411, F415 and F416

The earliest in the intercutting ditch series was F411, which extended northwest to southeast across the middle of the trench. It measured 0.75m wide and 0.34m deep with moderately-steep sloping sides and a concave base. The ditch contained a mid brownish-red silty-clay fill (112) that had a tip of small gravels extending down its northeast side. Two pieces of prehistoric worked flint were recovered from the ditch.

Ditch F407 was cut by ditches F405, F409 and F415. Ditch F405 was east to west aligned and located at the southern end of the trench. It measured 0.76m wide and 0.4m deep with moderately-steep sloping sides and a concave base. The ditch contained a mid brown silty-clay fill (406) that had occasional gravel and rare charcoal inclusions. One sherd of medieval pottery and a piece of iron slag were recovered from the fill.

East to west aligned ditch F409 was located to the north of ditch F405. It measured 1.48m wide and 0.28m deep with moderately-steep sloping sides and a broad flat base. It contained a mid yellowish-brown silty-loam fill (410) from which one sherd of medieval pottery was recovered.

Ditch F415 was aligned approximately parallel and to the north of ditch F410. It was 1.45m wide and contained a probable dumped deposit of mid brown silty-clay loam that was mottled with mid brownish-red clay (413). One sherd of medieval pottery was recovered from fill 413.

Ditch F416 was aligned northwest to southeast and cut across ditch F415. It measured 0.8m wide and contained a mid brown silty-loam fill (414). One sherd of medieval pottery was recovered from the ditch.

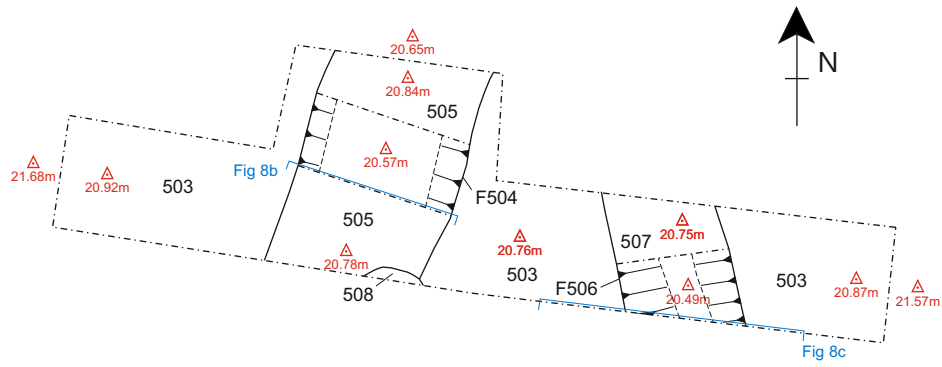
b) Section of ditch F504

Ditch F504 measured 2.15m wide and 0.23m deep with gradual sloping sides and a flat base. It contained a mid brownish-red silty-clay fill (505) that had common cobble and gravel and occasional charcoal fleck inclusions. Finds recovered from the ditch included a sherd of Iron Age pottery, three worked flint flakes and an iron bar fractured into four sections.

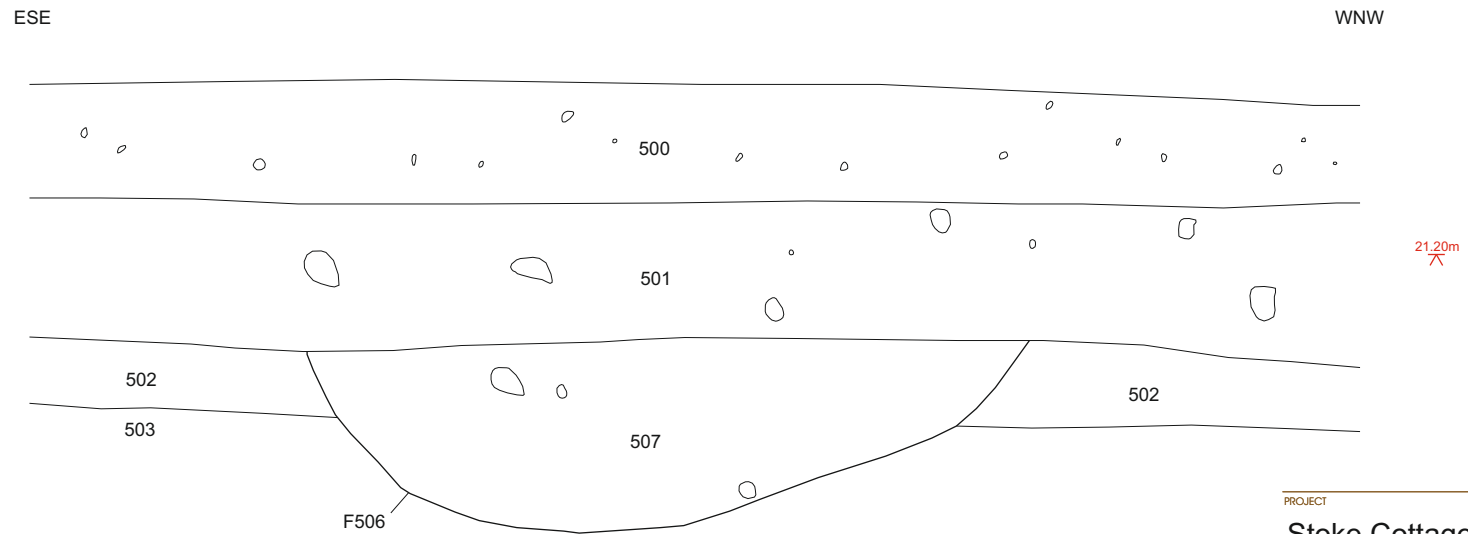
c) Section of ditch F506

Ditch F506 measured 1.48m wide and 0.5m deep with moderately-steep sloping sides and a flattish base. It contained a mid brown silty-loam fill (507) that had patches of

red clay and occasional gravel, volcanic stone rubble and charcoal fleck inclusions. Two sherds of medieval pottery was recovered from the ditch.

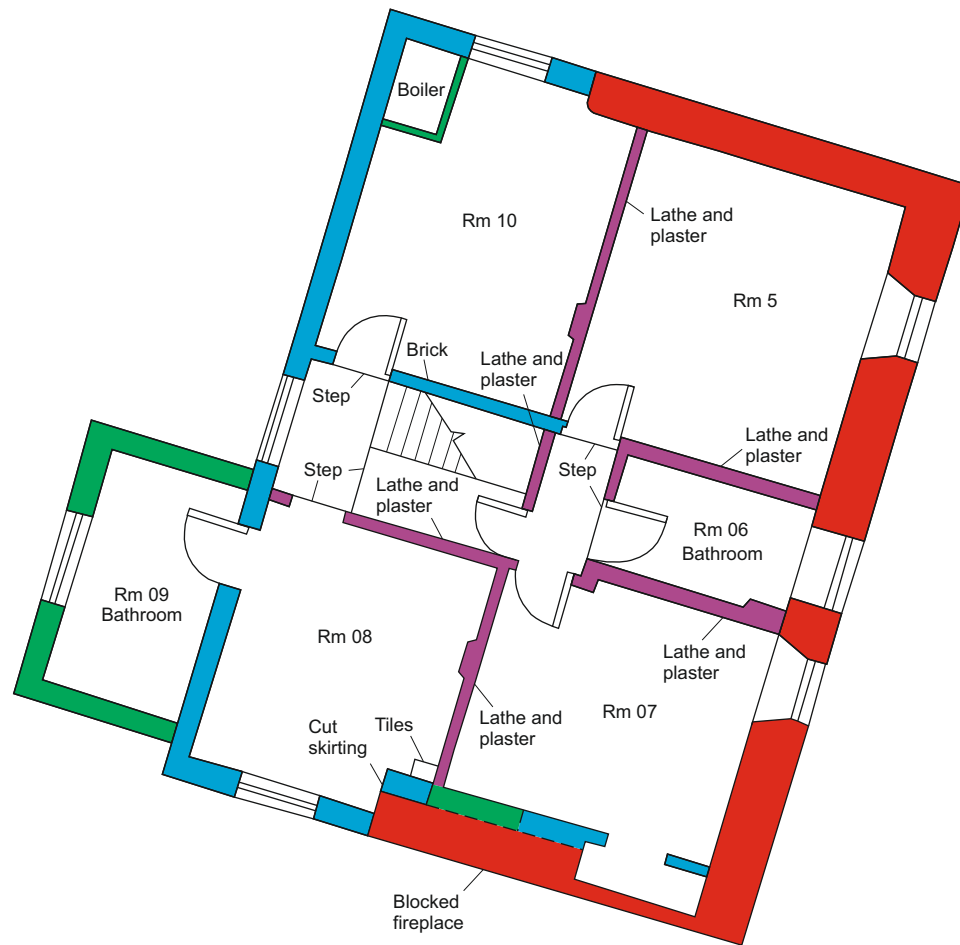
TITLE
Fig. 11: First-floor phased plan of Stoke Cottage

First floor

In the early 20th century the building underwent a phase of remodelling, the property appears as a single dwelling by the 1969-1970 25-inch Ordnance Survey map. The first floor arrangement dates to the early 20th century when the lath and plaster partition walls were inserted. It also is likely that the staircase was replaced at this time and the higher skirting with simple detail was added to some of the rooms, potentially the picture rails of the property were added at this time. The wainscoting in Room 1

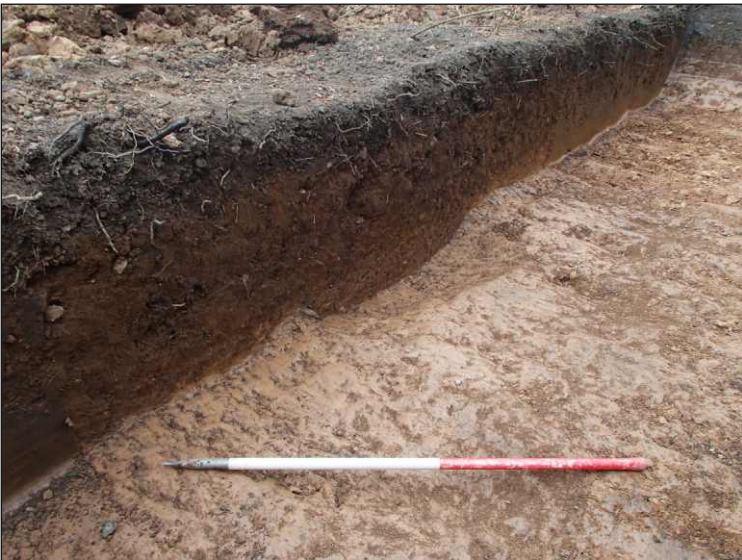
Plate 3: Trench 1, possible pit F104. View to southwest (scale 1m)

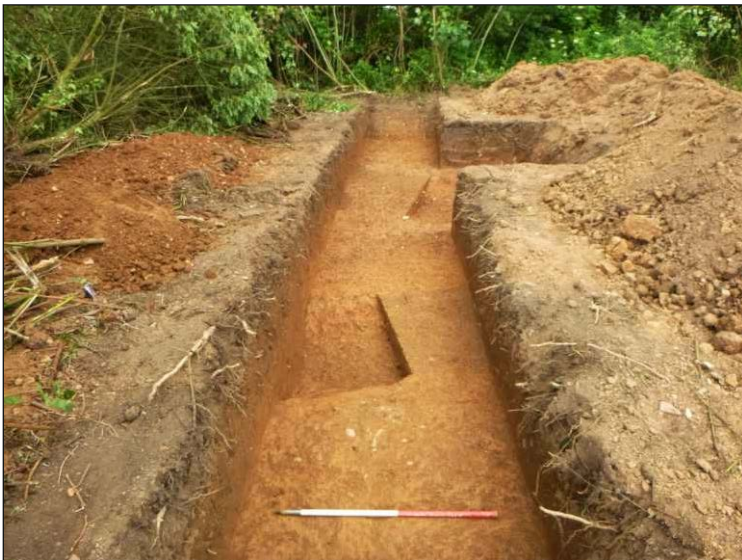
Trench 5 was excavated onto natural subsoil, which was exposed at a depth of 0.86m below existing levels. It was overlain by a weathered natural subsoil layer (502), a mid brown silty-loam subsoil (501) and garden soil (500). One sherd of Iron Age pottery, a post-medieval ridge tile fragment and a piece of iron slag were recovered from subsoil 501. The trench contained two probable ditches (F504 and F506) and a possible pit F508 that were cut into the layer 502 and sealed by subsoil 501.

Plate 5: General view to Trench 5, looking to west. (scale 1m)

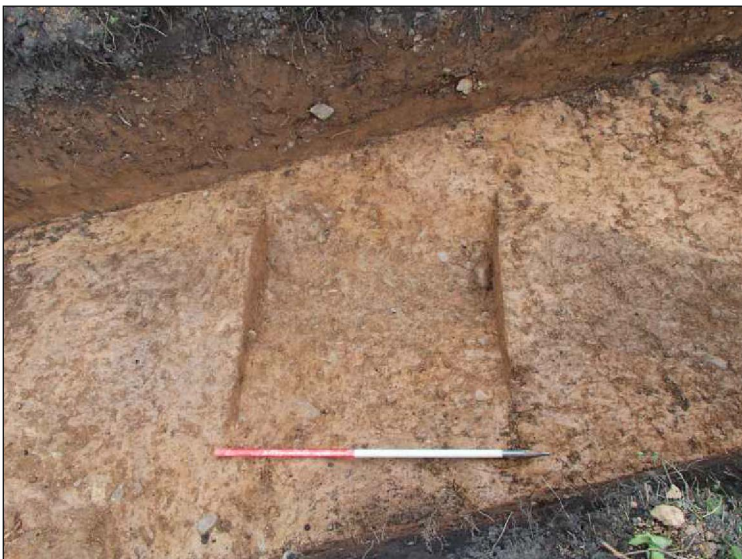
Ditch F708 measured 0.92m wide and 0.22m deep with moderately-steep sloping sides and a concave base. It contained a charcoal-rich mid brownish-grey silty-clay dumped basal fill (707) that also had common cobble and gravel inclusions. This was overlain by an accumulation of light reddish-brown clay (706). One sherd of medieval pottery was recovered from basal fill 707. A soil sample taken from fill 707 contained charcoal and charred plant macrofossils including cereal grains.

Plate 6: Trench 7, ditch F708. View to northwest. (scale 1m)

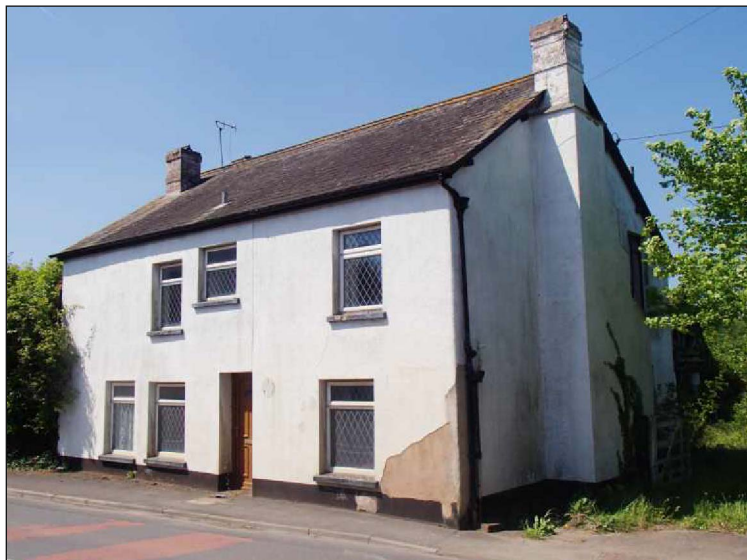
Plate 7: North gable end and east elevation of Stoke Cottage, looking west-southwest

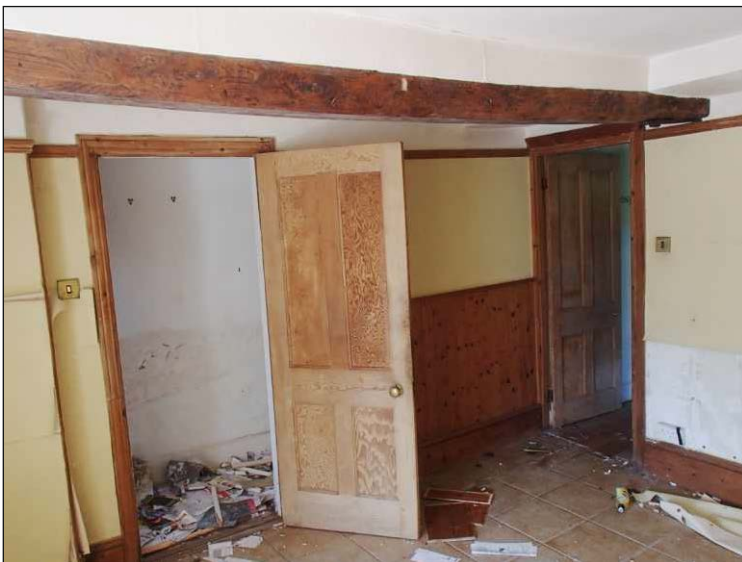
Plate 11: Room 1, showing chamfered beam, stripped timber doors, wainscoting, skirting and picture rail, looking southwest

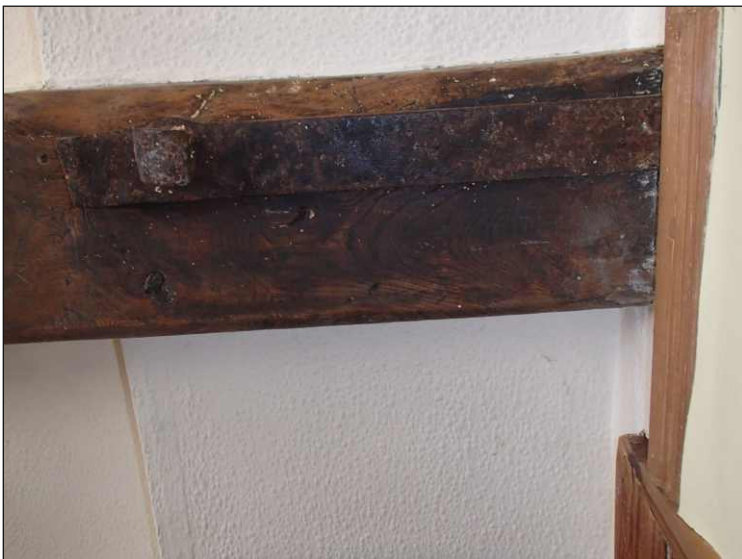
Plate 12: Room 1, detail of iron strap and bolt fitting to beam at west end, looking south-southwest

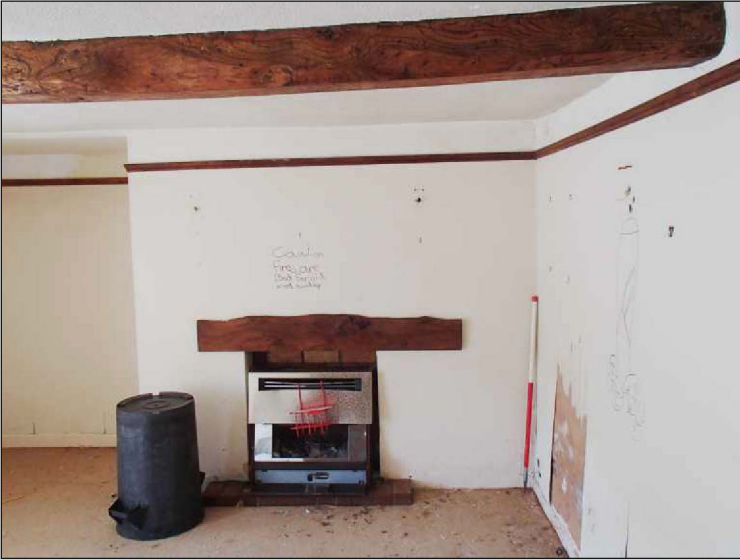
Plate 13: Room 2, showing earlier chimney breast along the south elevation and the chamfered beam, looking south-southwest. (1m scale)

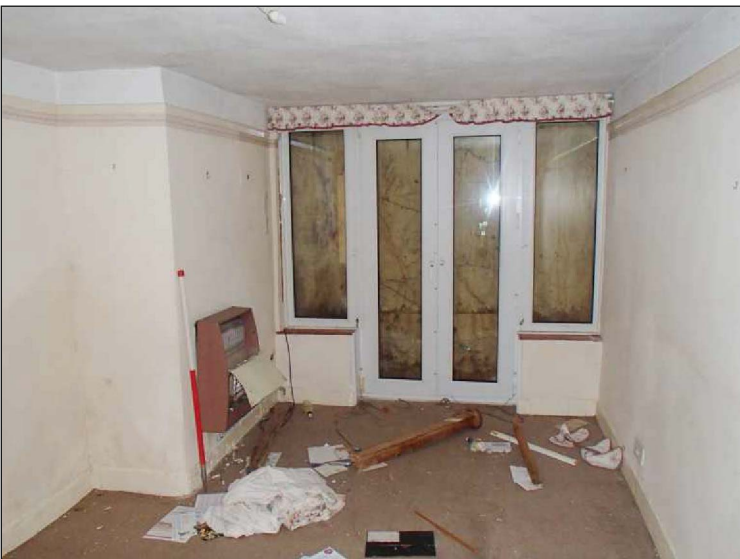
Plate 15: Room 4, view to modern French doors and possible chimney breast on east elevation, looking south-southwest. (1m scale)

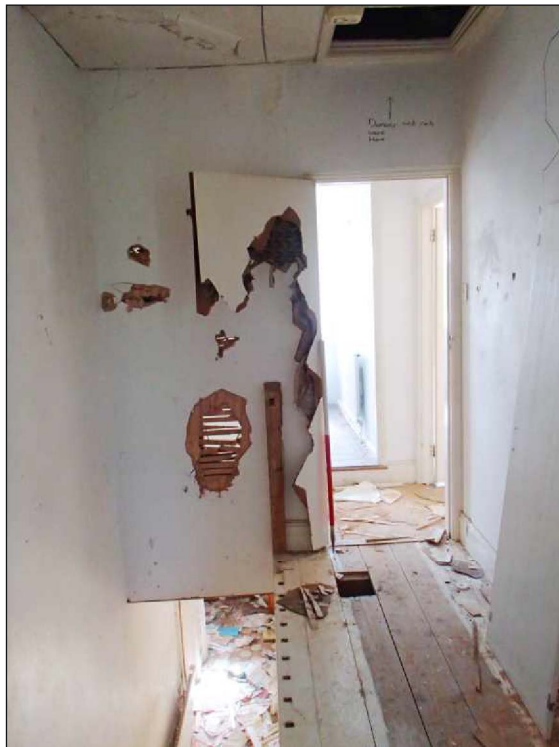
Plate 16: First floor landing, showing lath and plaster partition wall and location of removed railings, looking east-southeast. (1m scale)

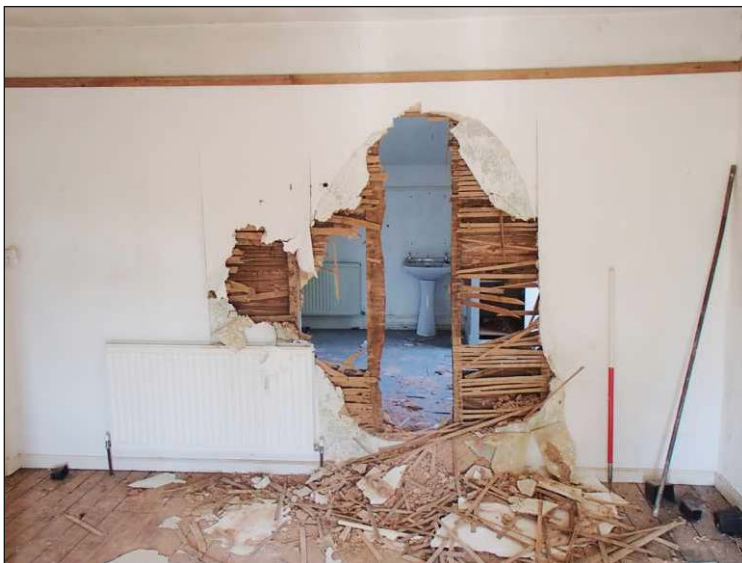
Plate 17: Room 5, showing the lath and plaster west partition wall, looking west-northwest. (1m scale)

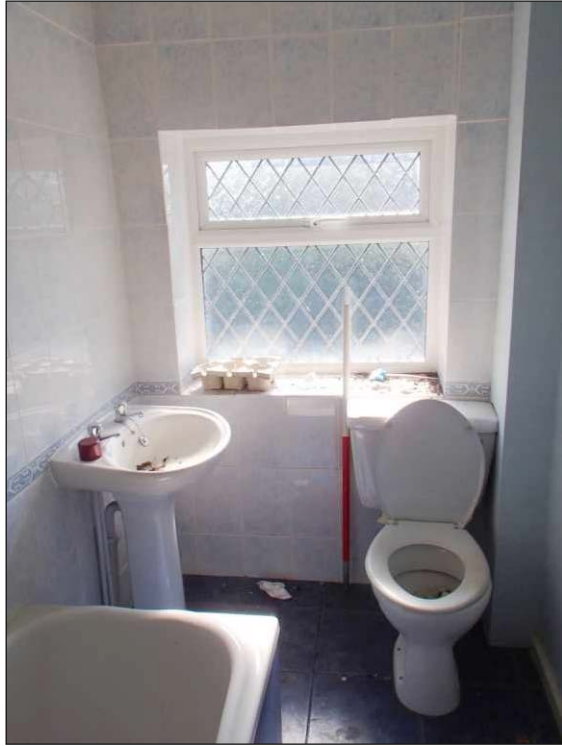
Plate 18: Room 6, showing modern finish and modern window insertion, looking east-southeast. (1m scale)

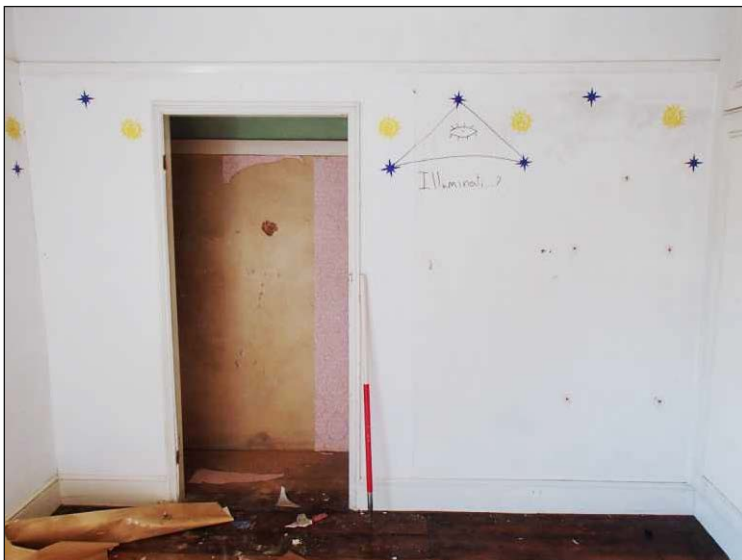
Plate 19: Room 7, showing recess at east end of south elevation and blocked fireplace to west side, looking south-southwest. (1m scale)

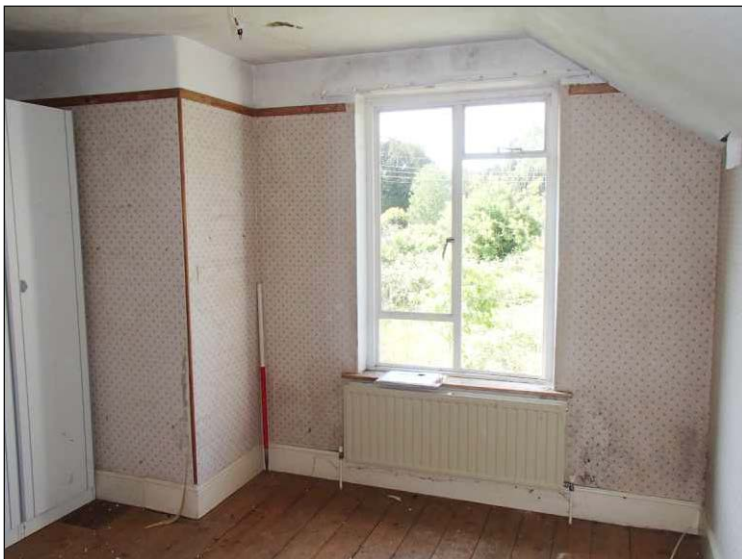
Plate 20: Room 8, showing blocked fireplace at east end of the south elevation, looking south. (1m scale)

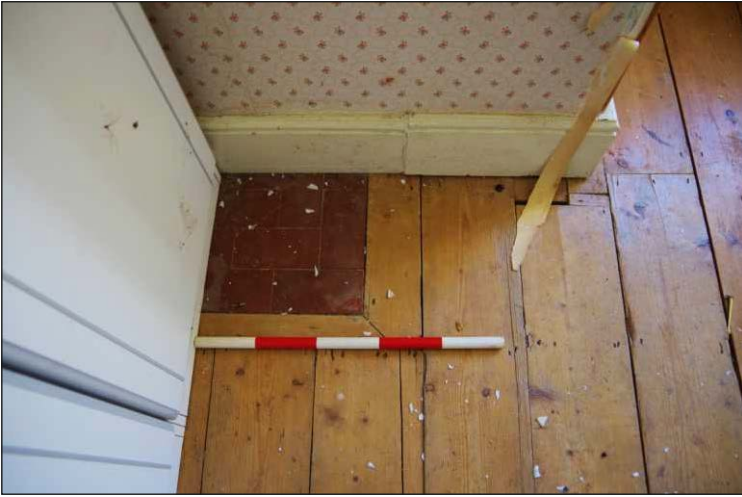
there are some tiles indicating a heath and the skirting boards in this area have been cut and repaired. The fireplace likely dates to the late 19th century, the floorboards and skirting of the room look to be of a similar date. There is a picture rail in the room which looks to be a later insertion.

Plate 21: Room 8, detail of fireplace tiles and replaced skirting, looking south-southwest. (0.5m scale)

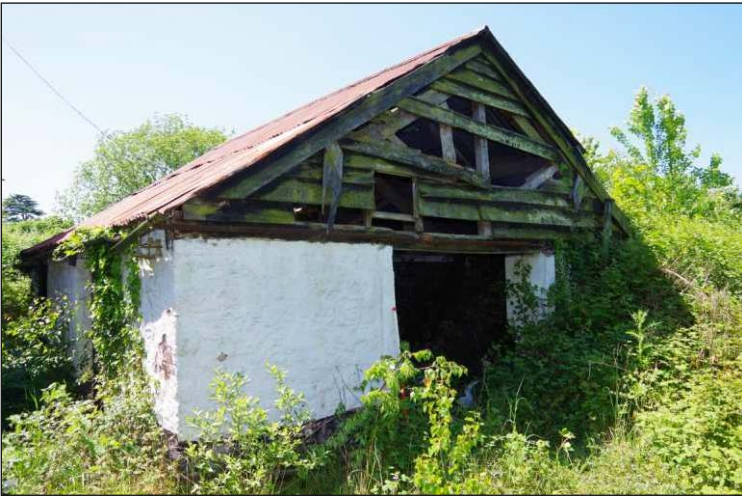
The north gable end of the building is constructed of painted rubble stonework, with degraded shiplap timbers covering the truss section of the building. Roughly centrally located there is a large late 20th century opening which likely once held a garage door. It has a cast iron I-beam lintel and the east side has brick repair to the reveal with possible concrete repair to the west side reveal. Obscured by vegetation is a doorway which appears to be fitted with a plank and batten door. The wide planks with beading down one side and the detail of the strap hinges suggest a probable late 18th century date. This door is fitted within the late 19th century extension of the building, suggesting that the door was re-used.

Plate 22: North and east elevation of the outbuilding, looking south

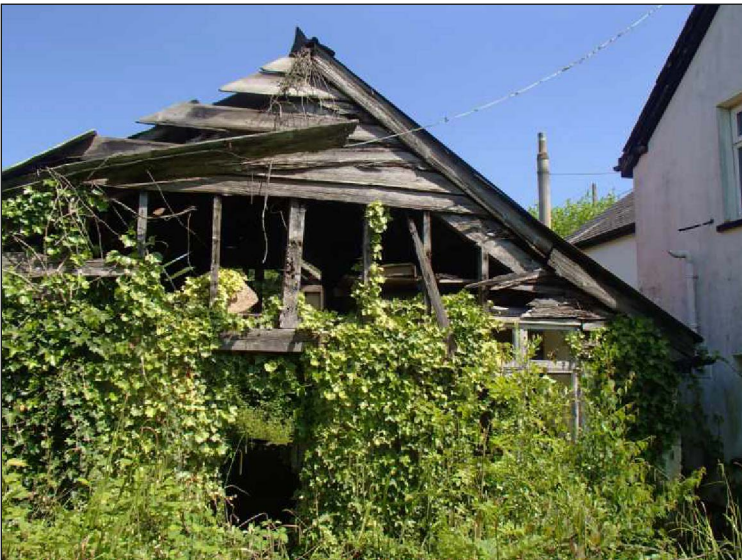
Plate 23: South elevation of outbuilding, looking north-northeast

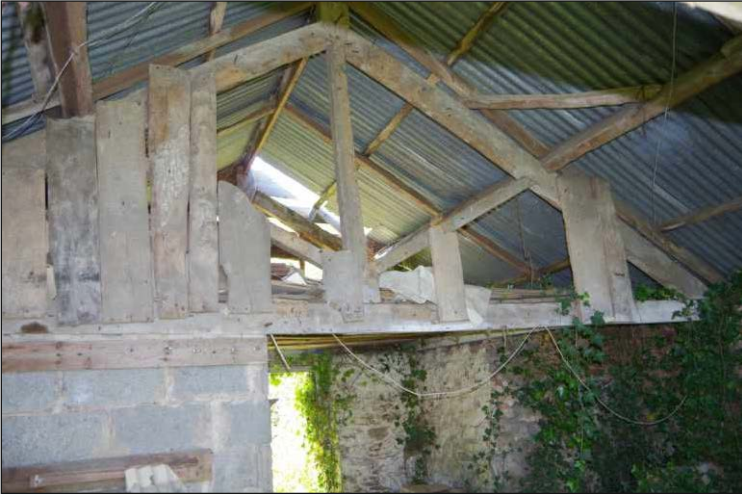
The gable roof is a late 19th century insertion correlating to the construction of the extension of the building to the west. It has a two bay roof with the A-frame trusses of a king post with diagonal support struts design. The south gable end truss is missing its diagonal struts but appears to have had vertical struts inserted as a repair. The trusses themselves look to be of an earlier 19th century construction and may have come from the main house as they both appear to have had extension in the late 19th century. The roof is constructed of corrugated tin overlaying corrugated asbestos, attached to purlins and rafters of a probably late 20th century date.

Plate 24: View of interior of outbuilding, showing central A-frame truss, looking southwest

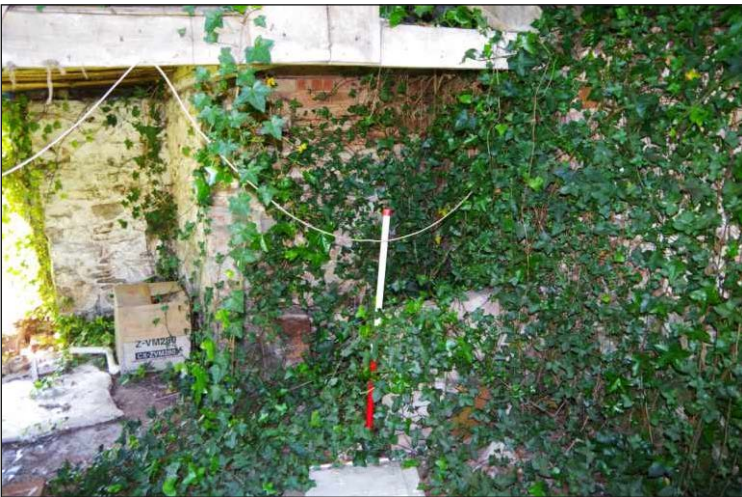
The interior of the outbuilding has exposed rubble stonework walls bonded with a pinkish-buff lime mortar, with paint remnants in places. There is a mezzanine platform above the south half of the building which is partially boarded with vertical rustic planks, some of which the bark remains. In the south west corner of the room within the late 19th century extension there is a probably late 20th century brick wall aligned east-west forming a small room which can only be accessed from the exterior south elevation. Directly to the north of this is late 20th century low wall constructed of concrete, this area looks to have been used as a coal store. In the southeast quarter of the outbuilding there is a late 20th potentially early 21st century breeze block construction forming a room that can only be accessed from the exterior east elevation, this room has a modern finish of painted plaster walls and ceiling.

Plate 25: View to southwest corner of the interior of the outbuilding, looking south-southwest. (1m scale)

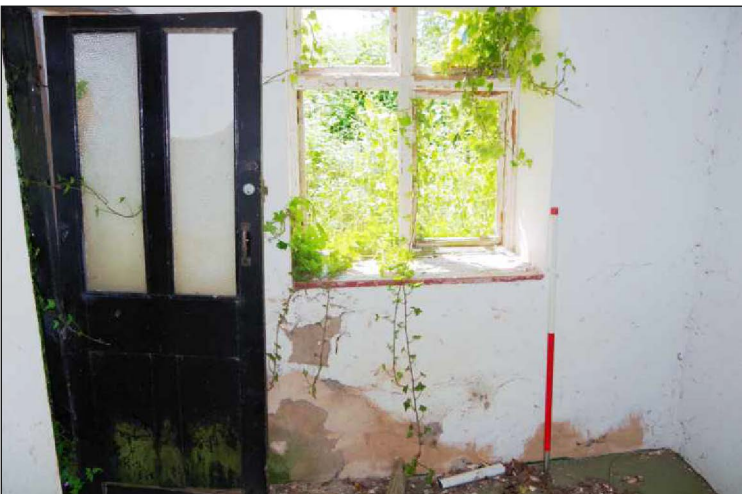
Plate 26: Room in the southeast corner of the outbuilding, looking south-southwest. (1m scale)

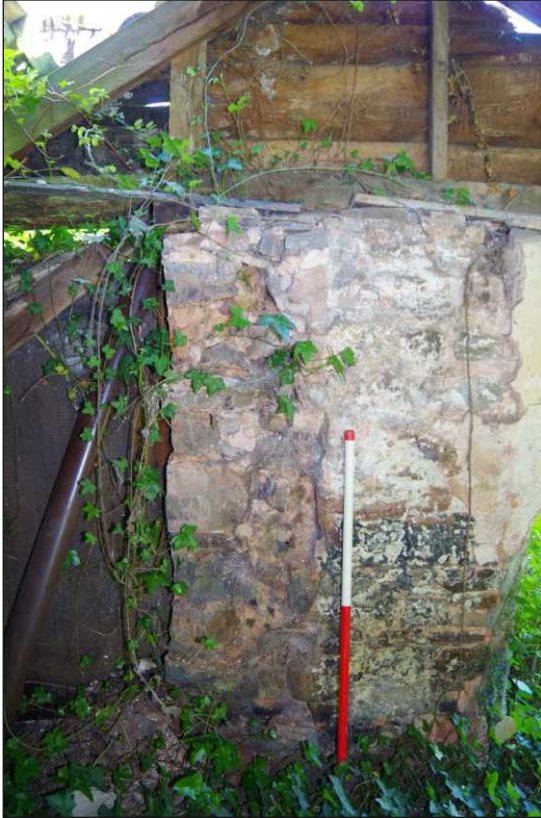
Plate 27: Internal stub wall towards west end of the north elevation, north-northeast. (1m scale)

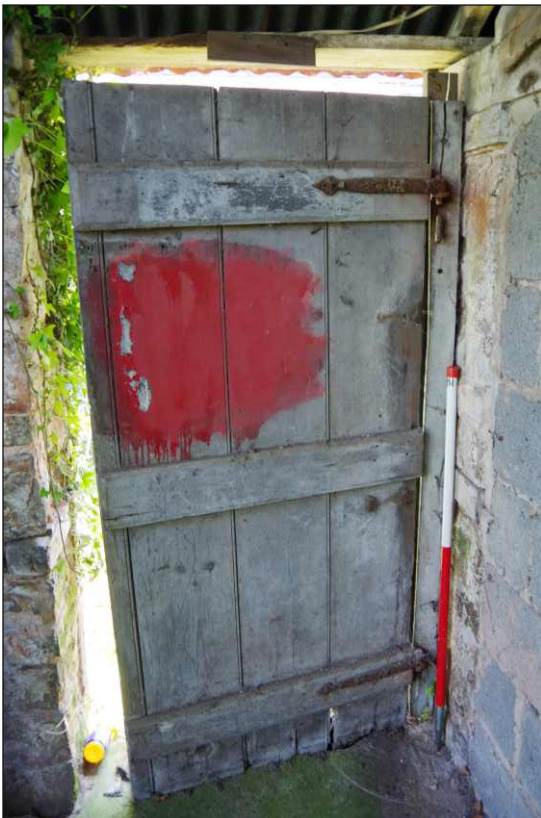
Plate 28: Detail of plank and batten door on east elevation of the outbuilding, looking east-southeast. (1m scale)
