DARLING COTTAGE, MANOR STREET, DITTISHAM,
DEVON

Results of historic building recording

South Hams District Council planning ref. 0902/17/LBC,
condition 3

Document No: ACD1623/2/0

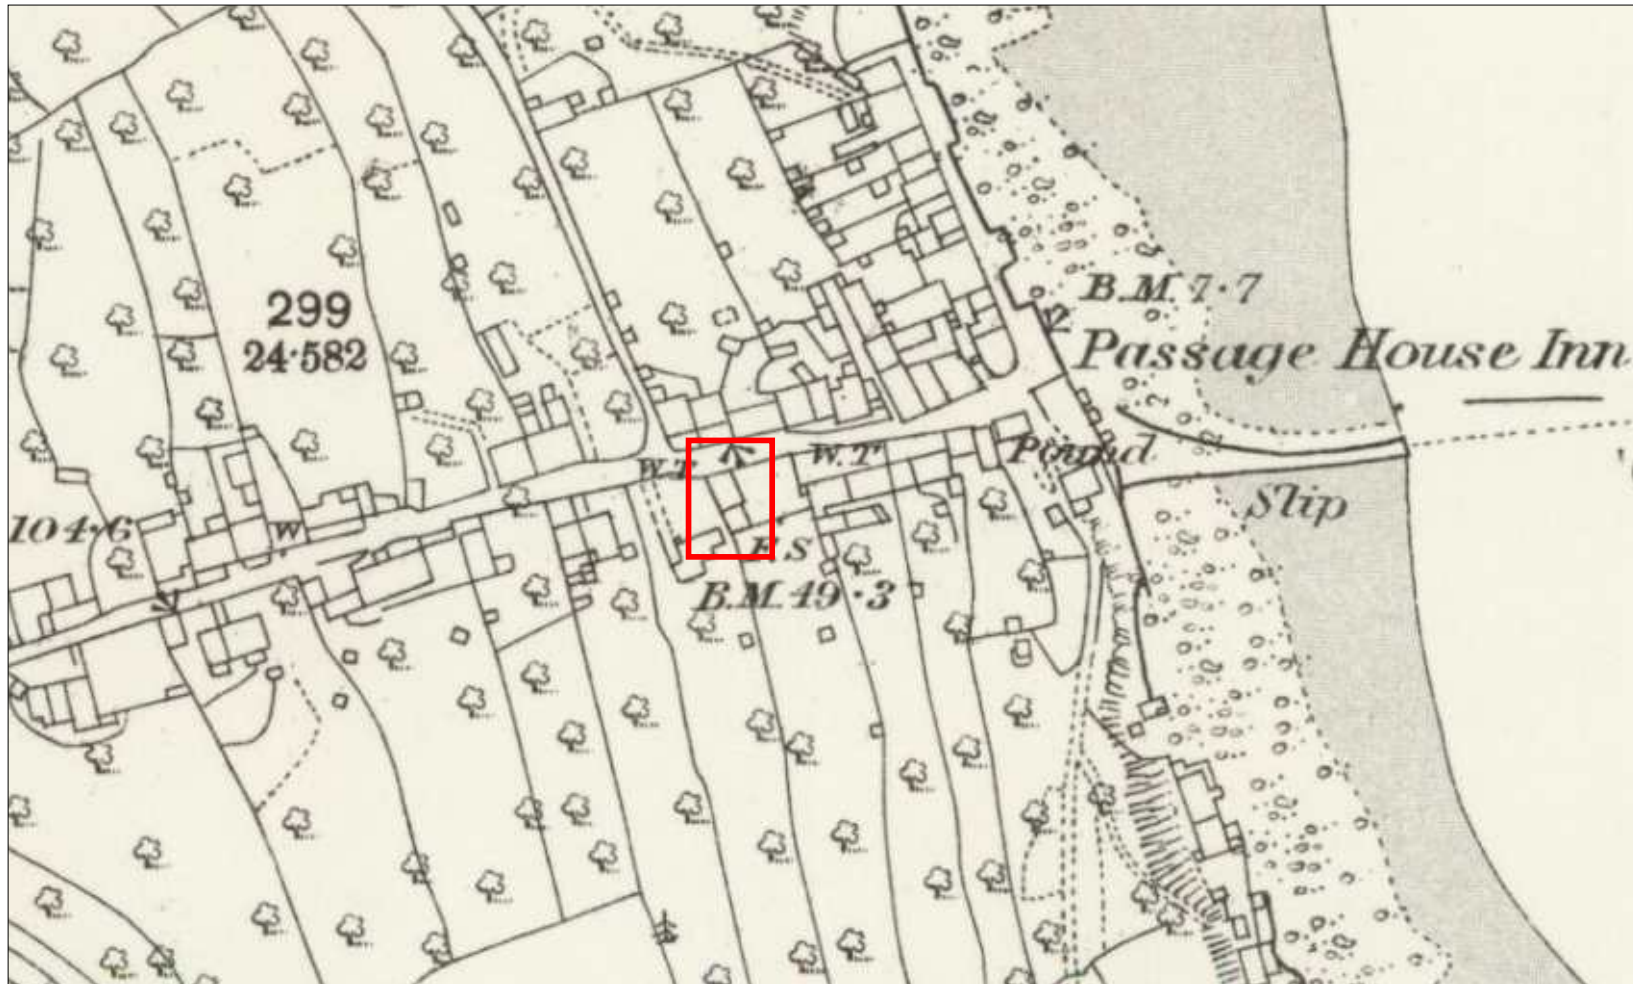
Fig. 3: Extract from the First Edition 25-inch Ordnance Survey map, 1890

- 4.2 The first edition 25-inch Ordnance Survey map of the area published in 1890 records an extension to the south side of the house, and that both the earlier structure and this extension were situated within a smaller plot subdivided from the land to the south (Fig. 3). The latter was still recorded as an orchard.

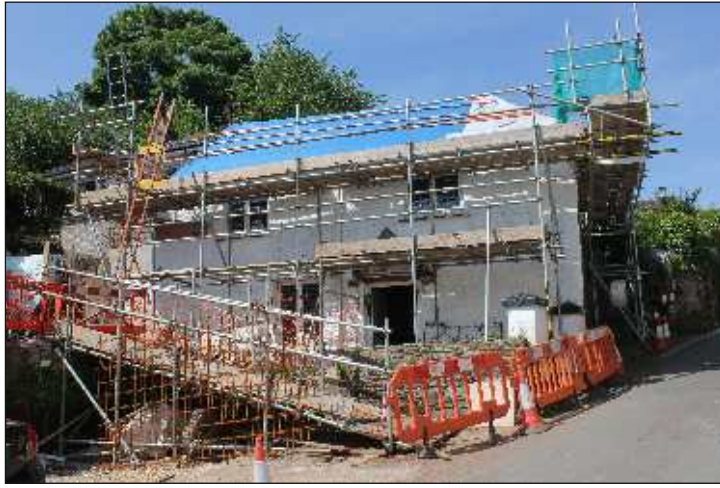
- 5.1 The cottage is a two-storey building under a part-hipped roof, set at right angles to Manor Street (Plate 1). It is constructed of local stone bonded in both red-brown earth and lime mortars, finished externally with a lime render coated with several 20th-century paint layers, and with a black band to the base of the walls. It is situated in the northeast corner of the plot, terraced into the hillside that rises up to the west and south. To the east is a parking bay, again terraced into the hillside, and beyond, gardens rise up to the south.

- 5.3 The east elevation incorporates a ground-floor doorway offset to the right of centre. The door itself is a 20th-century replacement, with a planked lower panel and a stained glass upper panel. The canopy over the door, recorded in the Listed Building description, has been removed as part of the previous consented works. To the left of the door there is a pair of 20th-century 2-light casement window fitted with leaded glass. Above the window is a long slate drip mould that extends beyond both sides of the opening. On the first floor there are 20th-century 2-light casement windows fitted with leaded lights; these are offset towards the gable ends of the cottage. As noted above, other than just below the eaves the northeast corner of the elevation steps in from the rest of the wall. Since the adjacent gate pier is set into this recess, this must be an early feature.

Plate 1: The cottage viewed looking west up Manor Street showing the principal east elevation

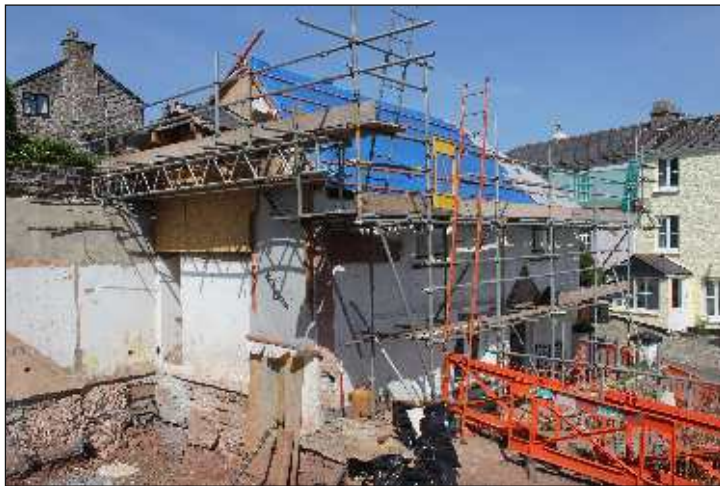
- 5.4 At the east end of the elevation is a ground-floor doorway that formerly led into the recently-demolished extension. At the west end is a second, mid-height doorway that also formerly provided access into the extension. Visible externally within this

opening are concrete steps leading down out of the cottage. This elevation, which was until recently internal to the extension, is finished with concrete render.

Plate 2: The east and south elevations, looking northwest. 1m scale

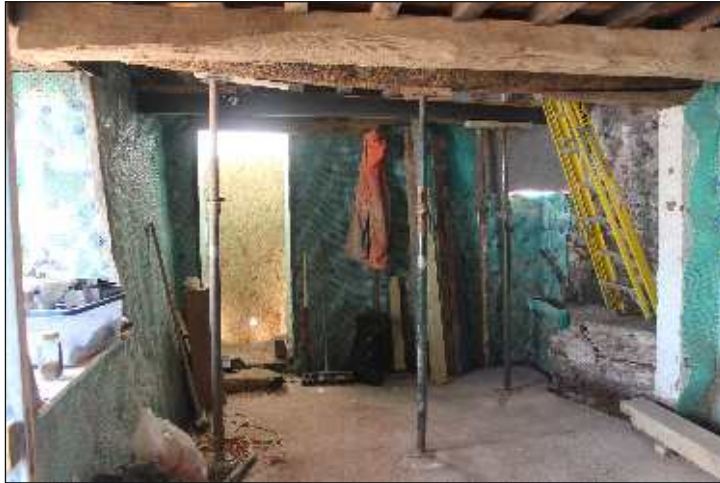
- 5.5** Internally the ground floor is a single space, with a 20th-century concrete floor and stone walls lined with a plastic membrane (Plate 3). The front door is set within a wider recess where the masonry to the north of the door is narrower than the rest of the walls (Plate 4). The lintel over the door passes across this narrower masonry into the thicker wall beyond. The thinner section of wall still retains 20th-century cement render onto which the live incoming electrical connection is fitted; any relationship with the adjacent wall is obscured by this render.

Plate 3: The ground floor showing the inserted openings in the south elevation, looking south. 1m scale

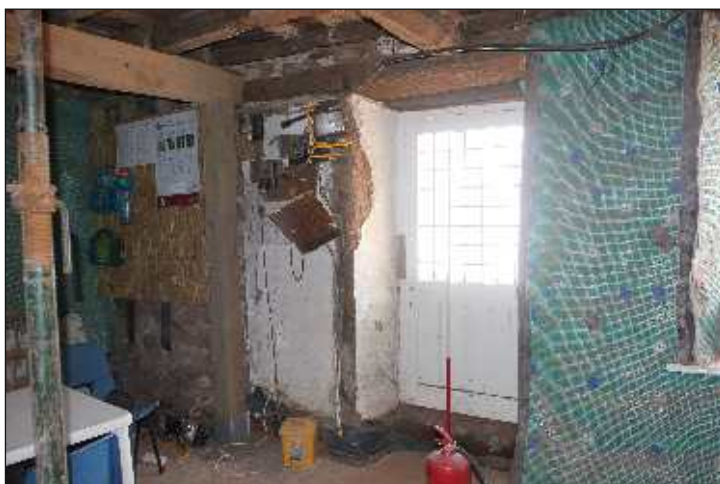
Plate 4: The ground-floor east wall showing narrower masonry adjacent to the front door, looking northeast. 1m scale

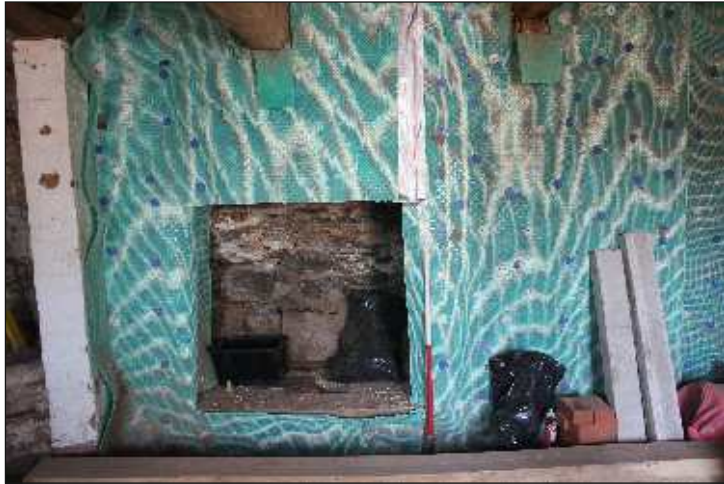
- 5.6** In the centre of the north wall is a projecting chimney stack and fireplace with a brick hearth (Plate 5). The fireplace has been altered with concrete lintels supporting the masonry above. On the south side of the opening these are laid onto concrete blocks, whilst the east side appears to incorporate a blocked bread oven – the fireplace is offset to one side of the stack allowing for such a feature within the wider masonry – with bricks and concrete blocks used for the infilling and to support the lintels.

Plate 5: The ground-floor fireplace, looking west. 1m scale

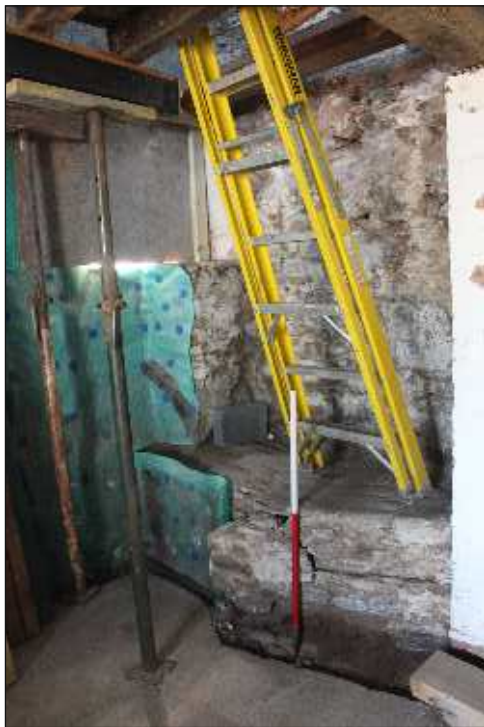
- 5.7** To the south of the fireplace is an area of flat masonry, raised 0.65m up from the the floor (Plate 6). The feature has an angled internal face, which reflects the addition of further stonework at the north end. The flat slabs across the whole of this feature are part of the additional masonry. This area most recently contained the stairs to the first floor and stairs up to the higher door in the south elevation. The stonework probably represents the base of an angled primary staircase predating the recently removed stairs.

Plate 6: The base of the stairs, looking southwest. 1m scale

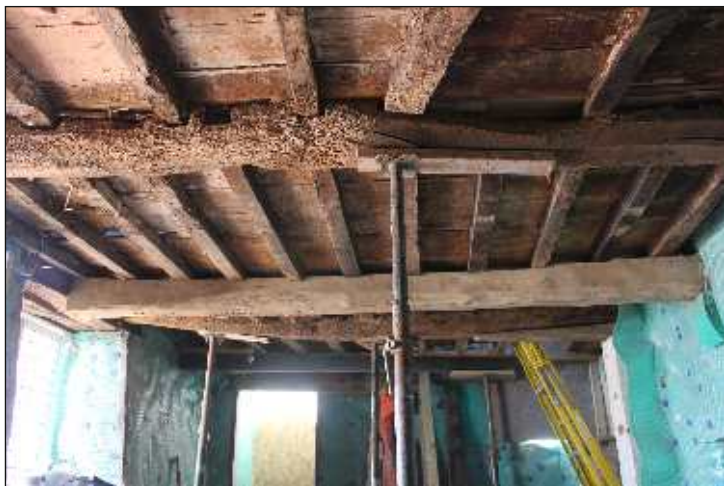
- 5.8** The first floor is supported on three primary slender beams and a slender mid 20th-century beam near the stairs, along with a newly-inserted beam; a late 20th-century central beam has also been replaced (Plate 7). The primary beams are heavily rotten; however, they display chamfers but without stops. There are abundant old nails visible indicating that they have previously been covered with lath and plaster. One has been braced with a nailed lower support resting on a later brick pier adjacent to the fireplace. The east ends of the beams are set into the door and window lintels. The west end of the southern primary beam, adjacent to the south wall has been cut back to allow the insertion of the mid-level doorway in the south elevation. The original joists are square and set into the tops of the beams. Some replacements, mainly in the east bay, are offset from the originals, and are fixed into new mortices using tenons. The boards above are wide and probably date to the 18th century, and are covered with later tongue-and-grooved boards.

Plate 7: Part of the first-floor structure, looking south.

6.6 There is no clear evidence for 17th remodelling as put forward in the Listed Building description. The surviving early bridging beams display chamfers but no datable stops. The arrangement of the joists, set fully into the top of the beams is an early feature, and perhaps indicates that the beams are primary features. Some of the joists – mainly in the north bay – have been replaced in the 19th century.

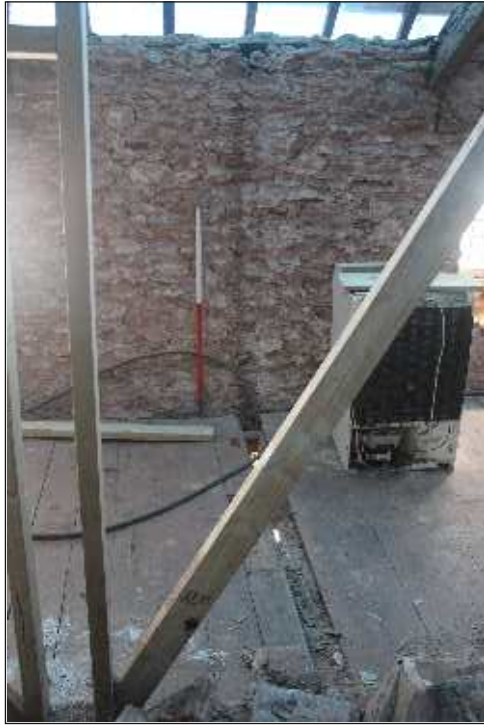
- ### **The first floor**
- 5.9** The staircase has been removed. The first floor currently has an open plan but there is a scar on the floor and east wall of a former, secondary central partition (Plate 8).

Plate 8: The scar of the former first-floor partition, looking east. 1m scale

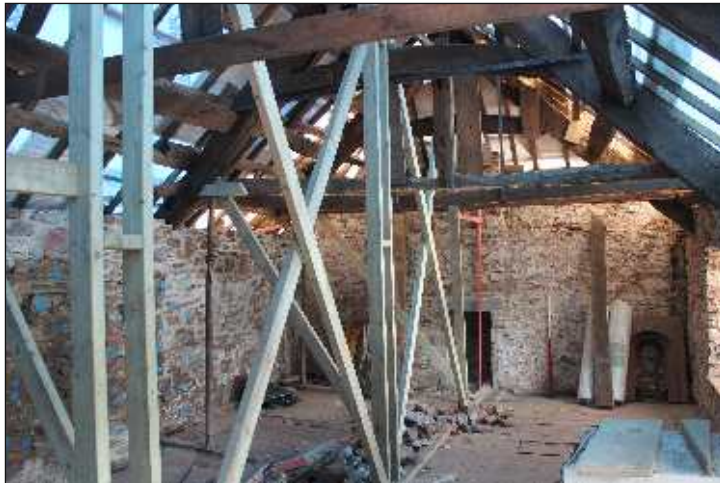
- 5.10** The west wall is curved incorporating a projecting chimney stack rising from the ground floor fireplace (Plate 9). There is no additional first-floor fireplace within this stack. To the south of the stack there is a narrow slightly splayed opening, which was probably a primary doorway (Plate 10). The north wall incorporates a small central fireplace with a slate hearth and Victorian/Edwardian grate, which has been removed from the opening (Plate 9). A late 20th-century wooden lintel has recently been replaced.

Plate 9: General view of the first floor showing stack to left and fireplace in the north wall (centre) with removed grate to the right, looking north. 1m scale

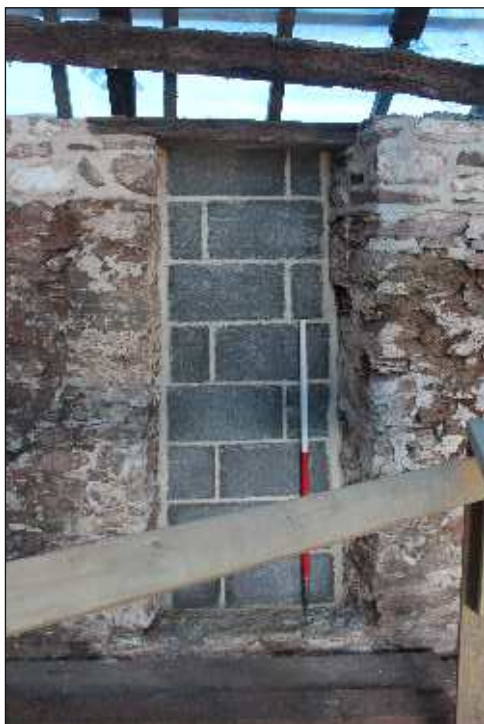
Plate 10: The first-floor blocked opening in the west wall, looking west. 1m scale

6.5 There is no clear evidence that there was more than one room on the first floor, although the presence of two windows in the front elevation may indicate that this was the case. The blocked doorway in the west elevation is a bit of a mystery. Bearing in mind the topography it cannot have led to an external staircase, and as an external door would have opened onto a separate historic (and modern) plot. An alternative explanation is that it opened onto a garderobe, although such a feature is probably too grand for a house of this scale.

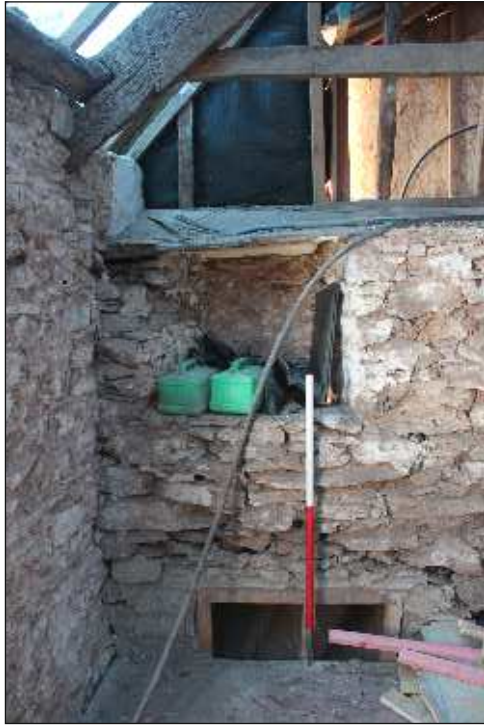
- 5.11** In the south elevation the western inserted ground-floor door rises into the stairwell (Plate 11). The eastern ground-floor doorway also rises above the first floor, and above the present angled head there is a void topped with a concrete lintel. Above is a primary splayed window lined with lath and plaster over primary painted masonry (Plate 11). The opening has been blocked externally using rubble stone. A patch of the same lime plaster is present on the wall above, possibly where the gable has been removed. This may indicate that it is of relatively late date, being associated with construction of the now-demolished historic extension.

Plate 11: The top of the ground-floor doorway with blocked first-floor window above in the south wall, looking south. 1m scale

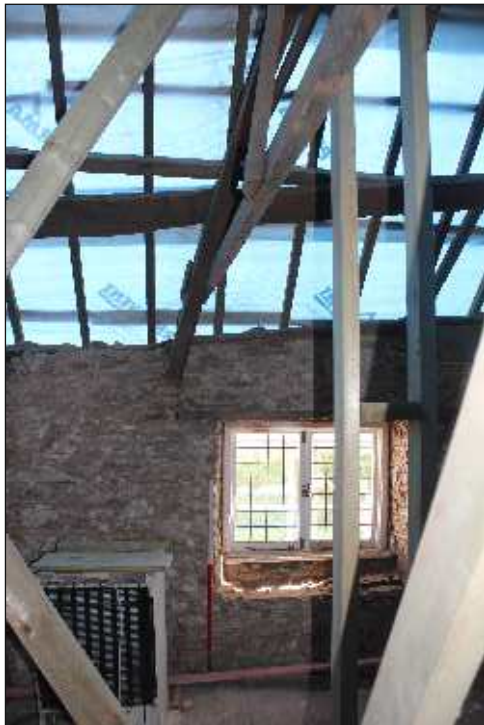
- 5.12** The roof covering, now removed, was supported on four primary A-frame trusses, which are heavily racking to the south (Plate 12). This has perhaps been partly caused by the central two trusses that are not aligned parallel to the building but are situated either side of the chimney stack in the west wall and are angled in towards each other on the east wall. The apexes of the trusses are lapped and fixed with pegs. The collars are high and slightly cambered, with mortice and tenon pegged joints (Plate 13); the cambering is a feature that indicates they were probably intended to be visible from the first-floor accommodation. The ridge purlin is set into a notch in the rafters. There are three rows of through purlins with lapped, pegged joints at the trusses (Plate 13). On the west side, within one of the central bays the lower purlin has been staggered over the (now-removed) chimney stack (Plate 14). All primary purlins either have pegs or display pegholes for the attachment of the secondary rafters (Plate 15). These partially survive on the west side of the roof. Some carpenter's marks were noted, although there was no consistent pattern. The mark 'II' was present on a truss, along with a star on a removed timber.

Plate 12: Part of the first floor showing racking of one of the trusses, looking east. 1m scale

- 5.13** Due to the racking the roof has been strengthened with additional supports. These include 18th/19th century applied lower collars and attached central vertical studs. At the northern end of the roof a primary straight gable only partially survives and the building currently has a secondary hip. At the south end the purlins continue beyond the southern truss, over the demolished gable, but there is no evidence that the roof continued beyond the wall indicating the presence of another room.

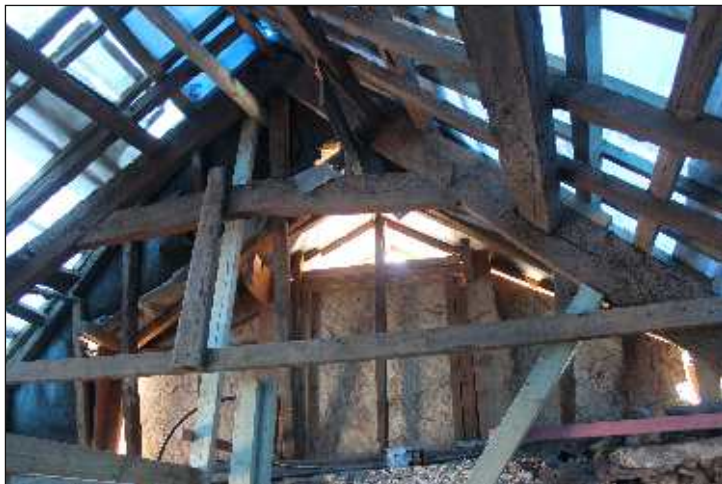
Plate 13: The south truss, showing cambered collar, lapped apexes and the through purlins, looking south

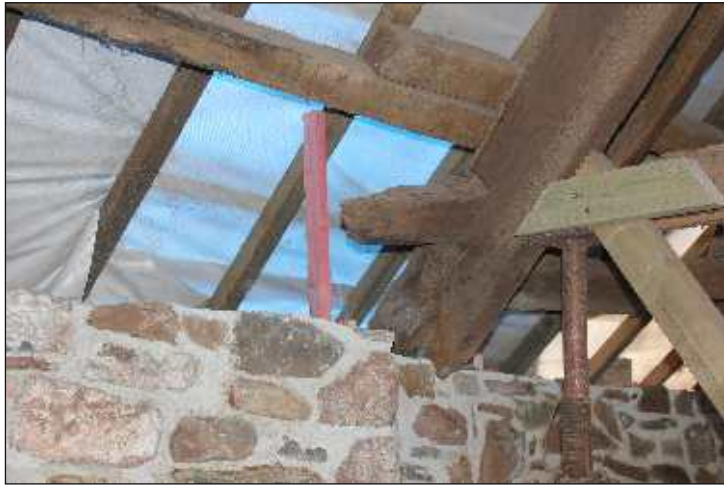
Plate 14: Close-up of the roof details in the bay over the chimney stack, looking northwest

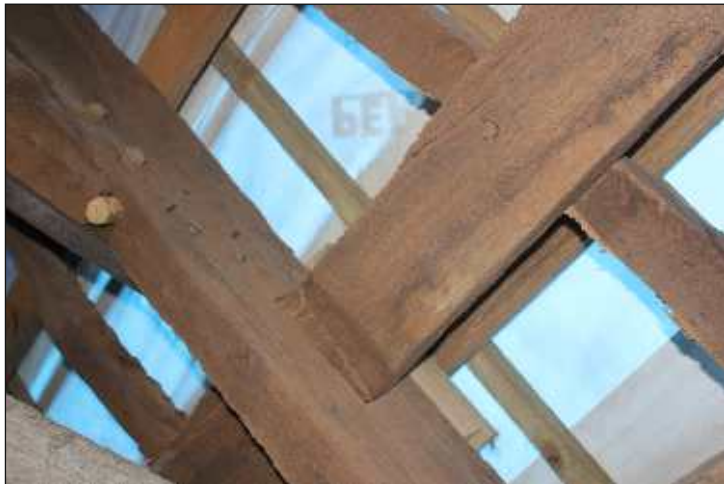
Plate 15: Close-up view of the roof showing collar joint, lapped purlins and pegged secondary rafter, looking northeast

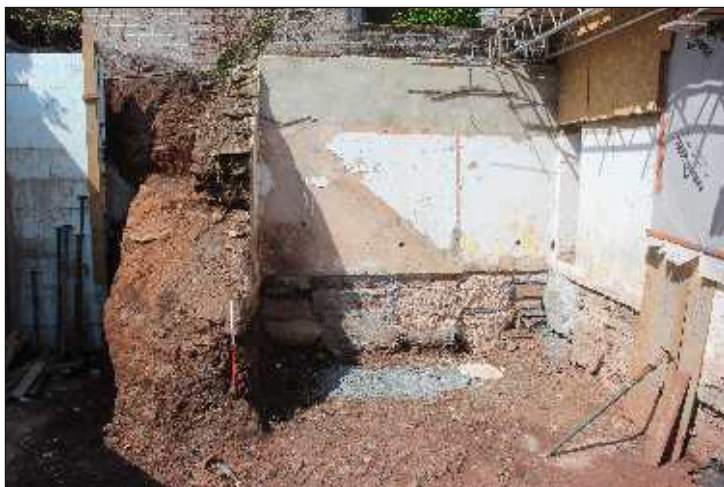
- 5.14** The demolition of the modern extension has exposed a 2.3m length of the south wall of the 19th-century extension, incorporated within the later structure (Plate 16). This measured 0.40m wide and was located 4.6m away from the main house. The west wall is of two-storey height, and is finished with modern cement render presumably over 19th-century stonework. The base of the wall has recently been underpinned, and there is no evidence of any historic footings or floors.

Plate 16: The extension showing remains of south wall, looking west. 1m scale

6.7 In the mid-late 19th-century historic maps indicate that the cottage had been extended to the south. The south wall of this extension has been exposed during the recent demolition of the more recent extension. The ground-floor doorway in the south wall was probably added at this time, and the first-floor window above blocked. The first-floor cast-iron fireplace was also probably added at around the same time, set within an existing opening.
