THE FORMER SHIPPON, BUCKFAST ABBEY, DEVON

Results of archaeological monitoring and recording

Dartmoor National Park Authority planning ref. 0238/16

Report No: ACD1647/1/0

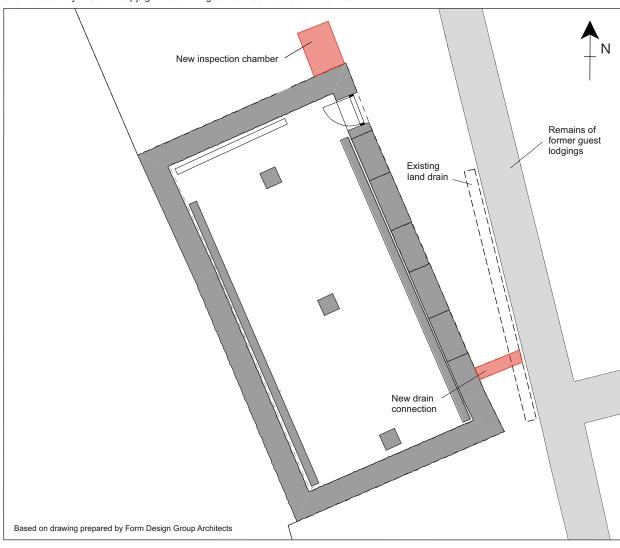
Fig. 1: Site location and position of monitored groundworks

Archaeological monitoring and recording was carried out by AC archaeology during groundworks associated with the upgrading of a drain and a sewer at the Former Shippon, Buckfast Abbey, Devon (SX 74042 67371). The Former Shippon is located some 50m to the west of the abbey church and lies within its precinct outer court. The two-story stone-built Former Shippon is terraced into a sloping bank allowing for access to first-floor level from the west. The work comprised the hand-excavation of a trench for a drain connection and a pit for a sewer inspection chamber; both of which were external to the structure.

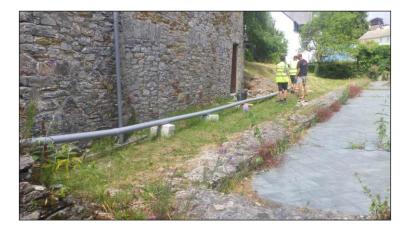
The Former Shippon lies within a scheduled monument that incorporates the North Gate and part of the precinct area of Buckfast Abbey (Heritage List for England number 1019607). Originally dating from the early 11th century, the Saxon monastery was briefly converted to Savignac Rule before becoming Cistercian in AD1174. It was following this later change that the monastery buildings were rebuilt, visible remains of which include exposed footings of former guest lodgings immediately to the east of the Former Shippon.

Plate 1: Showing Former Shippon building with medieval building remains in foreground View to northwest

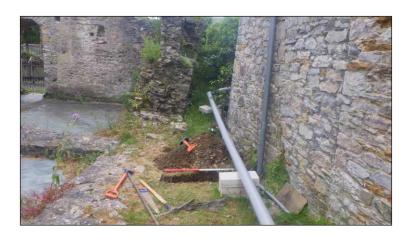
The trench for the new drain connection measured 0.3m wide and was excavated to a depth of 0.35m below existing levels. While natural subsoil was exposed on the base of the western portion of the trench, its majority was excavated into the backfill of the existing ceramic land drain. The natural subsoil overlain by a 0.1m thick layer of loose gravel, which was then sealed by topsoil.

Plate 2: General view of new drain connection trench, looking south (scale 1m)

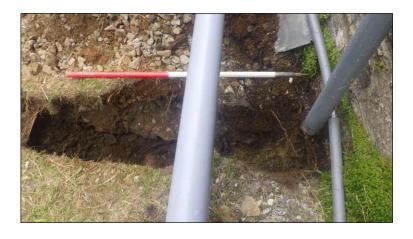
Plate 3: Showing detailed view of new drain connection trench. View to south (scale 1m)

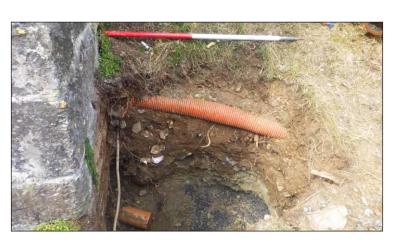
The pit excavated for the inspection chamber measured approximately 1m across and was dug down against the north corner of the building. It was excavated to a depth of 1.2m below existing levels, with this through the trench backfill of an existing sewer pipe that was exposed in the base of the pit. A single sherd from a 19th century Staffordshire type transfer printed plate was recovered from the backfilled material.

Plate 4. Showing pit for new inspection chamber. View to west (scale 1m)
