ROYAL CLARENCE HOTEL, CATHEDRAL YARD, EXETER

Results of a test pit evaluation

Document No: ACD1661/2/2

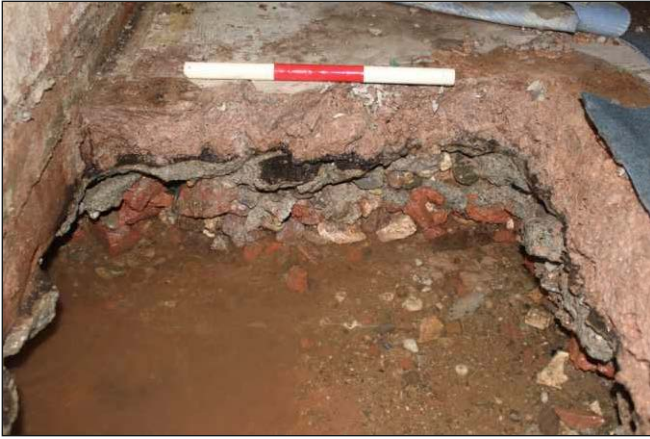
Plate 1: Test pit 1, southeast-facing section.
(0.30m scale)

- 5.2 The brick wall (S103) extended 80mm below the current floor surface, and was laid onto an 80mm thick concrete foundation slab (102) that also extended under the existing (separate) concrete floor (104). The earlier slab 102 had been laid onto a contemporary 140mm sand and gravel make-up layer (101), which in turn was laid onto the sandy clay natural (100) that was exposed at a depth of 0.24m from the surface at 37.86m aOD.

- 5.3 This length of the southwest wall of the cellar is a 20th-century rebuild, although in the southern cellar earlier brick masonry (probably of c. AD 1800) survives below the rebuild; the ground-floor brickwork also dates to c. AD 1800.
- 5.4 The wall had been constructed onto a concrete foundation that also supported the present floor, which is a separate layer of concrete. No archaeology was exposed within the test pit.
- 5.5 Water was present within the test pit at all times.

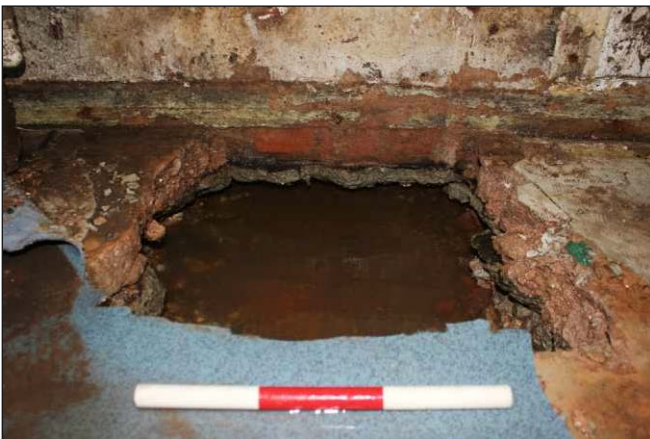
Plate 2: Test pit 1, northeast-facing section showing
wall of cellar. (0.30m scale)

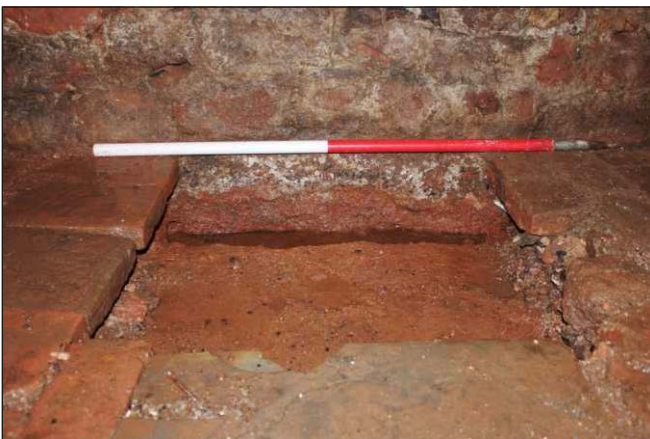
Plate 3: Test pit 2, southeast-facing section showing
wall of cellar. (1m scale)

- 5.7 The northwest cellar wall (S201) extended 220mm below the current floor surface, and had been cut and set slightly into the natural clay (200), which was exposed at a depth of 170mm below the floor surface at 37.90m aOD. The natural was overlaid by a 110mm thick make-up layer (202) for the floor surface (203). The pit was located within a brick repair to the flagstone floor and here the make-up layer (202) was associated with this later repair rather than the original floor.

- 5.8 The northwest cellar wall here is probably of 18th-century date, and has been constructed in a foundation trench cut into the natural.
- 5.9 The floor probably dates to c. AD 1800, with patches of later 20th-century brick repairs. No archaeology predating the c. AD 1800 floor was exposed.
- 5.10 The floor of the cellar slopes down from northeast to southwest. Water was present within the test pit at all times, and is also present at the lower west end of the cellar where the level fluctuates depending on weather conditions.

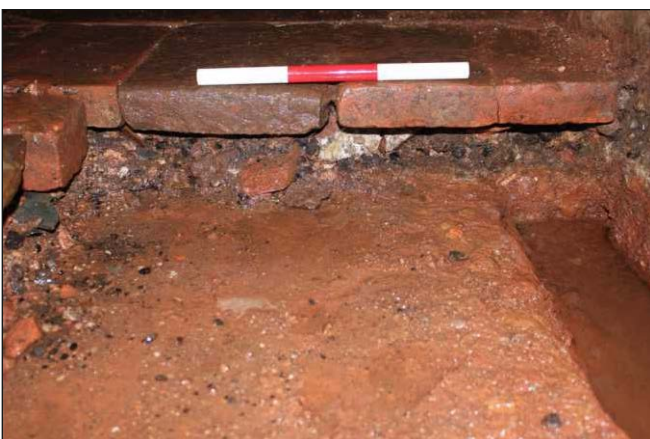
Plate 4: Test pit 2, northeast-facing section.
(0.30m scale)

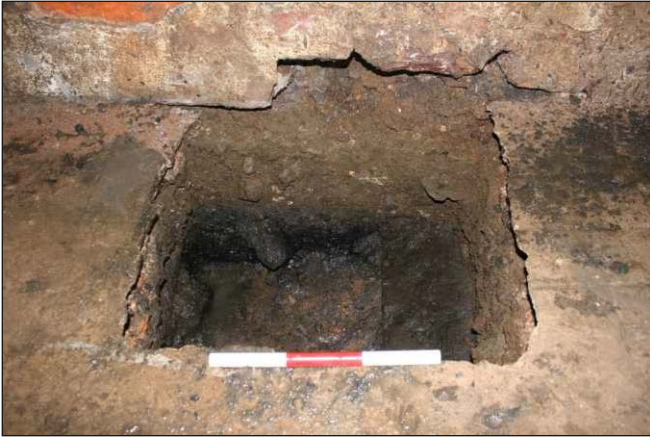
Plate 5: Test pit 3, northeast-facing section showing wall of cellar with soils below. (0.30m scale)

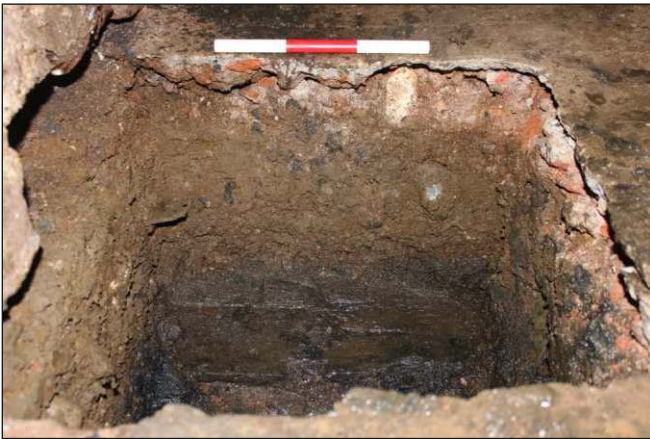
Plate 6: Test pit 3, southeast-facing section showing plank in the base of the pit. (0.30m scale)

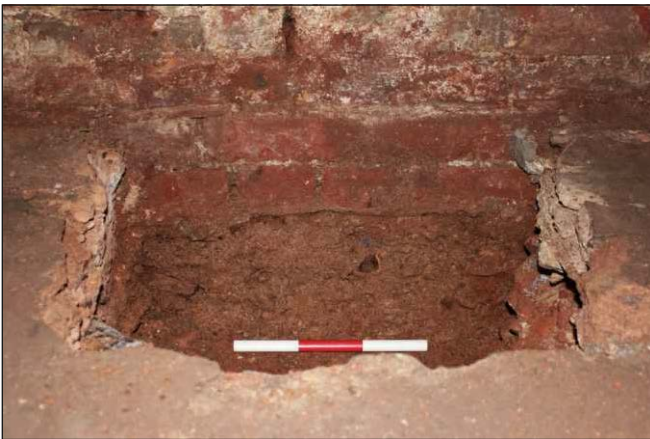
Plate 7: Test pit 4, northeast-facing section showing wall of cellar. (0.30m scale)

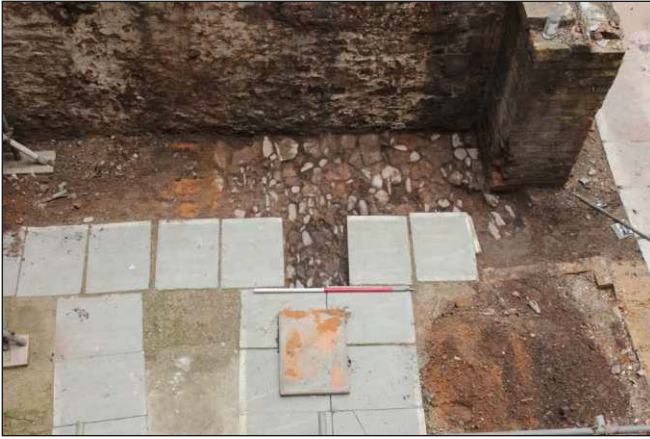
Plate 9: Test pit 5, cobbled surface 505 looking northwest down from the scaffolding over the cellar. (1m scale)

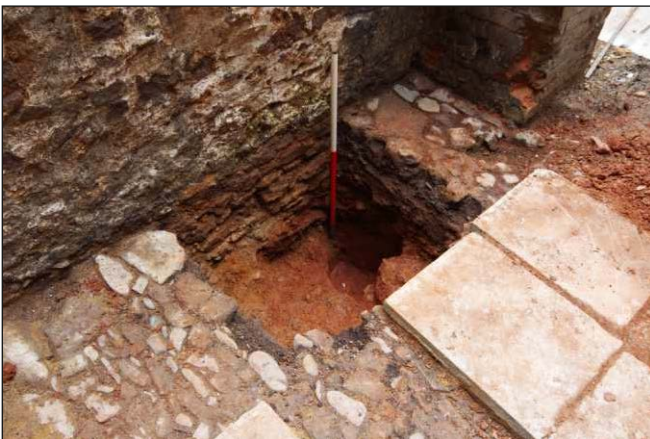
Plate 10: Test pit 5, post-excitation view looking north showing the cellar wall and pit F507. (1m scale)

- 5.27** The basement wall was constructed onto natural ground (and within the test pit into the fills of an earlier feature below the level of the natural).
- 5.28** Layer 506 and pit F507 are undated, but are probably Roman. Layers 502 and 503 above are undated (other than being later than the 12th- or 13th-century cellar) but given their location they also must be associated with former historic surfaces within the cellar. The medieval surface has been replaced with a later cobbled surface. The pottery from the layer below the surface suggests that this was laid in the 18th century, and although slightly later than these finds a context associated with the establishment of the hotel in the late 1760s is possible.

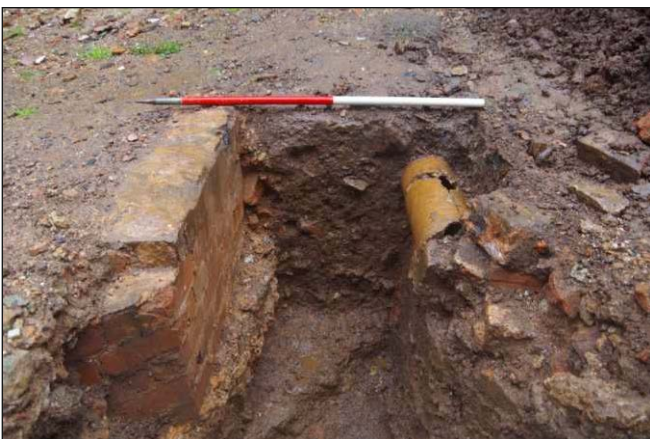
Plate 12: Test pit 6, northeast-facing section showing post-medieval deposits. (1m scale)

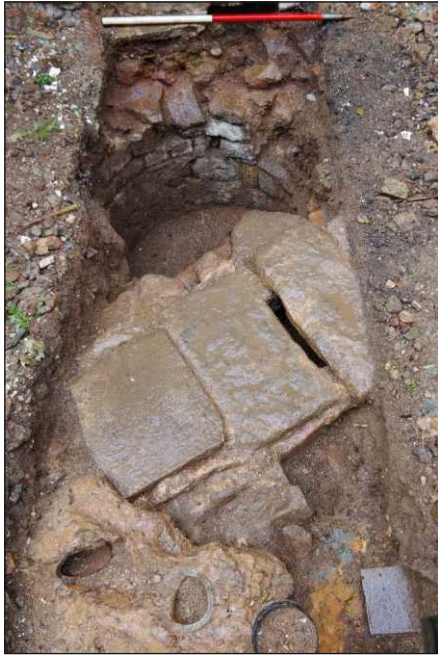
Plate 13: Test pit 6, east end of trench showing drain S602 overlying well S603, looking northeast. (1m scale)

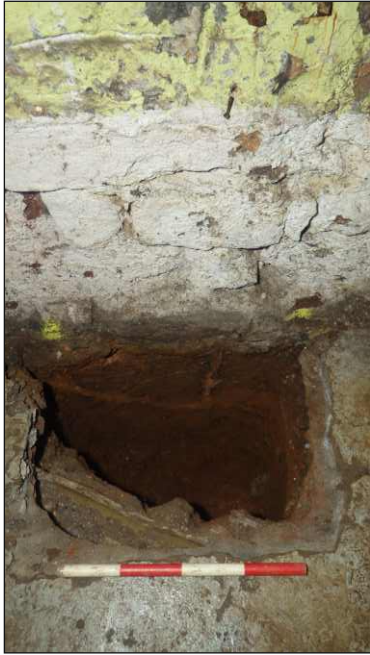
Plate 19: Test pit 10, northeast-facing section showing wall of cellar. (0.40m scale)

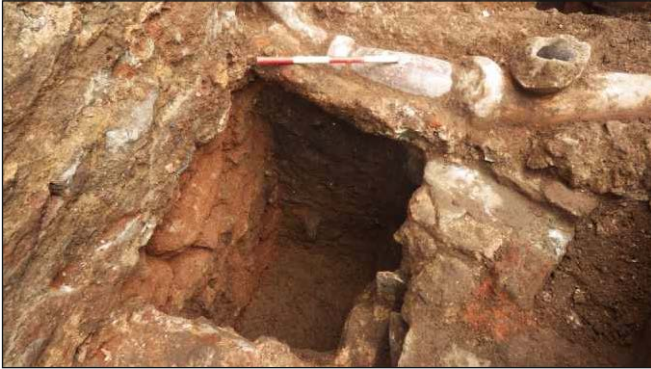
Plate 22: Test pit 11, post-excitation view showing medieval wall to left cutting through Roman soils, looking east. (0.40m scale)

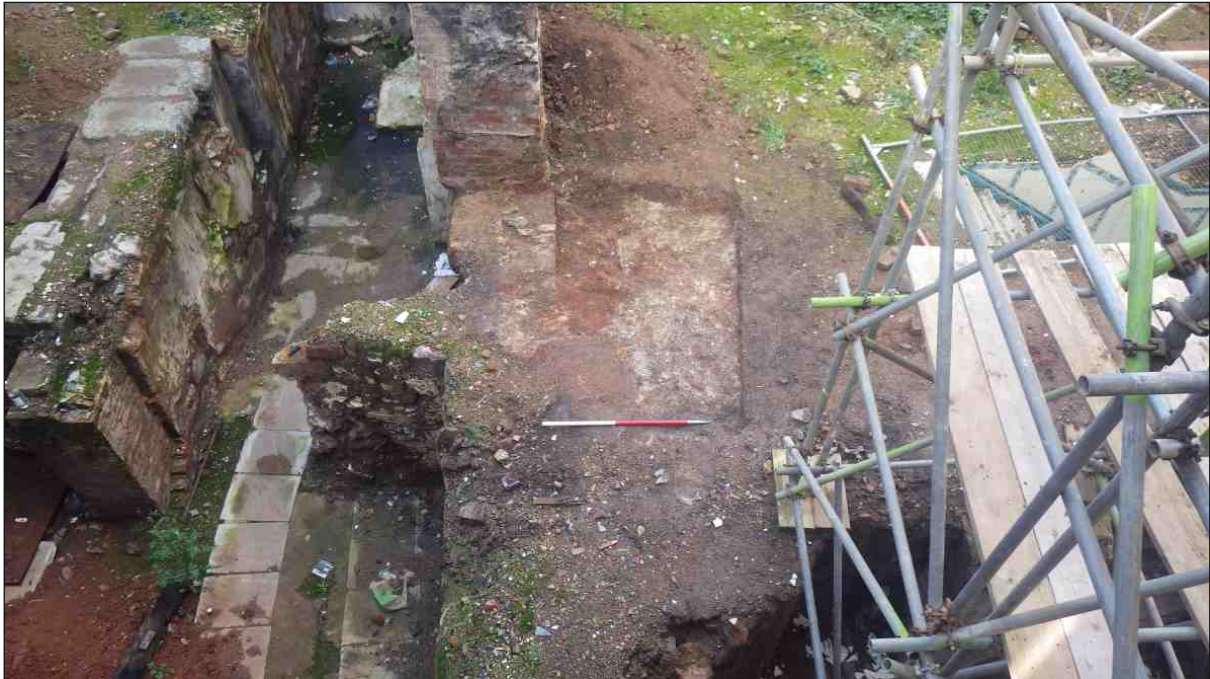
Appendix Plate 1: The investigations looking northwest down from the scaffolding showing wall 1307 below the scale, with wall 1306 above. 1m scale

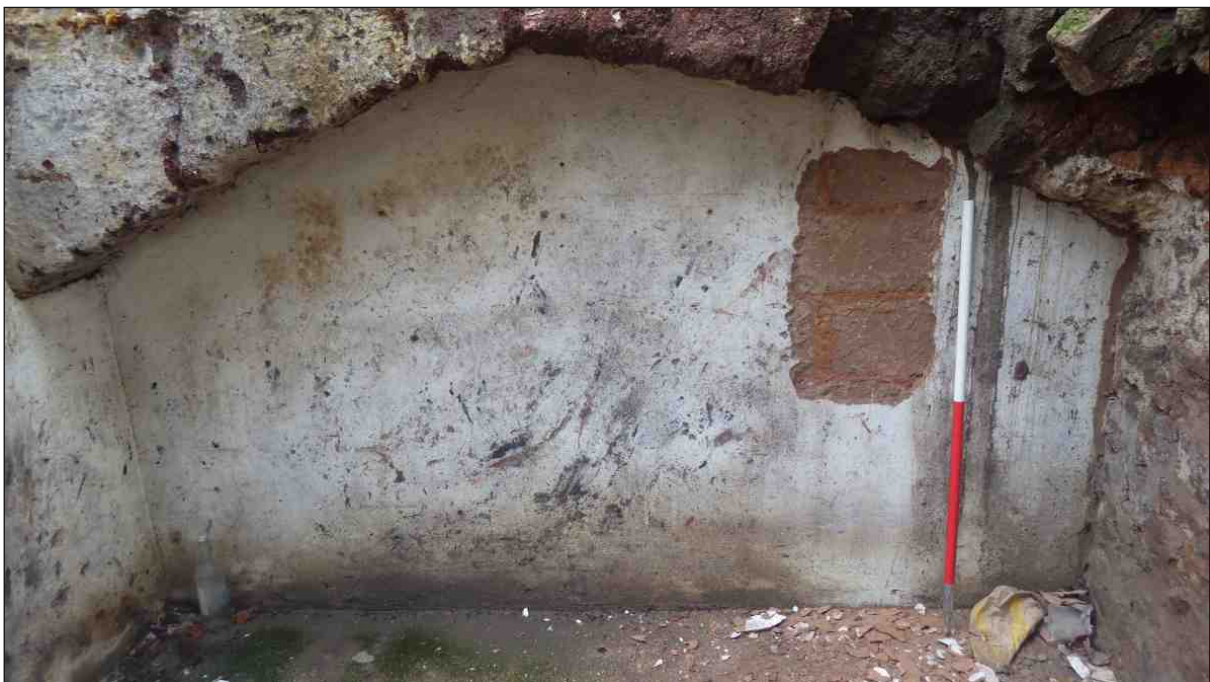
Appendix Plate 2: The east wall of the rear west cellar looking northeast showing the exposed concrete blocks. 1m scale

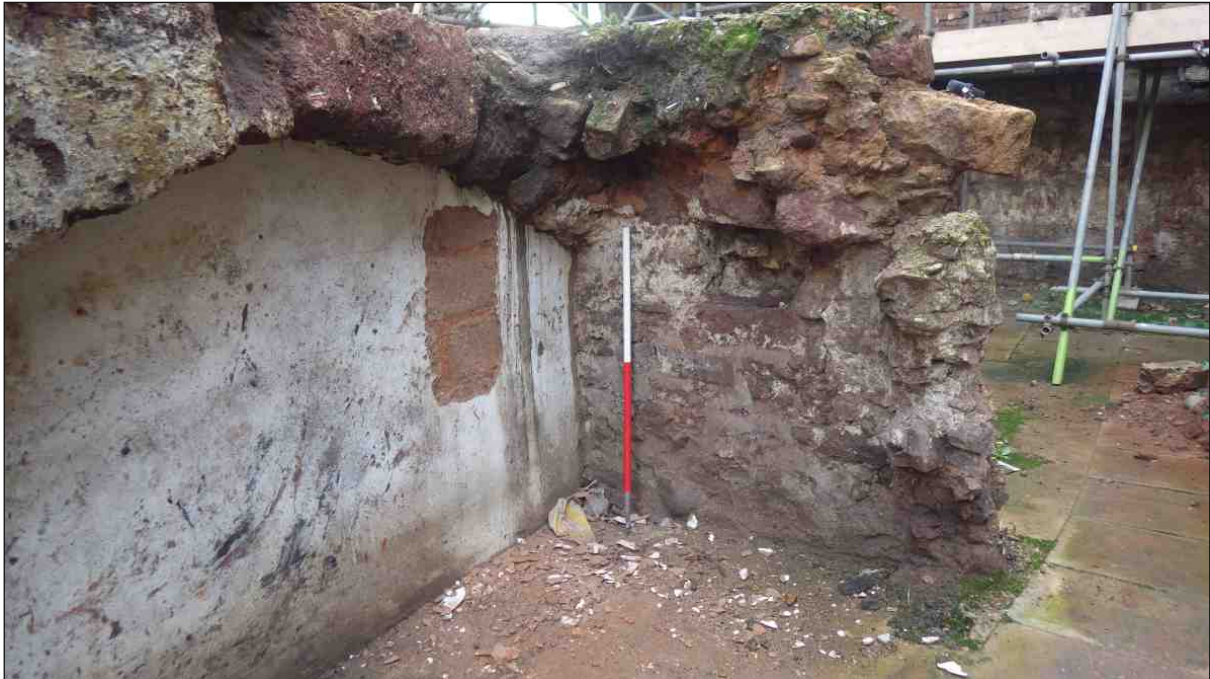
Appendix Plate 3: The east wall of the rear west cellar looking southeast showing the exposed concrete blocks. 1m scale

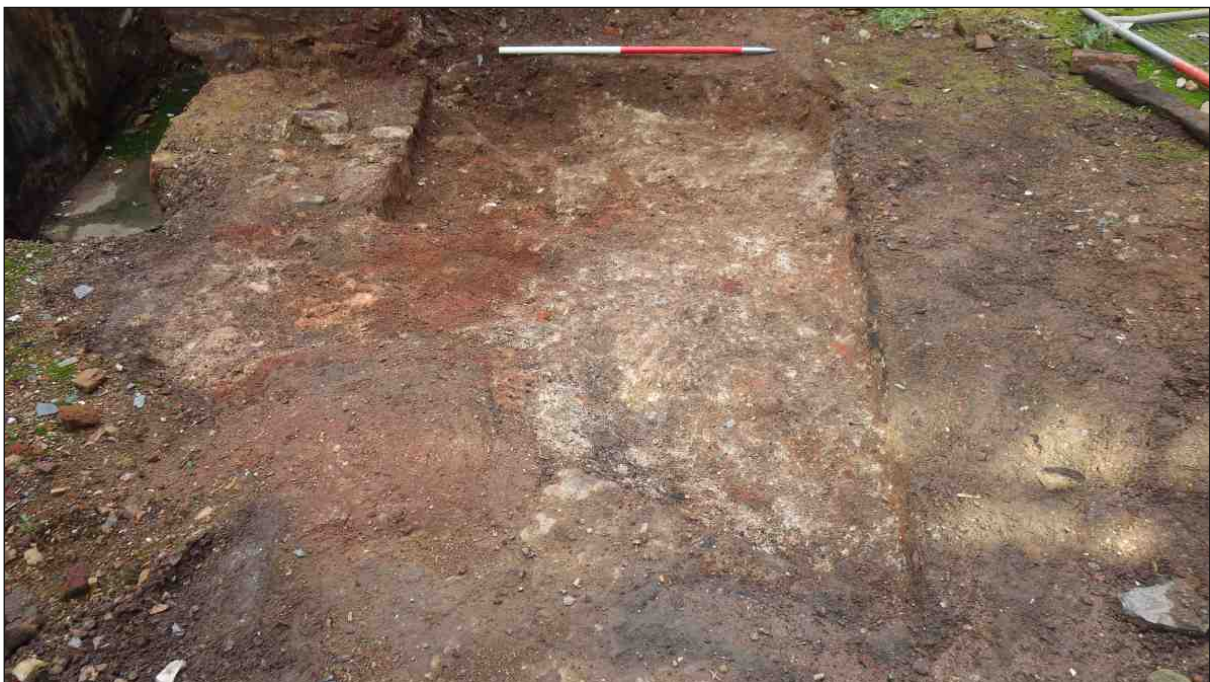
Appendix Plate 4: The investigations looking northwest showing the outer face of wall 1307 in the foreground with wall 1306 to the left, and feature F1308 centre left. 1m scale

- 5.3** The external face of the east front cellar (Z3-12) was exposed (Appendix Plates 4-6) with a straight edge aligned east to west, and was constructed of small rubble blocks of volcanic trap (S1307). The northwest corner of the early wall S1307 had been rebuilt to create the rear west cellar (Z3-14 and Z3-15) and the base of the collapsed ground-floor partition wall above (Z3-1). The wall (S1306) was constructed of blocks of breccia bonded in pale yellow-brown mortar, and incorporated a very large block at its south end, along with another large, but very degraded, block immediately to the north (Appendix Plates 4-6). Both these stones projected eastwards beyond the line of the wall to the north. Additionally, the cellar wall was very slightly wider on its eastern side than the upstanding masonry Z3-1 to the north.

- 5.6** Surface 1303 abutted the outer edge of wall S1307, and both surfaces abutted a linear feature (F1308) located against the outer edge of the west rear cellar wall S1306. The feature was filled with a friable mid brown sandy loam with patches of red clay and rare brick and wood fragments (1305). The large degraded block of breccia in wall S1306 was partially within this feature.

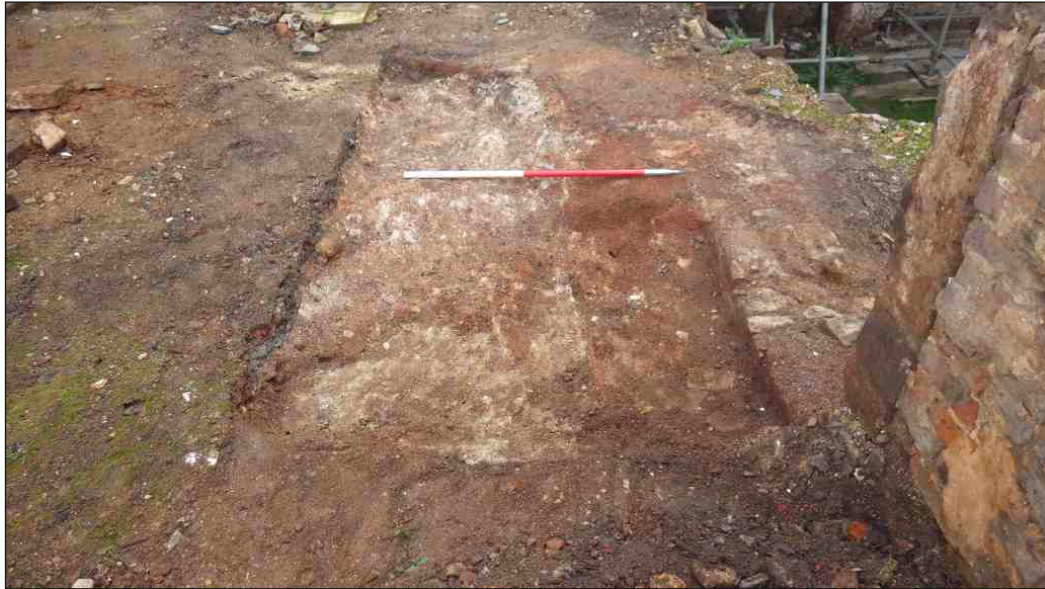
Appendix Plate 5: The investigations looking southeast showing wall 1306 to the right, feature F1308 centre, and surfaces 1303 and 1304 to the left. 1m scale

- 5.5** Below these were two possible surfaces which were exposed but not excavated (Appendix Plate 7). To the south was layer 1303, which consisted of very compact fragments of brick and sparse degraded breccia bonded in a pale grey to pale orange mortar. To the north, and almost certainly below 1303, was a softer layer of pale grey-white mortar (1304).

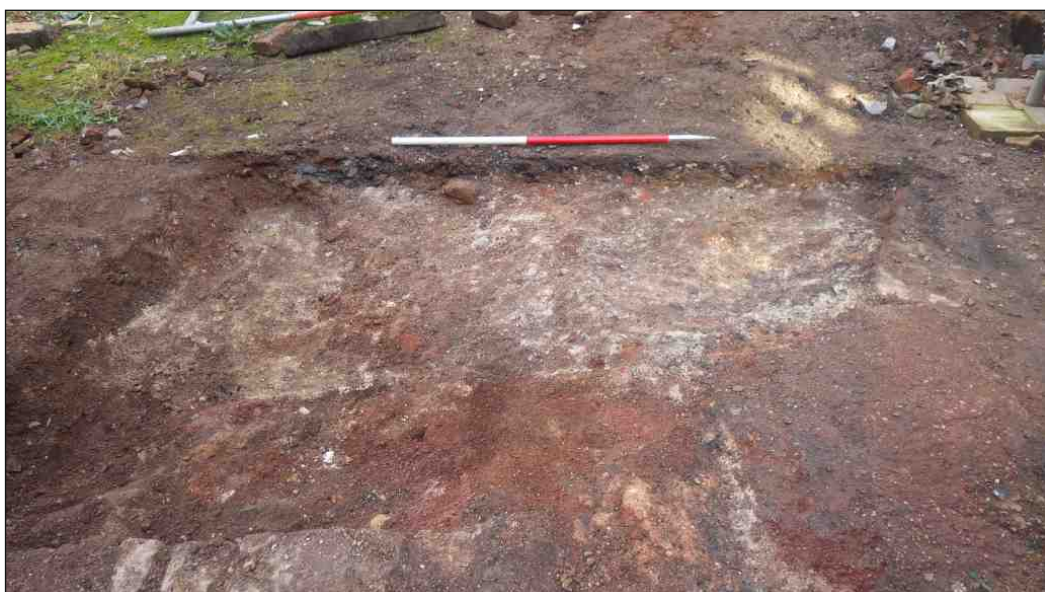
Appendix Plate 7: Surfaces 1303 to the right and 1304 to the left, with feature F1308 in the foreground, looking northeast. 1m scale

- 5.4** The overlying deposits (Appendix Plate 7) to the north of the east cellar comprised loose demolition debris (1300, measuring 0.07m thick), a 0.07m thick layer of compact dark grey silty loam fire debris containing burnt wood, glass and slate (1301), and a lower 0.06m thick deposit of very compact mid yellowish-brown silty loam containing fragments of brick, plaster/mortar, slate and degraded breccia (1302).
