STOVER GOLF COURSE, STOVER, DEVON

Results of an Archaeological Trial Trench Evaluation

Report No: ACD1667/2/1

Date: October 2017

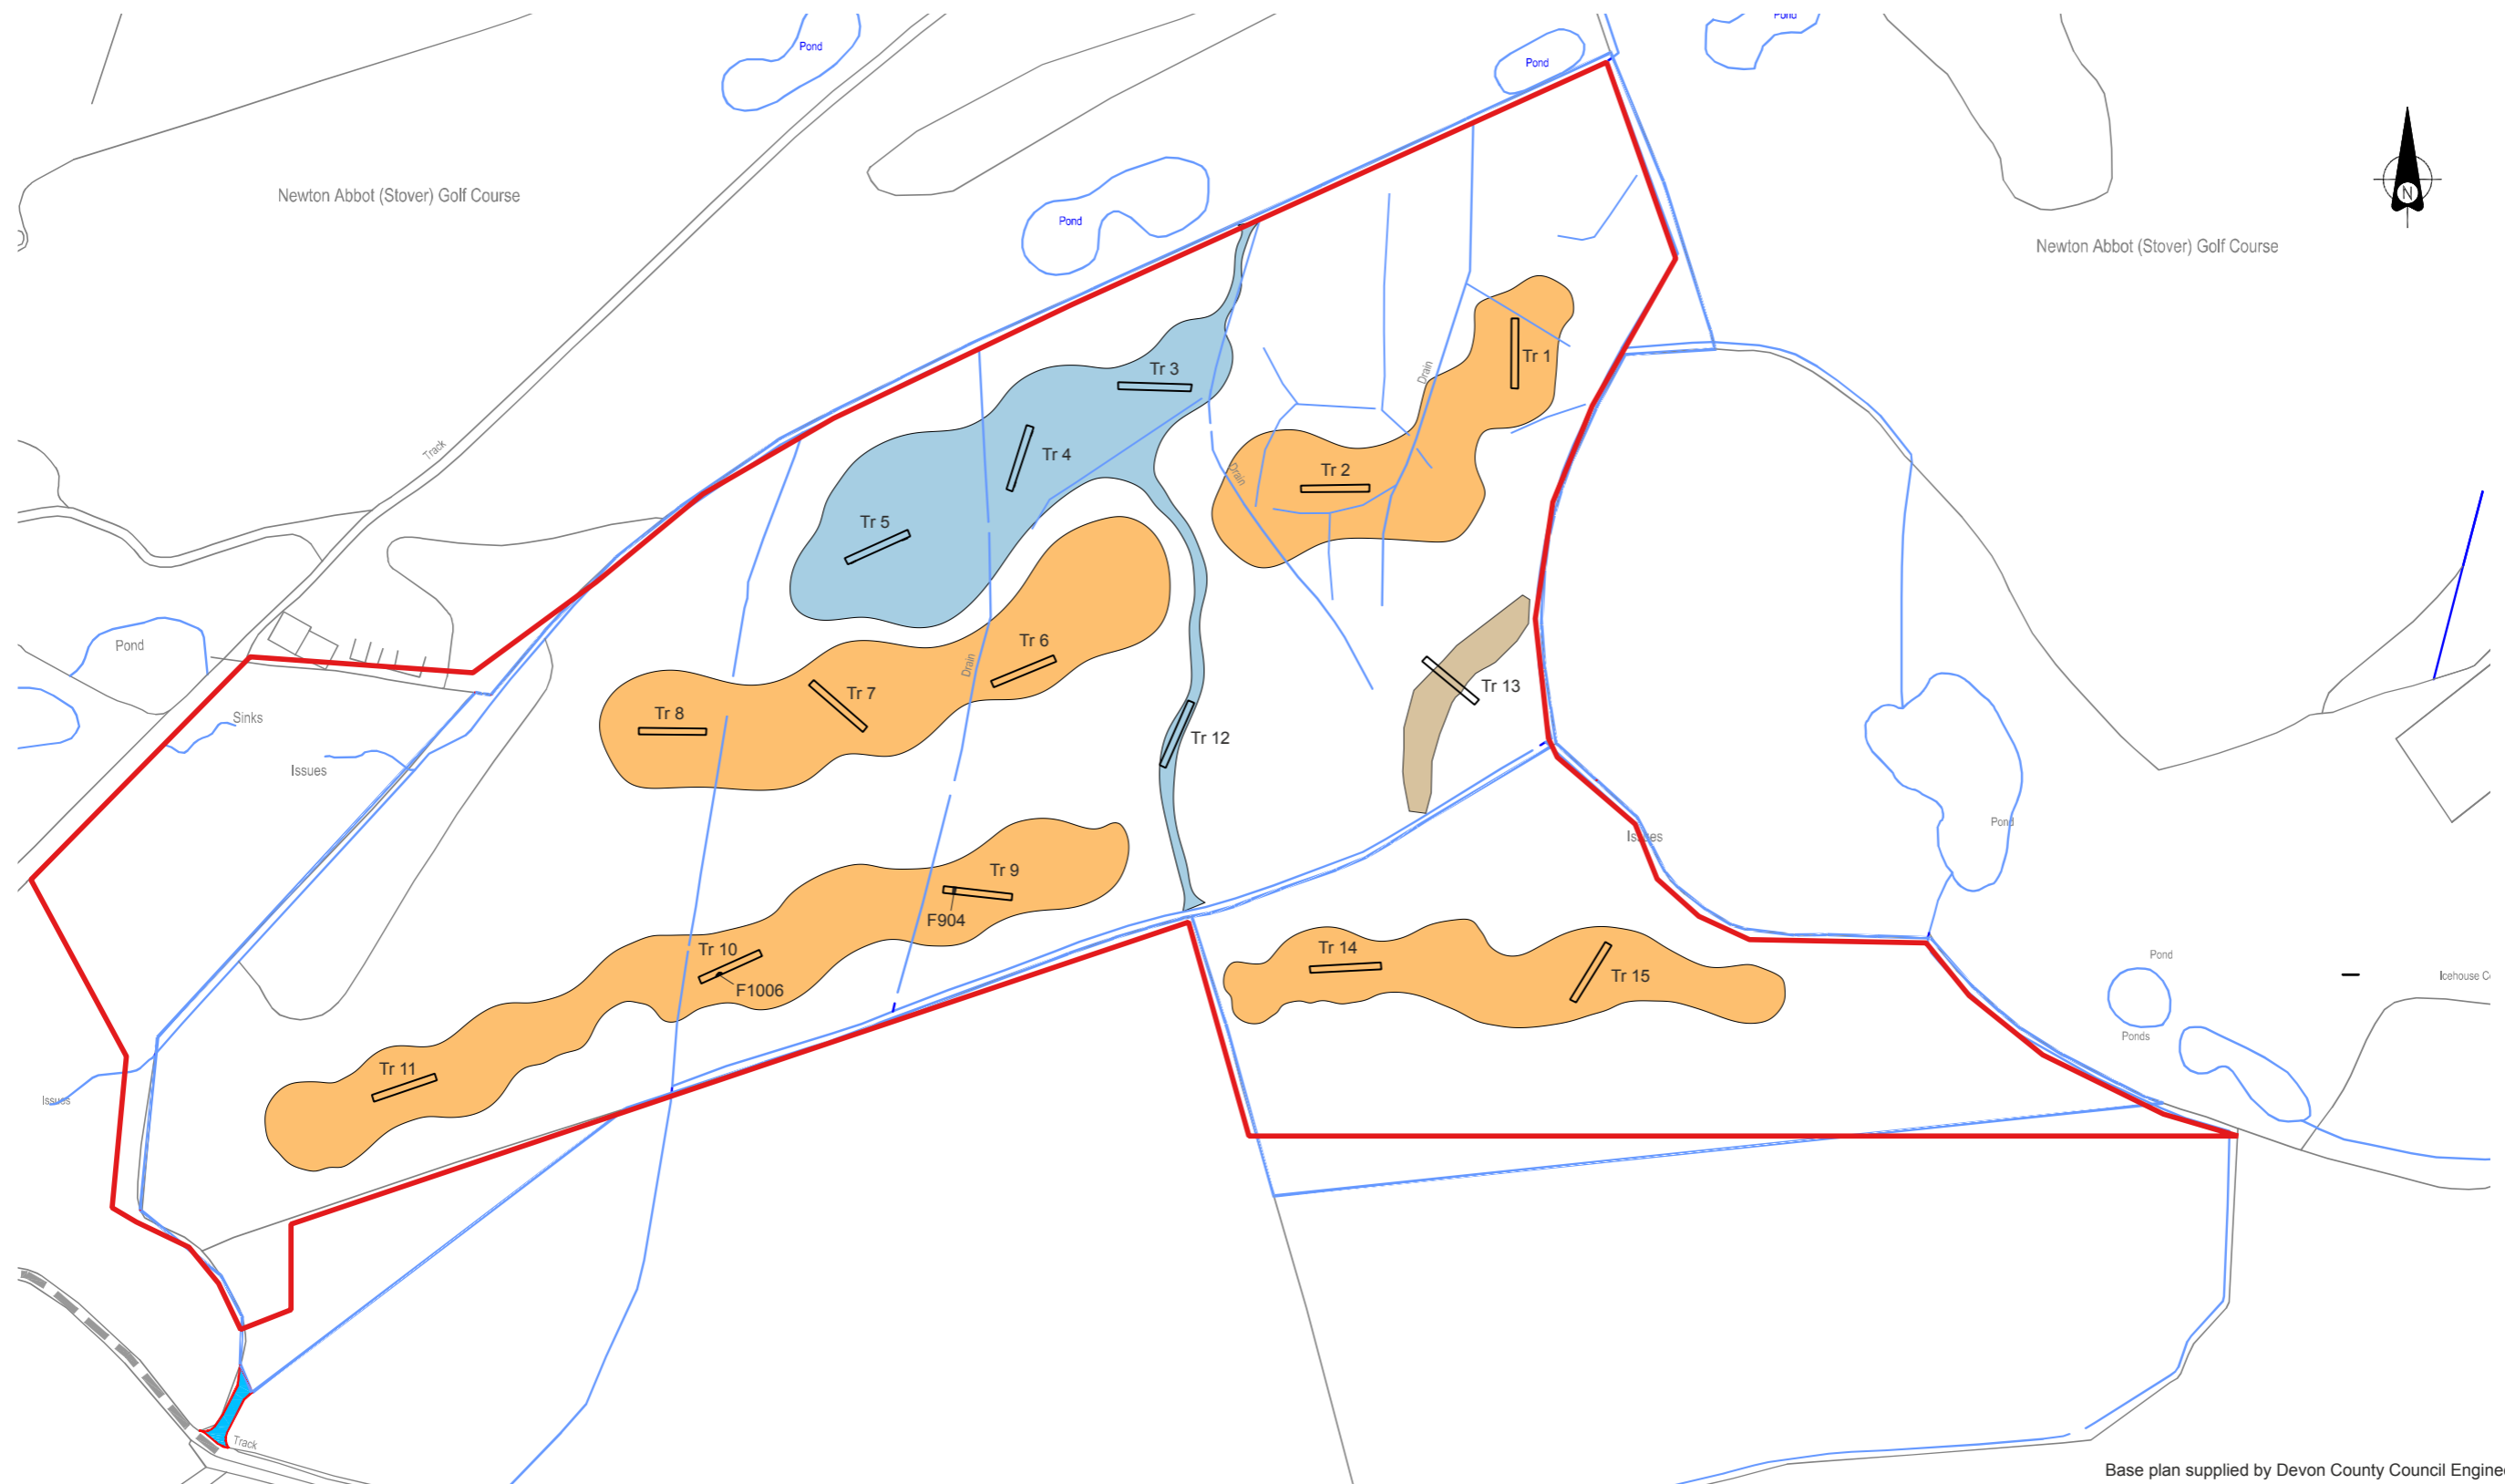
TITLE
Fig. 2: Trench location plan with archaeological features shown

Trenches showing archaeological features identified

5.1 Introduction (Fig. 2)

Two of the trenches contained archaeological features and thirteen (Trenches 1-8 and 11-15) had negative results. The trenches containing archaeological features are described in detail below, with descriptions for all trenches presented in tabulated form in Appendix 1. Across the site, the recorded layer sequence comprised a topsoil of mid brownish-grey sandy silt, above a mid greyish-brown silty sand subsoil. The natural subsoil largely comprised mid greyish-brown to light greyish-blue sandy clay. The natural subsoil was present at a depth of between 0.31m and 0.5m below the current ground surface. The majority of the targeted features identified on historic mapping or during the site walkover corresponded with the changing bands of natural geology and ascending ground level. Each of these were investigated and confirmed to be of natural origin. Machine excavated test sondages in trenches 3-5 showed that the natural subsoil was sterile and contained no material of palaeoenvironmental interest (Plates 3-4). A single sherd of post-medieval pottery was recovered from the topsoil of Trench 5.

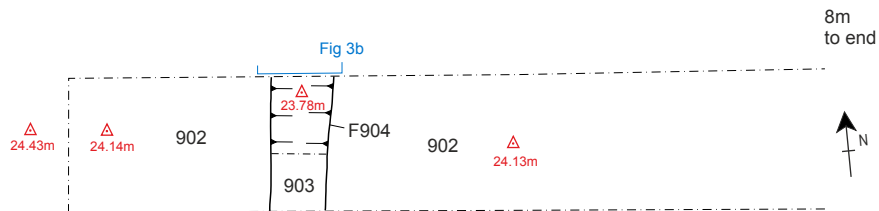
a) Trench 9, plan

This trench was located in the south part of the site and was aligned approximately east-west and was 20m long. The overlying layer sequence consisted of 0.16m of topsoil (context 900), overlying 0.15m of agricultural subsoil (901). The natural subsoil (902) was therefore present at 0.31m below the ground surface. The trench contained a ditch (F904).

5.2 Trench 9 (Detailed plan Fig. 3a and section Fig. 3b)

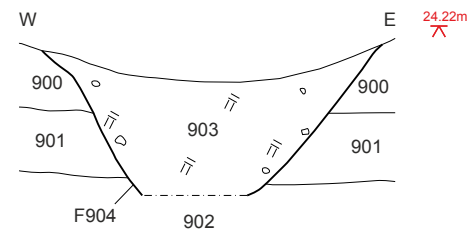
b) Section of ditch F904

This was a working drainage channel which measured approximately 1m wide and over 0.31m deep, but was not bottomed. It was partially infilled by natural weathering (903) composed of dark brownish-grey sandy silt with frequent partially decomposed organic debris and occasional sub-rounded pebble inclusions. There were no finds.

7.2 Ditch F904 in Trench 9 corresponded with a feature identified on historic mapping as an enclosure boundary shown on the Ordnance Survey map of 1904. The ditch was only partially infilled and was functioning as a drainage ditch on the low lying grazing area.

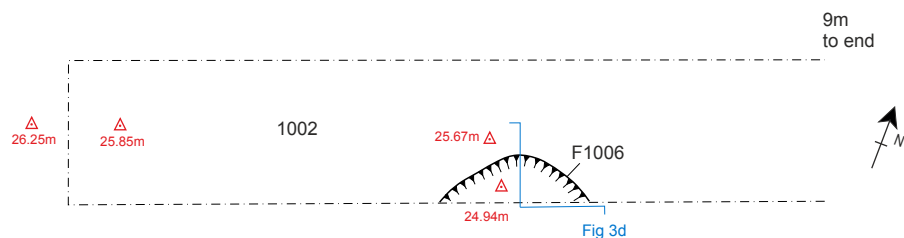
c) Trench 10, plan

This trench was located in the southwest part of the site and was aligned approximately northeast-southwest and was 20m long. The overlying layer sequence consisted of 0.30m of topsoil (1000), overlying 0.16m of subsoil (1001). The natural subsoil (1002) was therefore present at 0.46m below the ground surface. The trench contained one pit feature (F1006).

5.3 Trench 10 (Detailed plan Fig. 3c and section Fig. 3d; Plates 5-6)

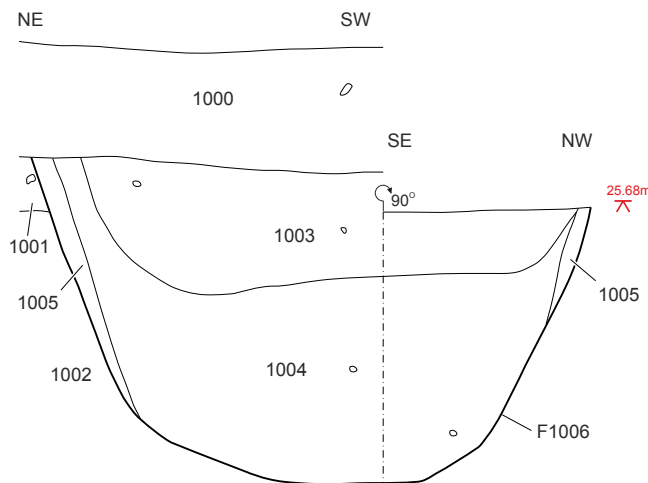
d) Section of pit F1006

This was partially revealed in the trench. It was oval in plan with steep sides and concave base and cut subsoil 1001. It contained three fills (1003-1005). Primary fill 1005 was composed of mid greyish-brown clay. Secondary fill 1004 was composed of dark yellowish-brown sandy clay, while upper fill 1003 was composed of dark reddish-brown sandy silt. A single sherd of Totnes ware pottery dating to between c. 1500-1750 was recovered from secondary fill 1004.

7.3 Pit F1006 in Trench 10 is likely to represent a post-medieval quarry pit associated with small scale extraction of clay. This feature lies within a wider area that contains a

number of clay quarries, with many of these depicted on early mapping (SLR Consulting 2016). It is therefore likely that this feature is associated with this activity.

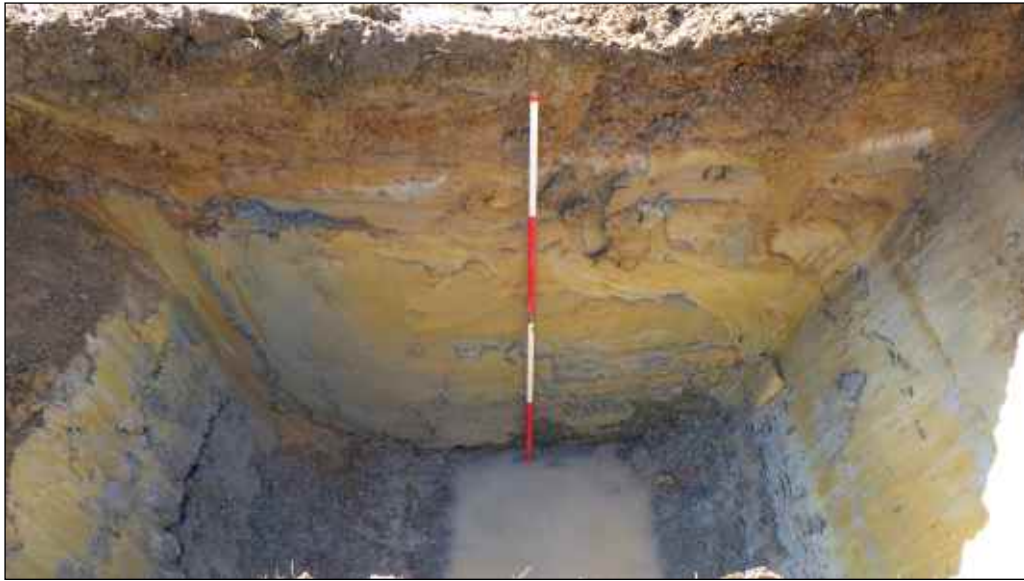
Plate 3: Test pit at the west end of Trench 3, view to north (scale 2m)

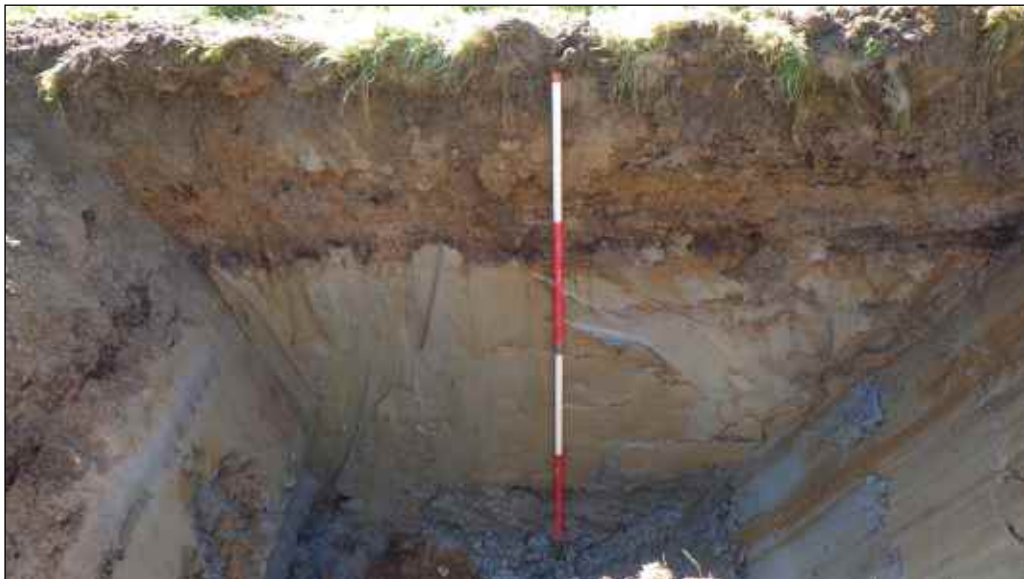
Plate 4: Test pit at the east end of Trench 3, view to south (scale 2m)

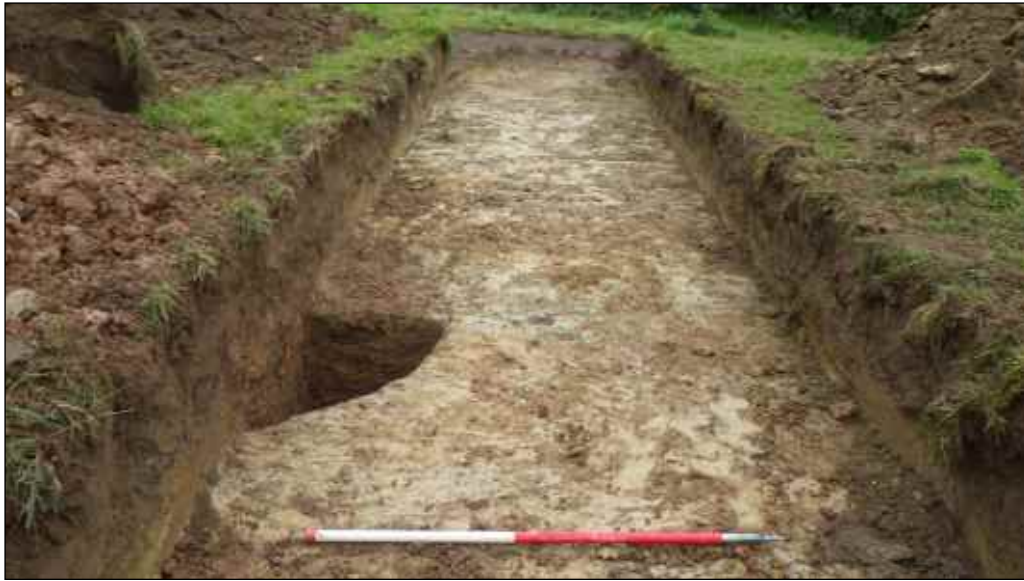
Plate 5: Trench 10, pit F1006, view to southwest (scale 1m)

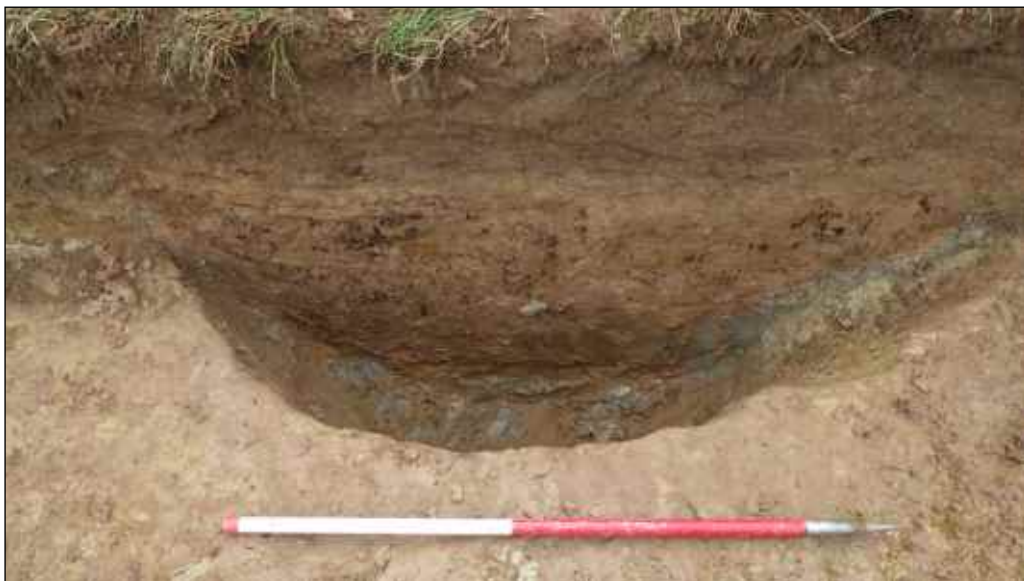
Plate 6: Trench 10, pit F1006, view to southeast (scale 1m)
