EXETER FREE COTTAGES, MOUNT DINHAM, EXETER

Results of an archaeological watching brief

Exeter City Council planning reference 11/1906/03, condition 6

Document No: ACD450/3/1

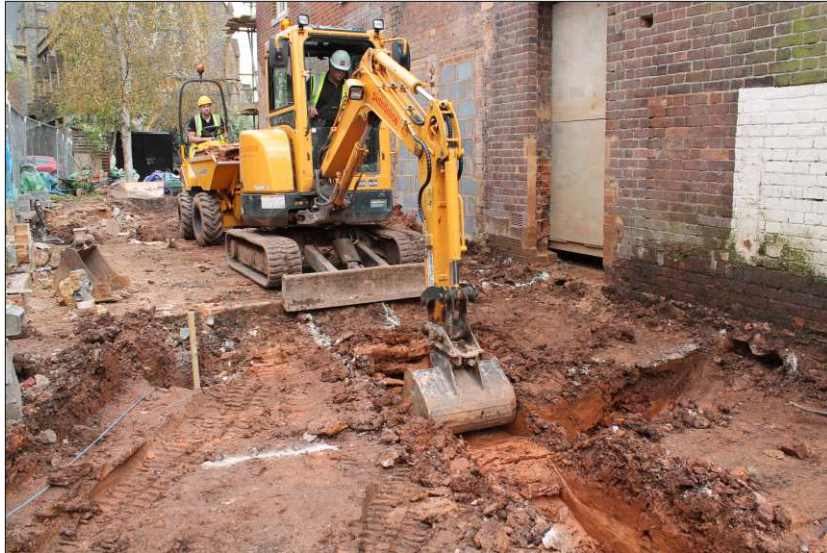
5.2 The full extent of the new foundation trenches for this block was monitored (Plate 1) The general deposit sequence was as follows (Plate 2):

Plate 1: Working shot of foundation trenches being excavated in block H, looking east

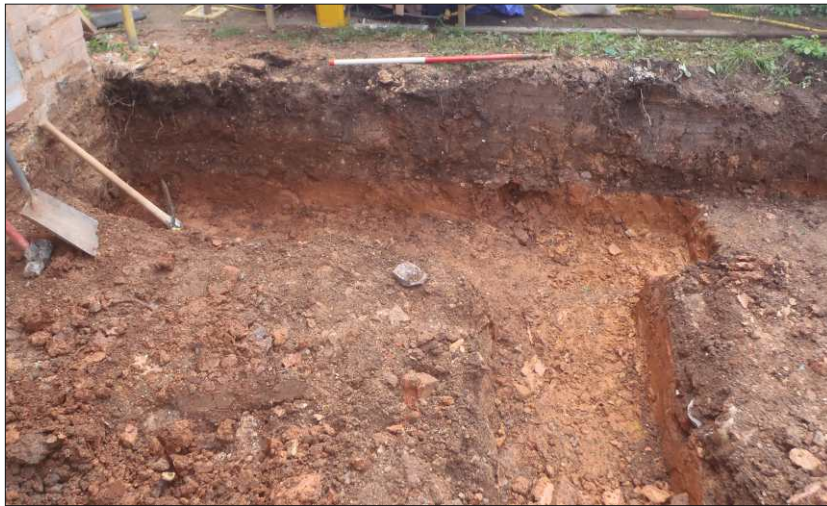
- 100 – 0-100mm dark brown friable humic silt;
- 101 – 100-250mm/400mm dark brown-red firm silty clay with frequent small-medium sized angular sandstone fragments, brick, slate and mortar fragments; and
- 102 – 250mm/400mm + natural firm light red clay with lenses of yellow and blue clay, and abundant small-large angular sandstone fragments (exposed at

the southwest end of the excavations, and towards the bottom of the trenches).

- 5.3** The foundation trench (103) for the rear of the cottages was visible across the site and its backfill (104) contained fragments of clay tobacco pipe and industrial china (not retained).

Plate 2: Representative section of foundation trench in block H, looking southwest (1m scale)

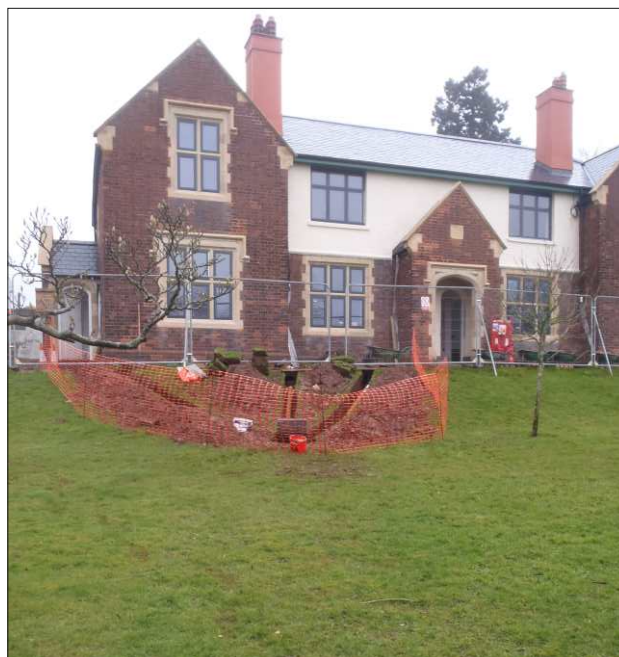
- 5.4** In addition to the foundation trenches at the rear of the buildings, the excavation of three drainage trenches situated within the landscaped grounds to the southwest of the block were monitored (Plate 3). These passed through the path in front of the cottages and down the slope in front of the path.

Plate 3: General view of drainage trenches situated to the southwest of block H, looking northwest

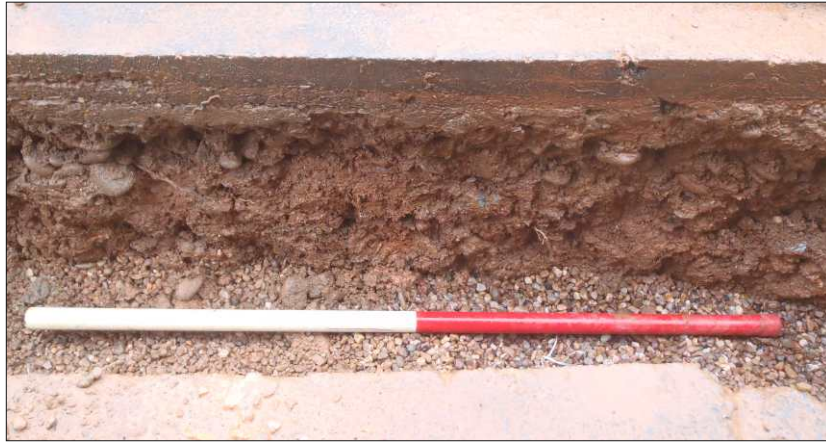
- 5.5** The following deposit sequence was exposed in the northwest end of the trenches adjacent to the cottages (Plate 4):
- 0-200mm tarmac path and hardcore make-up;

- 603 – 200-250mm purple-red sandy silty clay with moderate angular gravels, occasional sub-angular pebbles, and very occasional charcoal fragments;
 - 604 – 250-350mm red plastic silty clay with occasional angular pebbles and sub-angular pebbles, and very occasional CBM and plaster fragments; and

- 605 – 350mm + purple-red plastic silty clay with occasional mixed gravels.
- 5.6** To the southwest the following deposit sequence was exposed (Plate 5):

Plate 4: Representative section in the northwest end of the drainage trench, looking southwest (1m scale)

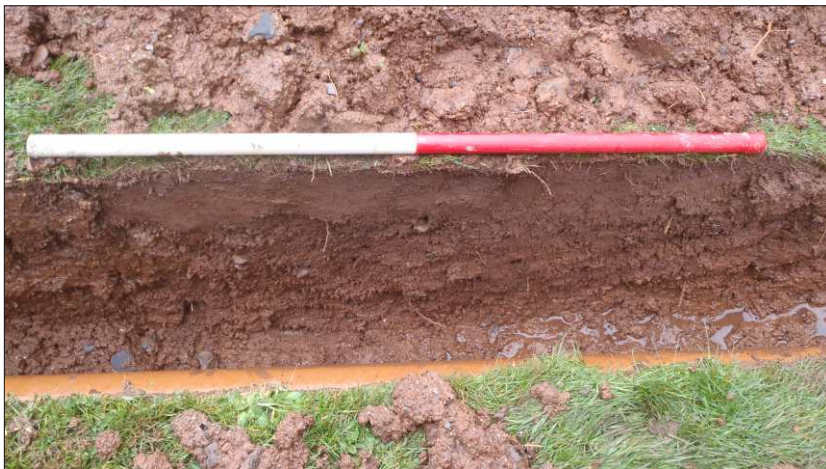
- 600 – 0-180mm turf and topsoil of purple-red plastic silty clay;
 - 601 – 180-400mm red plastic sandy silty clay with moderate very small gravel and pebbles, and very occasional charcoal and CBM; and

- 602 – 400mm + light purple-red plastic sandy silty clay with moderate slate fragments and mixed gravels.
- Block J**
- 5.7** The full extent of the new foundation trenches for this block was monitored (Plate 6). The general deposit sequence was as follows (Plate 7):

Plate 5: Representative section in the southwest end of the drainage trench, looking east (1m scale)

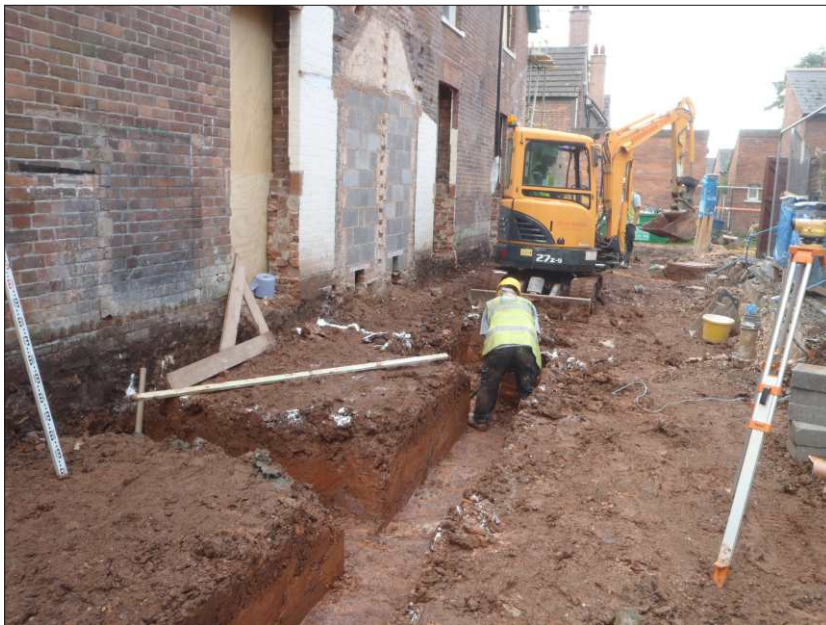
Plate 6: Working shot of foundation trenches being excavated in block J, looking southwest

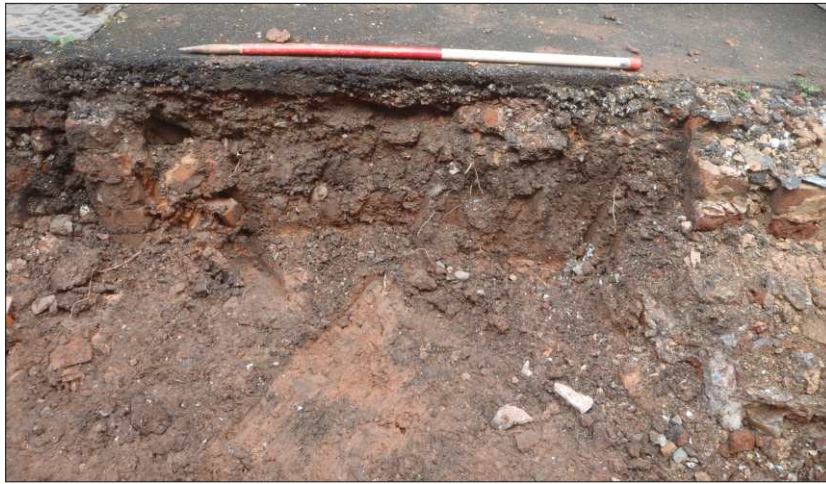
- 700 – 0-350/500mm medium reddish-brown silty clay with frequent brick, slate and mortar fragments; and
 - 701 – 350/500mm + natural firm light red and yellow clay.

Plate 7: Representative section of foundation trench in block J, looking northwest (1m scale)

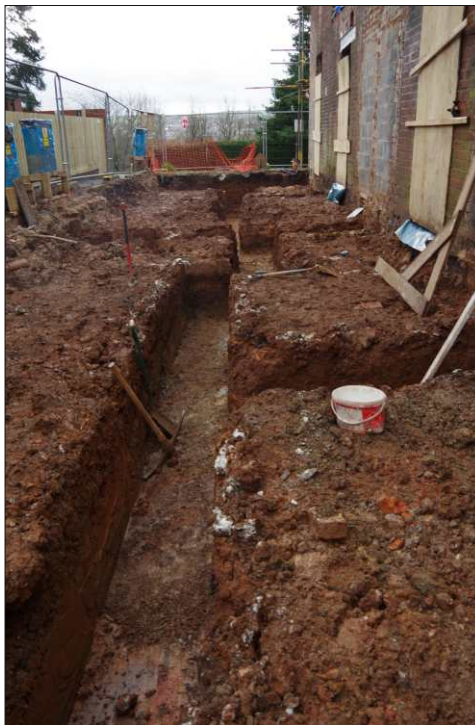
Plate 8: General view of foundation trenches in block E, looking southwest

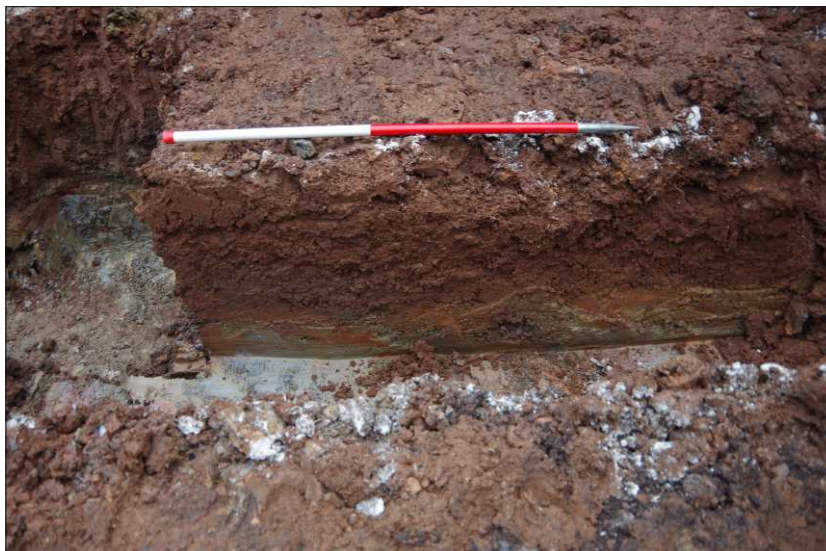
- 400 – 0-500mm medium black-brown silty clay with occasional brick and slate and mixed gravel;
 - 401 – 500-800/1100mm reddish-brown clayey-loam subsoil; and

- 402 – 800/1100mm + natural compact mixed light red and yellow clays and angular sandstone fractured bedrock.
- 5.9** A small pit was partially exposed within the excavations (F403). This was cut into the natural (402) and measured 1.10m long by 0.30m wide and a minimum of 0.20 deep. It contained a single fill (404) tightly packed angular gravel with some flecks of charcoal, as well as post-medieval pottery.

Plate 9: Representative section of foundation trench in block E, looking northwest (1m scale)

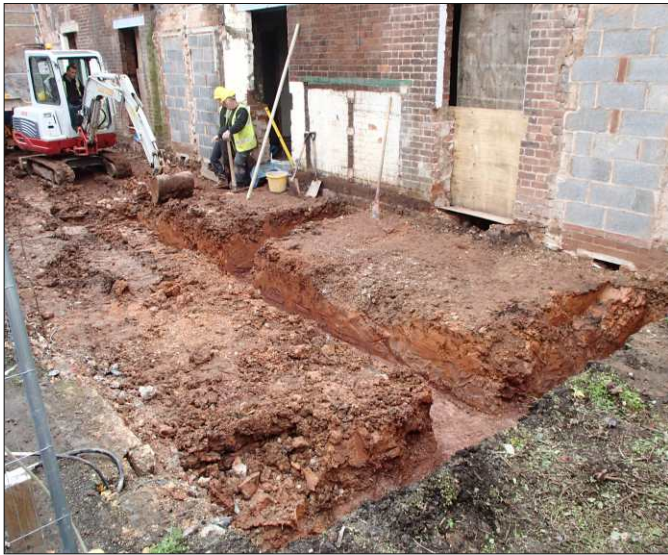
5.10 The northern half of the foundations (for cottages 23 and 24) were monitored (Plate 10). The general deposit sequence was as follows (Plate 11):

Plate 10: Working shot of foundation trenches being excavated in block F, looking southwest

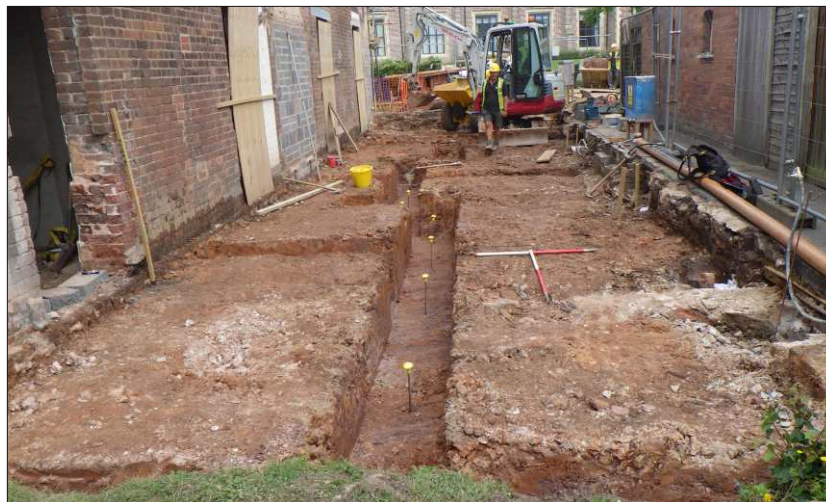
5.11 The full extent of the new foundation trenches for this block was monitored (Plate 12). The general deposit sequence was as follows (Plate 13):

Plate 12: Working shot of foundation trenches being excavated in block A, looking northeast

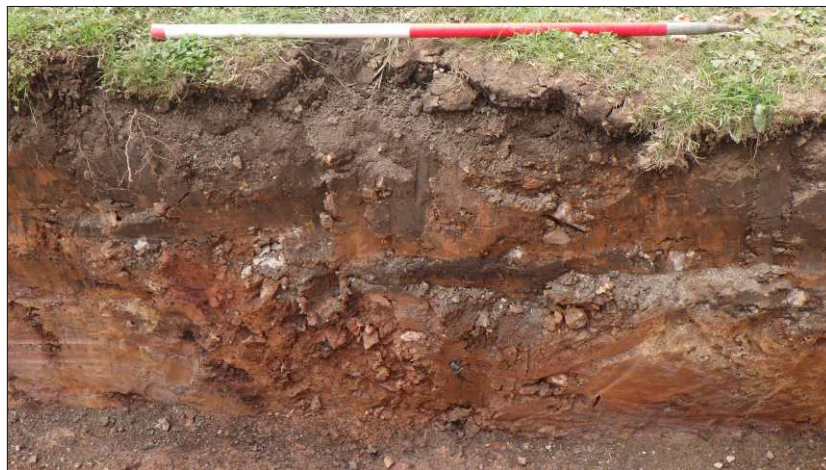
- 1200 – 0-280mm Dark grey-brown silt topsoil
- 1201 – 280-340mm medium reddish-brown silty clay with occasional brick, slate and mortar fragments and mixed gravel; and
- 1201 – 340mm + natural firm brownish-red red clay with occasional angular sandstone fragments.

Plate 13: Representative section of foundation trench in block A, looking southwest (1m scale)
