# 9 THE PARADE, PLYMOUTH

Results of historic building recording

Plymouth City Council planning reference 17/01124/LBC,  
condition 4

Document No: ACD1727/2/0

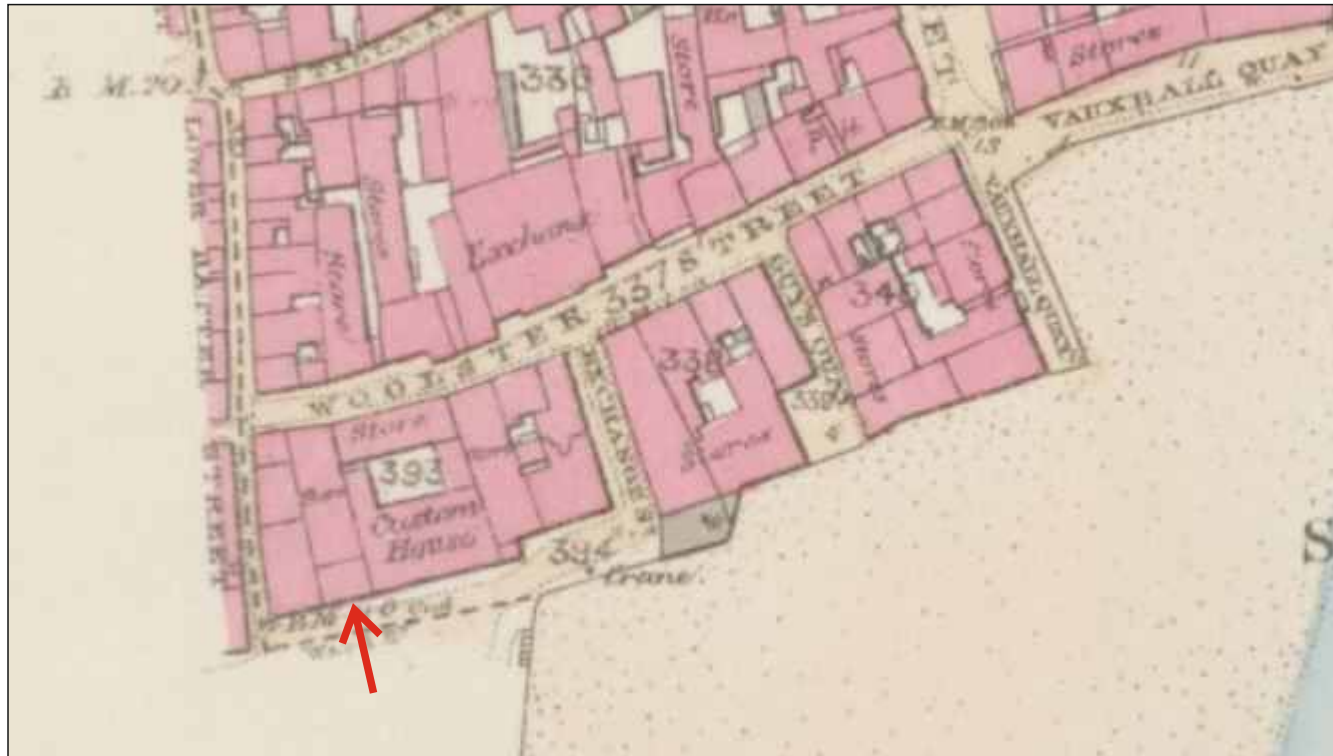
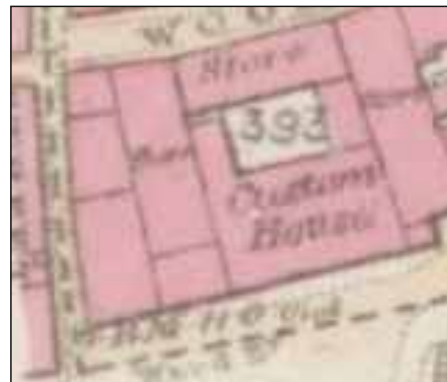
TITLE  
Fig. 2: Extract from the  
1st edition 25-inch  
Ordnance Survey map  
(1854-63)

- 2.3** The first edition 25-inch Ordnance Survey map (1854-63) records the site as two buildings – a shorter structure fronting onto The Parade, and a longer structure labelled store (occupying three-quarters of the length of the site) fronting onto Vauxhall Street (Fig. 2). By 1892-3 when the 25-inch map was revised the southern third of the Vauxhall Street building had been subdivided and now formed part of an L-shaped No. 8 The Parade (Fig. 3). Later maps record that this arrangement remained in place until at least 1914. The first post-Second World War maps, dating to 1949-52, record that both this property and the adjacent properties to the west were subdivided into pairs of buildings of equal length. Contemporary, early post-war photographs of the Custom House taken from The Parade show no. 9 as essentially the same as today, with different casement windows on the second floor, along with a, deeper but narrower sign below the central first-floor opening.

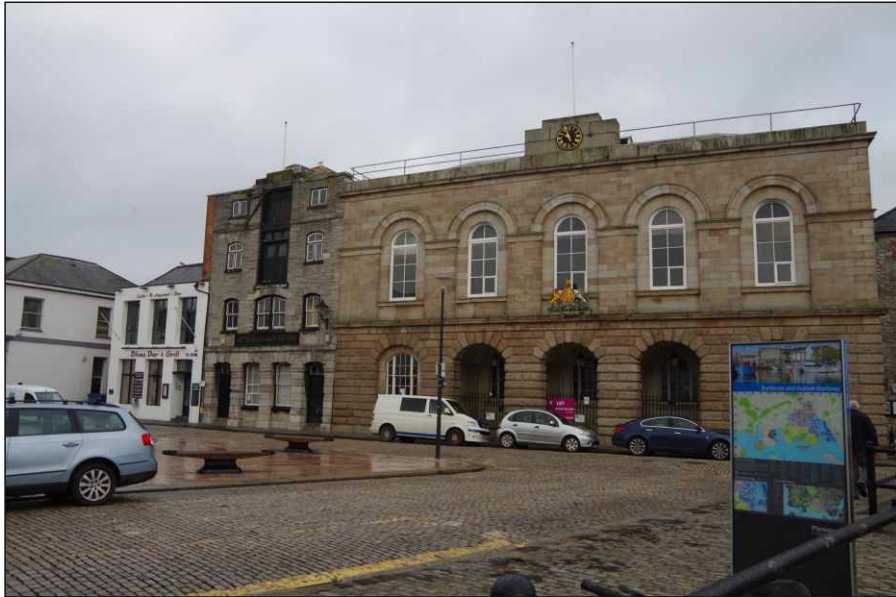
Plate 1: General view of the building showing the Custom House to the east, looking northwest (1m scale)

- 6.2** The east wall of the building is the earlier west elevation of Custom House, and the various openings on the ground and first floor – partially reused within the warehouse – represent architectural features of that structure.

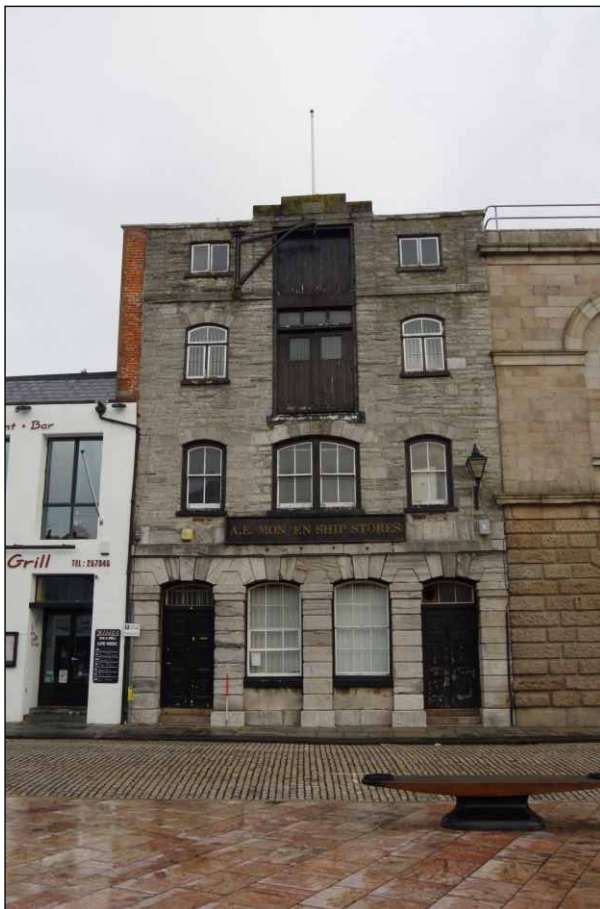
5.2 The south elevation faces onto The Parade and is constructed of grey local (Plymouth) limestone. The ground floor is finished with rusticated blockwork, whilst the upper floors are of coursed rubble blocks; all of the openings (except on the third floor) have voussiors forming segmental arches (Plates 1 and 2). The masonry of the third floor is slightly rougher and set between and back from four pillars of stonework; they incorporate a pair of flat headed-windows under a row of limestone voussiors. These differences may indicate that this represents a heightening of the building, however, the fenestration matches the alignments of the openings on the lower floors, and with shallow windows forming the top of a series of openings that decrease in size throughout the elevation; an architectural feature typical of Georgian architecture. The top of the elevation is a limestone date stone that reads '1847'. It is set within concrete rendered masonry, which is constructed on a replacement concrete lintel to the third-floor loading door. The building has a dry slate mansard roof with a hip at the south end and a straight north gable.

5.3 On the ground floor are pairs of doors and windows, set back slightly from the façade between pilasters. The double doors are of six panels with three-pane over lights; the

west lights are fitted with security bars. The window to the east is a 12-pane vertical sash, whilst the west opening has a fixed frame of 12 panes that attempts to replicate the adjacent sash. Both these windows are fitted with internal security bars. Above the ground-floor openings is a flat string course and above this is a later 20th-century wooden sign "A.E. MONSEN SHIP STORES"; the "S" in MONSEN is missing. On the first floor are three window openings, with the central one being twice the size of the others. All contain four-pane sash windows with small horns. On the second floor are two window openings and a central loading door. The windows are wooden framed two-pane casements with fixed two-pane lights above. They also have internal security bars. The central loading doors are double wooden plank doors incorporating small square windows. Above the doors are three fixed lights; both these and the windows in the doors have internal security bars. Above the second-floor opening is a flat string course, which is pierced by the loading door opening. On the third floor are a further two window openings and a central loading door. The windows are wooden-framed two-pane casements. The central loading door is a double plank door. To the west of the door is a large rotatable iron hoist bracket fixed to wall bearings.

Plate 2: South elevation of the building, looking north (1m scale)

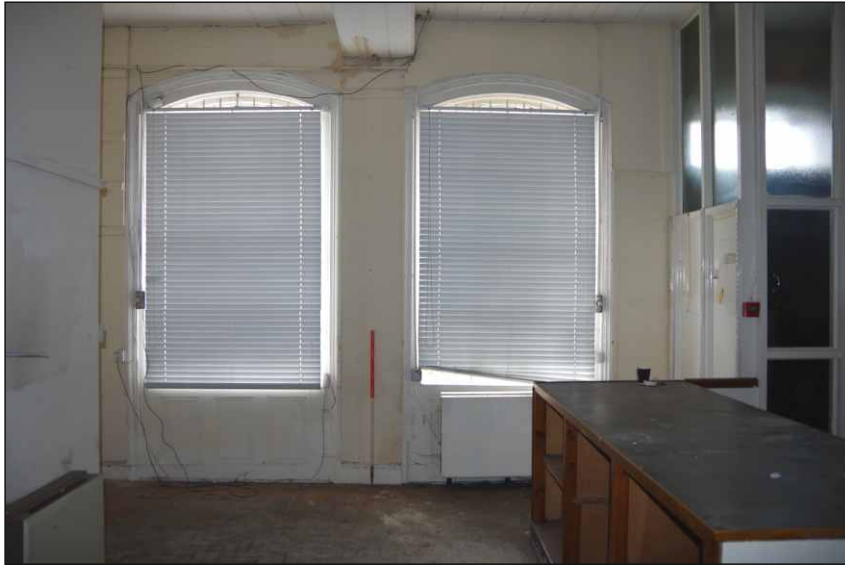
- 5.5** An office is present at the south end of the building, and is accessed via the western doorway, entered through a modern vestibule of timber and glass with a glass panelled door. Within the vestibule the south wall of the building is constructed internally of brick laid in stretcher bond with a hard lime mortar, incorporating a brick voussoirs above the doorway. The remainder of the south wall, along with all other walls in the office, has been finished with render. The windows in the south elevation have wooden surrounds with panels below set within slightly recessed reveals (Plate 4). The room has modern floor finishes with the majority being parquet; the skirting boards are low replacements featuring a simple bead moulding. The ceiling is covered with timber planks and there is a large boxed-in beam aligned north to south across the centre of the room.

Plate 4: South wall of the office on the ground floor, looking south (1m scale)

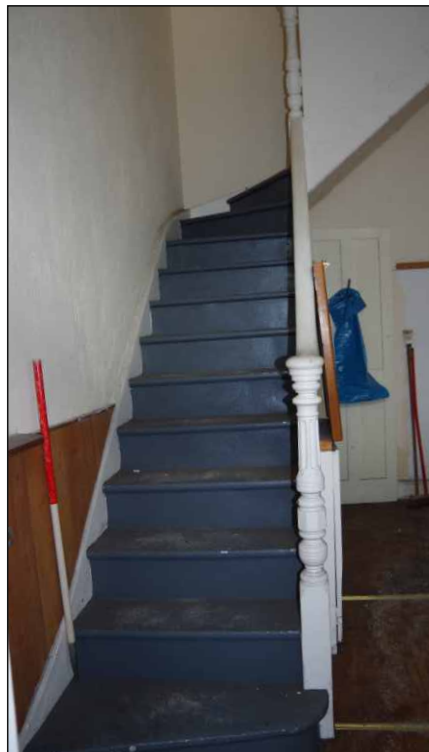
- 5.6** In the west side of the room is a wooden staircase with curving brackets typical of early to mid 19th-century open-string stairs; however, the space below has been infilled with panels and a (20th-century) door to create a cupboard. In the cupboard on the back of one of the stair treads is the chalked text "THE BOY 1/3/1966". Below this are some

poorly-preserved possible early 20th-century labels. The staircase has decorative newel posts and flat hand rails (Plate 5). The east side of the room has been subdivided with modern partitions to create two WCs and a secondary entrance that leads to a set of wooden stairs to the first floor. In the east wall inside to the main door is a small niche, the function of which is unclear. This wall is rendered. At the level of the half landing of these stairs (between the ground- and first-floor levels) there is an arched opening containing a cupboard set into the east wall. The cupboard has two-panel doors.

Plate 5: Stairs in the office on the ground floor, looking north (1m scale)

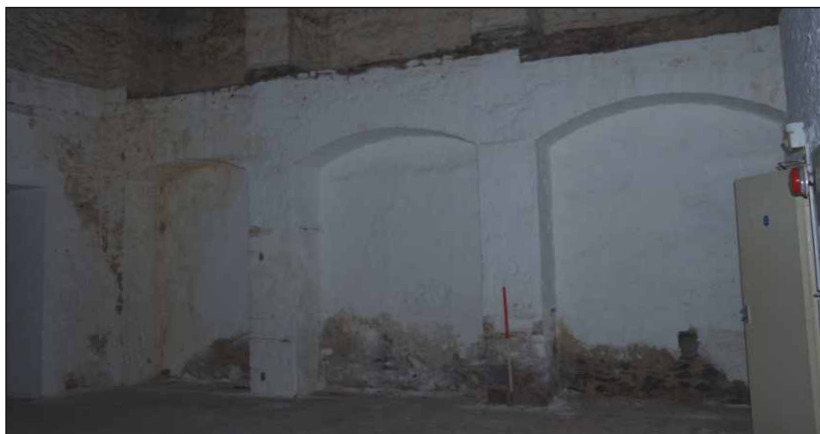
**5.7** The first-floor structure of this room has been removed, and the space is now open to the second-floor ceiling level. All of the walls are painted stonework. The west wall is featureless apart from the blocked openings of the first-floor bridging beams. In the south wall is an inserted doorway fitted with a 21st-century door. The north elevation contains two wide segmental brick arched openings. The west opening has been completely infilled with concrete blocks, whilst the east opening has been narrowed on both sides with brickwork. Above these openings are the sawn-off ends of the removed floor joists. In the east wall are three recesses with segmental brick arches (Plate 6). These are within the west wall of the Custom House to which No. 9 The Parade has been built against. Above the openings are brick-blocked sockets associated with the removed first-floor bridging beams.

Plate 6: Ground-floor east wall in the south store on the ground floor, looking northeast (1m scale)

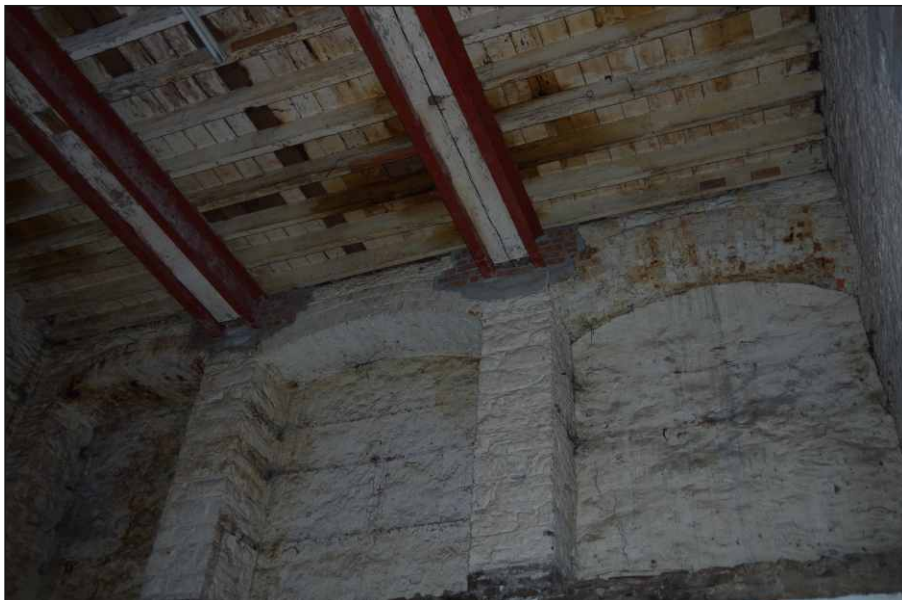
**5.8** On the first floor of the east wall are a further three blocked arched openings directly above those on the ground floor (Plate 7). Between the openings are the wooden bridging beams for the second floor. These have both been strengthened with the addition of pairs of RSJs set within wider sockets infilled with bricks. Scars on the base of the timbers indicate that they were previously additionally supported on three posts or columns situated approximately in the centre of the room. In the south wall at first-floor level, above the brick-blocked sockets for the removed joists there are two segmental brick arched openings. The opening in the centre of the room is wider than the opening to the west. Both have been infilled with block work (Plate 8). There are no openings in the north or west walls.

Plate 7: First-floor east wall of the south store, looking northeast

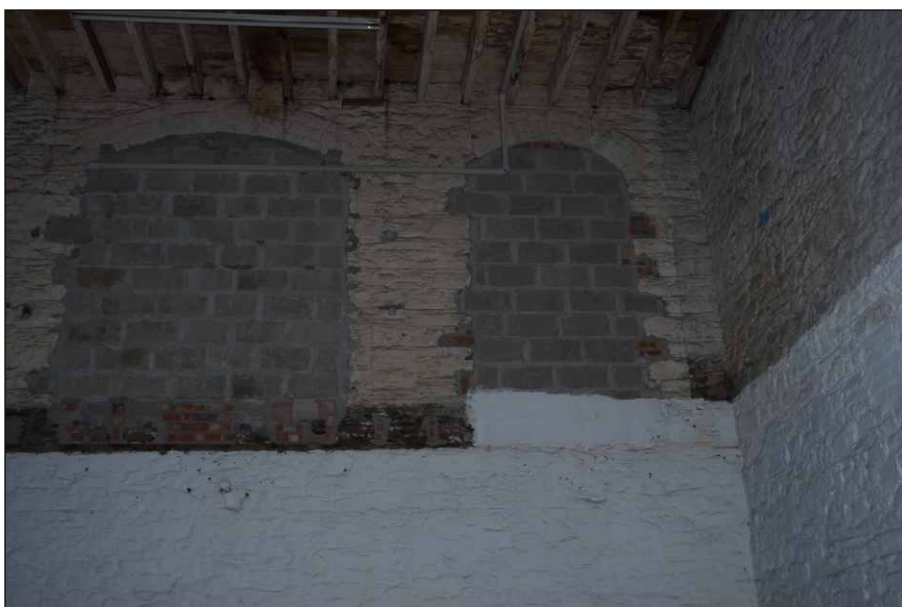
Plate 8: First-floor south wall of south store, looking south

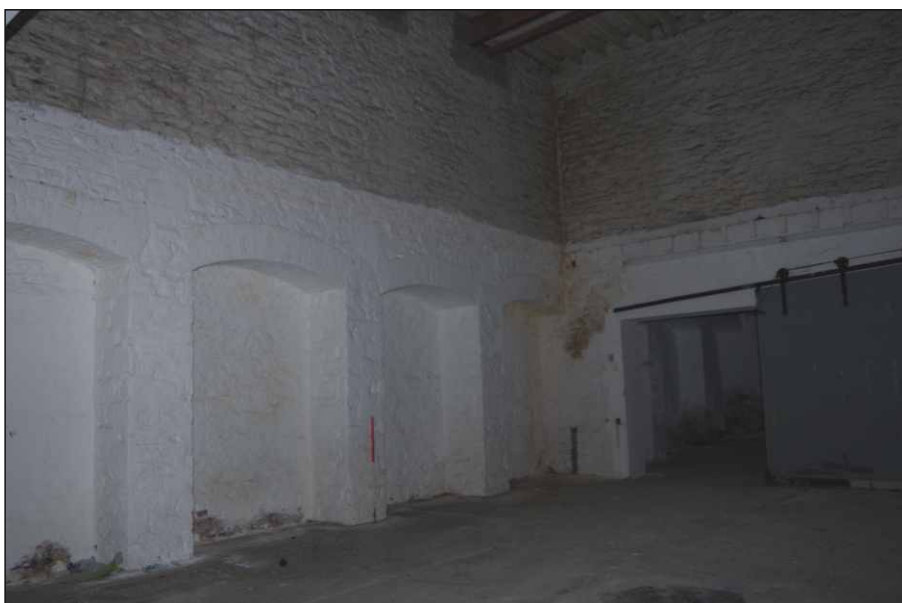
**5.9** As in the south store room, the first-floor has been removed, and the current space is open to the second-floor ceiling level. All of the walls are painted stonework. On the ground floor in the south wall are the openings described above, which on this face are fitted with a large sliding metal door (Plate 9). The only features in the west wall are four blocked openings for the first-floor bridging beams. The majority of this wall has been rendered but towards the north end there is a small area of exposed stonework that contains some brickwork near the base. In the east wall are four arched openings like those in the south store room, again with blocked openings for the removed first-floor bridging beams above (Plate 9).

Plate 9: Ground-floor east wall of north store, looking southeast (1m scale)

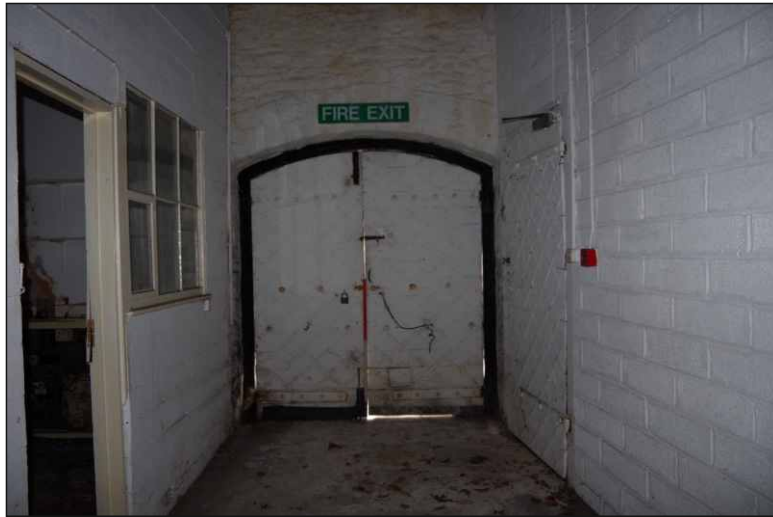
**5.10** The north bay of this store has been partially subdivided in the 20th century to create a small office and enclosed stairwell (Plate 10). The office is created from a timber plank partition incorporating a door and window in the east wall. The stairwell is created from concrete blocks, and incorporates a doorway in the west wall. The door has been reused and is similar to the adjacent ground-floor loading doors in the north elevation. As with the stairwell, the stairs themselves are modern. At their base is a safe with a label "Chawton – Milner". In the east wall next to the blocked door in the north elevation is a small niche, the function of which is unclear. Its position matches that recorded at the south end of the wall. At the level of the half landing of the stairs, between the ground and first floors, is a blocked segmental brick arched opening in the east wall, rising from a concrete sill.

Plate 10: North end of ground floor showing modern partitions, loading door and reused door (to the right), looking north (1m scale)

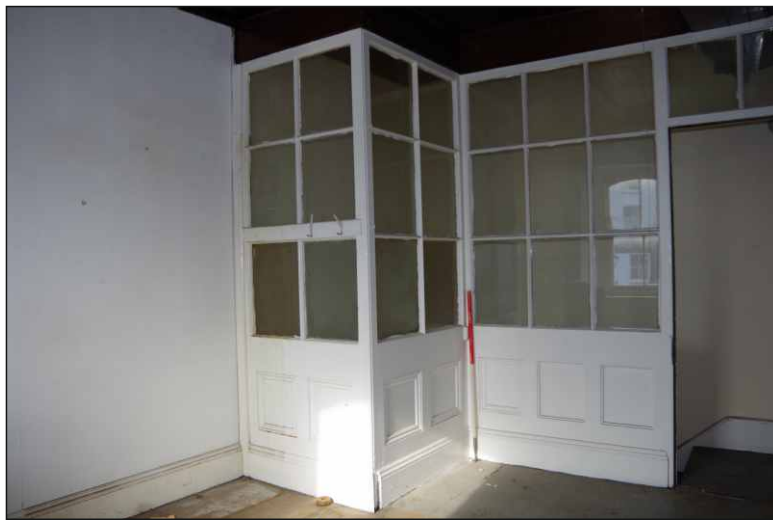
- 5.12 The south end of the building is divided into three areas by a pair of north to south aligned 20th-century partition walls. The room to the west has a wooden partition adjacent to the stairs with solid panels at the base and windows above; it incorporates a glass panel door (Plate 11). This partition appears to be of early 20th-century date. In the southwest corner of the room is a large safe with the manufacturer's plate "Phillips and Son manufacturers Birmingham. Improved fire and thief resisting safe". Within this office the walls are plastered and finished with a low skirting board with a simple bead moulding. The ceiling comprises timber planks and incorporates a boxed in timber aligned north to south. The walls of the central office are plastered with a plain skirting board on the south and west walls. The planked ceiling incorporates a second boxed-in north to south aligned timber. To the east, accessed from the central office is a small area containing a sink, along with the 20th-century stairwell. The stairs are wooden with plain square newel posts and rounded handrails (Plate 12).

Plate 11: Partition in southwest office on the first floor, looking northwest (1m scale)

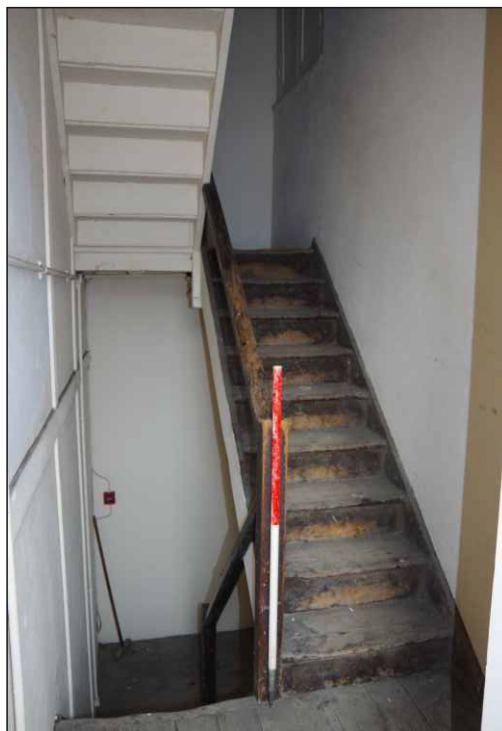
Plate 12: General view of stairs in the southeast corner of the building, looking north (1m scale)

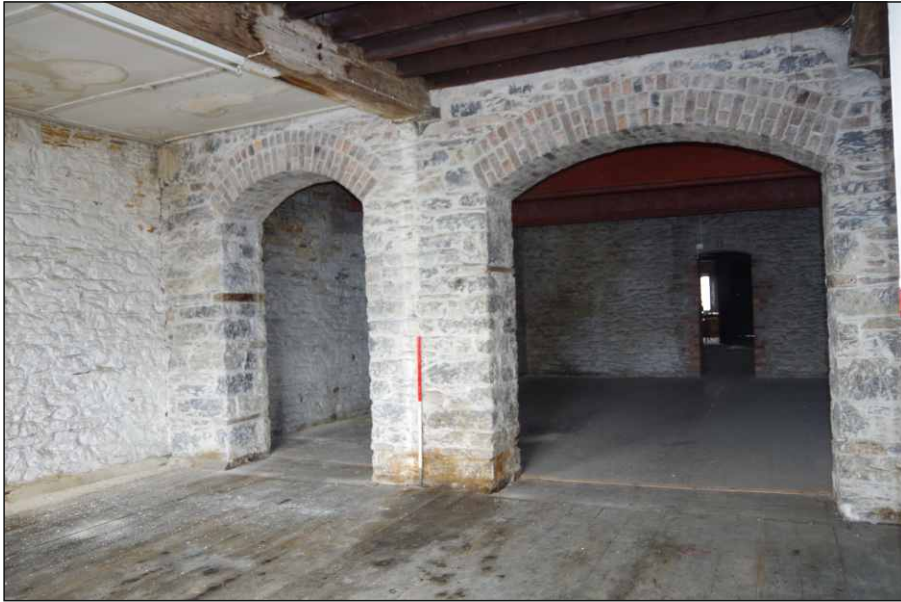
- 5.14 The building was historically divided into three stores. The south store has been subdivided with a partition created around the 20th-century stairs and associated lobby. opening containing a cupboard in the east wall; the doors are each formed from two panels. The walls are of exposed stonework, and the south and west walls are not keyed into each other. Matching those below on the first floor, there are two segmental brick-arched openings in the north wall – a wider central opening, and narrower western opening (Plate 13). The floor of the roof space is supported on two north to south aligned bridging beams attached with metal plates set into the north and south walls. The western part of the room was formerly enclosed, and this area retains a plastered ceiling. Other evidence are scars of the partition on the north and south walls. The only other features are segmental brick arches above the windows in the south elevation.

Plate 13: Second-floor north wall of the south store, looking northwest (1m scale)

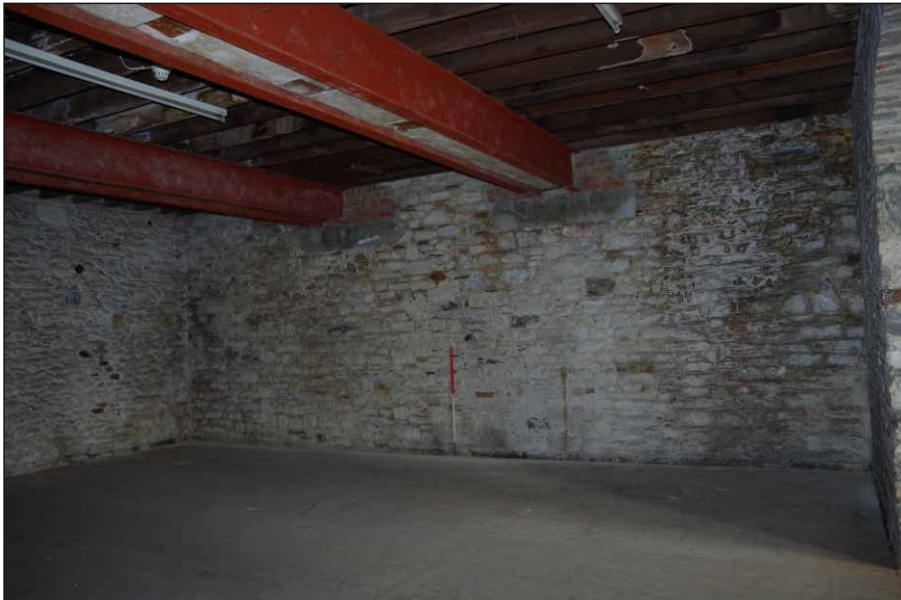
- 5.15 There is a single central segmental brick arched opening in the north wall connecting the space with the north store. Modern brickwork around the opening indicates that it has been repaired or altered, perhaps very slightly narrowed. There are two large bridging beams aligned east to west supporting the third floor. As with those on the

floors below, these have been strengthened with the addition of pairs of RSJs set into wider brick-filled sockets. The beams have three scars on their bases, indicating that they were supported on posts or columns (Plate 14).

Plate 14: Second-floor east wall of central store, looking northeast (1m scale)

- 6.8 The most significant changes to the building occurred later in the 20th century, and involved the removal of the first floor in the central part of the building, and the reinforcement of most of the bridging beams supporting the upper floors; this involved the removal of existing posts or columns, and the addition of new RSJ beams.

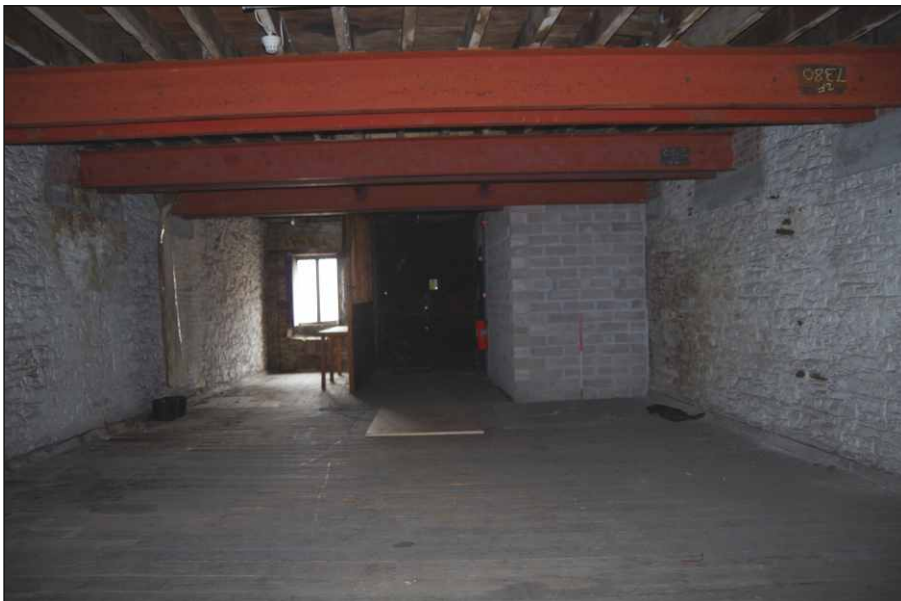
- 5.16 The west wall is not keyed into the north elevation. The windows in the latter wall have pegged wooden frames, and the west window retains wooden shutters of a similar style to the loading doors in this elevation. In the northeast corner of the room is a concrete block partition forming a stairwell, and to the west a length of modern timber partition (Plate 15). As on the lower floors the door in the west wall of the stairwell is of a similar design to the loading doors, and has been reused.

Plate 15: General view of second-floor north store, looking north (1m scale)

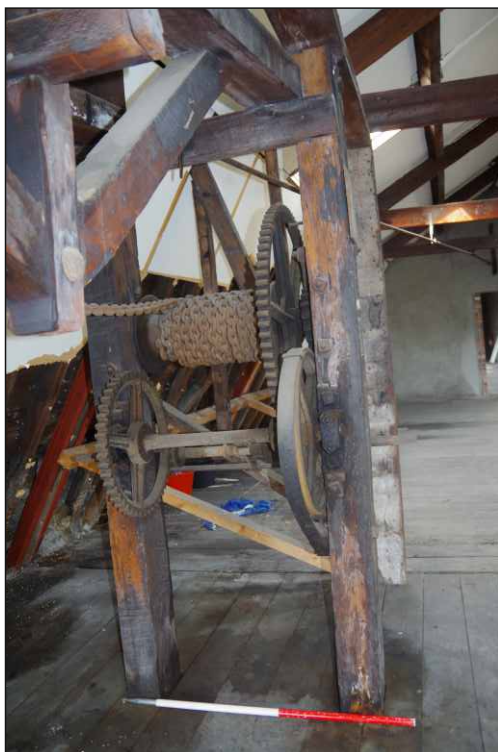
- 5.18 The third floor is divided into two stores. In the south store a modern addition has been added to define a stairwell and associated lobby. The central loading opening in the south elevation has been infilled internally with concrete blocks. To the west of the loading door is the winch arm associated with the external loading hoist. This retains its cogs and chain, the former incorporating a brake mechanism (Plate 16). The chain is supported on beams with braces beneath the arm and moves on metal rollers attached to the roof structure (Plate 17). In the north wall is a single central inserted doorway. This has brickwork around the opening and a concrete lintel.

Plate 16: Cogs and chains of winch arm in the third-floor south store, looking northwest (1m scale)

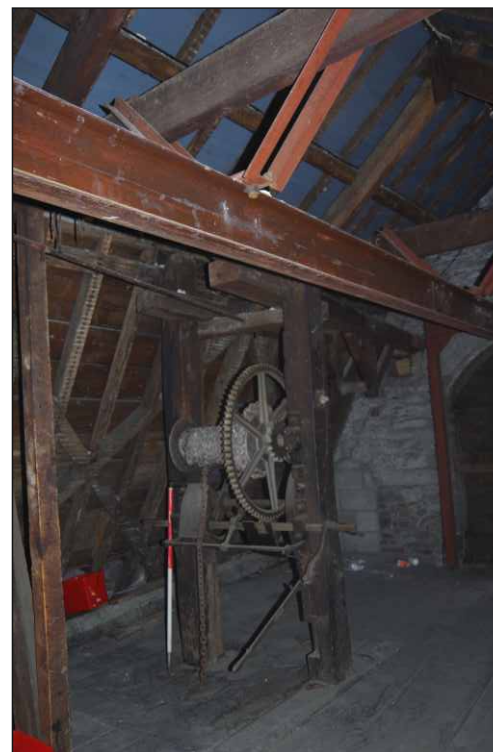
- 5.19 in the northeast corner of the room is a concrete block partition that defines the stairwell; as on the floors below the door in its west wall has been reused. The windows in the north wall have been infilled internally with concrete blocks. There is a loading hatch in the centre of the floor near the north end of the room. A metal loading arm runs from above the hatch to the front loading opening. To the west of the loading opening in the north elevation is a winch arm that is of the same design as the one to the south described in section 5.18 above (Plate 18).

Plate 18: Cogs and chains of winch arm in the third-floor north store, looking northwest (1m scale)

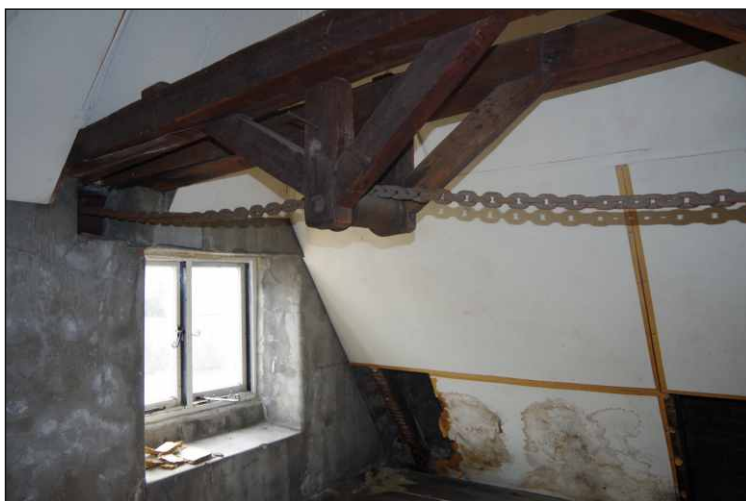
Plate 17: Chain of winch arm in the third-floor south store, looking southwest

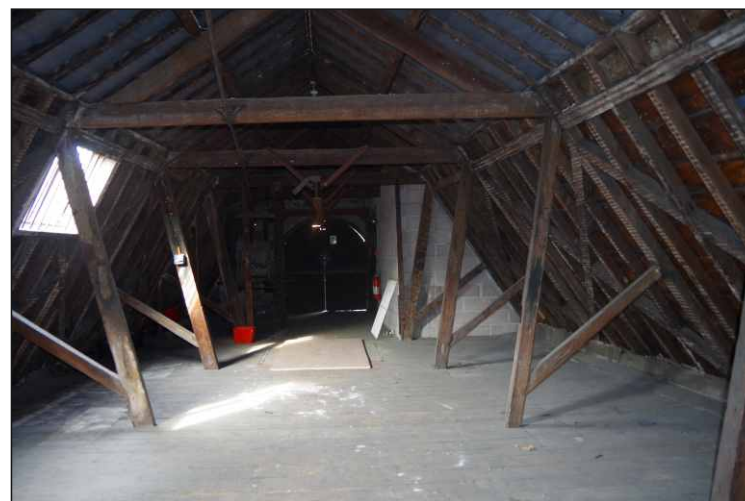
- 5.20 The roof structure comprises A-frame trusses additionally supported on angled near-vertical struts with additional angled braces (Plate 19). The trusses are lap jointed at their apexes. Trenched purlins, with length of timber joined at the trusses, support the secondary rafters, with the latter terminating at horizontal beams. Below these are vertical ashlar plates that are set into wall plates. The inside of the roof has been partially covered with chipboard, but is mainly exposed, and incorporates three skylights on its west pitch, one in its east pitch, and another in the south hip.

Plate 19: General view of roof structure, looking north
