4 ABBEY PLACE, TAVISTOCK, DEVON

Tavistock Abbey: Scheduled Monument no. 29679;
National Heritage List for England no. 1020401

Results of an archaeological watching brief

Document No: ACD1681/2/0

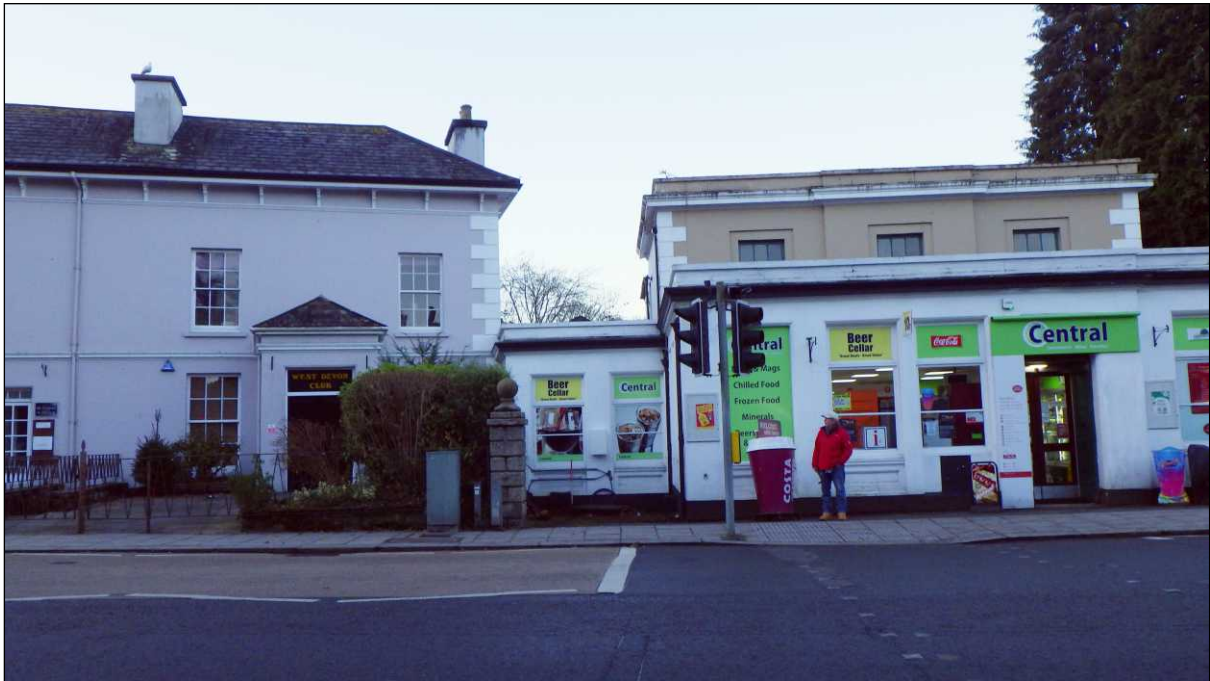
Plate 1: Location of site showing 4 Abbey Place to the right, looking southeast. 1m scale

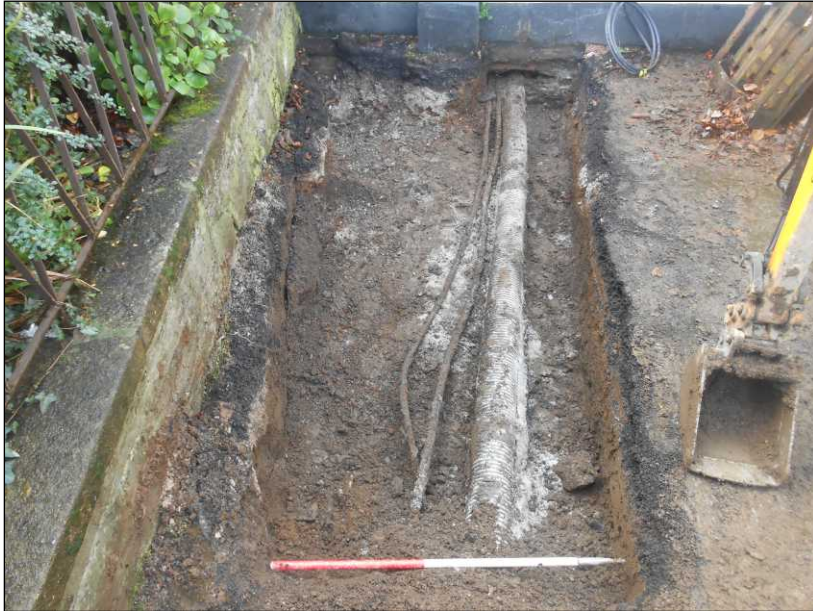
- 0-300mm tarmac surface and associated sand make up (102); and
- 300-520mm+ dark grey-brown sandy silty-clay (101) containing gravels, common brick, mortar and slate, and fragments of industrial china and glass (which were not retained).

6.1 The only exposed archaeological deposit was the top of a layer (101), which represents a landscaping deposit associated with the 19th-century raising of the ground level as part of the rebuilding of Tavistock by the Dukes of Bedford. The works did not extend deep enough to expose any earlier deposits or features.

Plate 3: The excavated joint pit, looking southeast. 1m scale

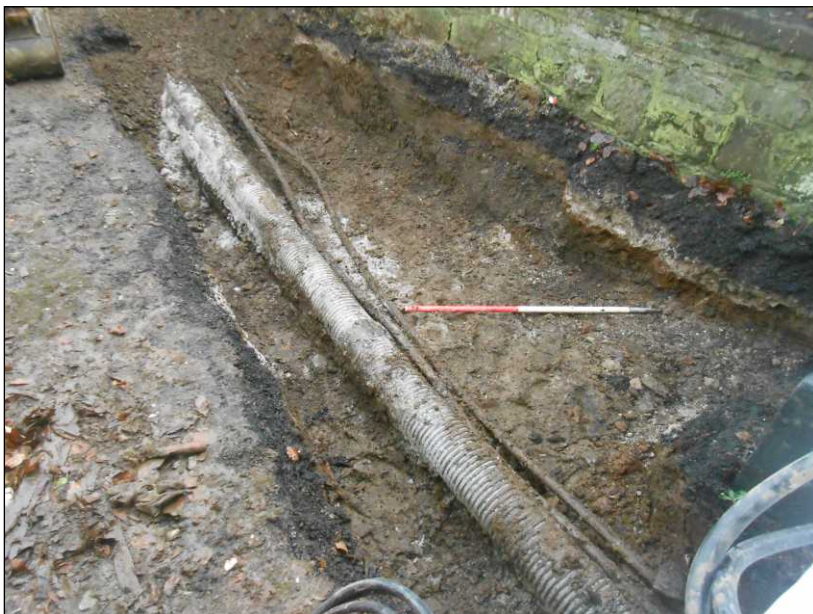
Plate 4: The excavated joint pit, looking east. 1m scale

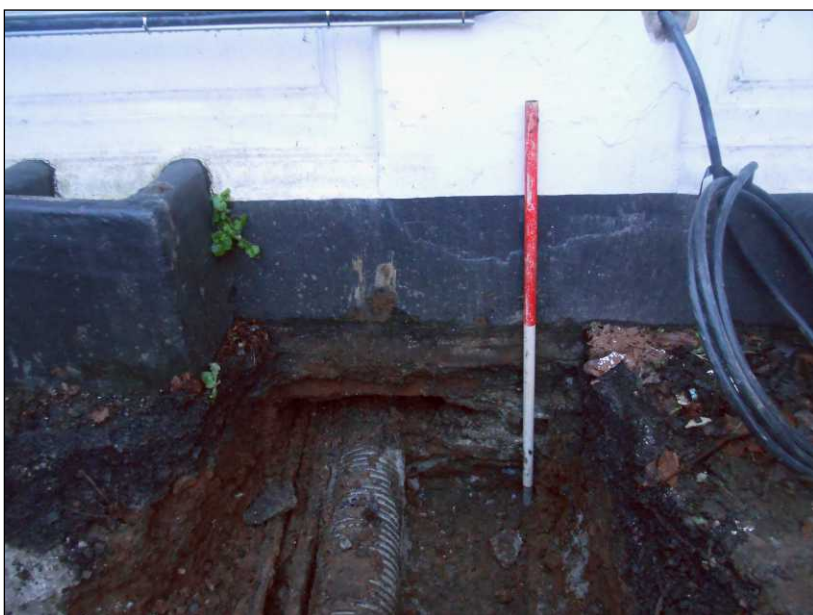
5.3 The existing service cable, and adjacent smaller cables were located within a trench (F103) below the tarmac surface, cut into deposit 101, and backfilled with a mid reddish-brown soft silty sandy-clay with rare sub angular gravels (100).

Plate 5: The existing cable where it enters 4 Abbey Place, looking southeast. 1m scale
