TEMPLE INN, TEMPLE CLOUD, BATH & NORTH EAST SOMERSET

Results of an archaeological watching brief

Bath & North East Somerset Council planning ref.
13/04456/FUL (condition 4)

Document No: ACD1398/2/1

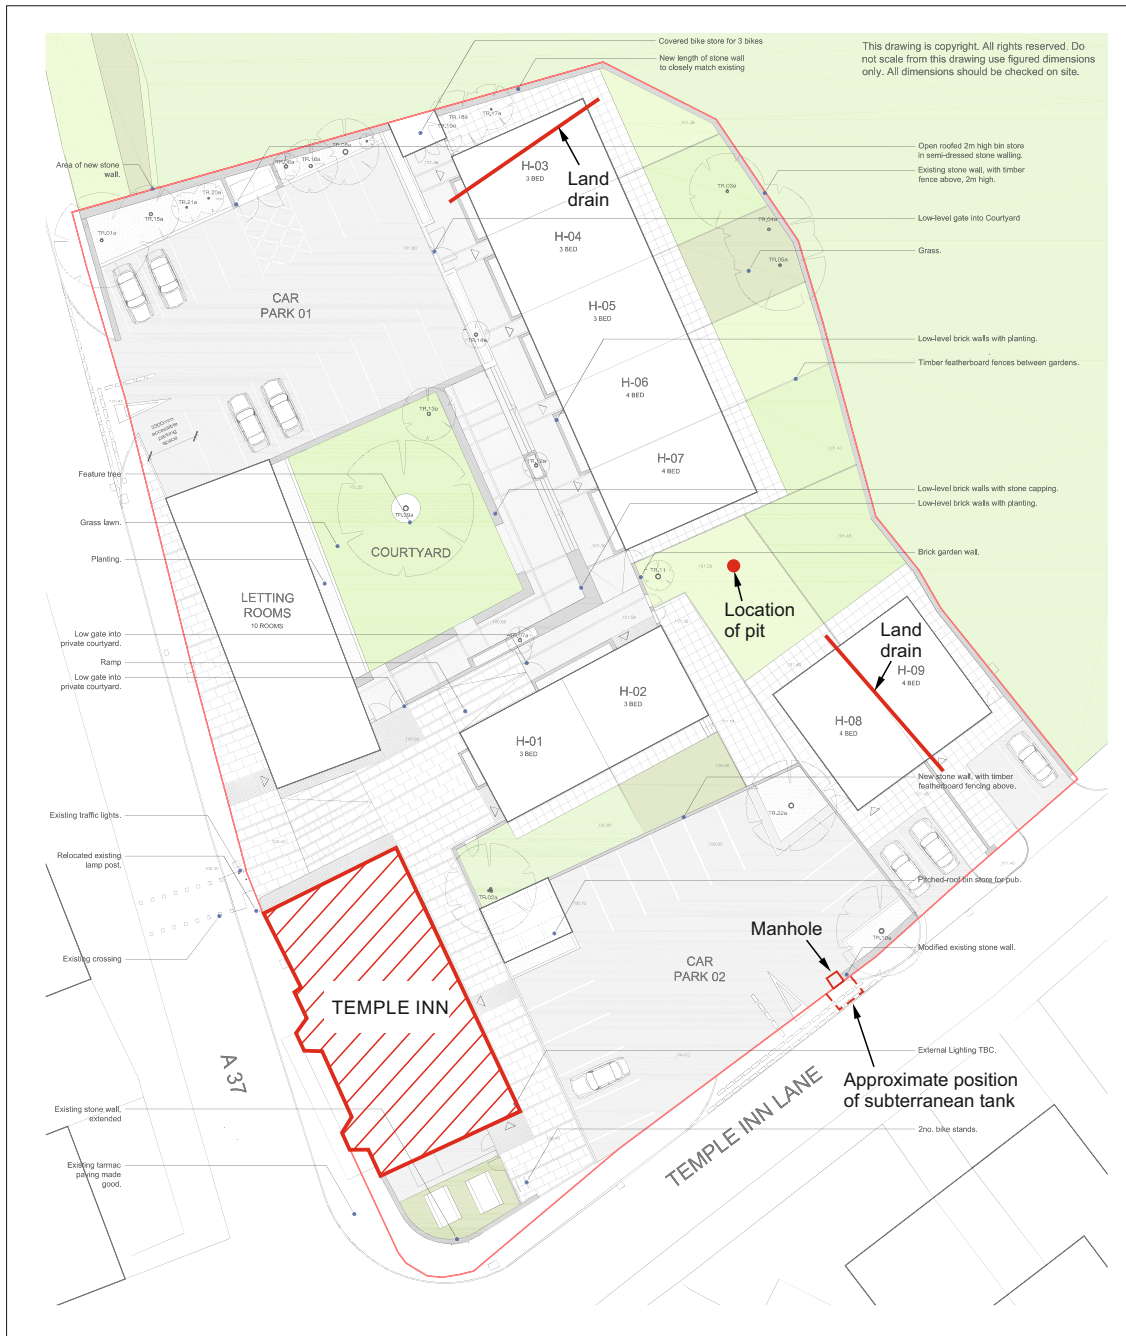
Fig. 1: Location of site and watching brief observations

5. RESULTS (Fig. 1)

- 5.1 Monitoring of the initial bulk reduction and later footings and drainage trench excavations revealed limited survival of archaeological remains. Observations from multiple visits across the site identified a very shallow surviving soil containing 17th-19th century finds (clay tobacco pipe stems, glass, and china, which were not collected). In the northeast corner of the site this was overlain by clear modern dumping, material which included concrete block fragments. In the southeast corner there were no modern dumped layers present. However, an increase in the depth at which the natural subsoil was exposed to the east of the surviving outbuilding east of Temple Inn indicated that the area containing the pub and associated hard-standing to the southwest had been terraced into the natural subsoil to some extent. The deeper resulting soils contained large amounts of large angular sandstone, no doubt deriving from terracing/construction activities.

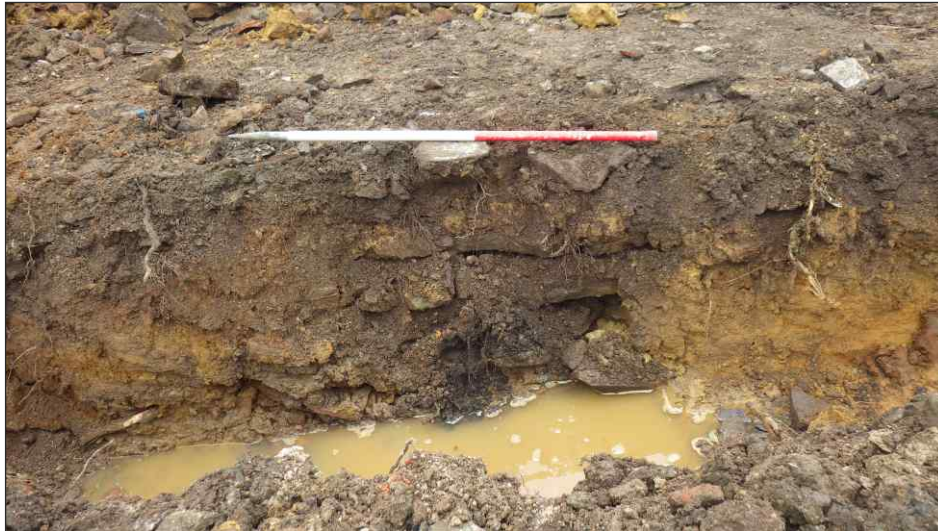
Plate 3: Southeast-facing section of land drain in southeast part of the site (1m scale)

- 5.2 The only features observed were a pair of probable 'soak-away' style linear land drains and a possible pit. One of the linear features was located in the southeast part of the site on an approximate northwest-southeast alignment (Plate 3), while the other was located in the northeast part of the site on an approximate northeast-southwest alignment (Plate 4). Both were cut through the post-medieval soil, and were primarily in-filled with large stone (aiding drainage), with a loose soil matrix above.

- 6.3 The perpendicular nature of the alignment of the probable soakaway land drain features, coupled with their similar appearance, suggests contemporaneity. Their positions enclosing the main plot containing Temple Inn and its associated outbuildings indicates they were designed to manage water flow and prevent drainage off the hard sandstone geology down into the depression created for the buildings.

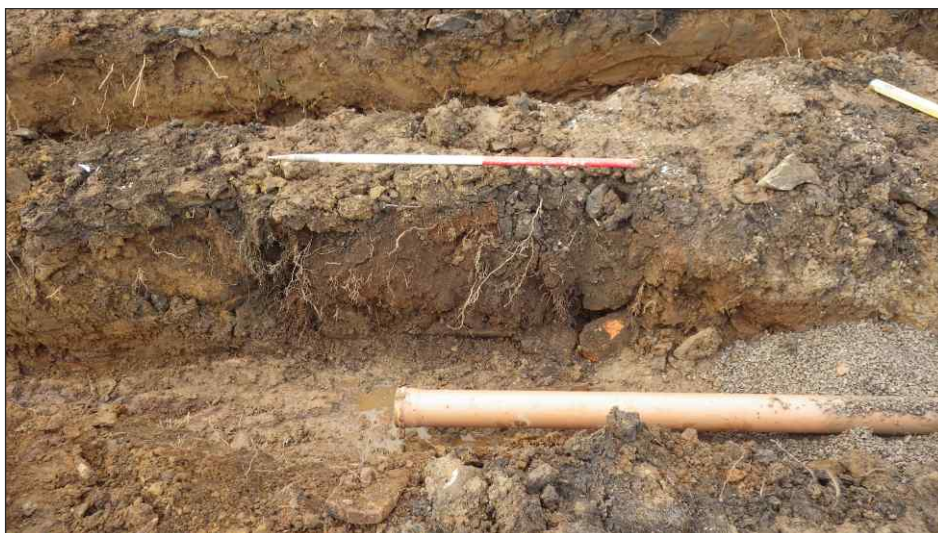
Plate 5: East-facing section of pit feature (1m scale)

- 5.3 The pit was situated central to the eastern side of the site and was in-filled with large stones, brick and a large piece of metal sheet (Plate 5).

- 6.4 The purpose of the pit is unknown, however the material incorporated within its fill suggests a date no earlier than the construction of Temple Inn and potentially much later based on the relatively good condition of the metal sheet. The large stone inclusions could suggest it is another feature concerned with drainage, perhaps being fed by a gutter/drain.

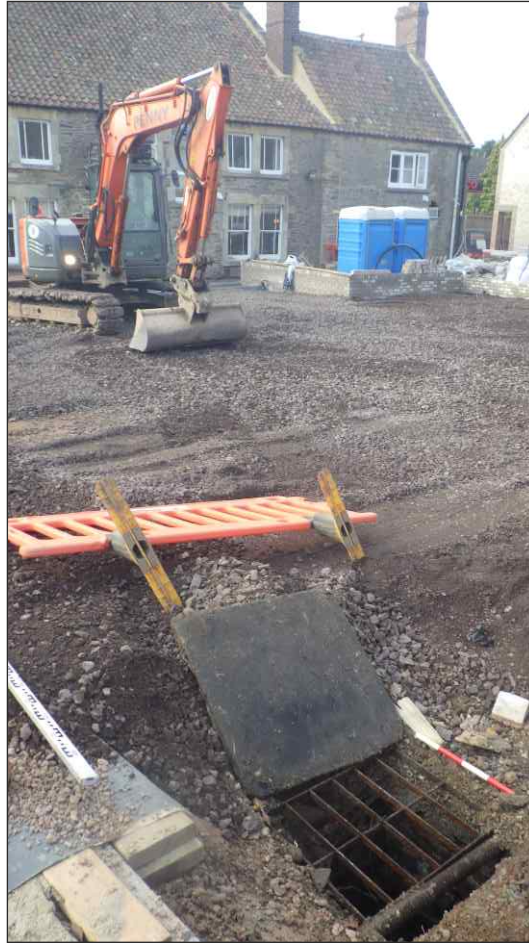
Plate 6: Manhole for access to subterranean tank, looking west (0.4m scale)

- 5.4 Against the southeast boundary of the site a slate capstone was found, which when lifted revealed an iron grill (Plates 6-7). This covered a manhole measuring 0.6m by 0.54m and providing access to a subterranean water-filled tank which was at least 2m wide and 4m deep and continued under the pavement to the southeast of the development area. Although little of the tank was visible it was constructed of brick and local stone and the metal mechanism for a probable pump was also observed.

- 6.5 The specific purpose and origin of the subterranean water tank is also unknown. It probably dates to the 19th or early 20th century.
