SPREYTONWAY, ST GERMAN'S ROAD, EXETER

Results of historic building recording

Exeter City Council planning reference 17/0727, condition
11

Document No: ACD1744/2/0

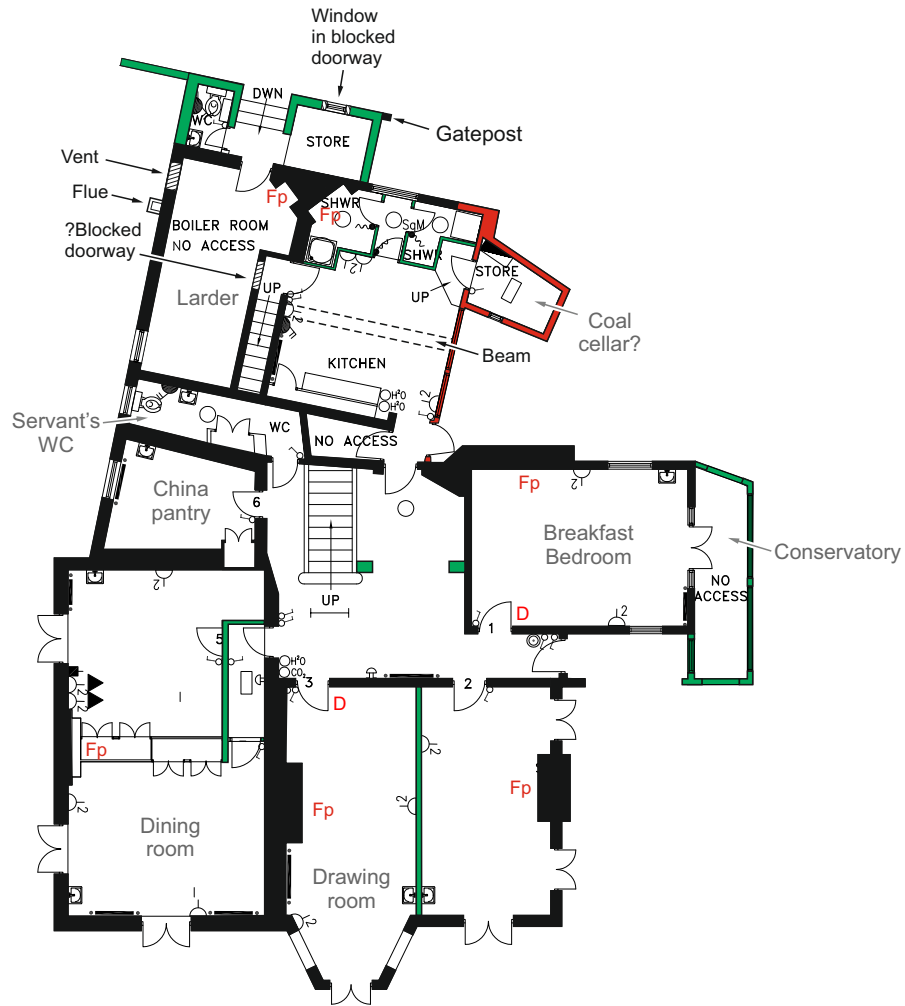
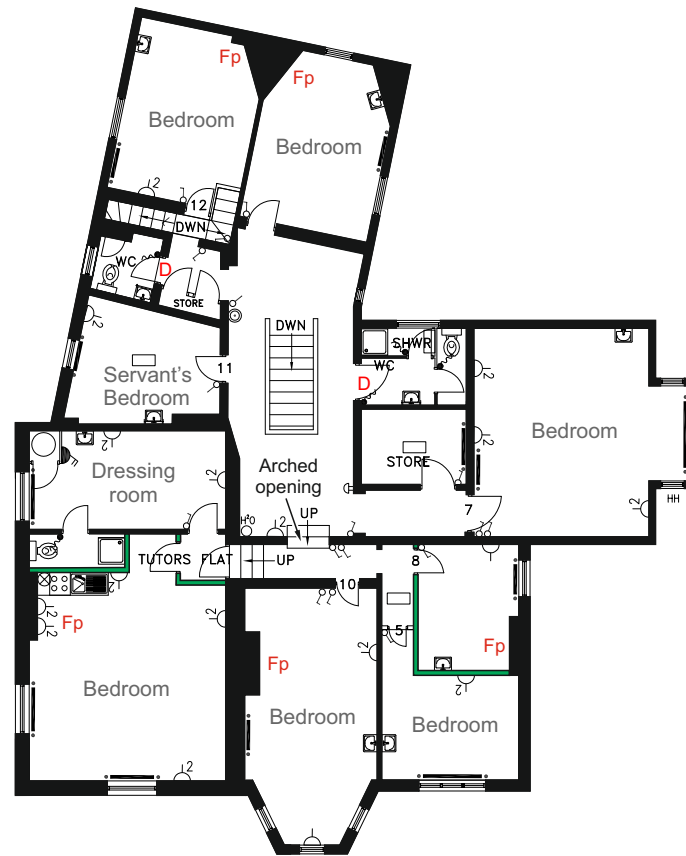
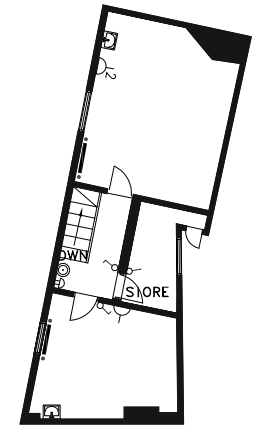
TITLE
Fig. 5: Phased floor plans
of the house

Fp = Position of historic fireplace
D = Panelled interior door

1830s Late 19th century (by 1890) 20th century (after 1905)

- 6.4** Overall, the plan of the building has changed very little and it had achieved its current shape by 1890. A single probable pre-1890 alteration to the house has been identified. This is the ground-floor extension eastwards of the kitchen, and construction of the associated attached store. It is almost certainly not primary due to its single storey scale (as opposed to the higher rest of the range), and the awkward position of the door in relation to the rear wall of the main house. Internally, the east wall of the kitchen must have been removed. The inner lobby

doorway adjacent to the stairs may be original, but formerly external. It is possible that to the west of the stairs there was access (now blocked) from the main entrance hall to the kitchen.

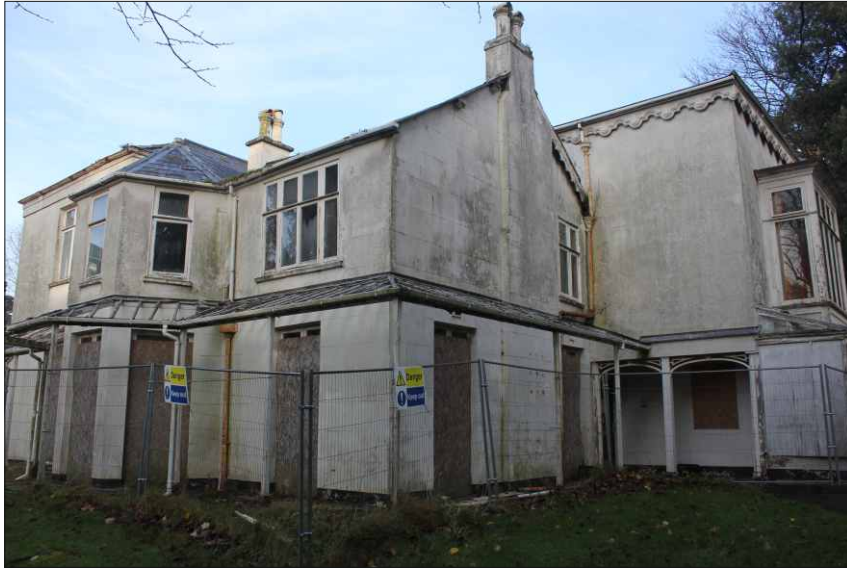
Plate 1: The house viewed from the southwest

- 5.1 The building is two-storeyed with, due to its shape, multiple elevations, all finished with stucco scored to imitate ashlar (Plate 1); the masonry is almost entirely obscured. Many of the windows are 20th-century replacements. Where possible

- 5.7 The east elevation of the front range incorporates a central projecting chimney stack topped with two ceramic pots (Plate 1). On the north side the barge board survives, and features a curved pattern. On the ground floor there is a pair of double doors (of the type recorded elsewhere), one to either side of the chimney stack. On the first floor is a single window located to the north of the fireplace. This has 4 panes with side-opening lower casements.

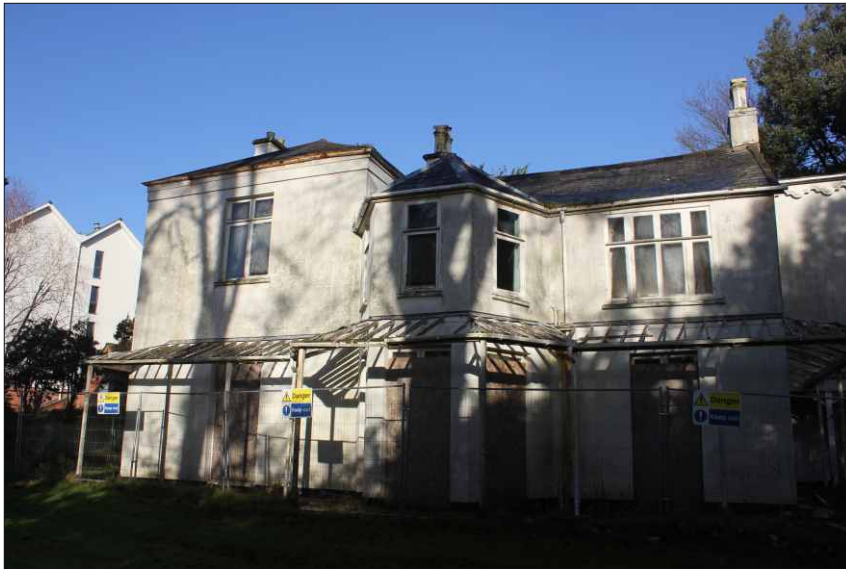
Plate 2: The south elevation of the house, looking north

- 5.2 This elevation incorporates a projecting bay window which is slightly off centre to the right (Plate 2). It features windows in the side walls and double doors with top-opening windows above in the south wall. The rooms to either side of this bay have tall double doors with top-opening windows above. An original cast-iron downpipe with hopper survives adjacent to the central bay, but the remainder of the pipework above has been replaced.

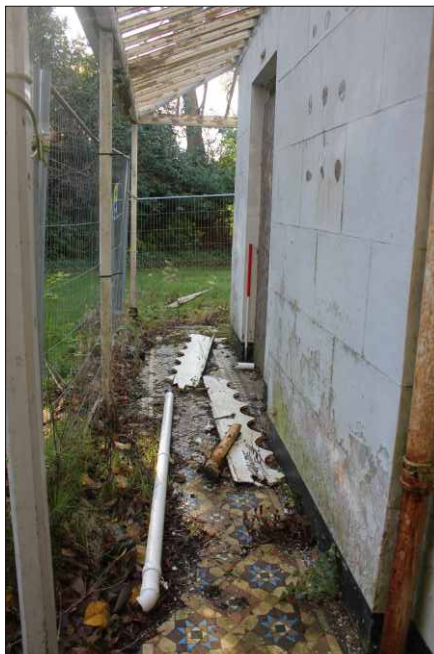
Plate 3: The veranda on the east side of the house, looking south (1m scale)

- 5.4 A veranda extends along the whole of this elevation and wraps around the southeast side of the house (Plate 3). It is formed from wooden posts (creating an open front) and rafters, all of which are finished with chamfers and broad ovolo moulding. The glass to the roof has been removed in the 21st century, probably as a safety measure when the building went out of use. The veranda has a tiled floor laid on a concrete base (Plate 4).

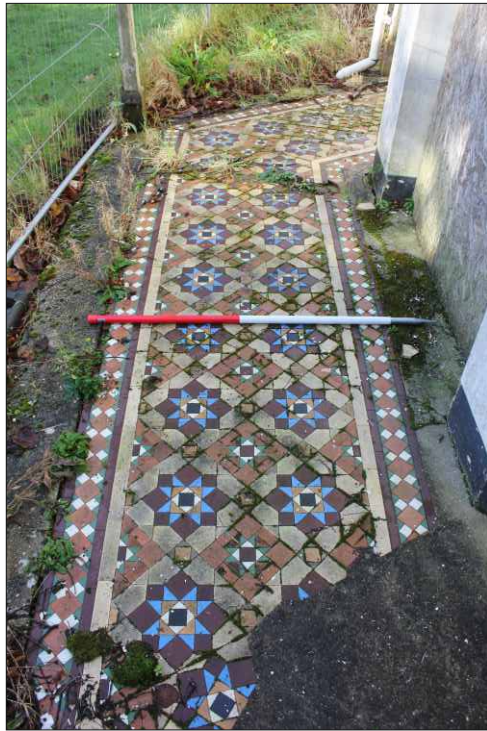
Plate 4: The floor of the veranda, looking west (1m scale)

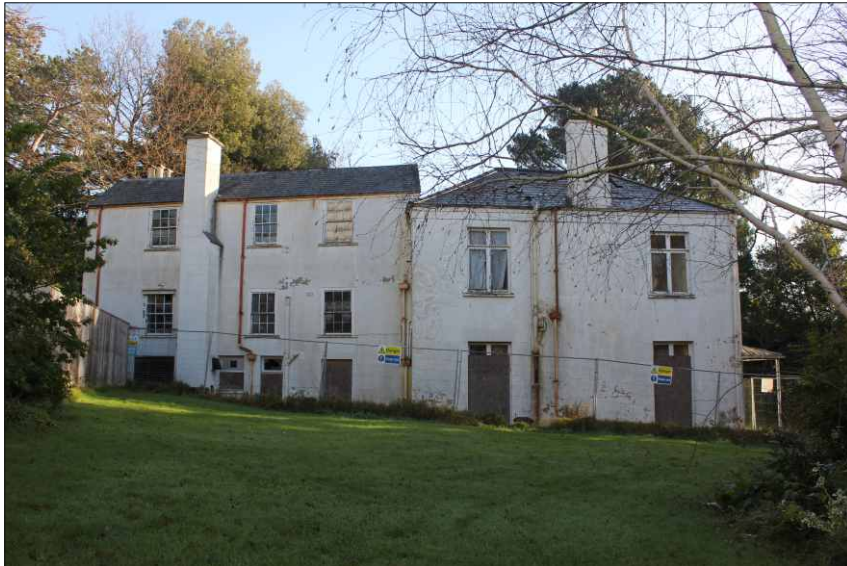
Plate 5: The west elevation of the house, looking east

- 5.5 On the ground floor the front section of the west elevation incorporates a pair of double doors of the type recorded in the south elevation (Plates 5 and 6); these are set to either side of a (flat) chimney stack. The rest of the façade to the north is set back from, and angled away from, the main house (Plate 7). Towards the north end is a projecting flue. This range has two full floors – the ground floor being slightly terraced into the hillside – and a partial second floor set towards the west side of the building. To the south of the chimney stack there is a fully boarded-up ground-floor window and two smaller 2-pane windows with top opening sections. Above on the first floor is a pair of 6-over-6 pane hornless sashes, and on the second floor a pair of horned 6-over-6 pane sashes. Beyond the chimney stack to the north is a ground-floor vent and a first-floor 6-over-6 pane hornless sash with a wooden hood (Plate 8), and a second-floor 6-over-6 pane horned sash.

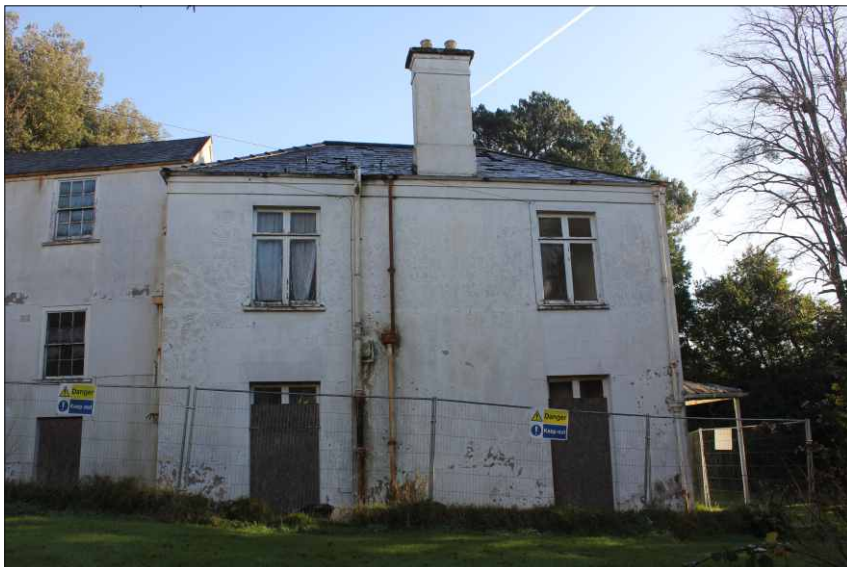
Plate 6: The west elevation of the front range of the house, looking east

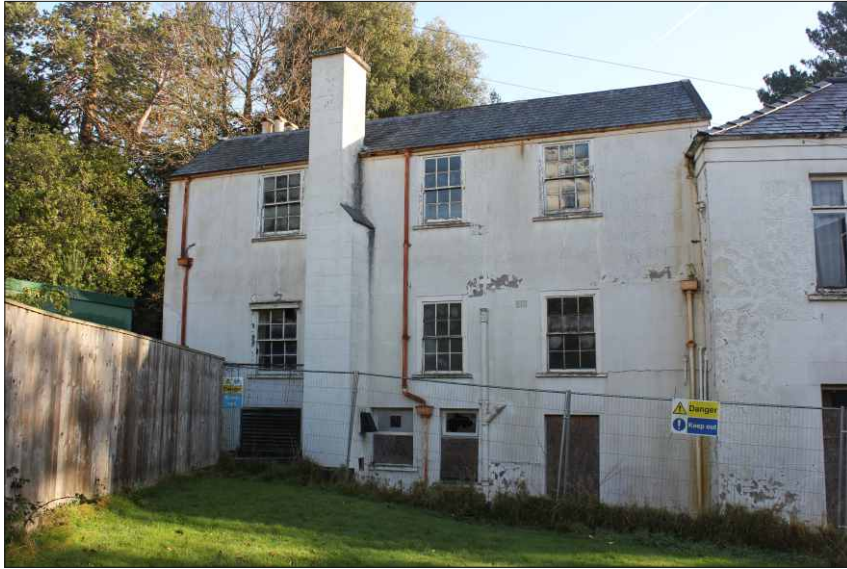
Plate 7: The west elevation of the rear service range of the house, looking east

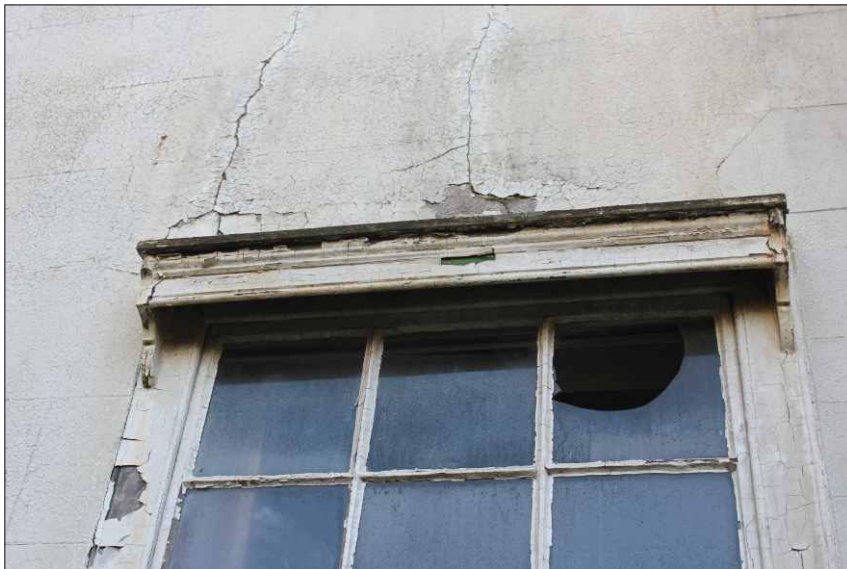
Plate 8: The hood over the sash window in the rear service range, looking east

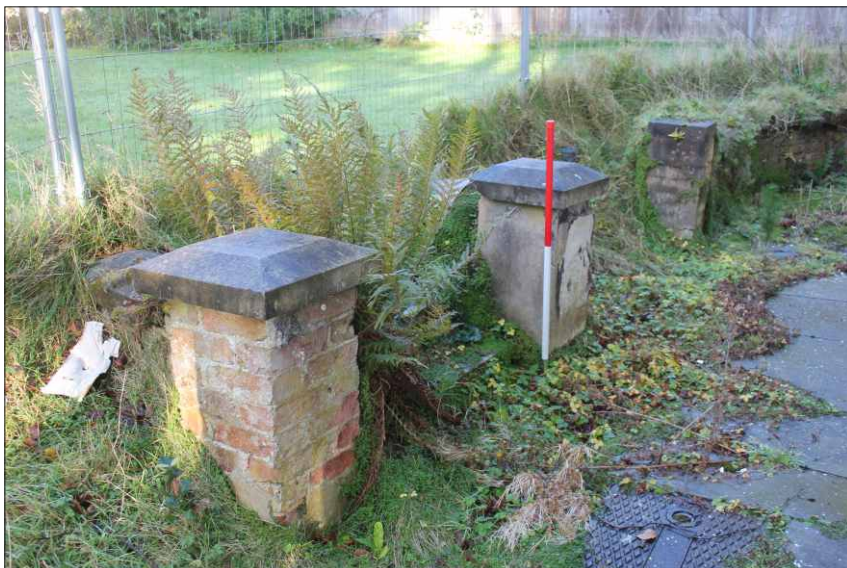
Plate 9: The granite steps and brick piers west of the house, looking northwest

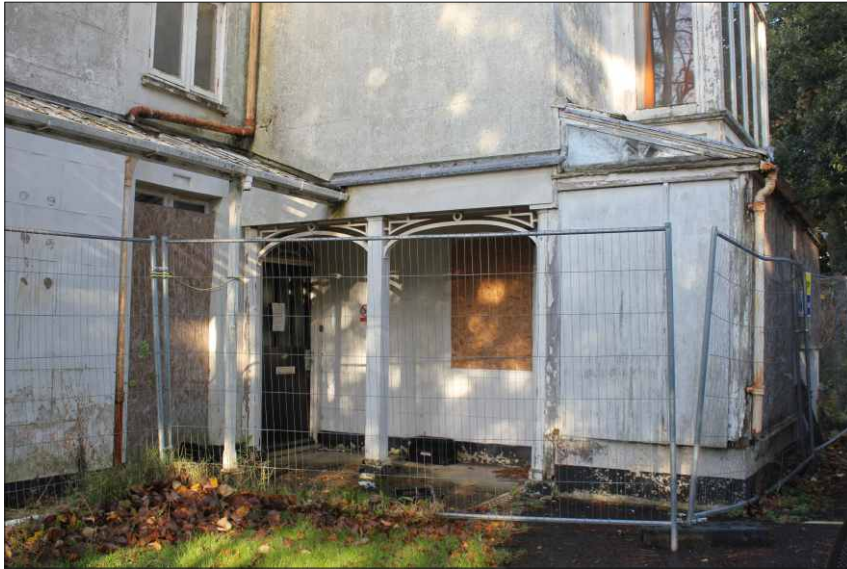
Plate 10: The entrance porch, looking northwest

- 5.8** The veranda continues around this elevation and terminates at a semi-open porch under a first-floor bedroom (Plate 10). Its head is defined by two shallow arches supported on a central wooden post. In the west side of the porch is a 6-panel door with the top 3 panels glazed (Plate 11). Above the opening is a semi-circular fanlight. The porch also has windows in the north and east walls; the latter has two side-opening casements finished with a form of wooden decorative tracery.

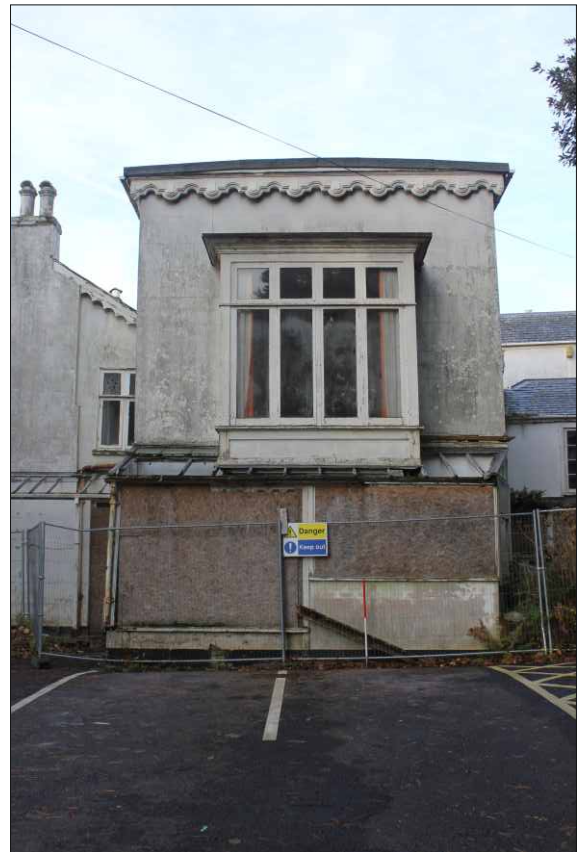
Plate 12: The east elevation of the house, looking west (1m scale)

- 5.9** To the northeast there is a conservatory attached to the west side of the breakfast room (Plate 12). This is constructed of brick walls supporting glazing of various heights with decorative tracery. The sloping roof was also glazed (although this has now been mostly removed) with opening rear sections operated using internal levers. The first floor is very tall, and incorporates a large square bay window that projects over the conservatory. This has a projecting flat roof with deep eaves, and 8-pane windows in the east side and 2-pane windows in the north and south sides; in the former the central lower casements are side opening, and in the latter the lower casements are side opening and the upper lights are top opening. Above the bay window, at eaves level, are horizontal barge boards finished with alternating semi-circular cut outs and projections; these boards continue around the north and south elevations of this range.

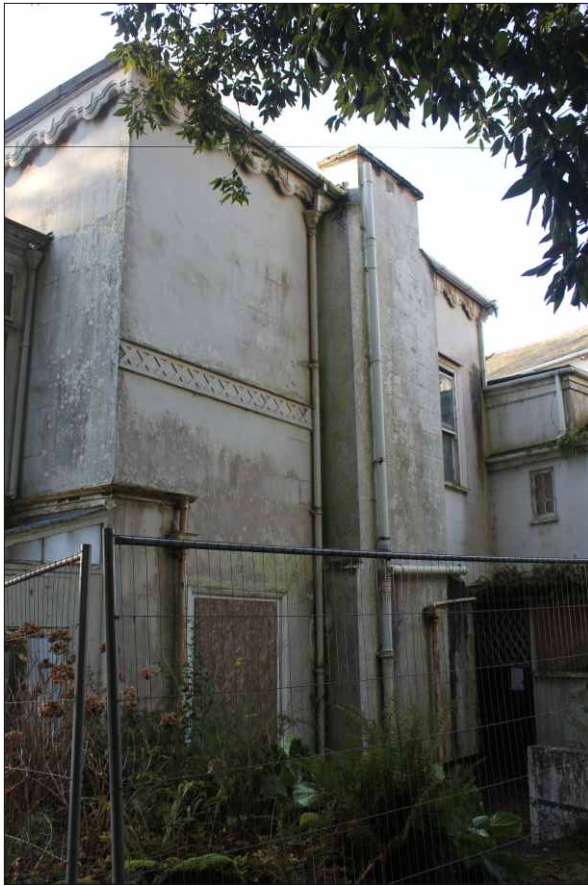
Plate 13: The north elevation of the main house, looking southwest

- The north side of the house***
- 5.10** The north side of the house is on multiple planes. The eastern section incorporates a central projecting chimney stack (Plate 13). To the east of this stack is a ground-floor window within a moulded frame. Above this at first-floor level is an applied band of lattice work. To the west of the chimney stack is a first-floor 1-over-1 pane horned sash window.

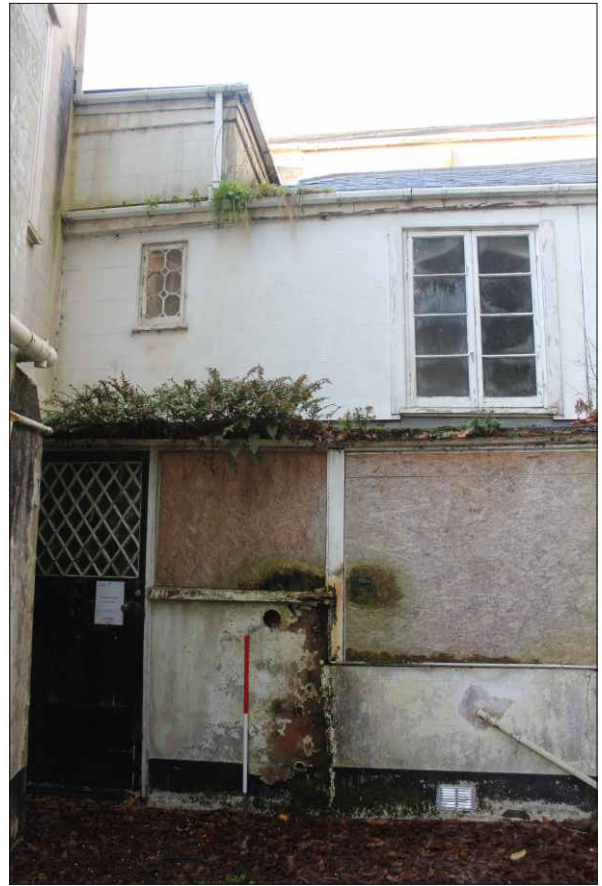
Plate 14: The east elevation of the rear service range, looking west (1m scale)

- 5.11** To the northwest there is a north-south aligned two-storey range under a low pitched roof that has been extended to the west (Plate 14). The latter incorporates windows and a door with partial latticework glazing. Internally, the east wall of the main range has been almost entirely removed but the first floor above remains incorporating a two-light window with 4-pane side opening casements, and a smaller side-opening casement window with wooden tracery (Plate 15). Above the latter window the masonry rises to a taller flat-roofed section. The north elevation of the main range has an inserted ground-floor window, offset to the east, fitted with a 4-over-6 pane sash modified to incorporate a vent. Above is a pointed headed side-opening window with leaded tracery and a small circular window above. A small store with a single pitched roof has been added to the east side of the extension.

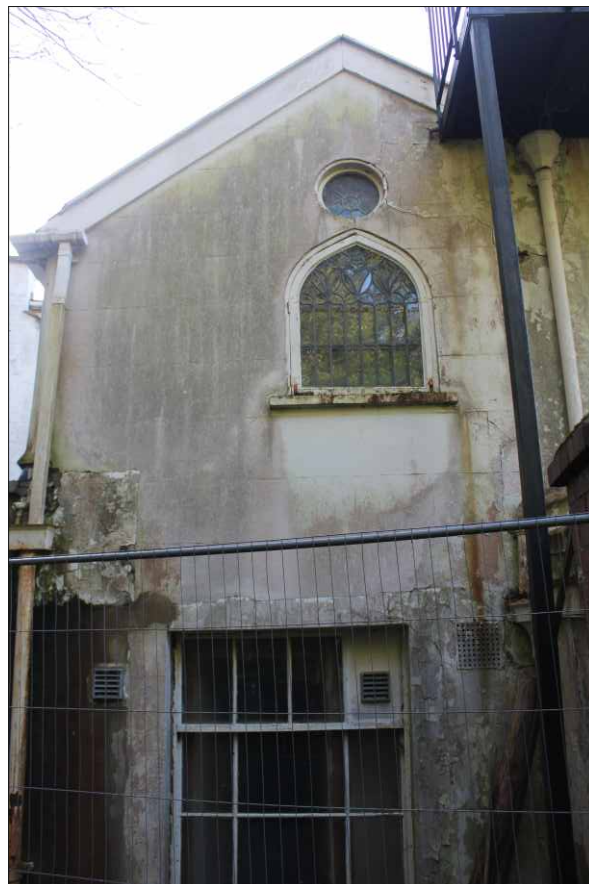
Plate 15: The east end of the north elevation of the rear service range, looking south

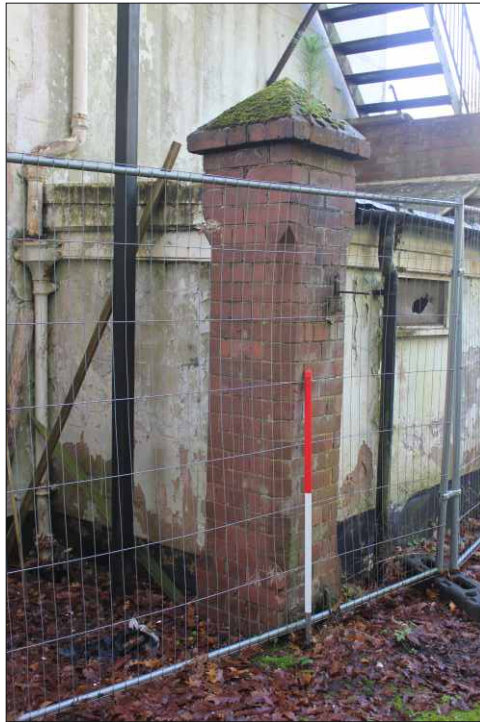
Plate 16: The gate pier incorporated into the rear extension, looking southwest (1m scale)

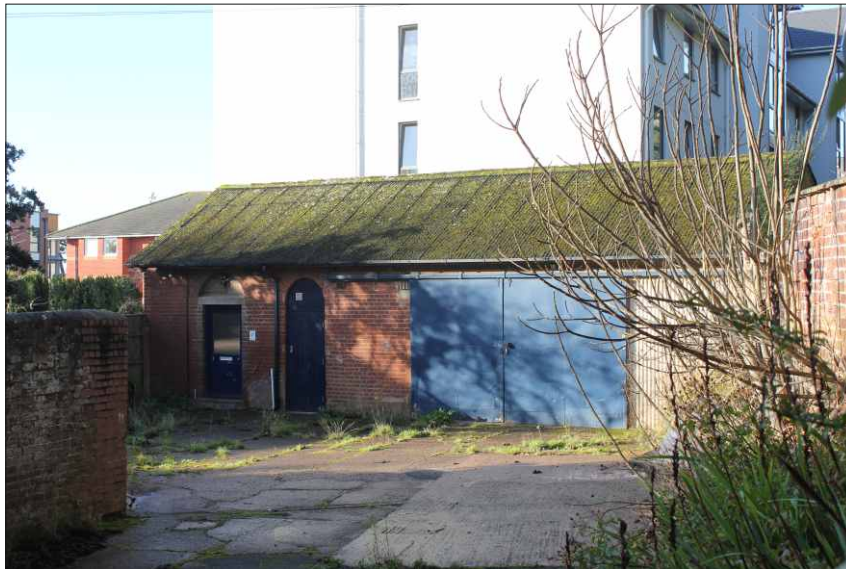
Plate 17: The east elevation of the stable block, looking west

- 5.19 The garage building (former stable block) is single-storeyed, and constructed of brick laid in Flemish bond, under a pitched asbestos sheet roof that dates to the 1940s. The east elevation incorporates sliding doors with asbestos cladding to the north, which again probably date to the 1940s (Plate 17). To the south are two full height doorways with semi-circular heads. The southern doorway has been reduced

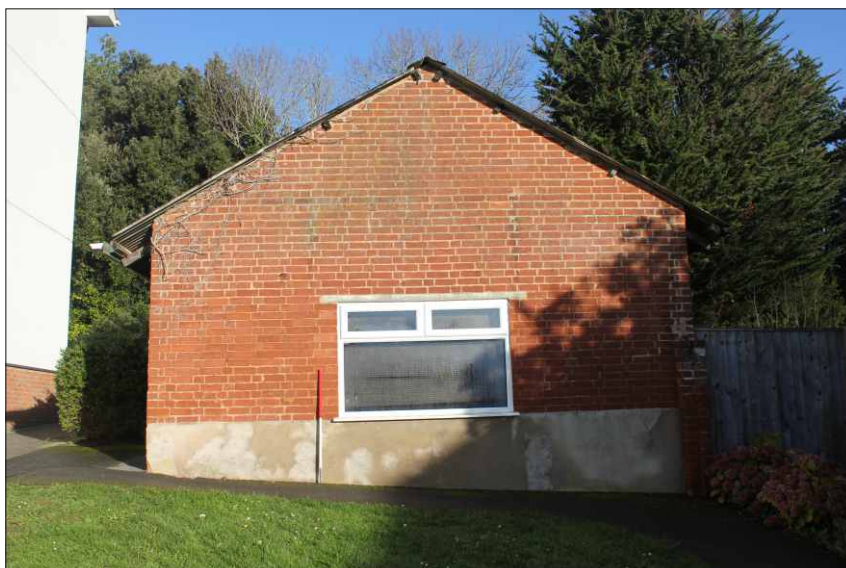
Plate 18: The south elevation of the stable block, looking north (1m scale)

in height with a new lintel added and brickwork infilling the void above. Both doors are later 20th-century replacements. The south elevation is a later 20th-century rebuild and incorporates a UPVC window (Plate 18). The west elevation is featureless.

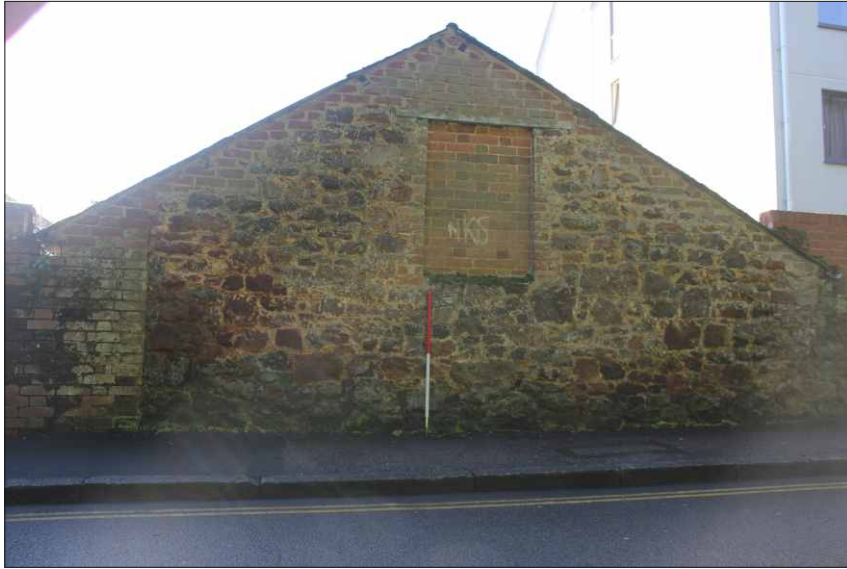
Plate 19: The north elevation of the stable block, looking south (1m scale)

- 5.20** The north elevation of the stables is constructed of rubble sandstone and volcanic trap, and continues a short distance to the west as a boundary wall. There is no clear break in the wall but the masonry of the upper gable is generally smaller than that below, and may represent heightening of an existing boundary wall when the stable block was constructed. The upper section at the eaves is a brick rebuild probably dating to the 1940s when the roof was replaced. This elevation incorporates a high-level window, now blocked with brick. The northeast corner of the garage is brickwork that also forms the west end of the yard wall. This is constructed of stretcher bond and extends nearly as far as a rear service entrance to the property. The end gate pier has been removed, and the wall on the south side of the opening rebuilt using bricks laid in header bond. However, the position of the gates is marked by concrete in the drive surface.

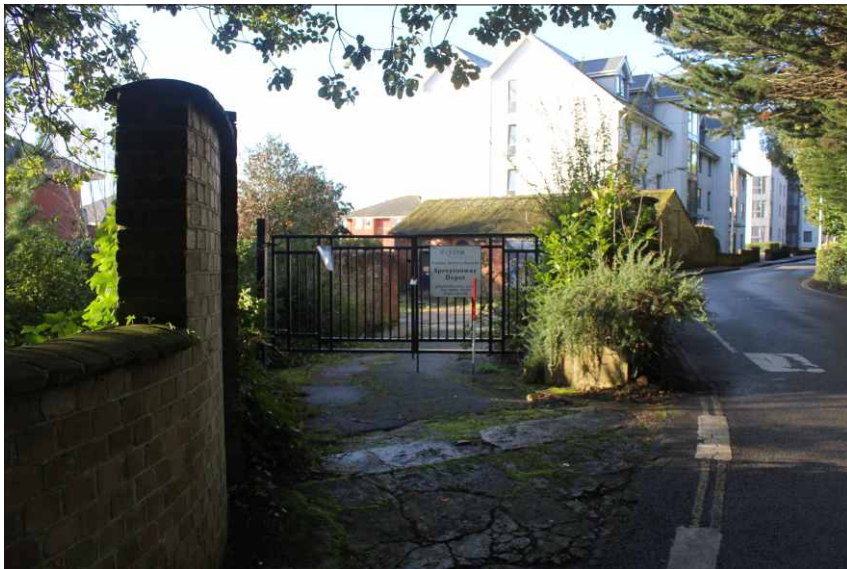
Plate 20: The entrance to the service yard, looking southwest (1m scale)
