LAND ADJACENT TO MALBOROUGH PARK, MALBOROUGH, DEVON

Results of an Archaeological Trench Evaluation

Report No: ACD1509/3/0

Date: March 2018

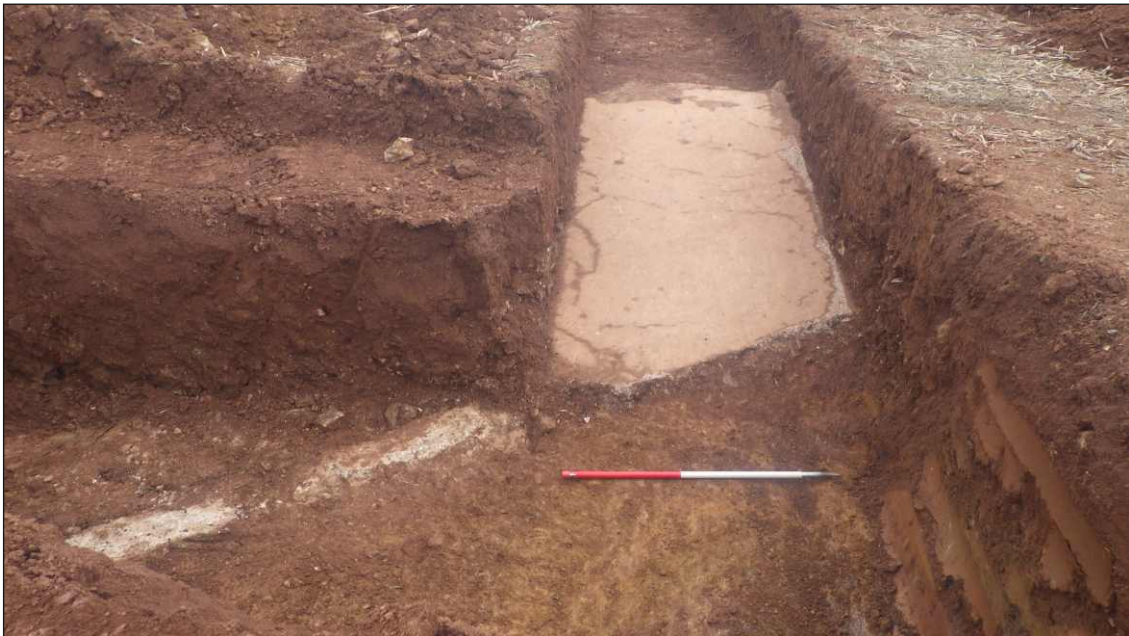
Plate 4: Trench 12, Structure 1, showing wall footing 1207 and floor surface 1205, looking southeast (scale 1m)

The partial remains of a building were uncovered within the junction of the T-shaped trench. It comprised wall footings (1207) composed of stone in a heavy lime mortar bonding. It was aligned

north-south and measured 0.25m wide. Due to the depth of the trench and looseness of the overlying soils it was not further investigated, although it appeared to be constructed within a foundation trench (F1206). To the south of wall 1207 an area of level floor composed of lime mortar was exposed (1205) continuing to the southeast for a distance of 4.10m. The building appeared to have been constructed within a terrace (F1204) cut into the hill which sloped up to the north. Within the terrace a thick deposit of demolition material or collapse was present (1209), which contained stone boulders, pebbles and lime mortar fragments.

7.2 Structure 1 was established as the poorly-preserved remains of a building which was present on a 1777 estate map of the area. This and subsequent historic maps and field name evidence indicate that it was a field barn or animal shelter, with the lack of evidence from the evaluation for domestic occupation supporting this conclusion. Historic maps show that the building had been removed by 1906.
