# DUNSTER CASTLE INFRASTRUCTURE WORKS, DUNSTER, SOMERSET

Results of Archaeological Monitoring and Recording

Scheduled Monument No. SM33039

Report No: ACD1728/1/0

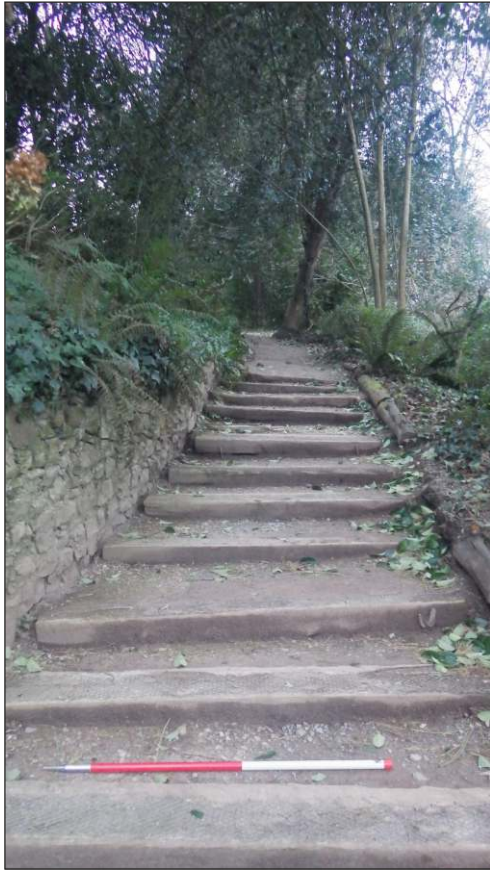
Plate 1: Pre-works view of Dunster Steps 1 (Lower Steps). View to southwest (scale 1m)

These consisted of 11 steps constructed from timber sleepers that were aligned northeast to southwest and measured 6.6m long (Plate 1). Following the removal of the existing steps, the groundworks comprised the excavation of an area measuring 1.6m wide that was dug to a depth of 0.23m below existing levels (Plate 2).

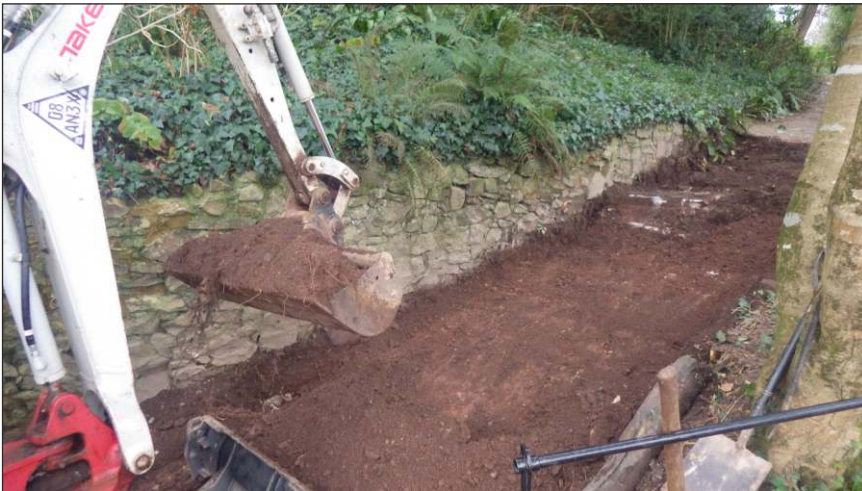
Plate 2: Working view during removal of Dunster Steps 1 (Lower Steps). View to south

The area was excavated onto a mid brownish-red clayey-silt loam made ground deposit with abundant sub-angular gravel and occasional sub-angular pebble inclusions. This was overlain by a dark reddish-brown silty-clay with frequent sub-angular gravel, rare sub-angular cobble inclusions and modern brick and concrete fragments. No pre-modern archaeological features or deposits or finds were exposed.

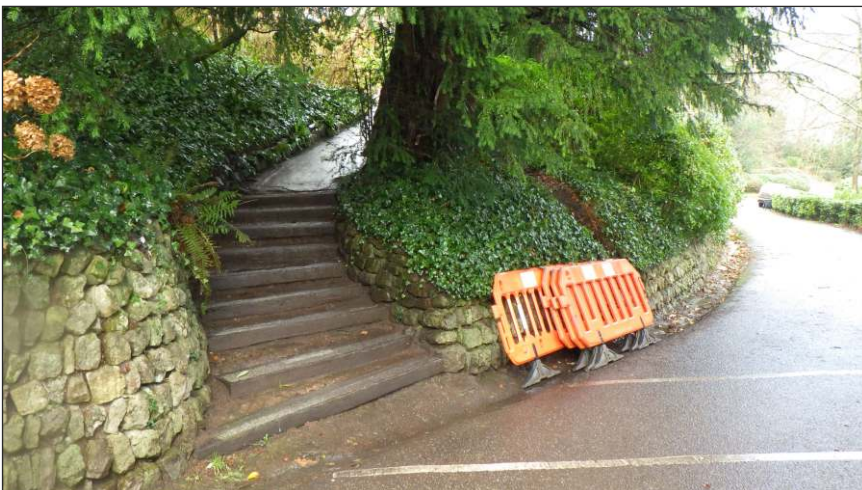
Plate 3: Pre-works view of Dunster Steps 2 (Upper Steps). View to northwest

Groundworks for Steps 2 comprised the excavation of an area measuring 4.5m long and 2.3m wide following the removal of the existing wooden sleeper steps (Plate 3). The area was excavated to a depth of 0.35m.

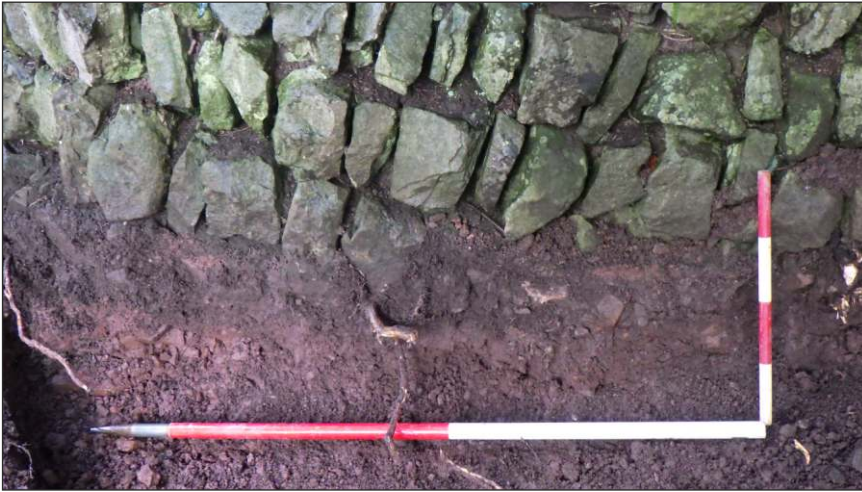
Plate 4: Dunster Steps 2, showing made ground layers. View to southeast (scale 1m and 0.4m)

The area was excavated into a mid brownish-red clayey-silt loam with abundant sub-angular gravel and pebble inclusions. This was overlain by a 0.16m thick dark reddish-brown silty-clay with frequent sub-angular gravel inclusions (Plate 4). No pre-modern archaeological features or deposits or finds were exposed.

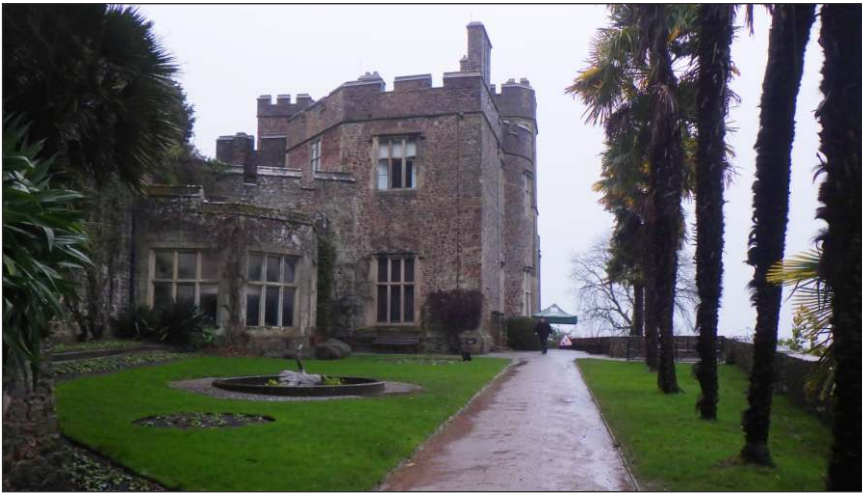
Plate 5: General view of pipe location test pits, on South Terrace. View to northeast

These were situated on the South Terrace and directly outside the Conservatory (Plate 5). The groundworks comprised the hand-excavation of three pits that measured between 1.25m and 3.3m long, 0.5m and 0.9m wide and up to 0.6m deep (Plate 6).

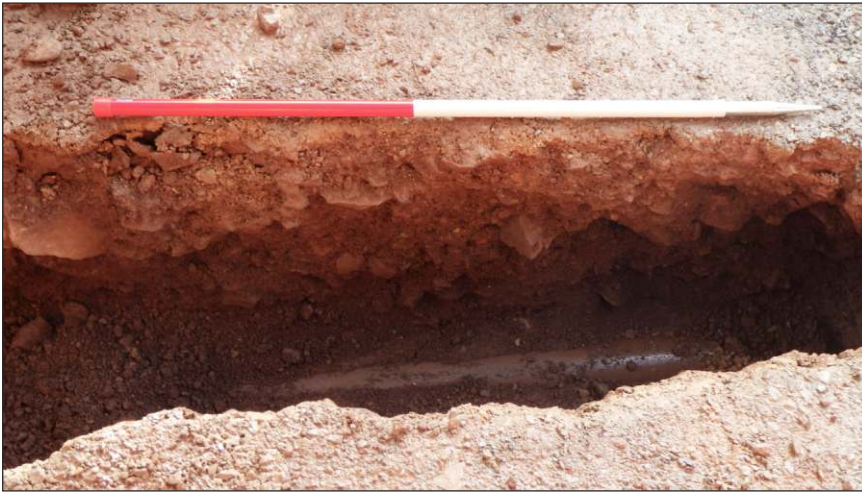
Plate 7: Showing section of a pipe location test pit. View to southeast (scale 1m)

The pits were excavated into a mid reddish-brown sandy-silt loam with abundant, poorly sorted sub-angular gravel and pebbles and common sub-angular cobble and boulder inclusions (Plate 7). This was overlain by the current tarmac surface. No pre-modern archaeological features or deposits or finds were exposed.

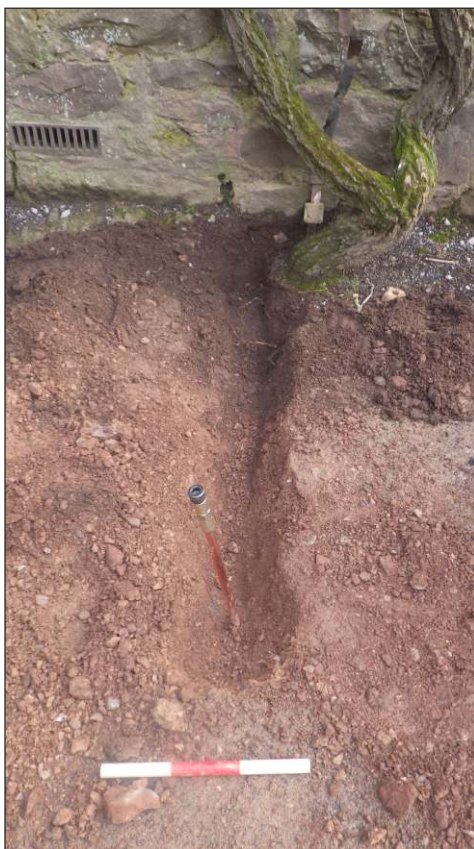
Plate 8: Lightning rod installation trench. View to northeast (scale 0.3m)

The installation of new lightning rods on the South Terrace comprised the hand-excavation of a 1.30m long, 0.30m wide and 0.15m deep trench (Plate 8). This was excavated into a dark brown silty-loam garden soil and partially across a gravel path. No pre-modern archaeological features or deposits or finds were exposed.

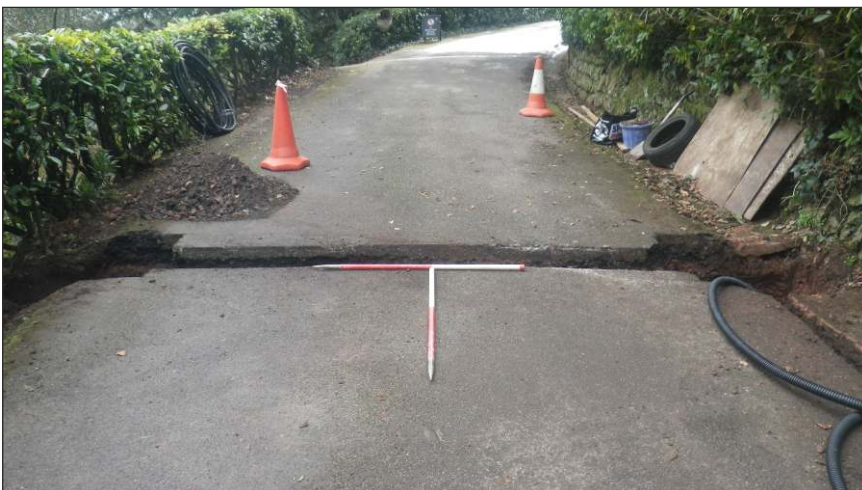
Plate 9: Electric gate installation works. View to south (scale 2x1m)

The groundworks for the new electric gate were located on the vehicular access road to the northeast of Dunster Castle. Groundworks comprised the excavation of two rectangular pits on either side of the road with a shallow linking trench (Plate 9).

The pits measured 0.9m long, 0.75m wide and 0.9m deep. These were excavated into a mid reddish-brown sandy-silt loam made ground with abundant sub-angular gravels and common sub-angular cobble and boulder inclusions. This was overlain by the current road surface.
