# THE OLD COACH HOUSE, BACK STREET, MODBURY, DEVON

## Results of Historic Building Recording

South Hams District Council planning reference  
2545/17/FUL, condition 4

Document No: ACD1906/2/1

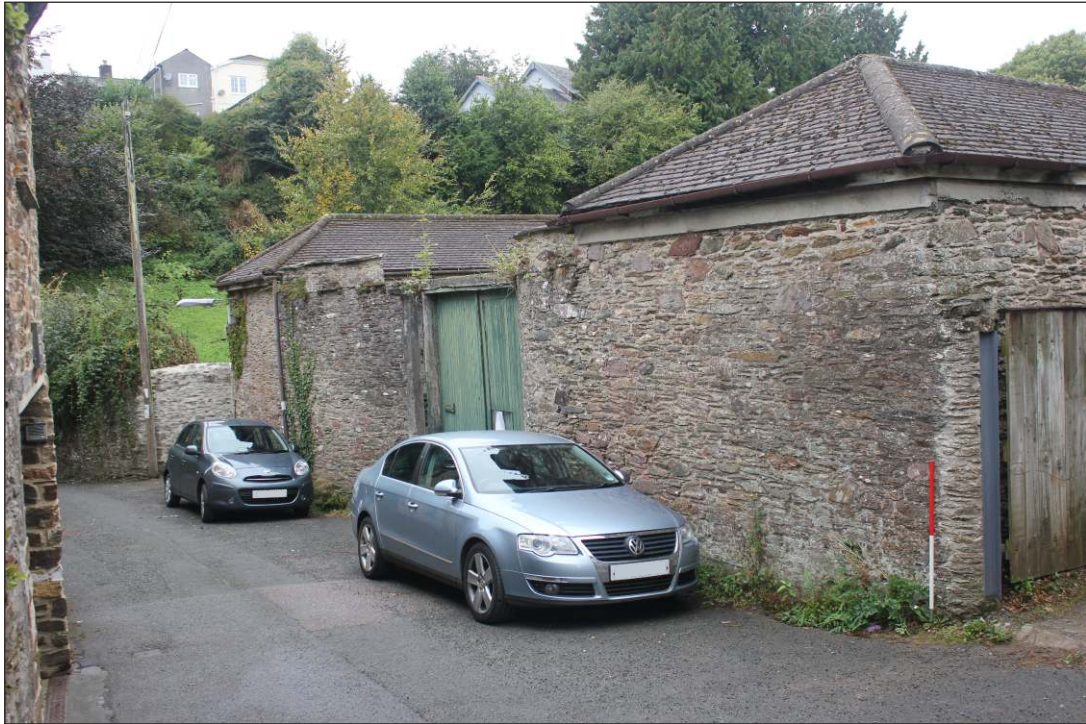
- 5.1 The building comprises three single-storied ranges under pitched roofs, and is constructed of roughly coursed local slates bonded in a slightly gravelly lime mortar with granite blocks used for some quoins (Plate 1). Rare fragments of red brick have also been used as a filler material, and the walls have been heavily repointed. The property faces south onto Back Street, and this south elevation incorporates the end gables of the east and west ranges and a central double gate opening. The gables are featureless. The yard walls curve into the gateway and these feature stone merlons – two on east side and three on the west side – with offset brick lined voids

Plate 1: South external elevation, looking northwest. 1m scale

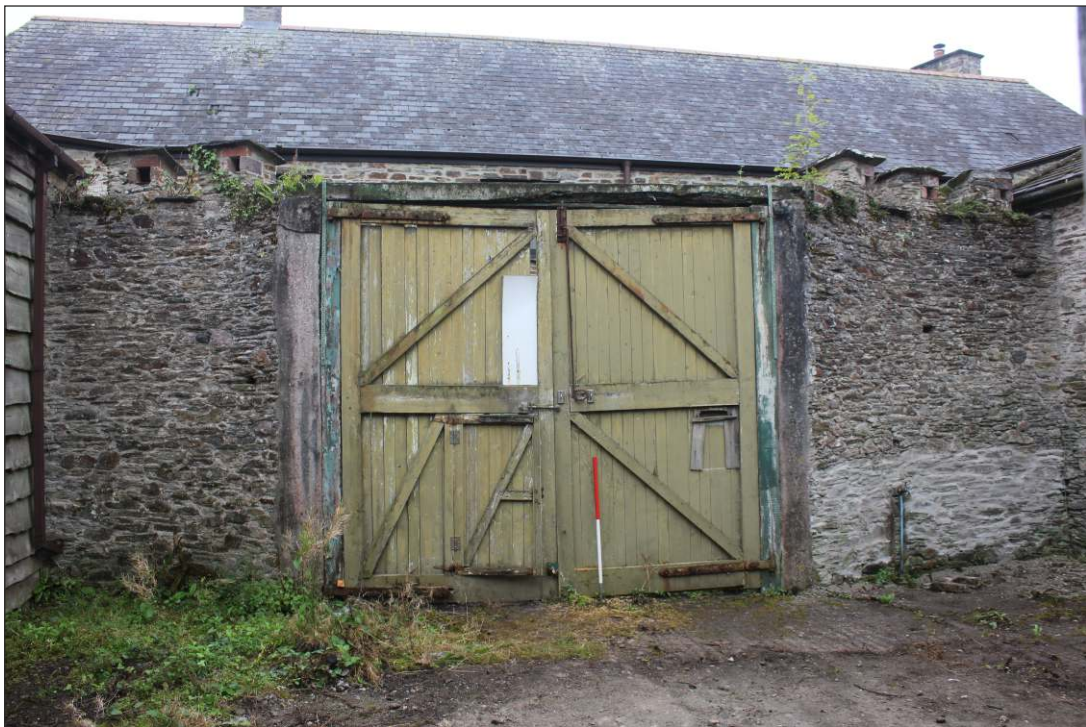
on the inside faces (Plate 2). They are topped with slate, which is also used to fill the crenels. The voids may have functioned as pigeon holes. The jambs forming the central opening have been rebuilt in the second half of the 20th century, and the gates are of the same date.

Plate 2: South wall of yard, looking south. 1m scale

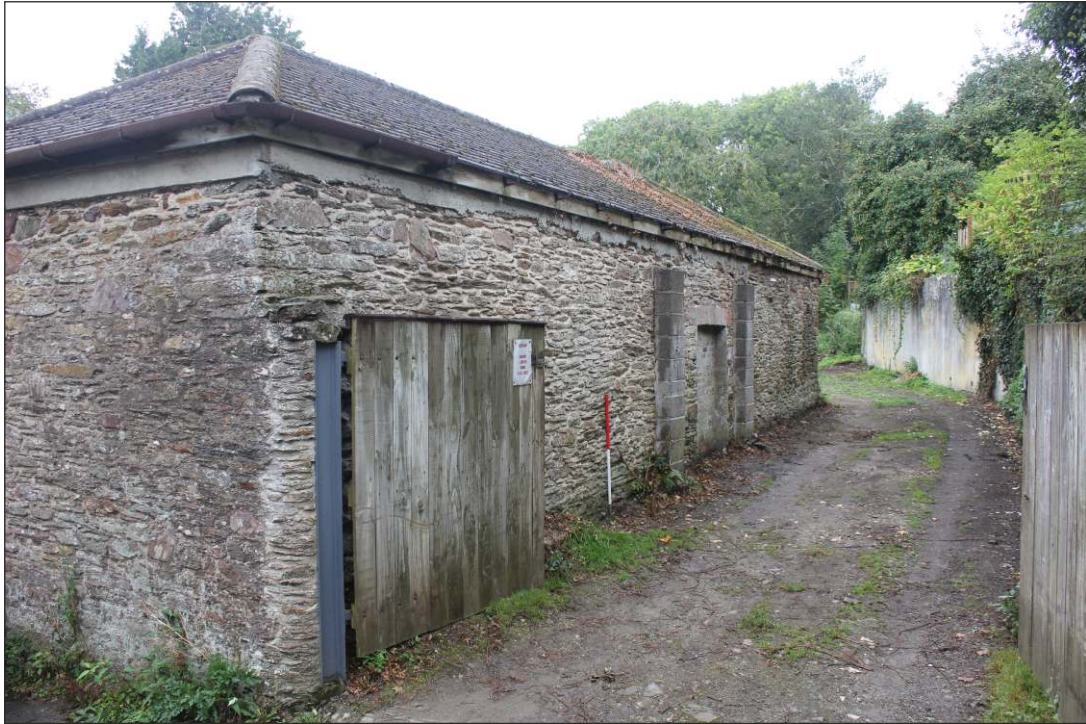
- 5.2** The east elevation incorporates a primary slight gate pier at the southeast corner, modified in the late twentieth century with the addition of a reinforced steel joist (rsj) (Plate 3). In the centre of the elevation is a doorway, under a slightly arched brick head. It has been blocked in brick in the 20th century. Externally, the remains of a slate surface survive within the adjacent access driveway. To either side of the doorway are concrete block piers. To the north is a window opening, set high into the wall (Plate 4). This has been blocked with the same local stone as the main walls. The top of the wall is finished with cement, which may have replaced some of the upper courses of stones.
- 5.3** Other than a structural tie the north elevation is featureless (Plate 5). The west elevation is also featureless (Plate 6).

Plate 3: East external elevation, looking northwest. 1m scale

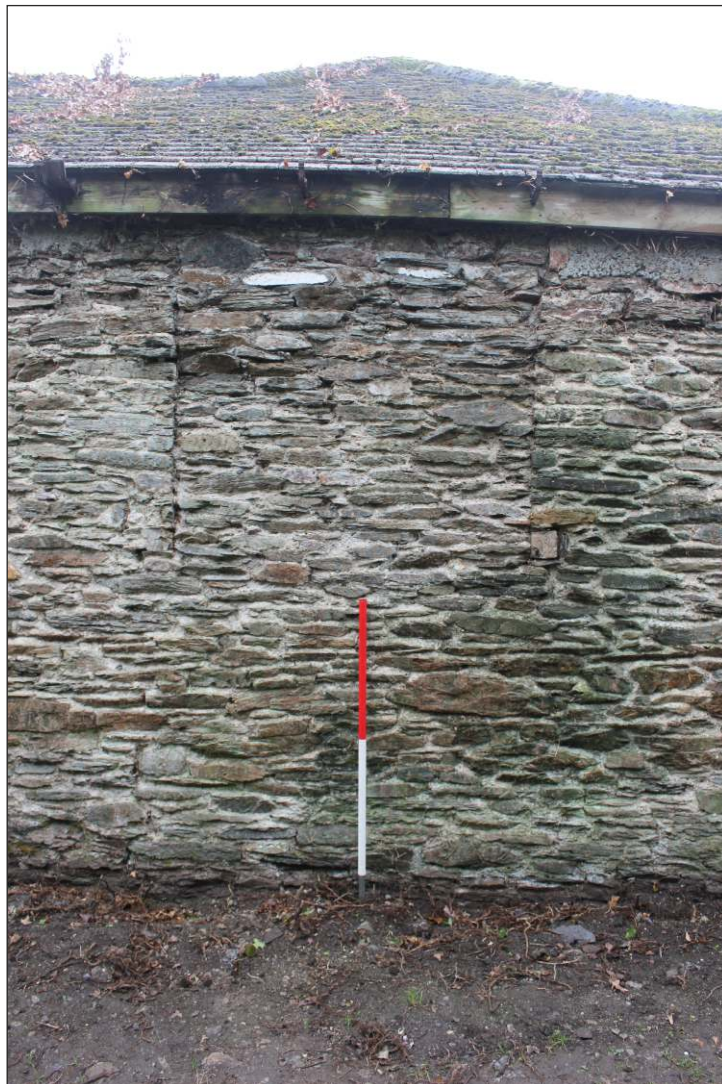
Plate 4: East external elevation showing blocked window, looking west. 1m scale

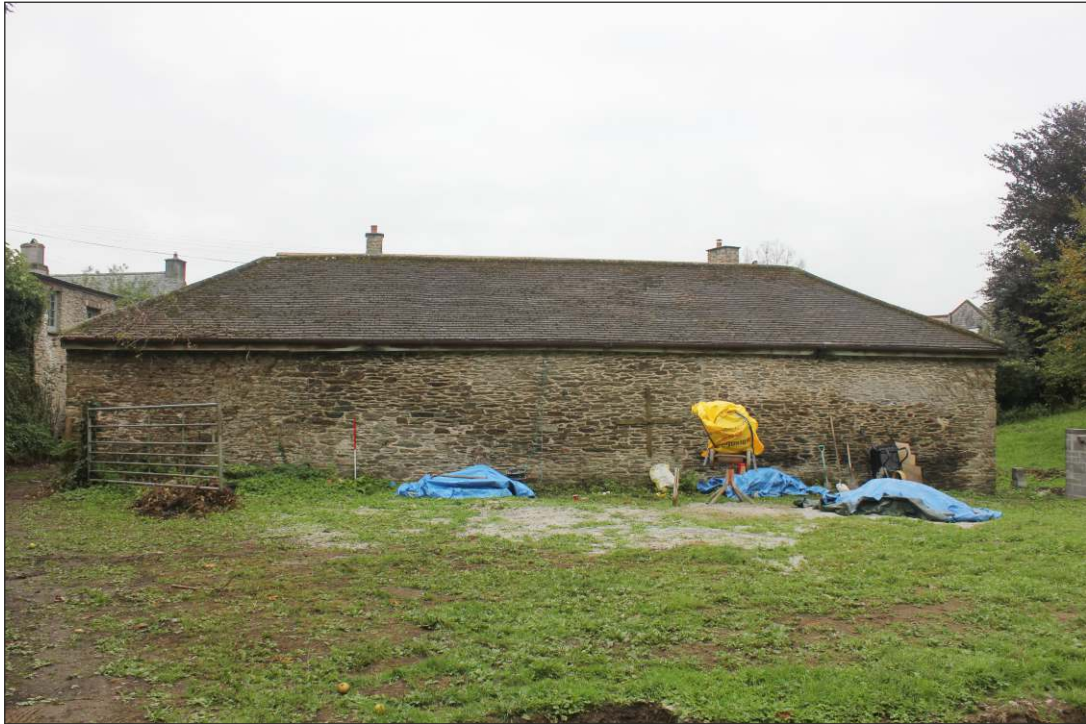
Plate 5: North external elevation, looking south. 1m scale

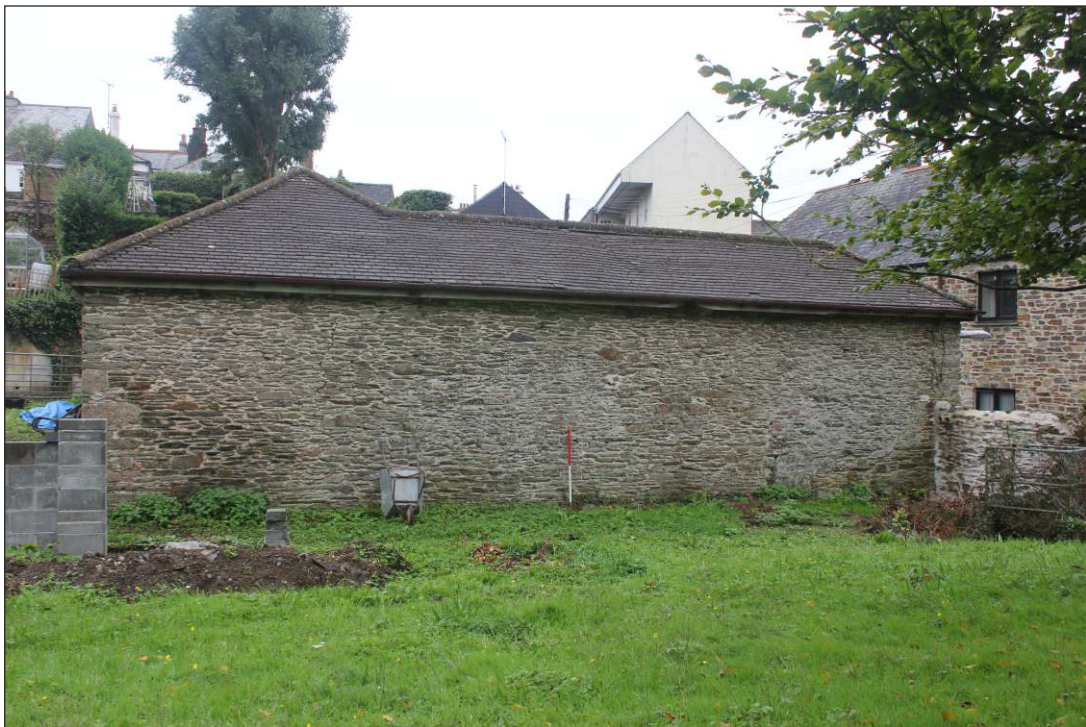
Plate 6: West external elevation, looking east. 1m scale

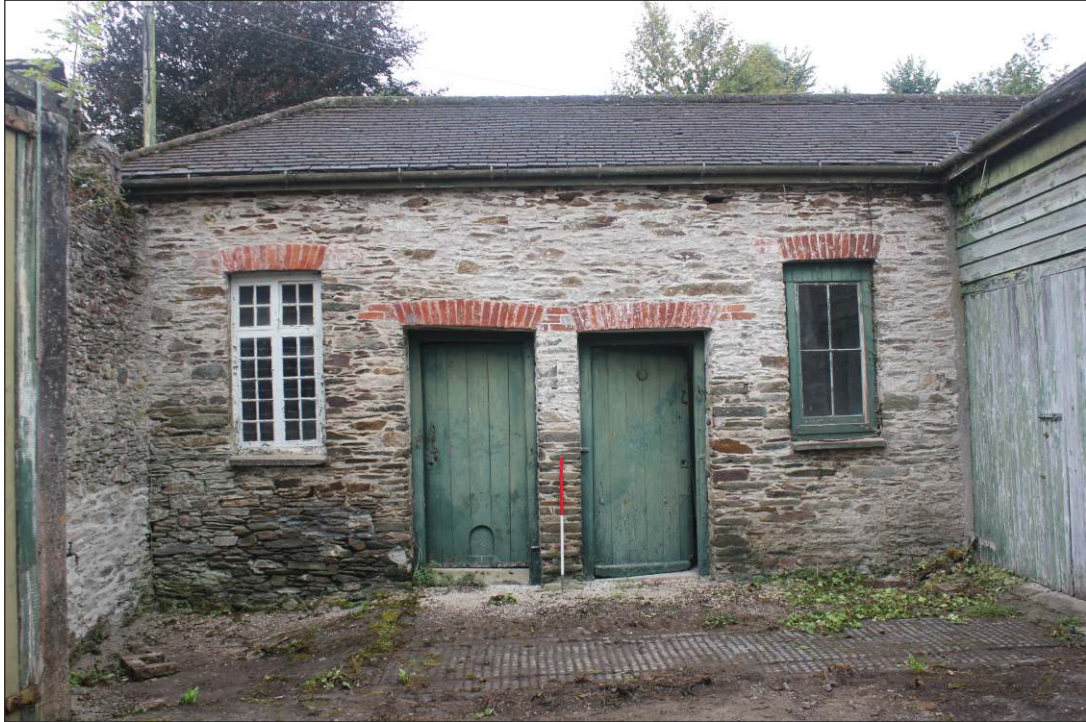
- 5.4** The west internal elevation to the yard incorporates symmetrical fenestration with a pair of central doorways and windows to either side (Plate 7). All are under brick heads, and the windows have slate fills. The doors are plank and batten types set within slightly moulded frames. The bases of the doors are currently at different levels, with the south doorway higher than the north opening. The south window has two lights each with 10 lower panes and four upper panes. The north window has four larger panes.

Plate 7: West range, east elevation, looking west. 1m scale

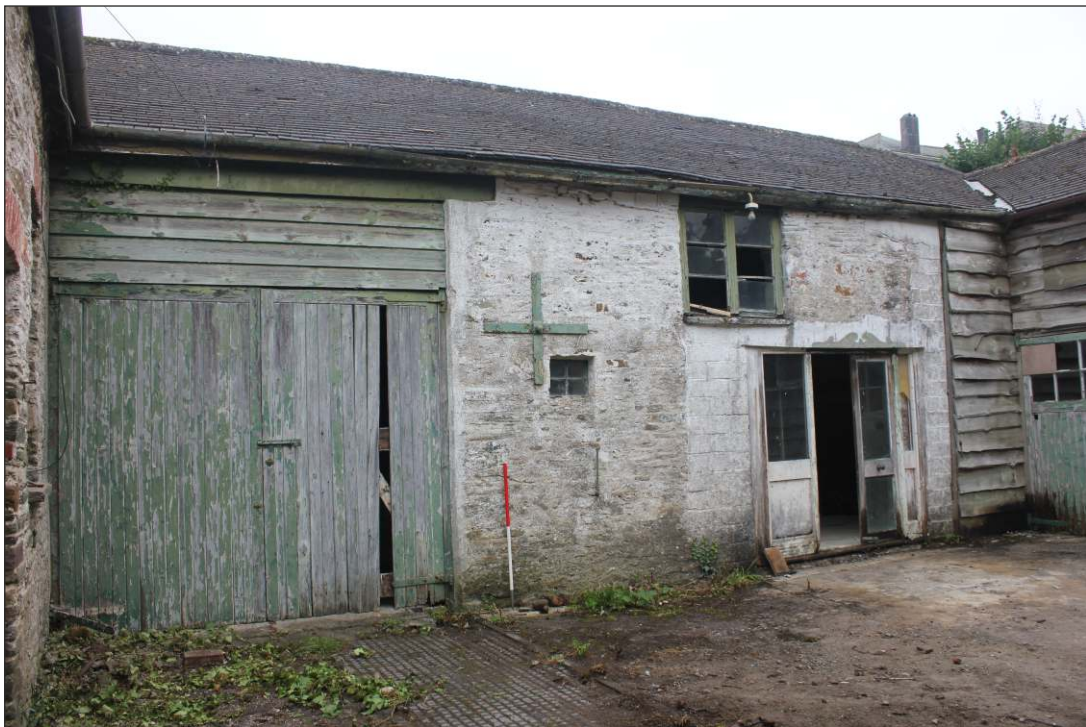
- 5.5** The north elevation comprises a central section of stone work incorporating a small wooden four-pane window and the other end of the structural tie present in the north external elevation (Plate 8). To the west is a wide opening featuring a pair of twentieth century doors with weatherboarding above. The eastern half of the wall comprises concrete block masonry incorporating later 20th-century doors and windows, above which is earlier stone masonry incorporating a two-light window, each of six panes. The extreme east end of the wall is finished with large planks of weatherboarding of late 20th century date that extends to the full length of the east elevation (Plate 9). Here this finish incorporates a pair of wide doors and a long window with side opening end panes.

Plate 8: North range, south elevation, looking north. 1m scale

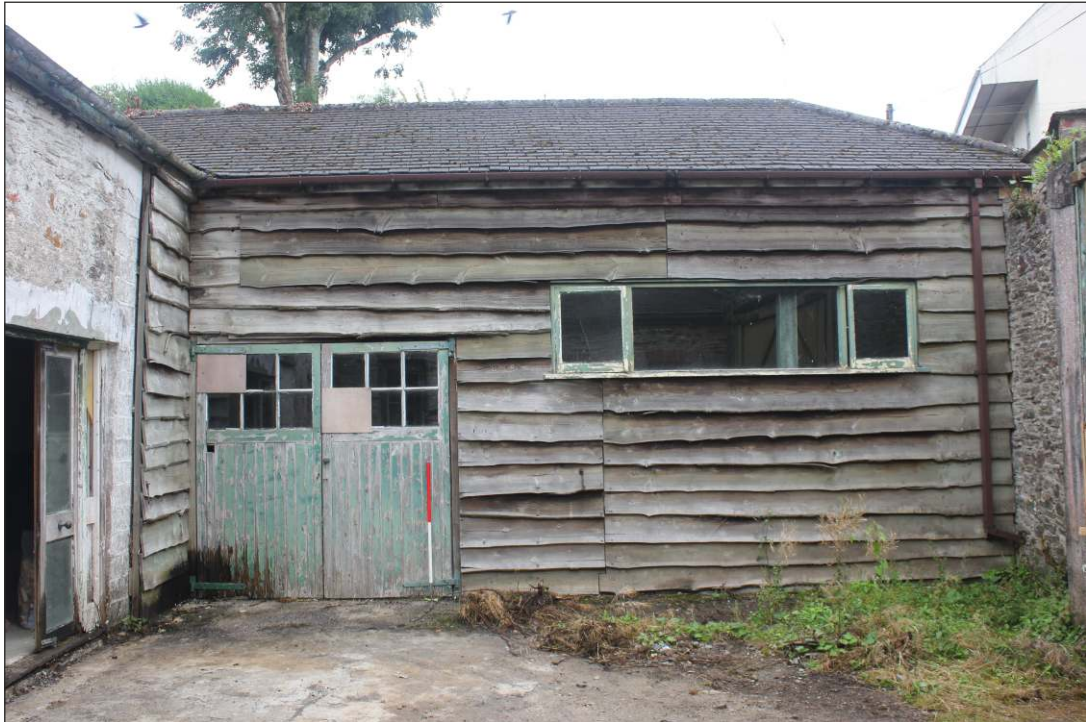
Plate 9: East range, west elevation, looking east. 1m scale

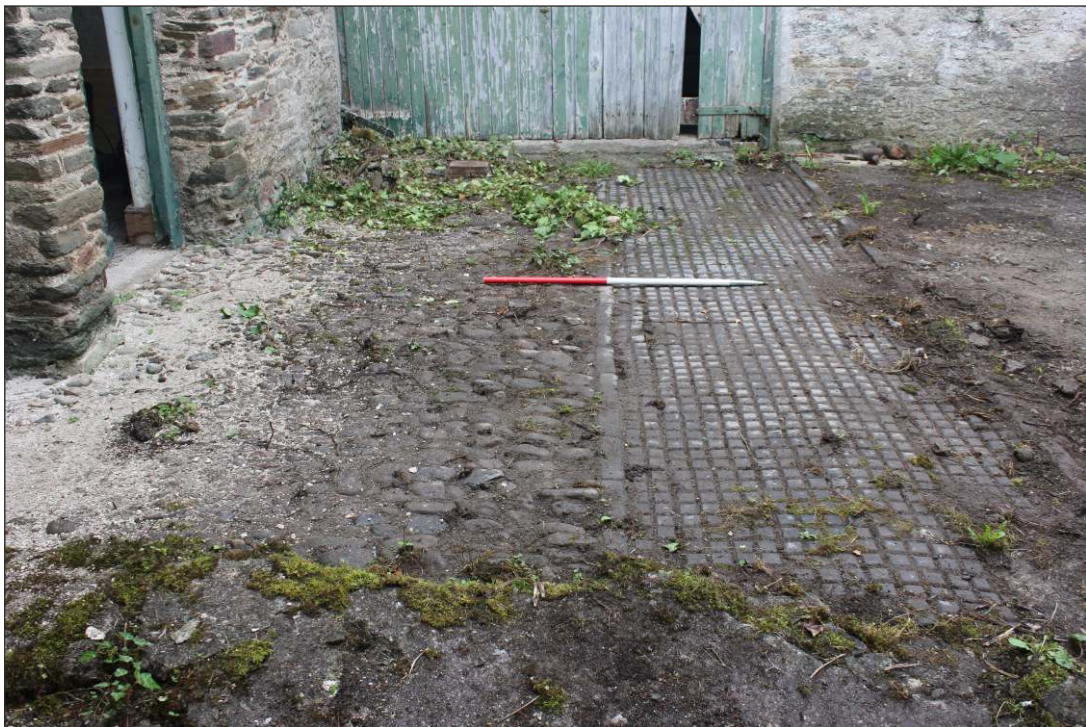
- 5.7** The yard is mainly finished with phases of 20th-century concrete, but earlier surfaces survive at the west end. Alongside the west range is a cobbled surface, which has been replaced on its east side by a north to south aligned black brick paviour path edged with granite kerbs (Plate 10).

Plate 10: Yard surface, looking north. 1m scale

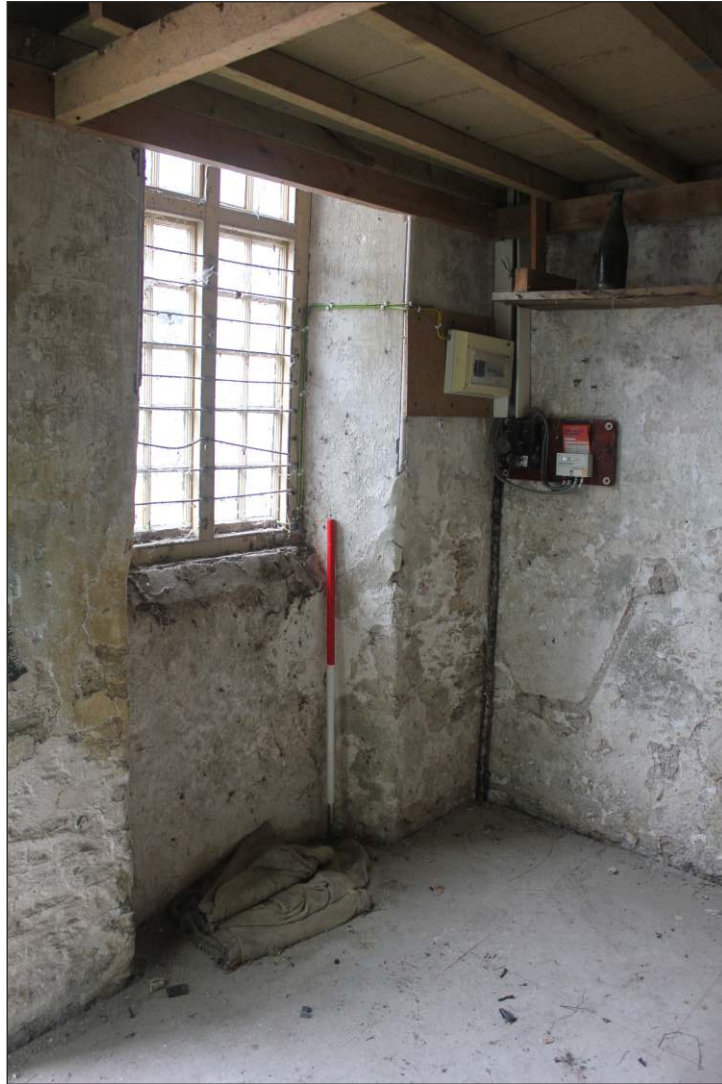
is laid with modern boards, and has probably been raised from the lower historic level (as in the adjacent room), with the base of the door cut off to accommodate this. The walls are plastered and feature a slight walk-in reveal for the window (Plate 11). Wooden beading has been added to the reveal and partially survives. There are no other historic fittings, with a modern mezzanine floor (that cuts across the top of the window) and shelving on the south wall being later 20th-century additions. The roof structure above the mezzanine is entirely modern.

Plate 11: West range, south stable, looking southeast.  
1m scale

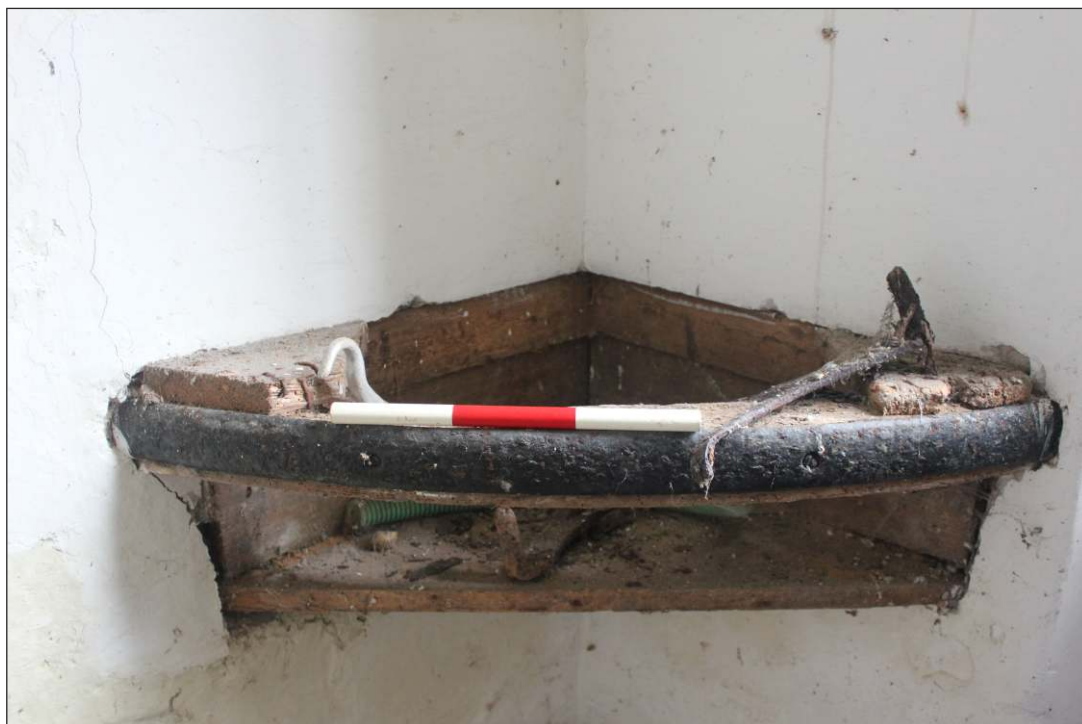
- 5.9 The north room has a granite threshold and black brick paviour floor, along with secondary skirting boards. The walls are again plastered, and a modern ceiling has been added at eaves level. The only feature of interest is the remains of a wooden and iron feeding trough attached to the northeast corner of the room (Plate 12).

Plate 12: West range, north stable showing feeding trough, looking northeast.  
0.30m scale

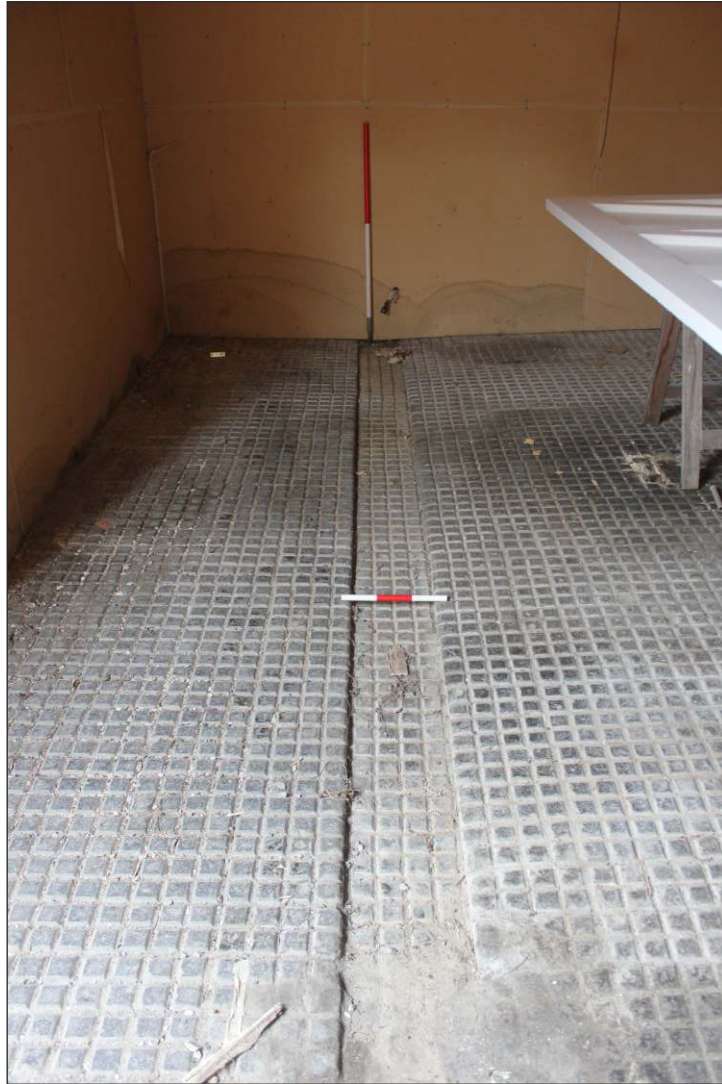
- 5.10 The large west room in the north range is divided from adjacent rooms by primary stone walls but all the walls have been entirely lined with boards, a material also used to create a high-level ceiling. The room has a black brick paviour floor incorporating an east to west aligned drain set towards the yard side of the building (Plate 13). Also set within this surface are four sockets for vertical posts associated with partitions between three former stalls. Parts of the floor have been replaced with bricks and concrete.

Plate 13: North range, west room drain, looking west.  
1m and 0.30m scales

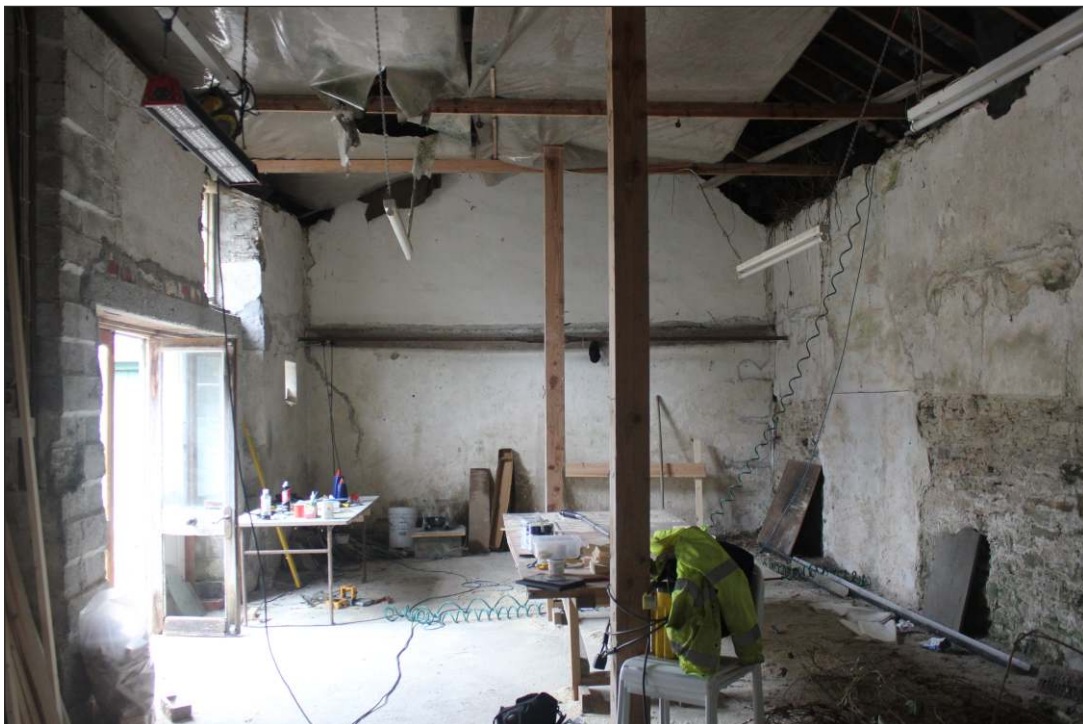
- 5.11 The remainder of the north range is open plan with the east range (Plates 14 and 15). It has a modern concrete floor with a tiled slope down from the doorway in the east external elevation (Plate 16). Immediately north of this door is a pier of primary masonry that supports an rsj. A further two second rsjs, of differing lengths, span the length of the east range yard frontage supported by a vertical rsj post down to the floor. The stone pier displays a scar of a former doorway, with smooth masonry above where the stone masonry that continued to the west above the opening has been removed. To the south, in the east elevation, there is a row of sawn-off joists at eaves level that presumably supported a ceiling (and possible first-floor loft) rather than being associated with the original roof structure.

Plate 14: North range, general view, looking west

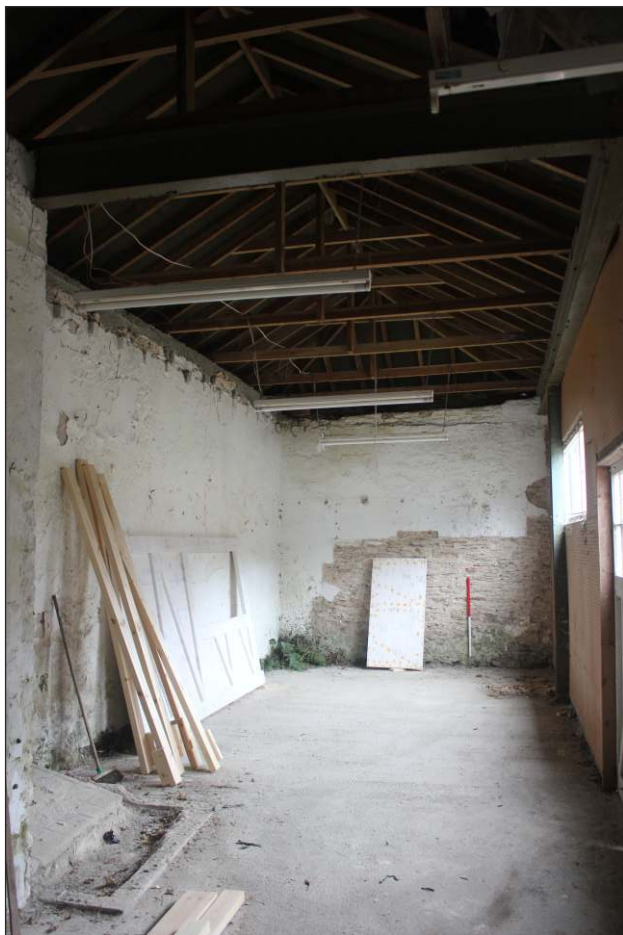
Plate 15: East range, interior, looking south. 1m scale

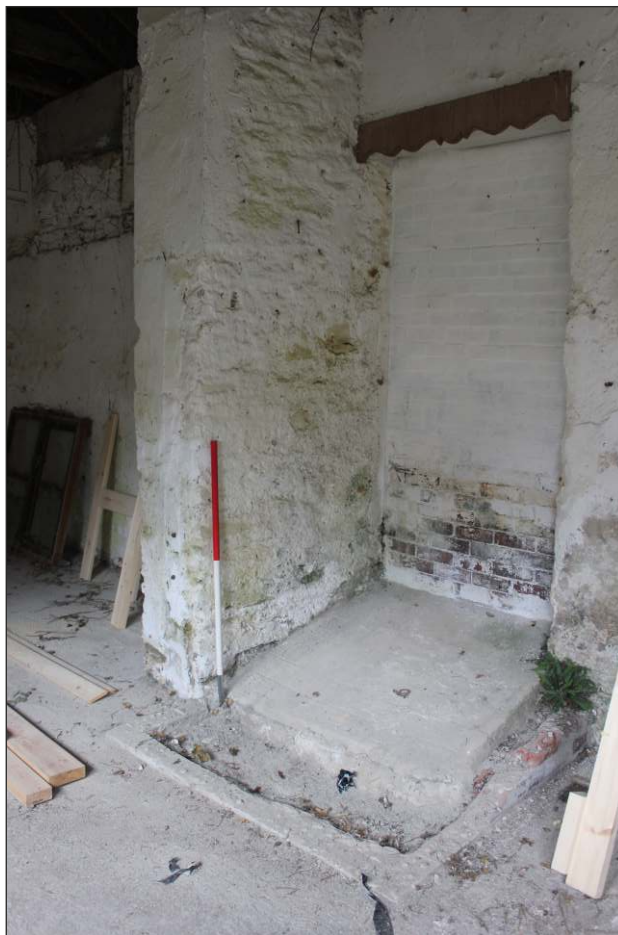
presence of the tiled ramp to the doorway to the adjacent field may indicate additional stabling or a passage through the range into the adjacent field. The remainder of the north range may have been divided into two spaces, both with a floor over. Ground-floor uses may have included a tack room and accommodation for a stable hand. The surviving masonry in the south elevation indicates that there was a ground-floor window below the surviving first-floor window, and the first-floor masonry extends too low for coach storage. It seems likely that the first floor was a hayloft, perhaps with the blocked opening in the east elevation being a loading door from the slightly higher exterior ground.

Plate 16: East range, ramp and remains of partition, looking northeast. 1m scale

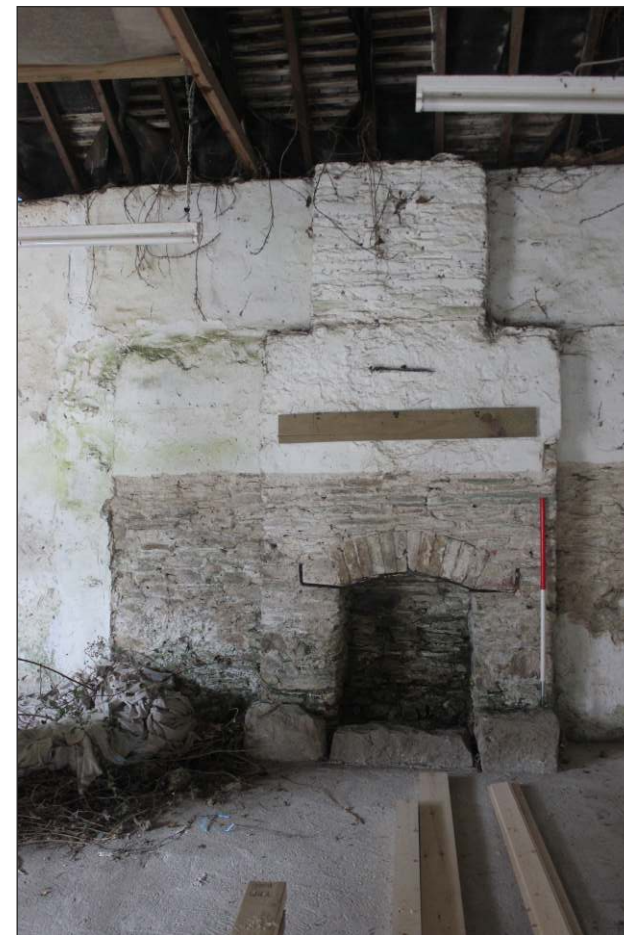
- 5.12 Towards the east end of the north elevation is a slightly projecting chimney stack incorporating a fireplace with a brick arched head supported on an iron plate (Plate 17). There are scars in the plaster above and to the west of this stack which appear to define a room, with a ceiling, in the northeast corner of the building. The horizontal scar however conflicts with the window in the east elevation. The scar continues to the west where there are also infilled joist sockets indicating the whole of this area had a ceiling. The western end joist, adjacent to the partition wall, remains *in situ*.

Plate 17: North range, fireplace in north elevation, looking north. 1m scale
