# LAND AT HOLSOME PARK, DIPTFORD, DEVON

Results of an archaeological watching brief

South Hams District Council planning reference 3222/18/FUL, condition 8

Document No: ACD1964/2/0

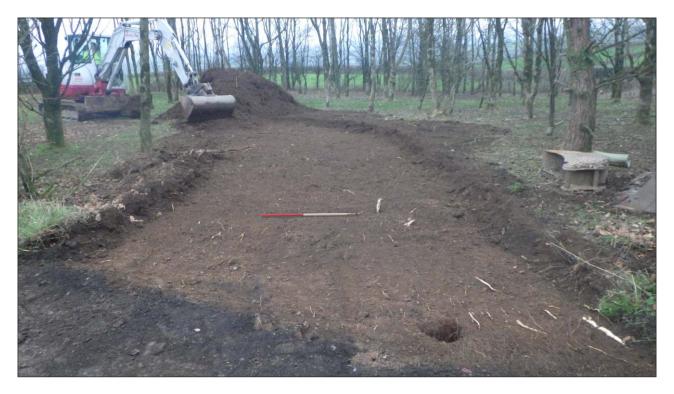
Plate 1: The access track looking northwest (1m scale)

The monitored groundworks consisted of the removal of topsoil (using a tracked machine fitted with a toothless bucket) from the footprint of the new building measuring 26m (east-west) by 9m (north-south), as well as an access track to the east measuring up to 15m long by 3m wide.

The deposit sequence consisted of 0.3m mid reddish-brown soft silty-loam topsoil overlying natural subsoil of mid yellowish-brown silty-clay with abundant natural slate inclusions.

No archaeological features or deposits were exposed; some modern plough marks and tree throws associated with the recently felled trees were present within the natural. No finds were present within the topsoil.
