HEMYOCK CASTLE, CULMSTOCK ROAD, HEMYOCK, DEVON

Results of Archaeological Monitoring and Recording

Scheduled Monument: National Heritage List for England
Reference 1004583

Report No: ACD1798/2/0

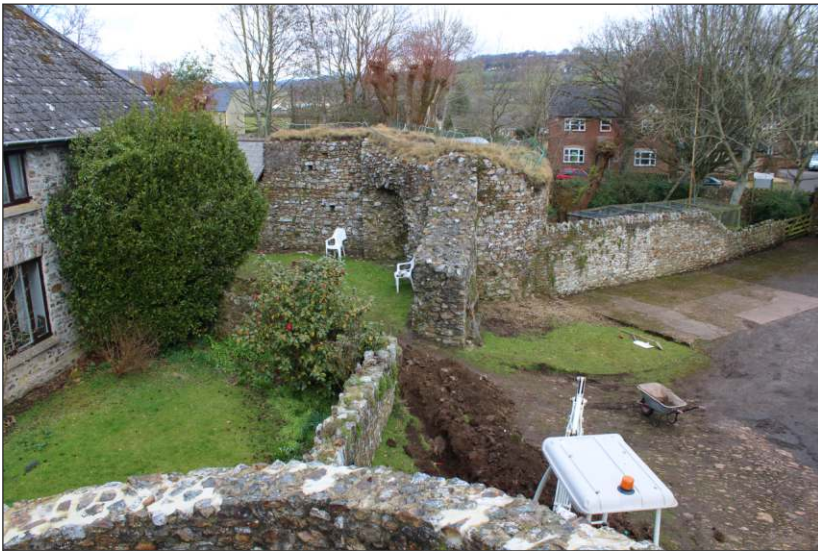
Plate 1: General view of excavations in progress. Looking north from Gatehouse towards breached curtain wall and northeast corner tower with wall S1008 visible in trench

5.1 Introduction (*Plan Fig. 2; Plate 1*)

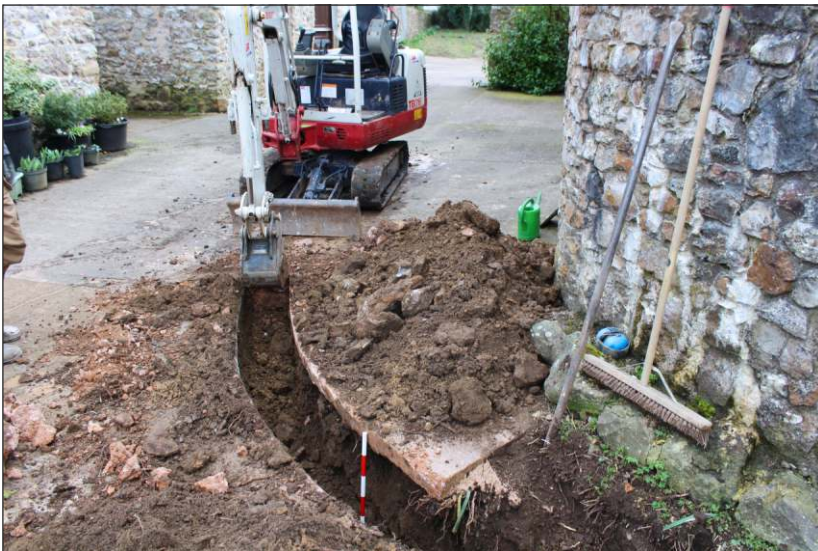
Plate 2: Working view of excavations through top of moat F1011 deposits. View to south (scale 0.5m)

- 5.2 Moat F1011 and curtain wall S1008** (*Plan Figs 2 and 3a and section 3b; Plates 2-4*)
Between the Guard Houses and Gate House, the trench cut across the position of the former moat (F1011). This measured approximately 4m wide, with its uppermost exposed deposits present immediately below the current concrete surface and comprised of a mid yellowish-red sandy clay (1012) overlain by a dark grey clay (1013). To the southeast, the edge of the moat cut through the natural subsoil and was overlain by a modern levelling layer (1014), while to the northwest, the moat deposits extended over a dark greyish-brown clayey-loam levelling layer (1010). Finds recovered from layer 1010 consisted of 26 sherds of post-medieval pottery, six iron objects and a 19th century brass thimble.

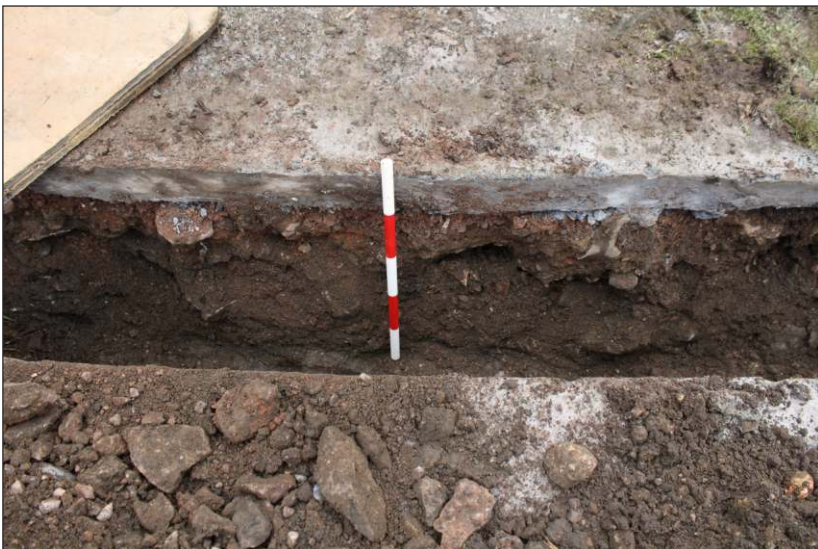
Plate 3: Showing section through moat infill deposits. View to west (scale 0.5m)

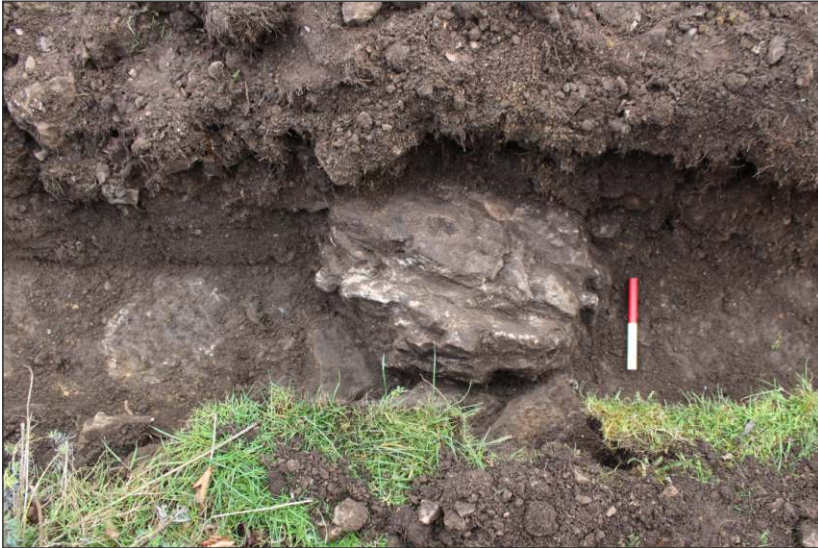
Plate 4: Curtain wall S1008. View to north (scale 0.2m)

Curtain wall S1008 was partially exposed where the trench crossed between the Gate House and the northeast corner tower of the castle. Here the fabric of the wall protruded through a levelling layer (1005), which represented a probable continuation of deposit 1010. The curtain wall was recorded at a depth of 0.19m below existing levels and measured 1.38m wide. The wall had been robbed of its facing stones, with only its lime mortar bonded rubble core remaining. Finds recovered from overlying levelling layer 1005 consisted of one sherd of medieval pottery, one sherd of post-medieval pottery, a fragment of clay tobacco pipe and a brick fragment.

7.2 Exposure of the castle moat (F1011) and curtain wall (S1008) comprised only the upper portions of these features. The curtain wall, which is breeched between the Gate House and northeast corner tower, survived below ground as a rubble core stripped of any faced masonry. Comparable removal or partial removal of the curtain wall basal courses was also exposed during the excavations in 1989 (Blaylock 1989). The presence of made ground deposits that sealed the remains of the curtain wall and infilled the moat are likely to represent a phase of landscaping; undertaken to provide direct access to the Manor House. Finds recovered from these deposits (1005 and 1010), suggest that this modification took place during the 19th century.

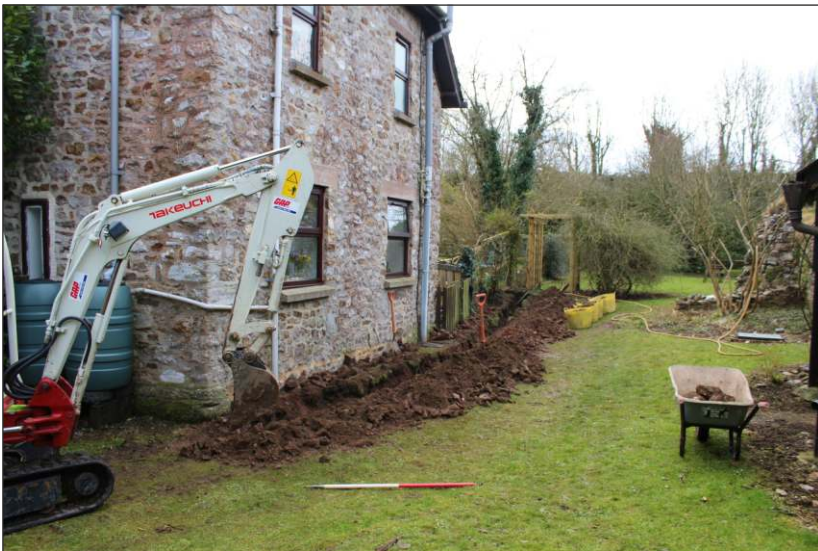
Plate 5: General view of excavations along north side of the Manor House. View to west (scale 1m)

- 5.3 Cobbled surfaces 1004 and 1006** (*Plan Figs 2 and 3c and section 3d; Plates 5-7*)
Cobbled surfaces 1004 and 1006 were present in the area to the north of the Manor House. Surface 1006 was the earlier of the two and was set on a dark greyish-brown clayey-silt loam possible levelling deposit (1007). The surface, which was comprised of sub-angular cobble stones, was 2m across, 0.16m thick and cambered in profile.

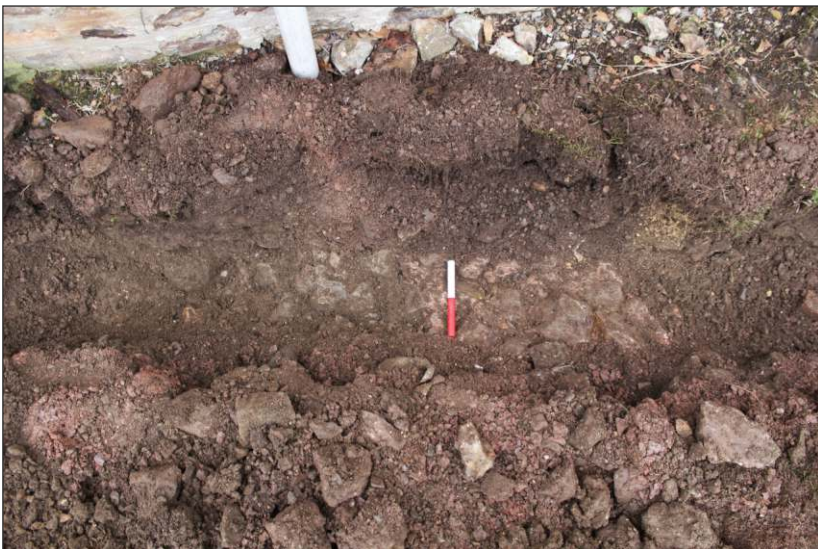
Plate 6: Surface 1006, view to south (scale 0.2m)

- 7.3** The cobbled surfaces exposed immediately to the north of the Manor House clearly represented two phases. The cambered profile of the earlier of the two surfaces (1006) may have indicated that it represented a northeast to southwest aligned pathway. No dating was recovered from the earlier surface or its underlying clay levelling, but, based on the overlying 19th made ground (1005), it was of probable post-medieval origin. The later surface (1004), which overlay made ground 1005, was therefore of approximate 19th century date.

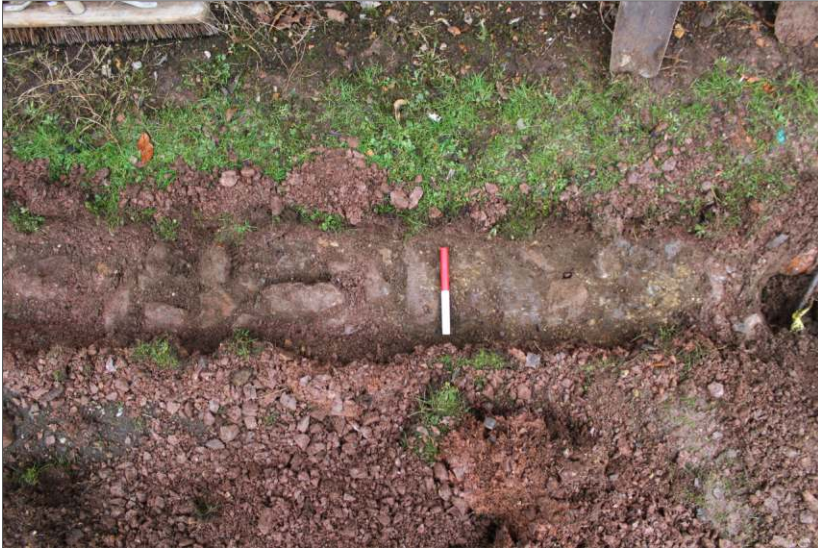
Plate 7: Surface 1004, view to south
(scale 0.2m)

Surface 1006 was sealed by levelling layer 1005, which, as described above, extended across the remains of curtain wall S1008. Levelling layer 1005 was overlain by later surface 1004. Surface 1004 measured 5m across and 0.12m thick. It was comprised of sub-rounded and occasional sub-angular cobbles. It was overlain by a broad demolition layer (1002), comprised of mid greyish-brown clayey-silt loam with frequent medium to large sub-angular stone rubble and occasional mortar fragment inclusions. Amongst the stone rubble were fragments of roughly faced stone. Layer 1002 was sealed by subsoil 1001 and topsoil 1000.
