# THE OLD MILL, ANTHONY PASSAGE, SALTASH, CORNWALL

Results of historic building recording

Cornwall Council planning reference PA18/05856,  
condition 4

Document No: ACD1899/2/0

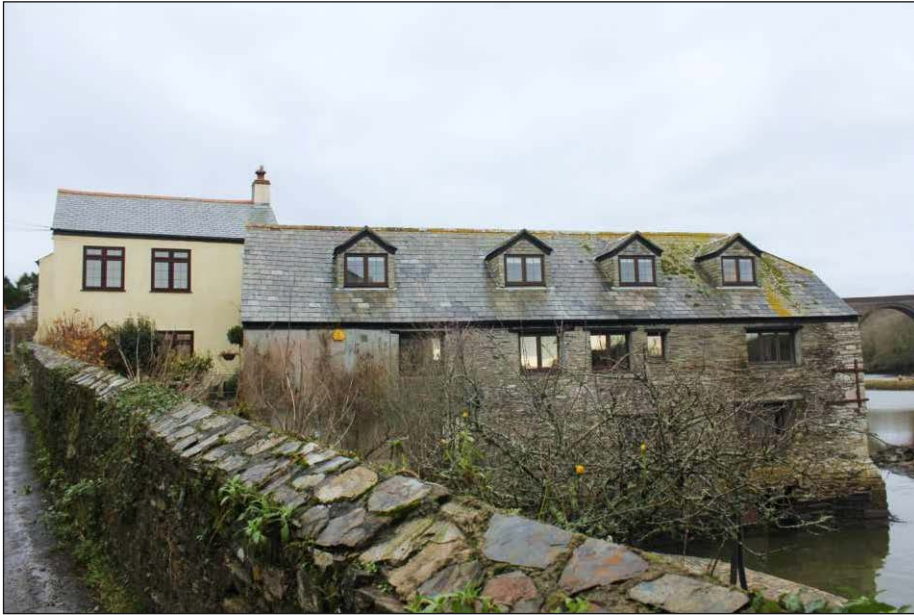
**5.1** The tide mill is situated at right angles to the river, with its west end set onto a quayside. Extending to the northwest is the abutting mill house (Plate 1), while the site of the previous cottage to the southwest now forms part of the garden to the property. The tide mill has three storeys – a lower utility area, a ground floor with living spaces (accessed from the level of the adjacent road and up from a flight of steps on the north elevation), and with bedroom accommodation in the roof; much of the ground floor appears to have been rebuilt in the 19th century when the height of the building was raised. The abutting mill house is a two-storey structure, with entrances from the gardens to the north and south.

Plate 1: The tide mill, with mill house to the left, looking north

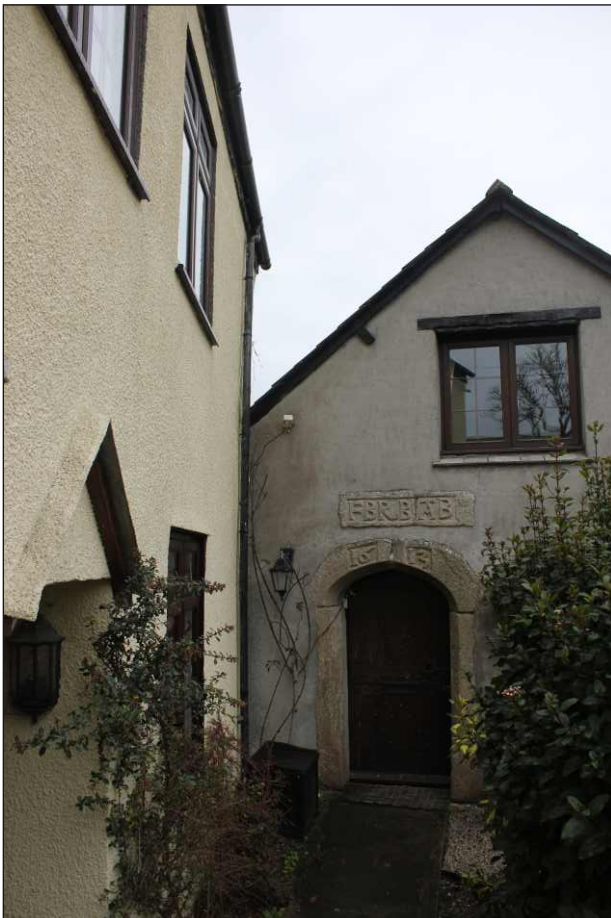
**5.2** Externally, the south junction of the buildings is obscured by render (Plate 2). On the north side of the property, the north wall of the tide mill displays exposed masonry of local slates, whilst the east elevation of the mill house is also rendered (Plate 3).

Plate 2: The west elevation of the tide mill, with south elevation of the mill house to the left, looking northeast

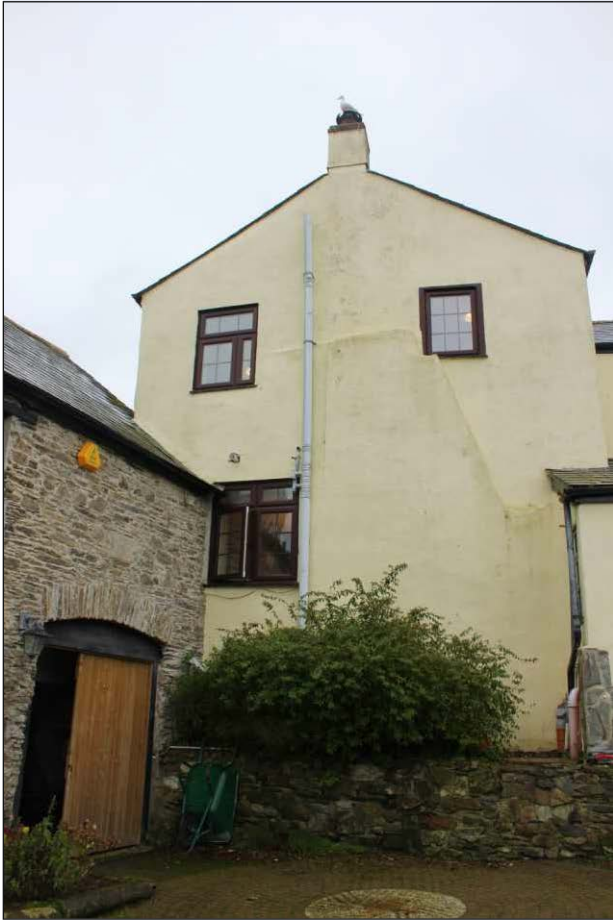
Plate 3: The east elevation of the mill house with the north elevation of the tide mill to the left, looking southwest. In the latter rebuilt masonry is visible above the doorway

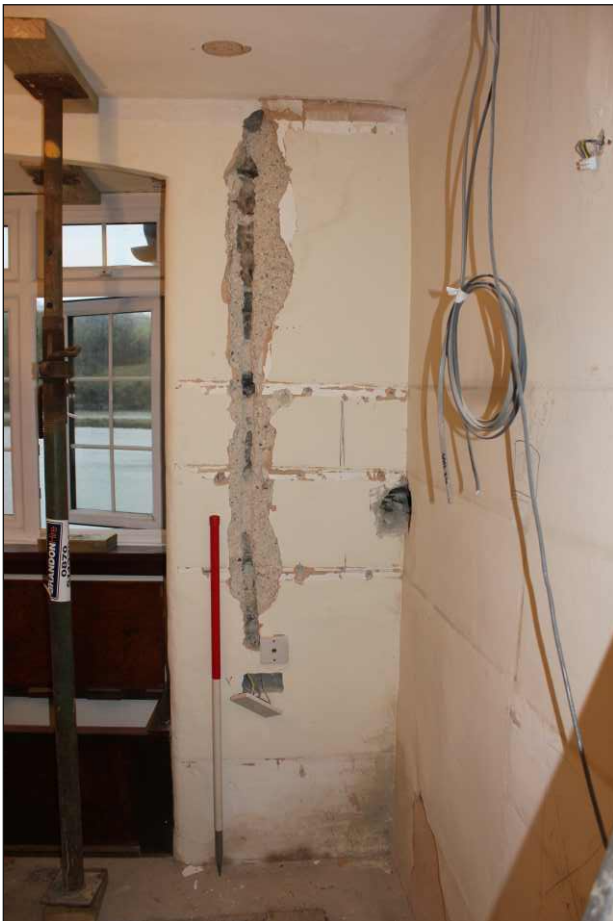
- 5.3 The east wall of the mill house was finished in an historic white lime plaster with coarse unsorted gravel inclusions up to 6mm long (Plate 4). The window reveal to the west had a cement render finish, which continued over the lime plaster in a thin skim. The adjacent south wall was finished in modern cement render.
- 5.4 The west wall of the tide mill was finished entirely in modern cement render, with no visible historic finish present (Plate 5). Architectural features exposed at ground level and the ceiling level are discussed in Sections 5.7 and 5.8 below in relation to the relevant masonry.

Plate 4: The interior face of the east elevation of the mill house prior to removal of finishes, looking northeast (1m scale)

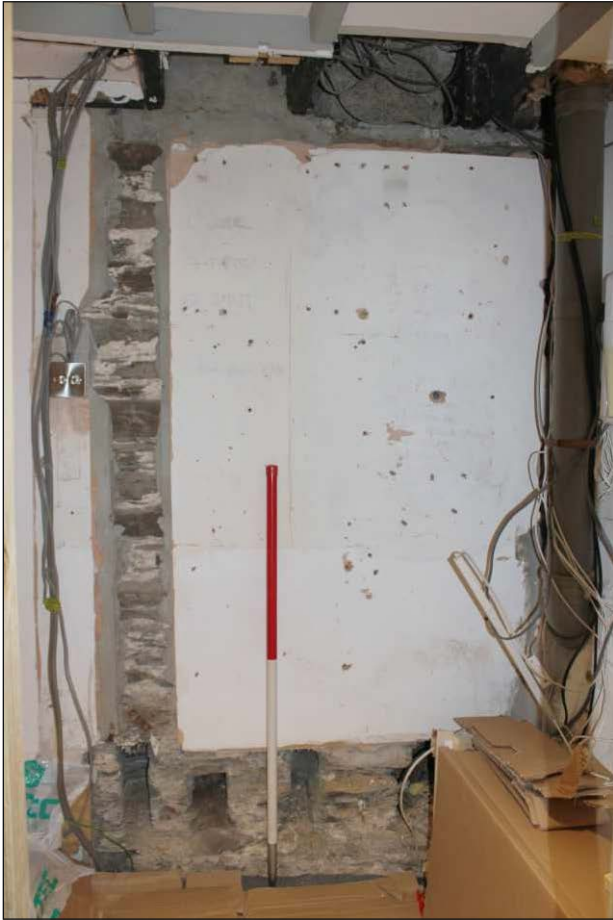
- 5.7 The primary masonry of the tide mill comprised the same thick fine-grained slates exposed in the mill house, but bonded in a hard white lime mortar with rare inclusions. The current floor level has been lowered by 400mm below the historic floor level exposing the wall curves matching the (historically external) curve recorded in the mill house (Plate 9) as well as on the lower level below. The masonry here incorporated four joist sockets, measuring 80mm wide by up to 280mm high (Plate 5).

Plate 5: The interior wall of the tide mill prior to removal of finishes, looking southwest (1m scale). Joist sockets are visible at the base of the wall

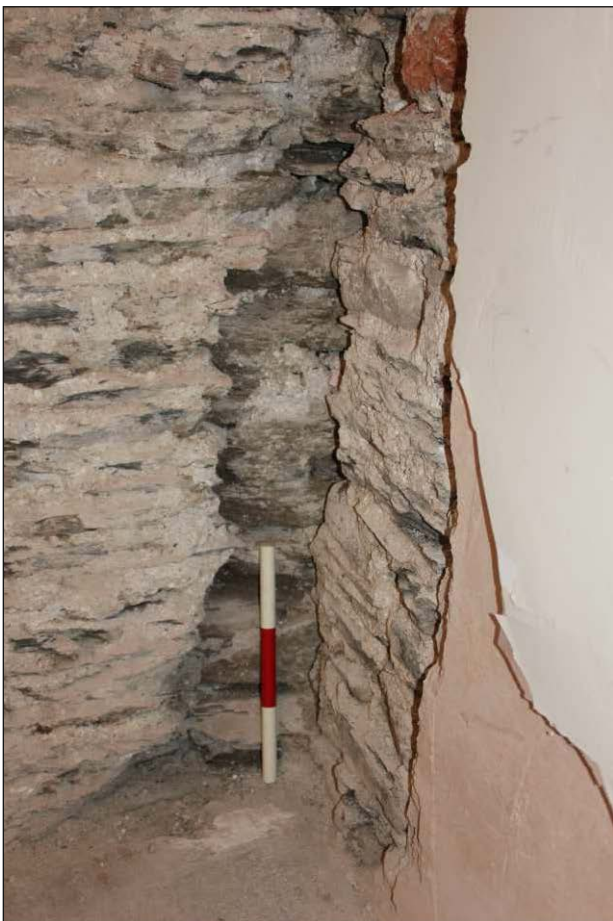
- 5.5 In the mill house, elevation fabric of the tide mill was exposed in the corner of the room, extending up to 200mm from the southeast corner and up to 800mm above the current floor (Plate 6). The masonry was curved and comprised thick fine-grained slates bonded in mid brown loose earth mortar; the same masonry is currently visible at the lower level in the adjacent north elevation (both externally, and internally where there is corresponding curved masonry on the inside face of the wall).

Plate 6: The primary curving masonry of the tide mill exposed within the mill house, looking east (0.30m scale)

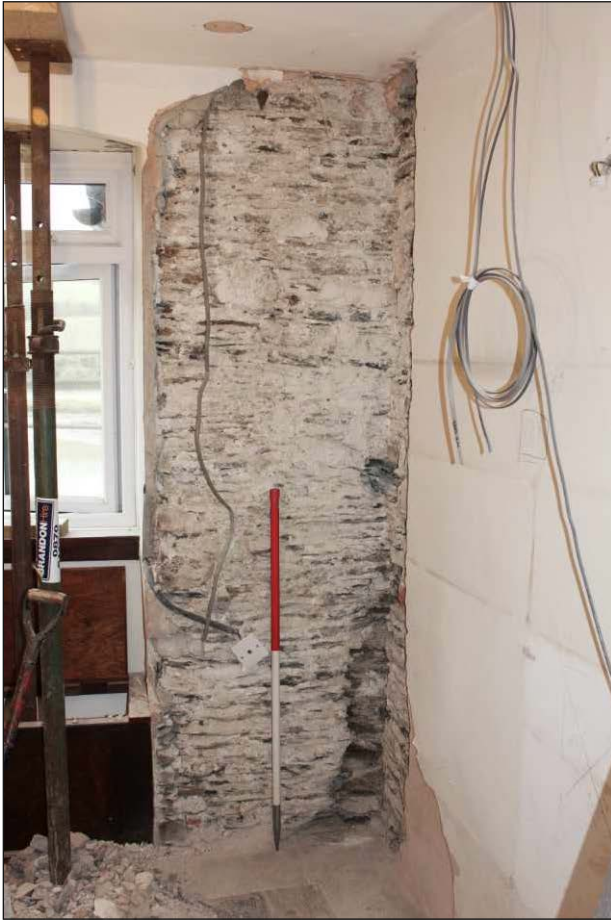
- 5.6 The masonry was overlaid, and to the southeast abutted, by later masonry forming the southeast corner of the mill house (Plate 7). This was constructed of thin slates bonded in gravelly lime mortar. This masonry also formed, where exposed, the northeast end of the south wall of the mill house (Plate 8). The edge of the stripped plaster here coincided with the north side of a blocked doorway in the wall. Handmade bricks and wooden battens were incorporated into the reveal. The doorway was infilled with concrete blocks.

Plate 7: The masonry of the mill house following removal of plaster, looking northeast (1m scale)

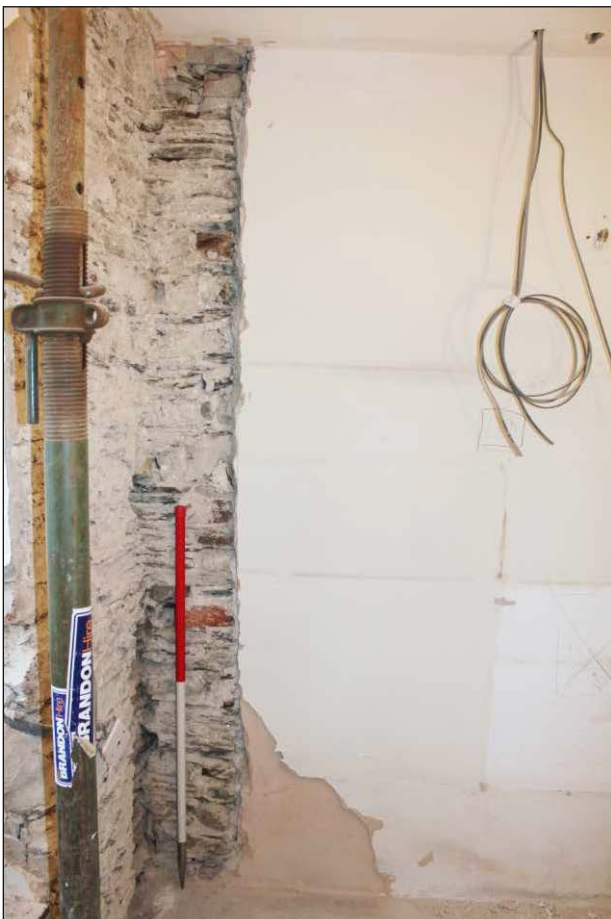
Plate 8: The masonry of the mill house following removal of plaster showing the east edge of a blocked doorway, looking southeast (1m scale)

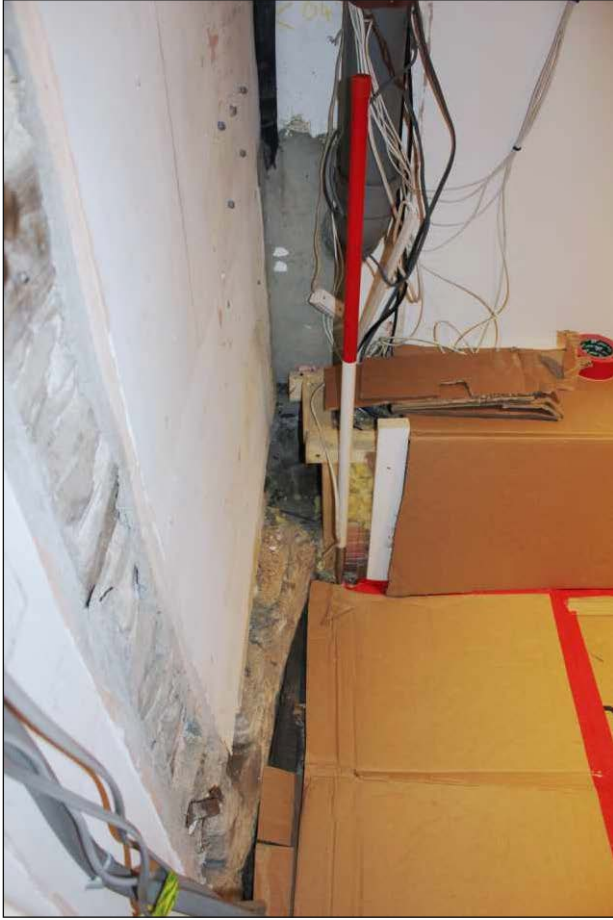
Plate 9: The lower curved masonry of the tide mill, looking northwest (1m scale)

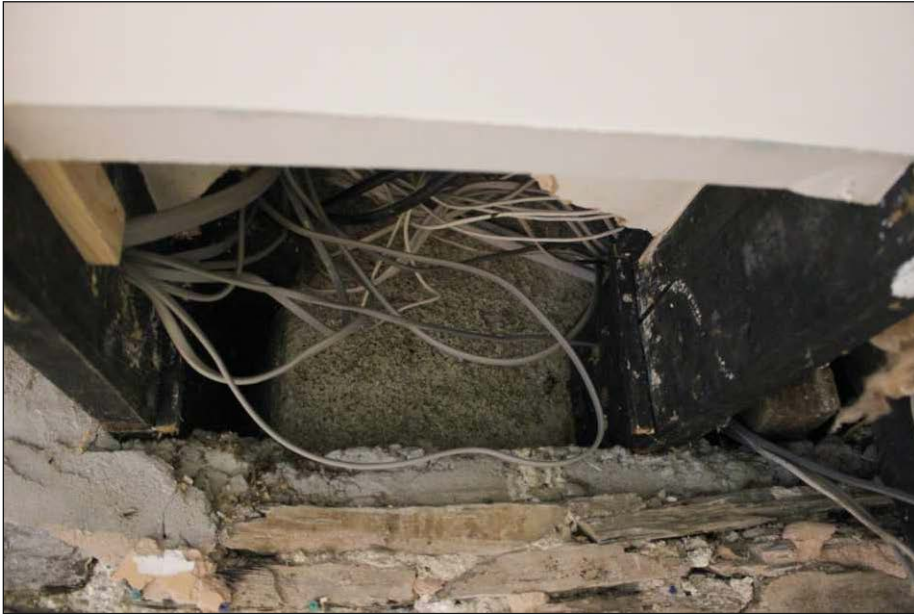
- 5.8 At a high level there was a rebuild of this masonry in similar but slightly lighter stone laid more randomly and bonded in a softer gravelly white lime mortar (Plate 10). This rebuild measured approximately 0.7m<sup>2</sup> and continued into the north wall where it was deeper and abutted the earlier stonework below. This masonry is visible externally where it randomly contains larger blocks of stone (Plate 3). Above this masonry, three joists have been exposed supporting the floor of the bedroom accommodation in the roof. These are laid onto concrete and have probably been reset during the later 20th-century conversion into a house. Behind these, the rendered masonry of the southeast corner of the mill house was visible, overlying part of the west wall of the mill (Plate 11).

- 6.1 The investigation successfully achieved the aim of confirming that the mill house is later than the tide mill. The southeast corner of the mill house was observed to have abutted, been constructed into, and overlaid historic masonry of the west wall of the tide mill.

Plate 11: The southeast corner of the mill house overlying the west wall of the tide mill, looking northwest
