PADDOCK WOOD, CHURSTON FERRERS, TORBAY

Results of an archaeological watching brief

Torbay Council planning reference P/2017/0429, condition 3

Document No: ACD1662/2/0

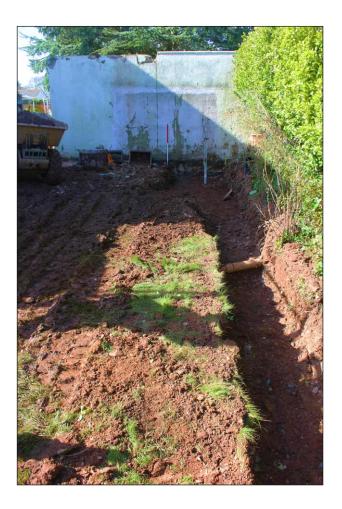
Plate 1: Trench 1, general view, looking northwest (1m scale)

The excavation of two 0.60m wide trenches was monitored – the eastern foundation trench (1), measuring up to 0.70m deep, and the southern foundation trench (2), measuring 0.80m deep. At the north end of trench 1 the following deposit sequence was exposed:

- 0-0.20m reddish-brown loose silty-loam topsoil (100);
- 0.20-0.30m patchy layer of black ash and charcoal (101);
- 0.30m-0.50m light grey-brown loose clayey silt with fragments of natural limestone that became more frequent at depth, oyster shell, lime mortar, and roof slate (102); and
- 0.50m+ fracturing limestone bedrock (103).

At the south end of the trench, layer 102 decreased in depth to 0.10m and overlaid natural mid reddish-brown clay (104) that was not fully removed.

The northwest extension to this trench was located within a former patio, and here the patio surface had been constructed onto a levelling layer (105) of roof slate and mortar fragments that extended below the depth of the trench.

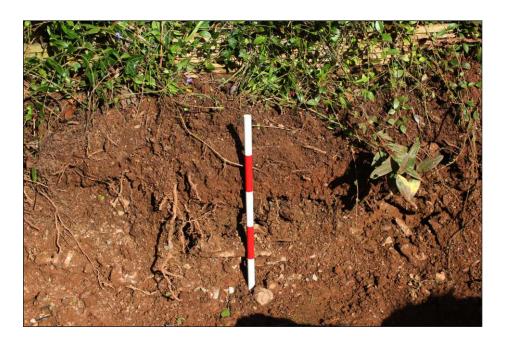
Plate 2: Trench 1, typical section, looking northeast (0.50m scale)

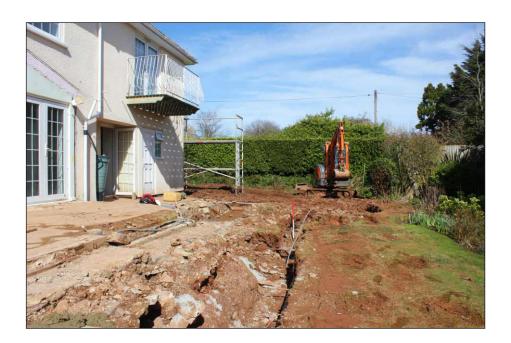
Plate 3: Trench 2, general view, looking northeast (1m scale)

A similar, but deeper, sequence of deposits was exposed in trench 2:

- 0-0.30 reddish-brown loose silty-loam topsoil (100);
- 0.30-0.60m light grey-brown loose clayey silt with fragments of natural limestone that became more frequent at depth, oyster shell, small lime mortar, charcoal, rare red sandstone, roof slate, and rare industrial china (102); and
- 0.60m+ natural mid reddish-brown clay (104).

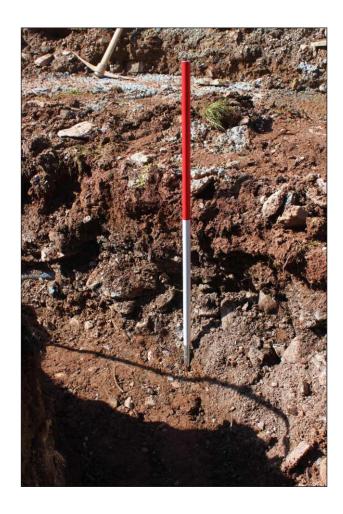
Plate 4: Trench 2, typical section, looking southwest (1m scale)
