PENWITH STREET DEPOT SITE, PENZANCE, CORNWALL

Results of archaeological recording and monitoring

Cornwall Council planning reference PA16/12036

Document No: ACD1606/3/0

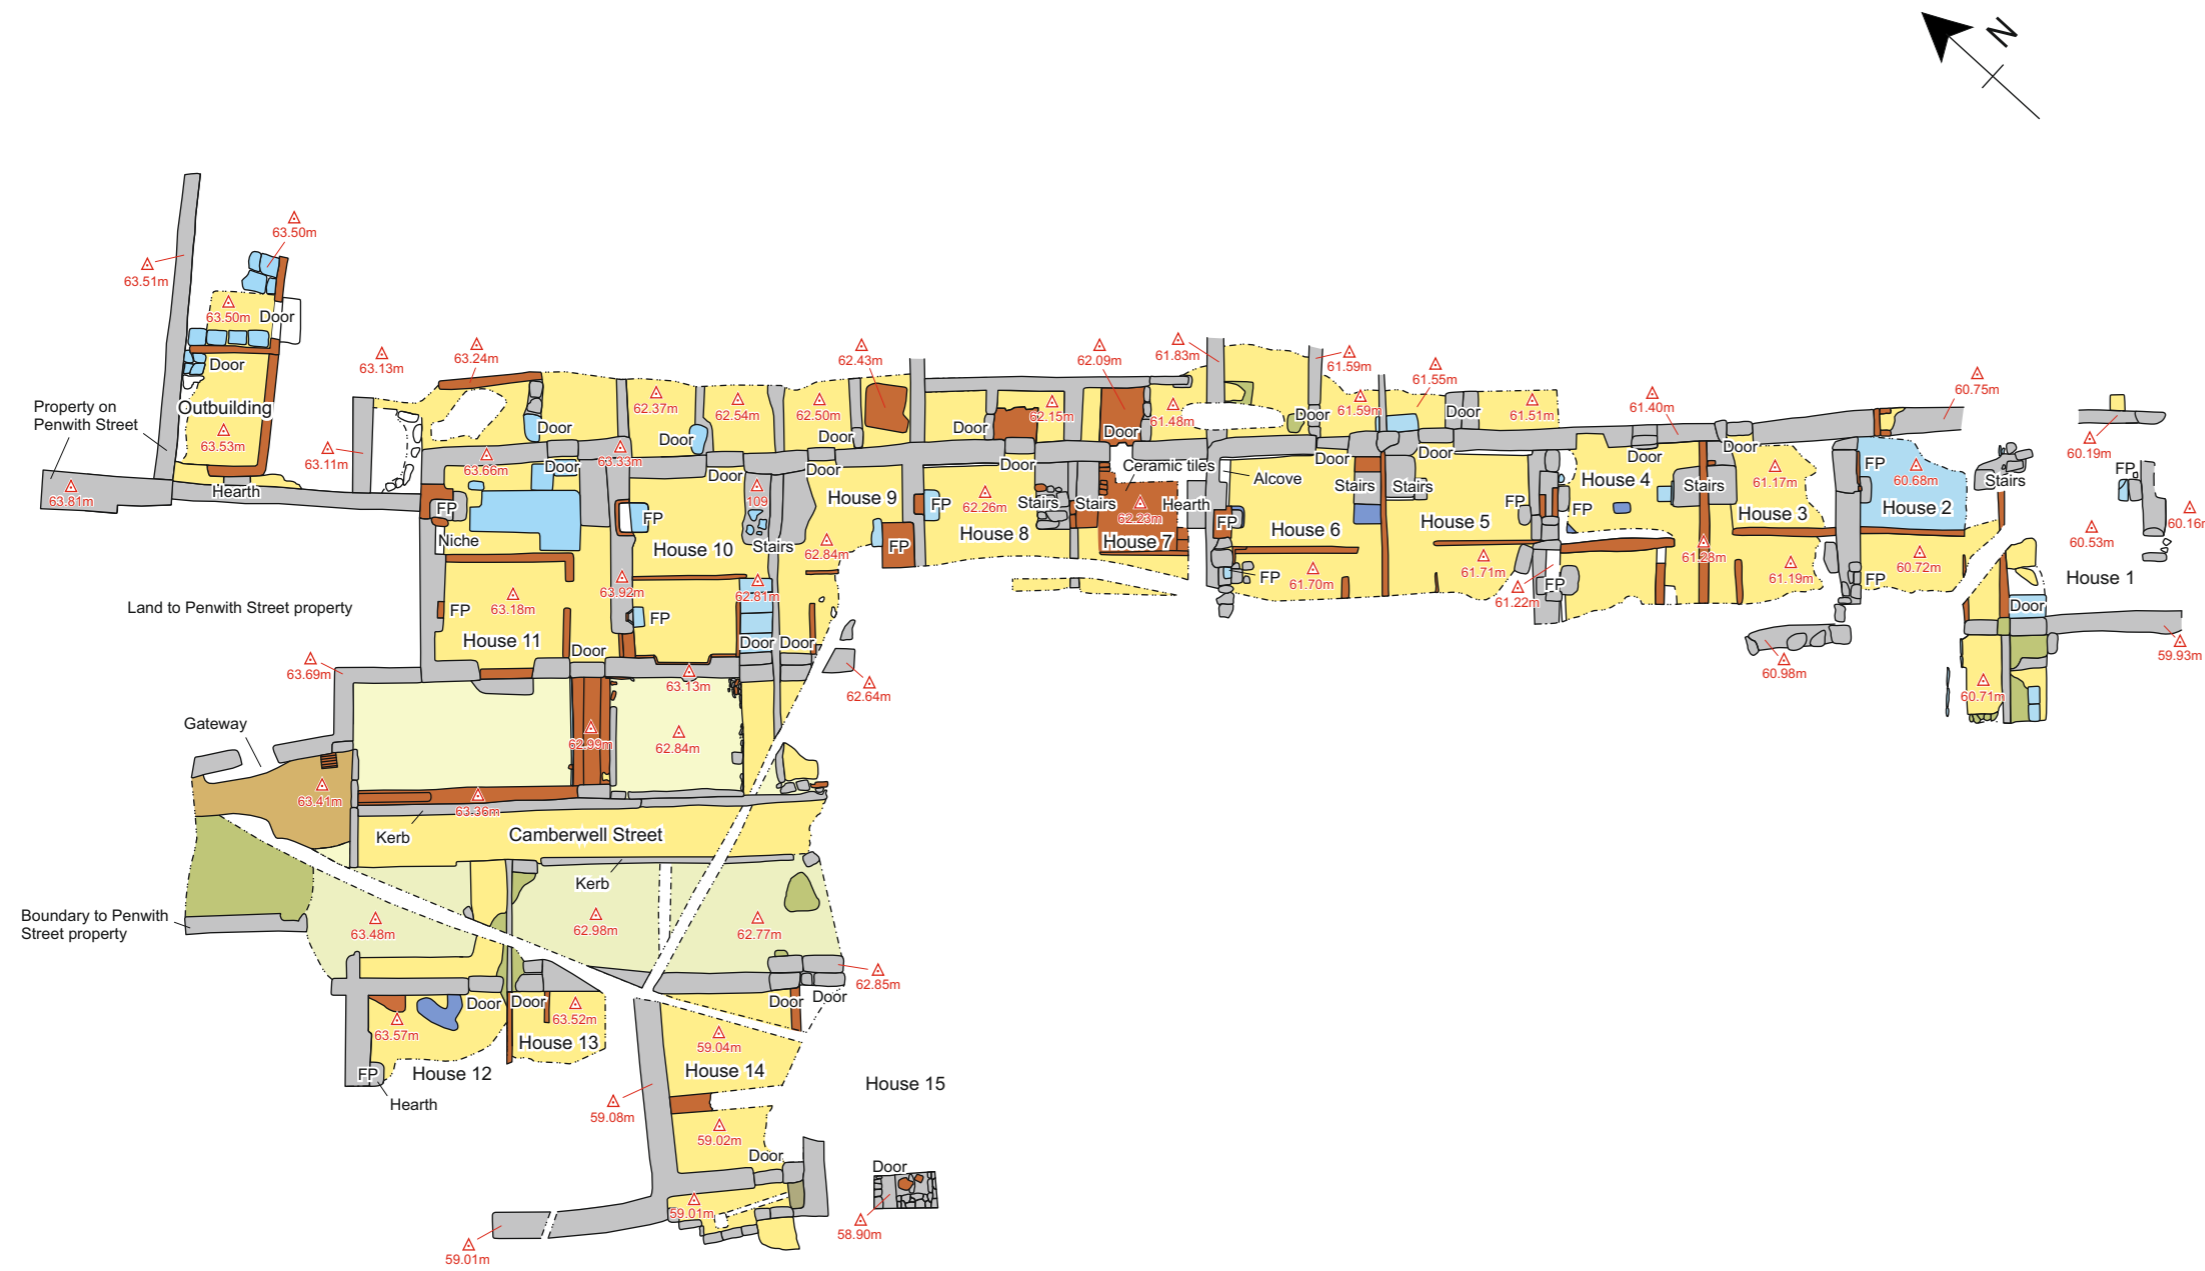
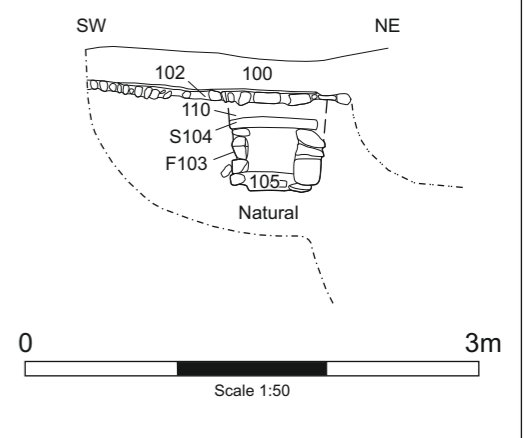
TITLE
**Fig. 4: Plan of existing remains,
 and section of drain S104**

a) Plan of the terrace houses

b) Section of drain S104

5. RESULTS (Fig. 4; Plates 1-18)

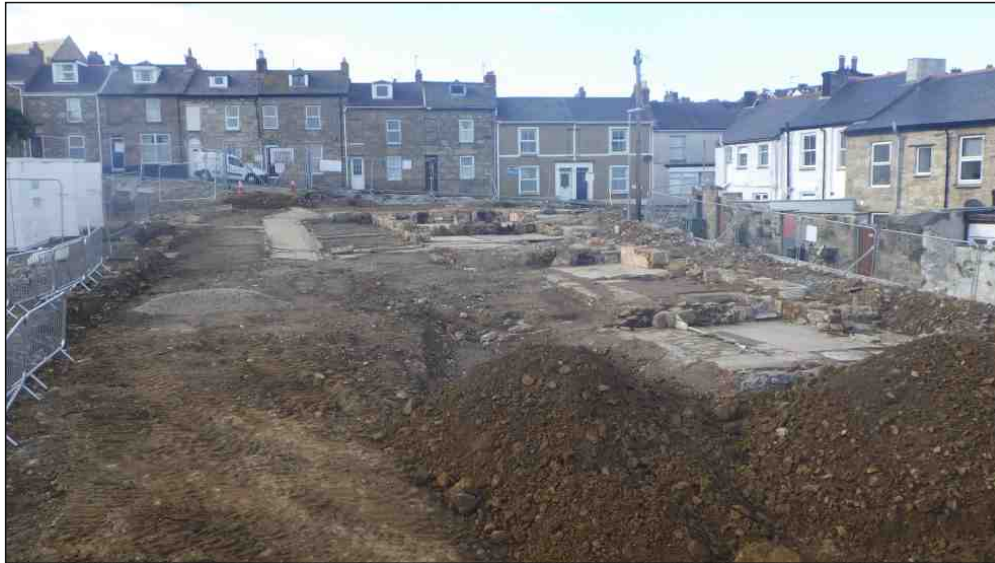
Plate 1: General view of the site showing Camberwell Street and houses 6-11, looking northwest

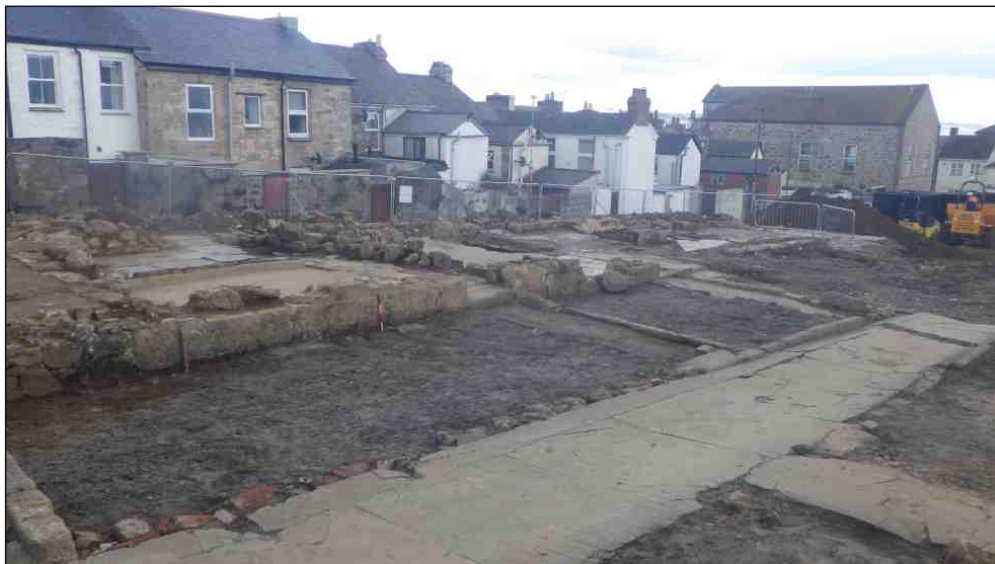
Plate 2: General view of the site showing Camberwell Street (foreground) with houses 8-11 to the rear as well as the front gardens of houses 10 and 11, looking east. 0.40m scale

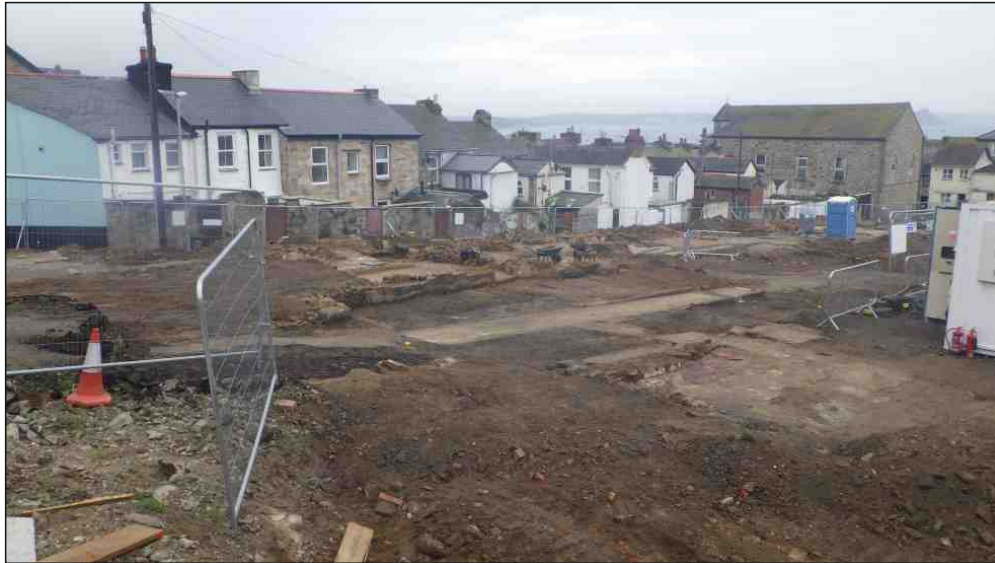
Plate 3: General view of the site showing house 12 (foreground), Camberwell Street, and houses 6-11 to the rear, looking southeast

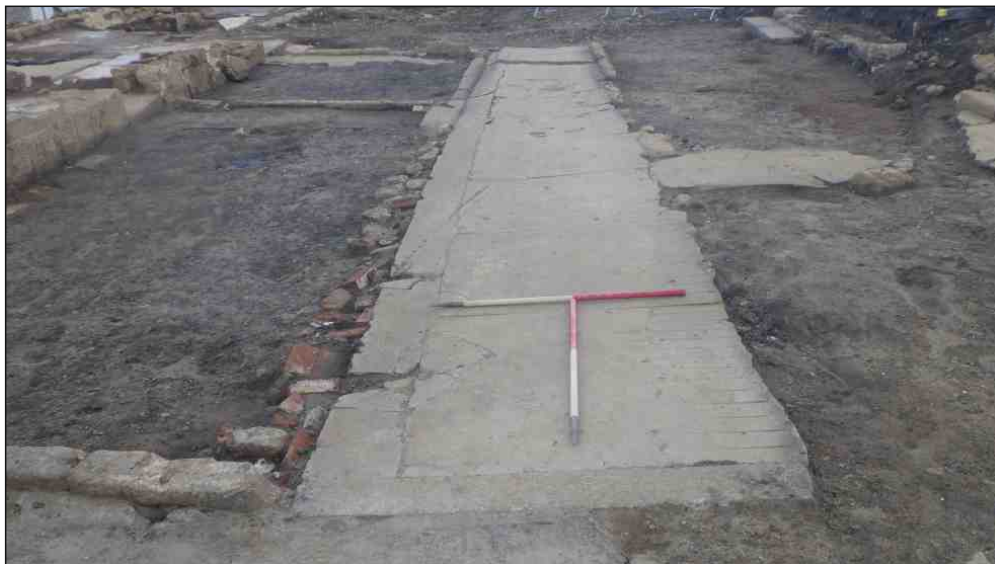
Plate 4: The excavated surviving length of Camberwell Street, looking southeast. 2m scales

- 5.2 A 12.5m length of Camberwell Street was exposed (Plate 4). It measured 1.60m wide with a concrete surface incorporating a gutter along its east side. Both sides were edged with granite kerbs. Unlike the adjacent streets there were no associated pavements, but the terrace houses had 3m deep front yards. Some of these yards had granite boundary walls between the properties, and historic photographs in the Morrab Library show that others had wooden fences, a boundary treatment also used on the roadside. This correlates with the excavated evidence with only a few granite wall footings present dividing some of the yards. There was some evidence for cobbled surfaces in the yards, but others were finished with secondary concrete or contained garden soil. Paths to the front doors were finished with either concrete or earlier red tiles, slate, or cobbles, and were defined by slate or granite edging.

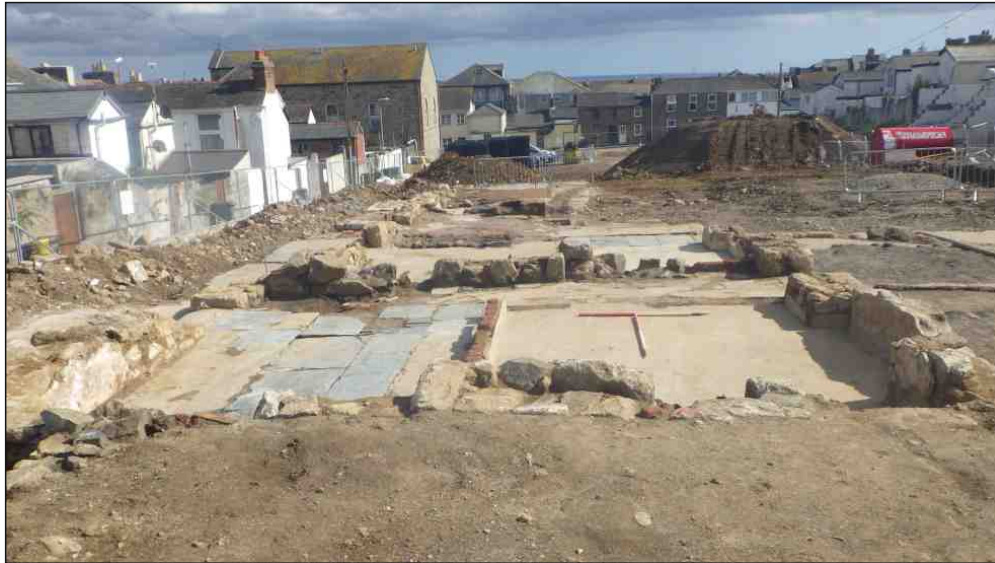
Plate 5: Houses 10 and 11 (foreground) showing the slate flag floor in the rear room of house 11, looking southeast. 1m scales

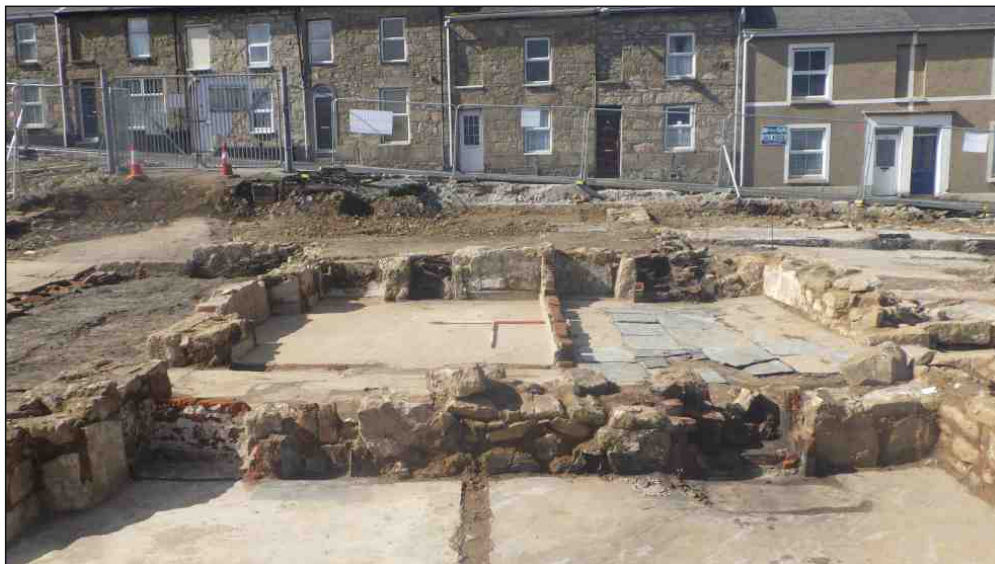
Plate 6: Houses 10 (foreground) and 11 showing the positions of fireplaces and adjacent alcoves, looking northwest. 1m scales

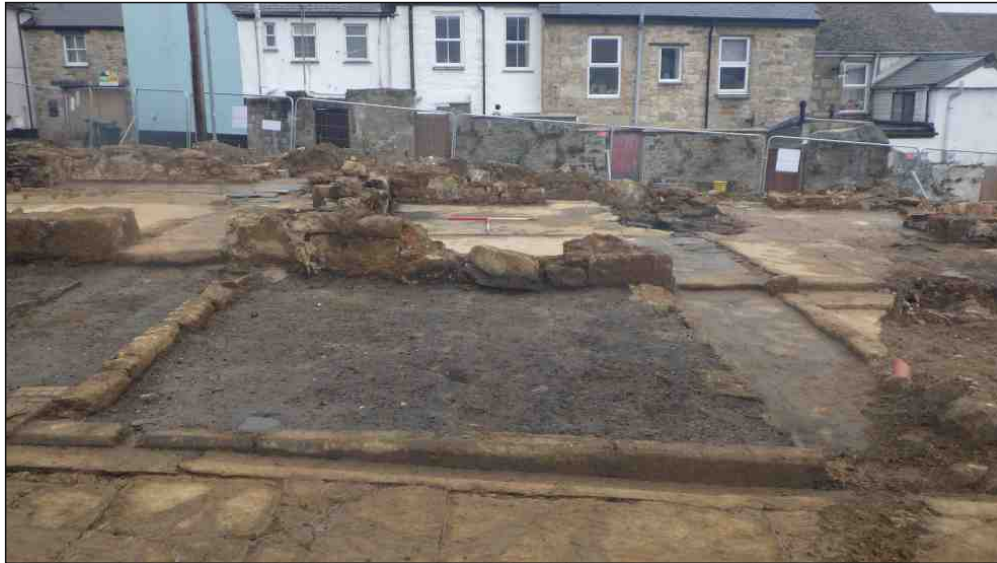
Plate 7: House 10 showing the front garden and remains of the front path, as well as the slate floor of the entrance hall, looking northeast. 1m scales

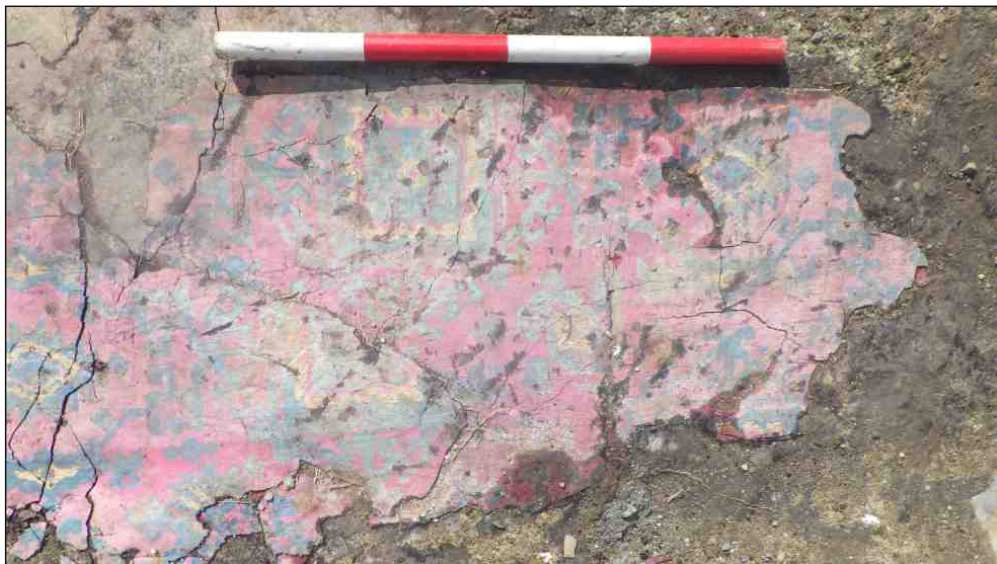
Plate 8: Close-up photograph of the lino floor covering in house 4, looking northeast. 0.40m scale

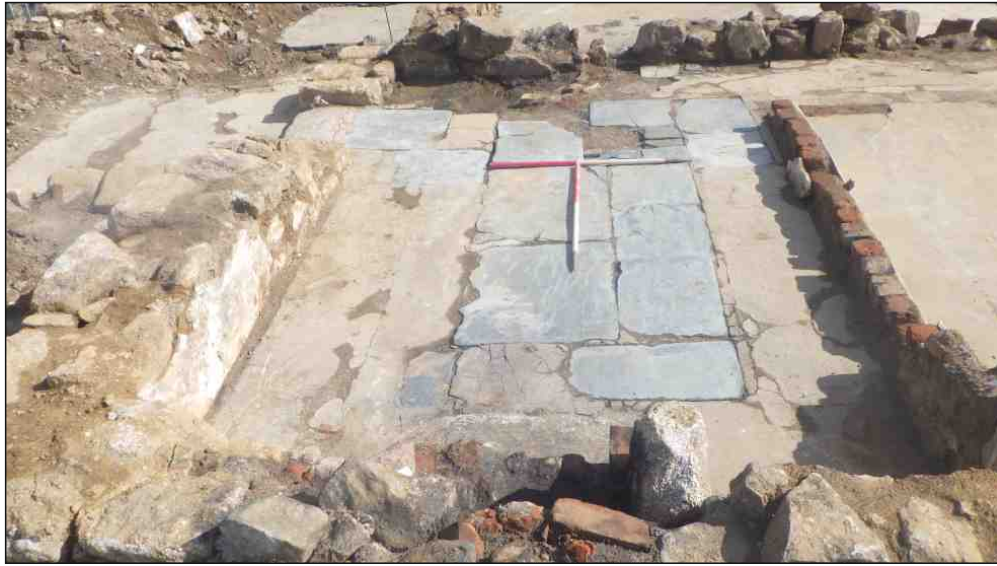
Plate 9: House 11 showing the slate flag floor in the rear room, looking southeast. 1m scales

- 5.3 The houses were broadly identical (although the plan form was generally reversed on pairs of houses), with significant differences discussed individually in Sections 5.5-5.15 below. They were constructed with granite exterior and party walls, the latter being of either thicker granite incorporating fireplaces or between pairs of houses thinner brick on granite or mortar foundations (Plates 5 and 6). Each house measured 4.80m deep by 3.75m wide internally, and contained two principal reception rooms served by a front entrance hall. The internal partitions were constructed of red brick. All were originally plastered, which partially survived, generally adjacent to the floors. Where surviving, the entrance halls had a slate floor (Plate 7), but the majority of the rooms had concrete floors, some with fragments of a lino covering (Plate 8). There was very little evidence for original floors, which where present was slate laid onto a bedding of lime mortar (Plate 9). Contemporary

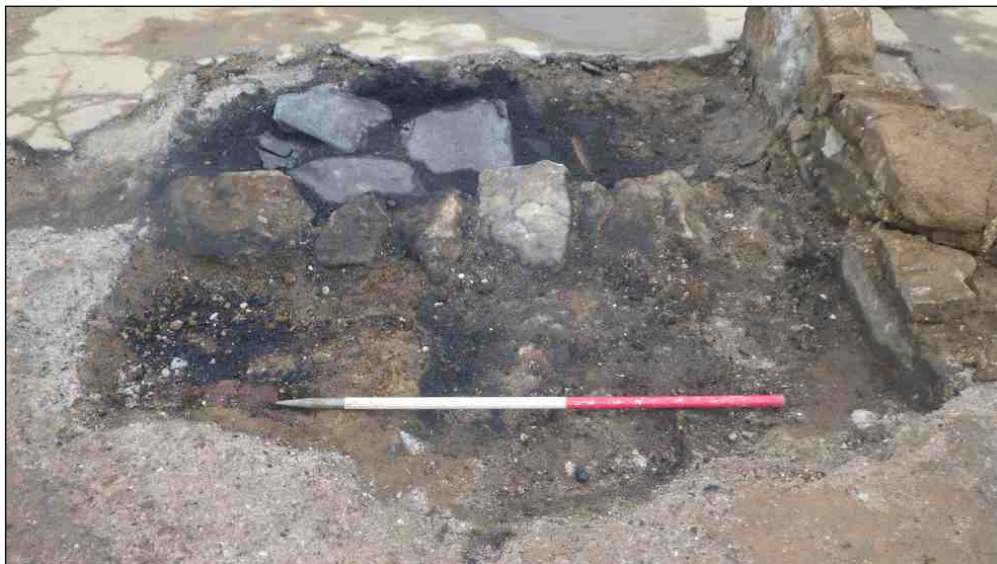
Plate 10: Close-up photograph of the remains of the base of the stairs in houses 9 and 10, looking northwest. 1m scale

cement skirting also survived in some houses. Consistent areas of disturbance (including evidence of burning) within the rear rooms, behind the entrance hall, indicated the position of stairs to the first floor (Plate 10). Adjacent to the position of the stairs were doors to rear yards (Plate 11). The front rooms had central windows with partial walk-in reveals. No evidence for windows in the rear rooms was identified. (Historic photographs in the Morrab Library show that the houses had six-over-six pane hornless sash windows with single first-floor windows only on the front and rear elevations.) Both the front and rear rooms were heated with brick-lined fireplaces, with slate or other stone hearths; rarely fragments of stoves survived *in situ* in the rear rooms (Plate 12), indicating that kitchen facilities were located here. The positions varied slightly to allow for the insertion of two fireplaces, in adjacent properties, in the party walls.

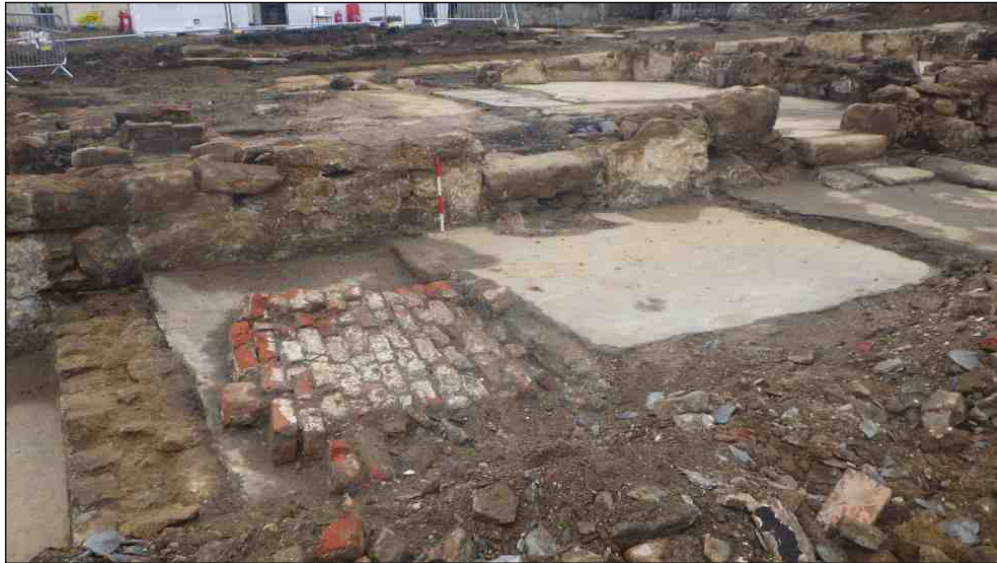
Plate 11: Houses 9 and 10 showing the doorways to the rear yards, and collapsed brick wall of the outshut to house 9, looking west. 0.40m scale

- 5.4** Limited evidence for back yards was exposed (Plates 11 and 13). This principally comprised granite boundary walls between the yards, granite foundations of outshuts, and remains of concrete surfaces overlying or replacing original brick, cobble or slate surfaces. There were steps down into the rear outshuts, and down again from the outshuts into the back yards.

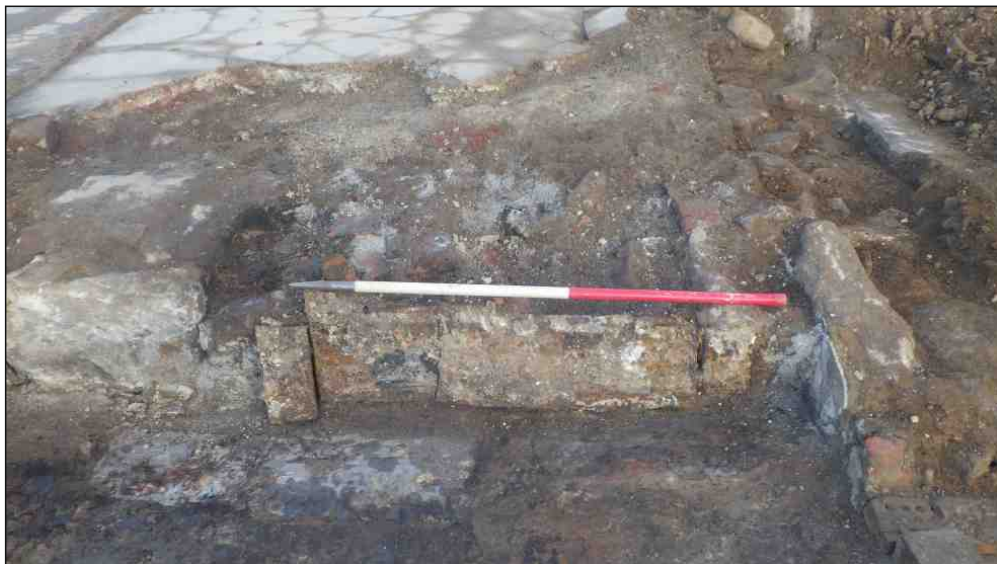
Plate 12: House 2, the brick-lined fireplace with remains of stove, looking northwest. 1m scale

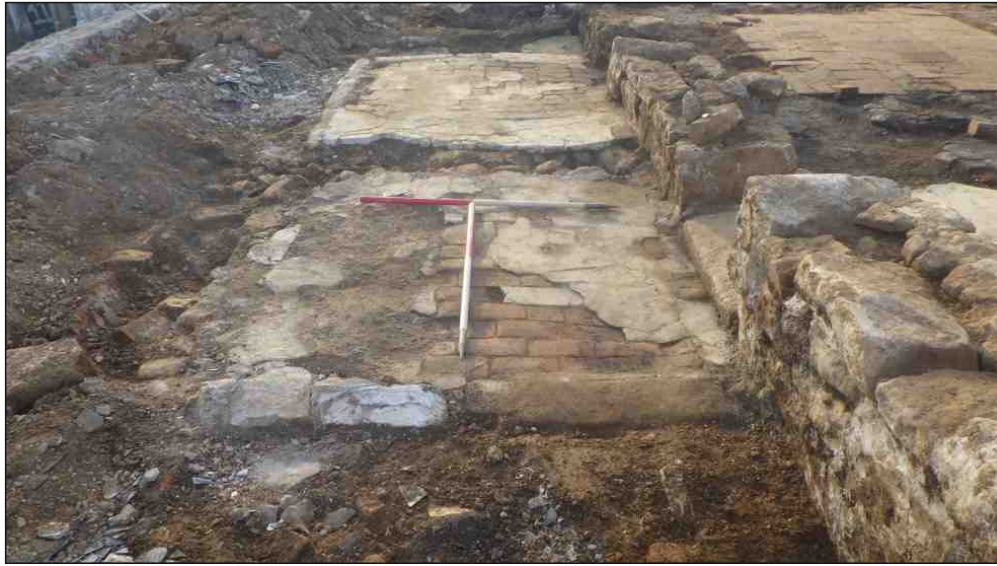
Plate 13: The rear yards and outshuts to houses 7 and 8 showing brick surfaces, looking southeast. 1m scales

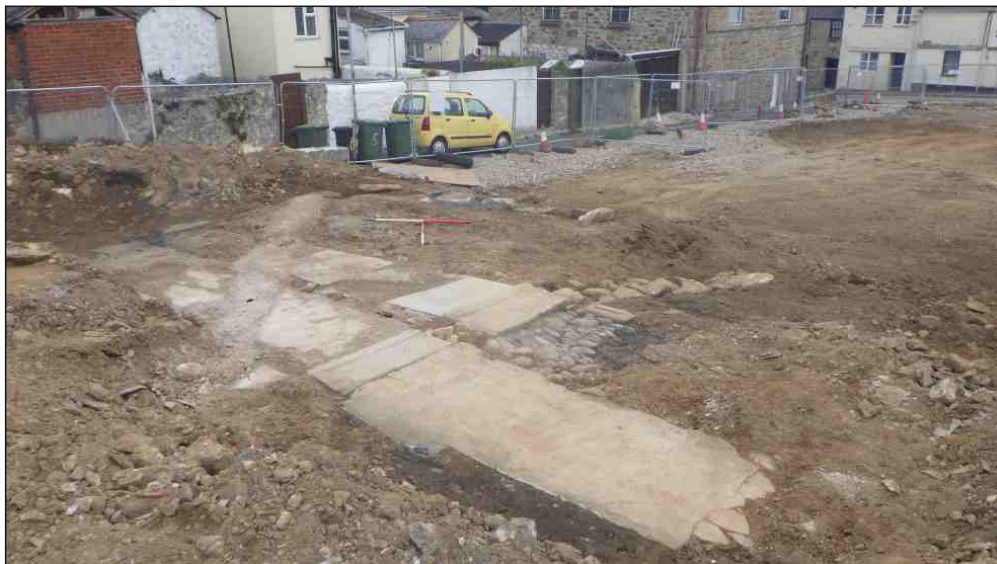
Plate 14: The remains of houses 1 and 2 showing the cobbled and concrete path surfaces, looking east. 2m scales

- 5.5** This house had been heavily disturbed with fragments of its outside walls surviving, along with surfaces in the entrance hall, and the hearth of a fireplace in the southeast wall. Externally part of the slate, cobbled and granite front path also survived (Plate 14).

- 5.6** The front of this house had been heavily disturbed, but internally the concrete surface of the front room survived along with a lime bedding for the original surface of the rear room. Both fireplaces in the northwest wall were also exposed. Externally, the cobbled front path with later concrete covering was also present (Plate 14).

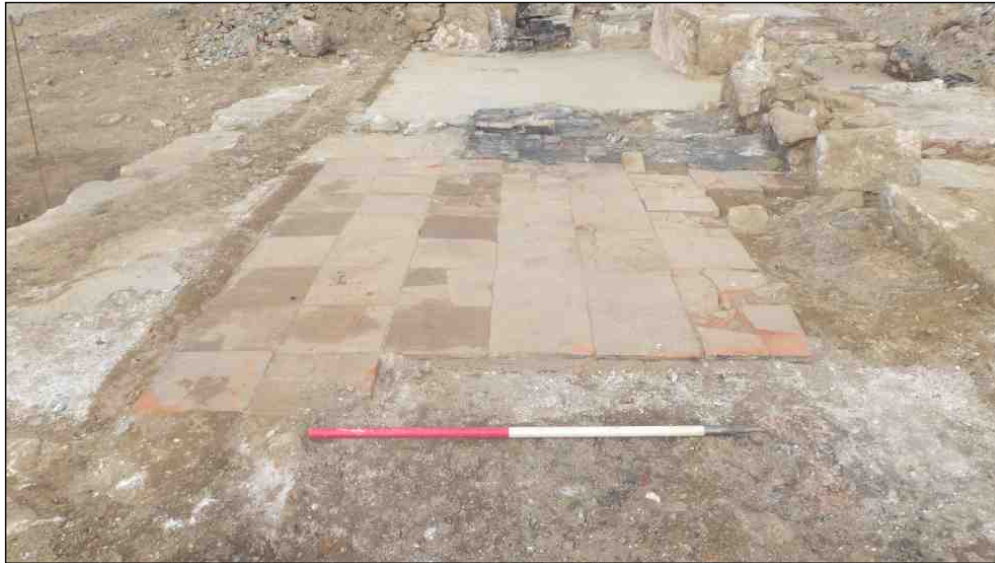
Plate 15: House 7 showing the red tile floor to the rear room, and the remains of stairs in houses 7 and 8 beyond, looking northwest. 1m scale

- 5.11 The front of this house had been disturbed, including parts of the internal walls, but the tile and concrete floors (Plate 15), and evidence for the fireplace in the rear room located in the southeast wall were present. Externally the rear yard walls and a rear outshut survived along with associated brick and concrete surfaces.

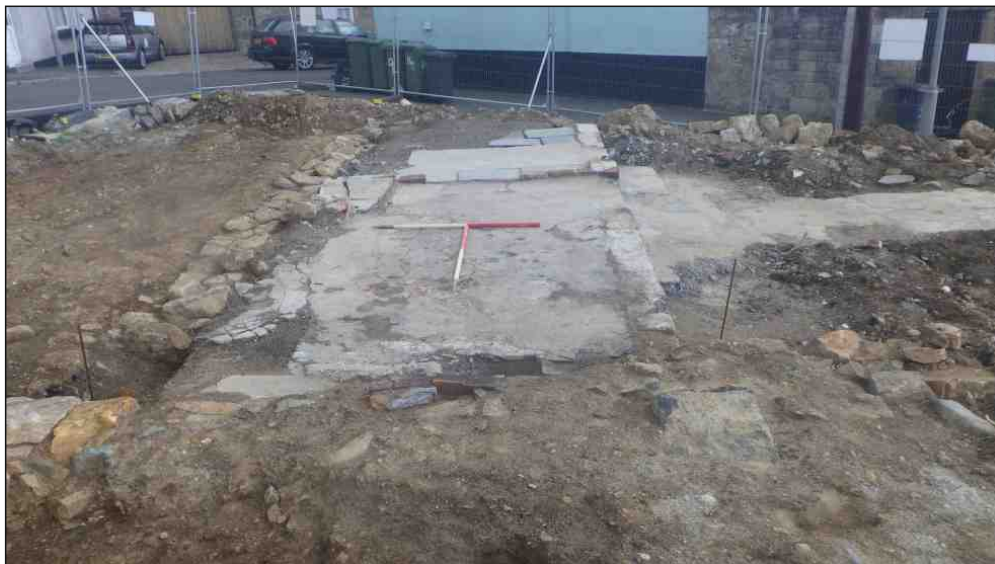
Plate 16: The rear extension to the outbuilding on Penwith Street, looking northeast. 1m scales

- 5.16 Historic maps record two yards to the north of house 11 associated with a pair of larger houses on Penwith Street. Parts of the granite boundary walls of the western yard was exposed, incorporating a pedestrian gateway from Camberwell Street. The granite rear wall of the northern property was exposed, and within the yard was a further length of granite wall, and a two-roomed brick extension to the building (Plate 16). This had slate and concrete floors.

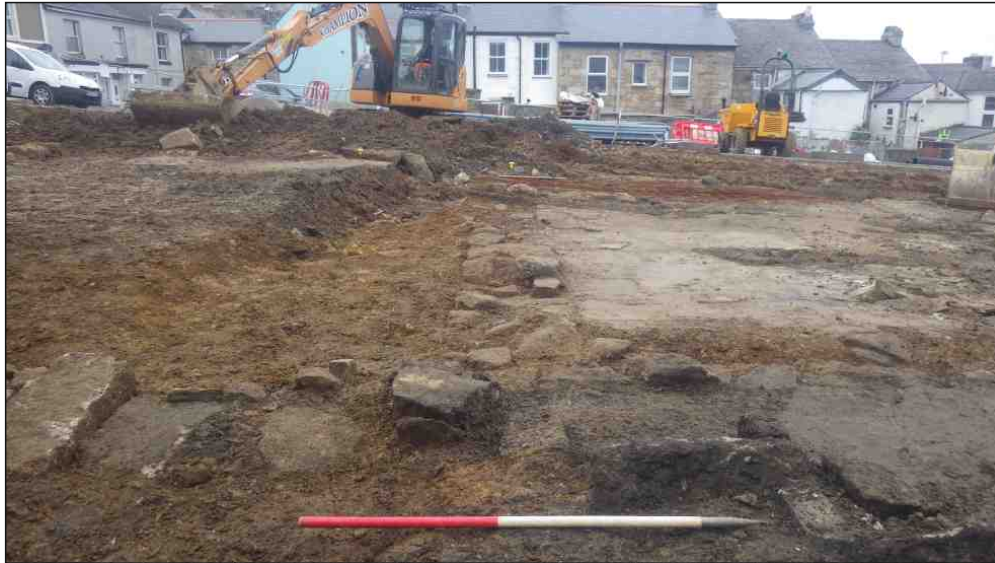
Plate 17: The heavily disturbed remains of house 13 (left) and 14 (right), looking northeast (1m scale)

- 5.17 The highly truncated remains of houses 12-15 were exposed at the northwest corner of the site (Plate 17). As on the opposite side of the street the end house (12)

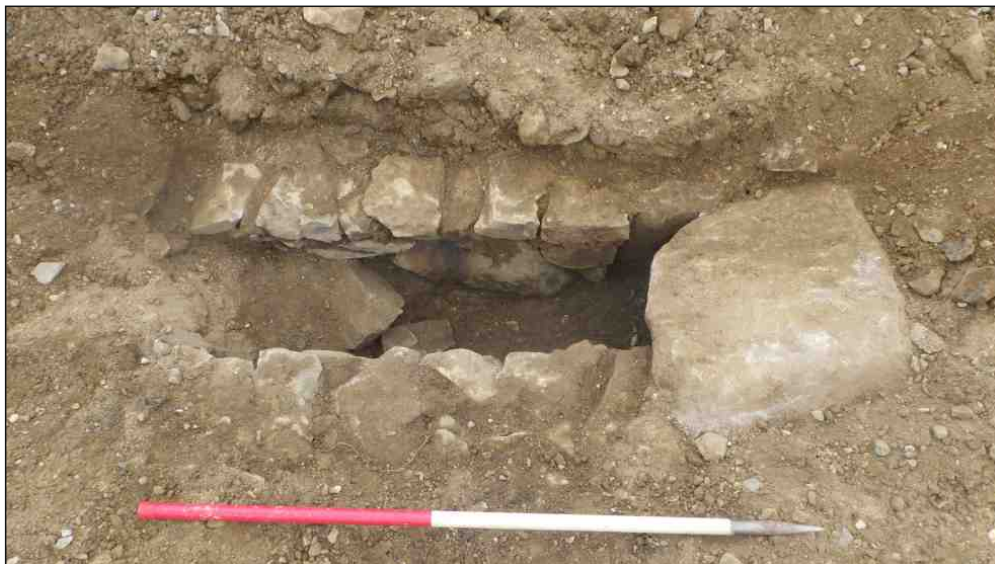
Plate 18: Drain S104, looking northeast. 1m scale

- 5.19** Removal of the retaining wall between the northern and southern portions of the site exposed a northwest to southeast aligned granite drain (S104) constructed within a trench (F103) dug into the natural clay subsoil (106). It was exposed for a length of 1.48m and had internal dimensions of 0.60m wide by 0.84m high (Plate 18). The lower part of the drain was infilled with a dark brown silty clay (105). The drain was sealed by a backfill deposit of medium brown silty clay (110) above which was a cobbled surface set in a bed of yellow clay (102). This surface was sealed by a later, thin surface of concrete (101).

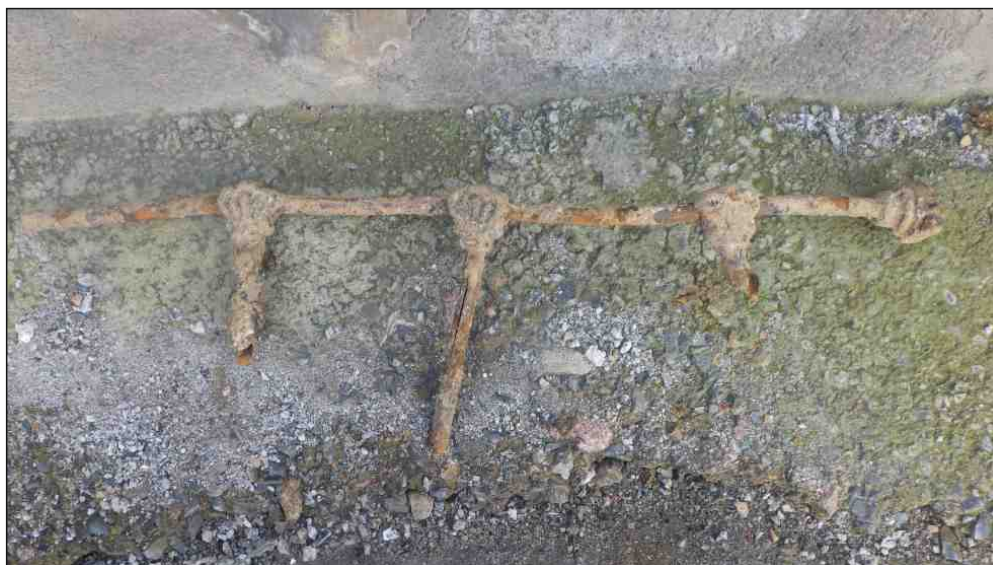
Plate 19: The remains of the bedframe

- 6.3** The iron finds include a piece of a cast-iron bed frame (Plate 19), a bolt, a bottle top, a bracket, a piece of a hollow chair leg with a turquoise plastic coating, an incomplete fire grate, a horseshoe, a knife blade fragment, nine nails, an oven door (Plate 20), a large split ring, a piece of twisted wire and three unidentified fragments. The cast-iron oven door from a range is broadly square with two large hinges, a central latch and a circular copper alloy fan. A rectangular copper alloy plaque on the inside of the door reads: 'P B Corin / Anchor Foundry / Penzance'. The Anchor Foundry, which was located in Causewayhead, was purchased from the trustees of J. M. B. Corin by Philip B. Corin in 1900. According to the 1914 *Who's Who in Business*, the Anchor Foundry employed about 35 people in 'mechanical engineering, coppersmithing, &c., gas fitting, electric lighting, telephones'.

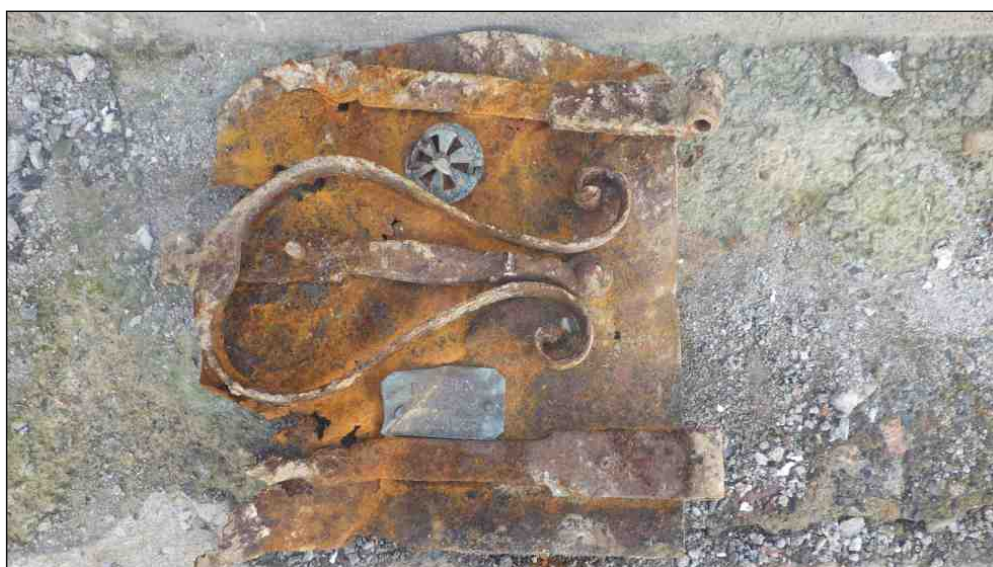
Plate 20: The iron oven door with maker's plaque.
