EMERGENCY FLOOD RELIEF CULVERT, LOE BAR, HELSTON, CORNWALL

Results of Archaeological Investigations

Cornwall Council Planning Reference: PA17/00115
(Condition 5)

Report No: ACD1789/3/1

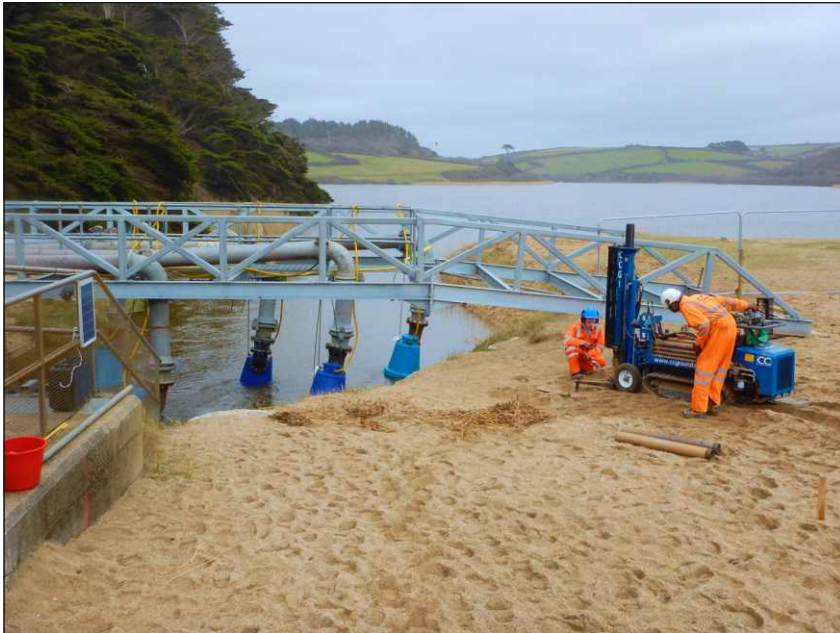
TITLE
**Fig. 1: Location of site and
 development plan showing
 borehole position**

Fig. 1: Location of site and development plan showing borehole position

The borehole survey was undertaken in advance of construction of the flood relief culvert. It was carried out to assess the palaeoenvironmental potential at the anticipated depth of excavation for the proposed culvert. This was carried out using a Dando Terrier coring rig (Plate 1). The location of the borehole is shown on Fig. 1 and the results are summarised below.

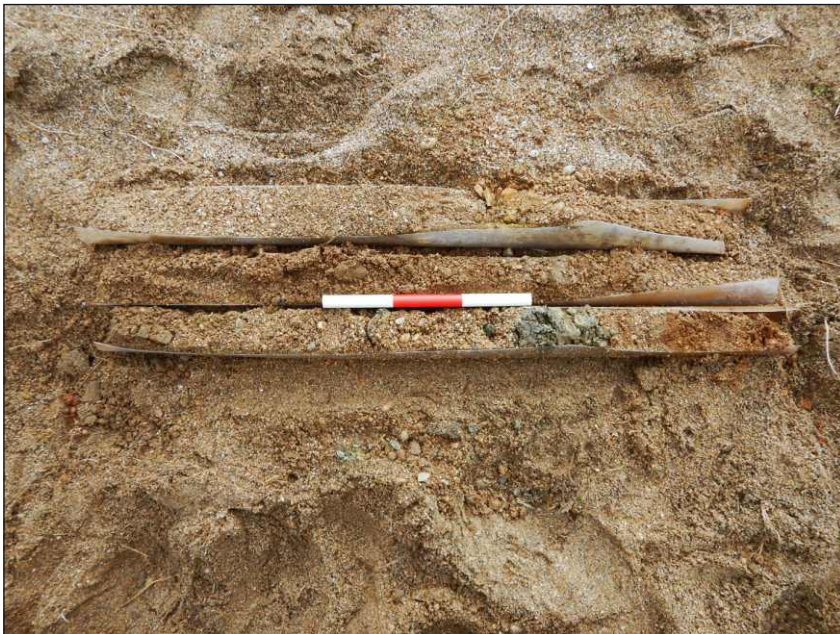
Plate 2: Showing borehole sleeves with recovered sand layer sequence (scale 1m)

The borehole was drilled with sleeves to 4m (Plate 2). Recovered sleeves demonstrated that only sand layers were present throughout (see Table 1). The depth of the borehole exceeded the anticipated depth of 3.2m below existing levels for the new culvert.

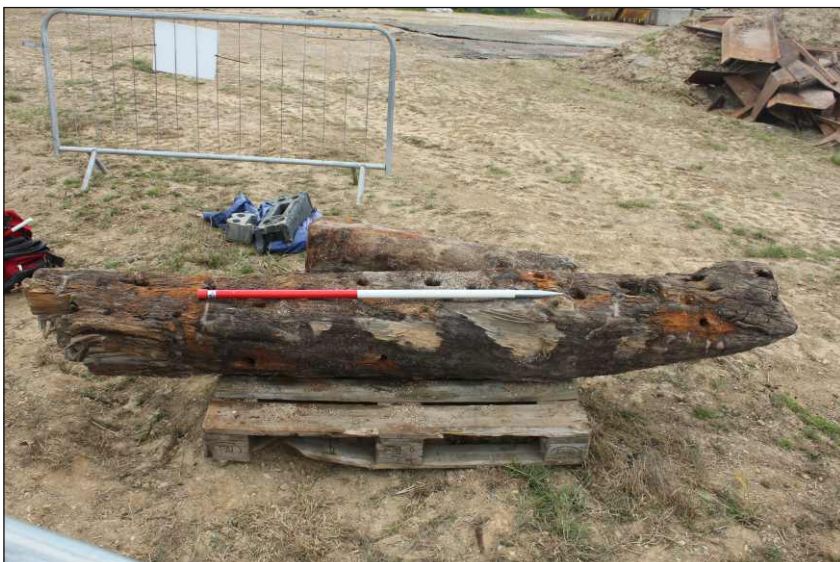
Plate 3: Timber 1 (scale 1m)

4.1 Two timbers (Timbers 1 and 2) were recovered during the groundworks for the flood relief culvert (Plates 3-5). These comprised small sections from futtocks; the curving frame timbers or ribs that form the structure of a ship. The timbers were square-cut, measuring 0.25m across and 2.5m and 1.2m long, respectively. Both had numerous c.40mm perforations representing the position of former rivets for attaching planking. These were largely stained with iron corrosion product (rust), while a small number were stained green with copper corrosion product. This would suggest that the vessel had also been clad with copper.

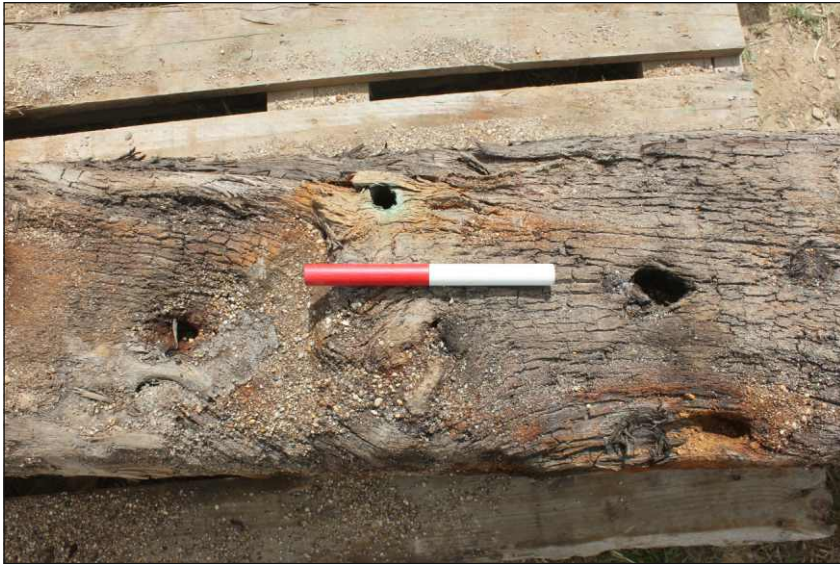
Plate 4: Timber 1, detailed view with copper stained rivet hole (scale 0.2m)

7.2 The two timbers recovered during the groundworks represent fragments of futtocks from a ship. Evidence for copper corrosion, as shown by the staining of the timbers, has suggested that the hull of the vessel from which they were derived may have been clad in copper sheeting; a protective technique used from the 18th century. The results from the dendrochronology provided broadly equivalent late 19th century dates for the

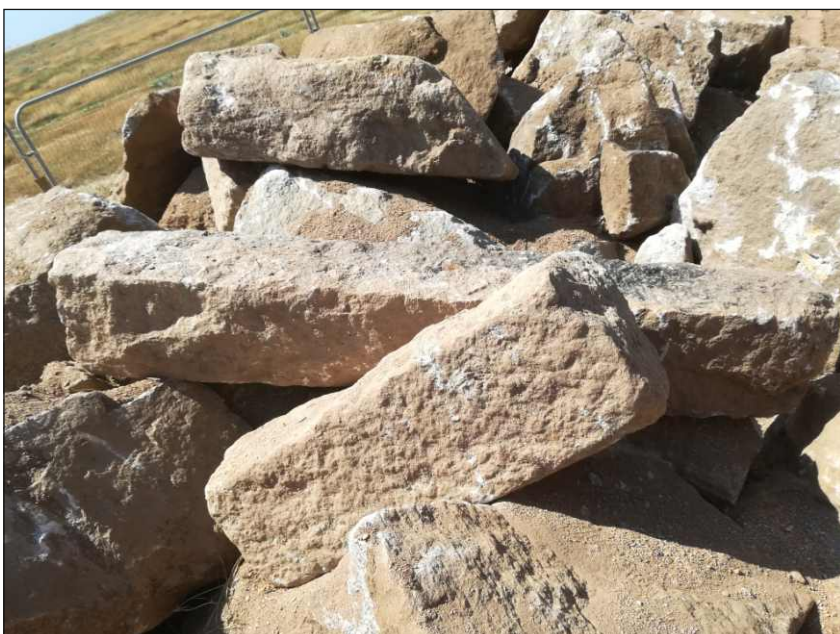
Plate 6: Showing recovered stone pieces from groundworks (image provided by BAM Nutall)

6.1 A quantity of worked stone pieces were recovered during the course of the groundworks. These consisted of a number of granite boulders and a small number of roughly dressed broadly rectangular blocks (Plate 6). No clear drill marks were visible on the dressed blocks. The stone is considered to have been derived from the former channel and sluice arrangement depicted on 19th century and later maps.

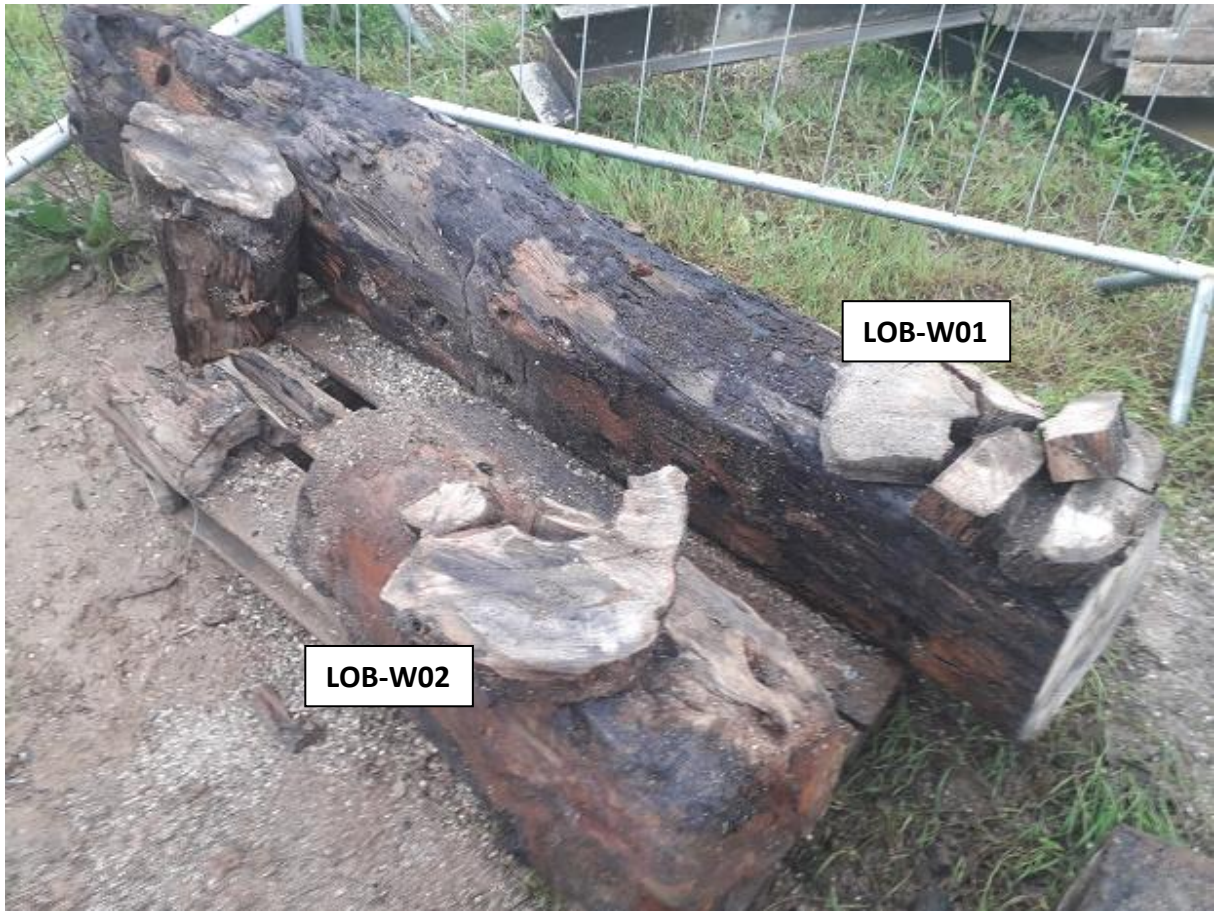
Figure 2: View of the sampled timbers (see Table 1)

Thus, from the 2 timbers available, a series of full cross-sectional slices were taken using a chainsaw. Each sliced sample was given the tree-ring code LOB-W (for 'Loe Bar Wreck'), and numbered 01 and 02 (see Fig 2). Details of the samples are given in Table 1, including the timber sampled, the total number of rings each sample has, and how many of these, if any, are sapwood rings. The individual date span of each dated sample is also given.
