# LAMETTON MILL, ST KEYNE, CORNWALL

Results of historic building recording

Cornwall Council planning reference PA18/05326,  
condition 9

Document No: ACD1936/2/0

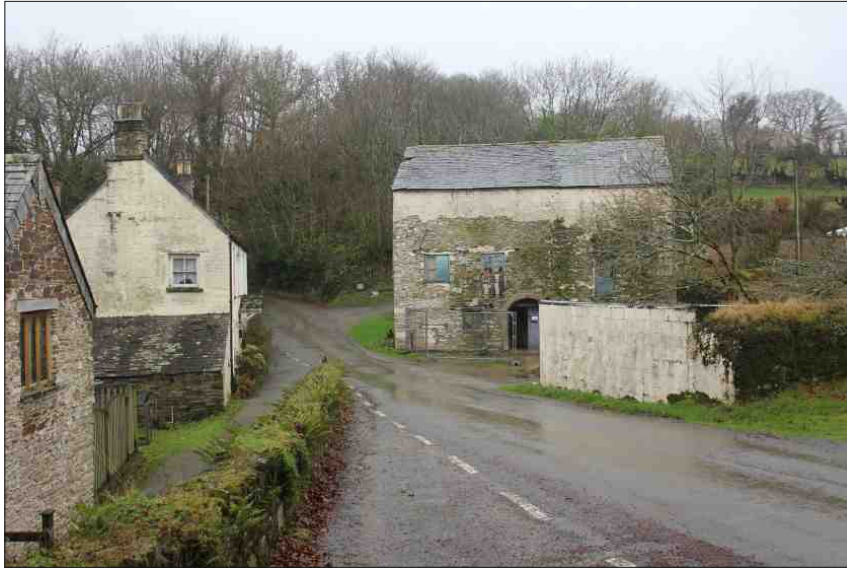
Plate 1: The mill viewed from the canal bridge showing the miller's house to the left, looking west.

The mill is situated to the north of a road that crosses the East Looe River, the former Liskeard & Looe Canal, and the Liskeard to Looe branch line to the east. It is positioned at right angles to the adjacent road facing east, and is terraced into the hillside (Plate 1). It is orientated north-northwest to south-southeast but for the

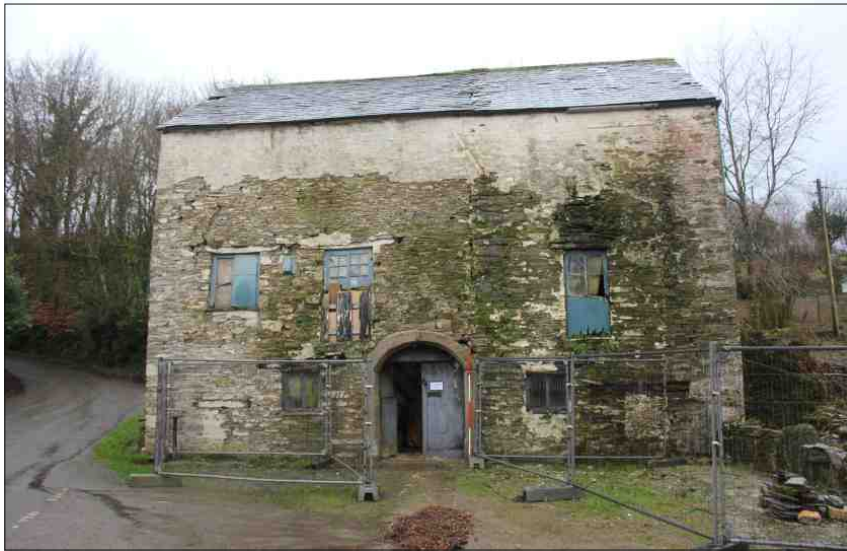
The main facade of the mill is to the east (Plate 2). In this elevation it is clear that the mill has been extended to the north above ground-floor level, with a vertical break visible above the doorway. There are granite quoins to the masonry at ground-floor level, and this section of wall appears to be of one phase across the length of the mill, with the rebuild only occurring above this level. There is a central round arched doorway with granite jambs, fitted with a pair of plank and batten stable-type doors. The surround is thought to have been salvaged from a nearby chapel. On the inside faces initials and dates have been carved into the jambs. These include "H 1683", 'LL 1912', 'J ?', 'NSL 183?', 'NL 1859', and 'HA 173' on the north side (Plate 3). To the south there is the letter 'M', the numbers '10' and '12', and the initials 'AP' (Plate 4); there are further inscriptions, but these are not decipherable. On the ground floor are two window openings with, to the north and south of these, a further two low blocked openings, both with wooden lintels. The windows are fitted with 20th-century two-light wooden-frames. On the first floor are two windows and a door; the central window is set within a former taller loading door. Both windows are two-light casements. All have mid 20th-century wooden frames. Within the northern half of the masonry is a scar of a former roofline, relating to the now demolished late 19th-century or early 20th-century extension; the foundations of its north wall are visible in the yard to the east of the mill. There are no openings on the second floor but at this level there are the ends of two structural tie rods.

Plate 2: The east elevation, looking west (2m scale)

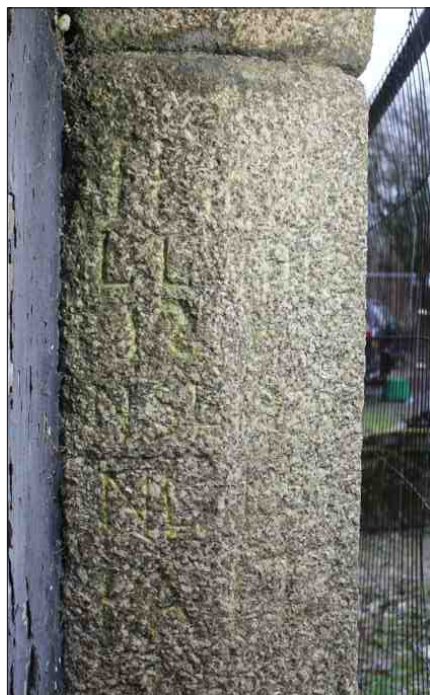
Plate 3: Graffiti on north jamb in east elevation doorway, looking north

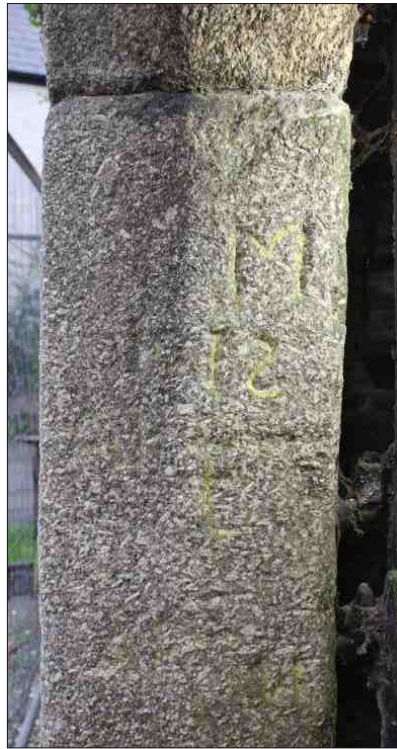
Plate 4: Graffiti on south jamb in east elevation doorway, looking south

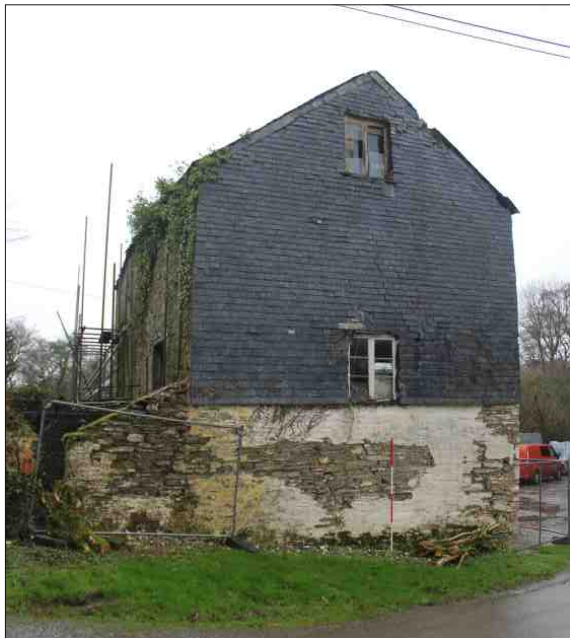
The ground-floor level of the south elevation is exposed masonry with the remnants of cement render; the remainder of the wall above is covered with hung slates. There are central windows with 20th-century wooden framed two-light casements on the first and third floors (Plate 5).

Plate 5: The south elevation, looking northeast (2m scale)

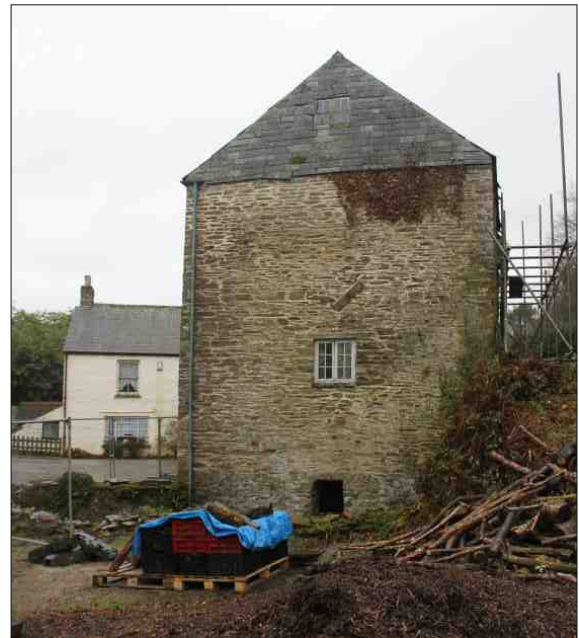
The north elevation has an opening for the wheelshaft of the northern waterwheel on the ground floor. There are also single window openings on the first and third floors (Plate 6); the former is a two light side-opening casement each with six panes, and the latter is a two-light casement each with four panes. There is a brace for the end of a tie rod over the first-floor window. The third floor is covered with hung slates. Although the masonry surrounding the first-floor window has been repointed, it appears to be an insertion into earlier masonry. Other than the difference in quoins there is no clear evidence of phasing in the wall.

Plate 6: The north elevation, looking south

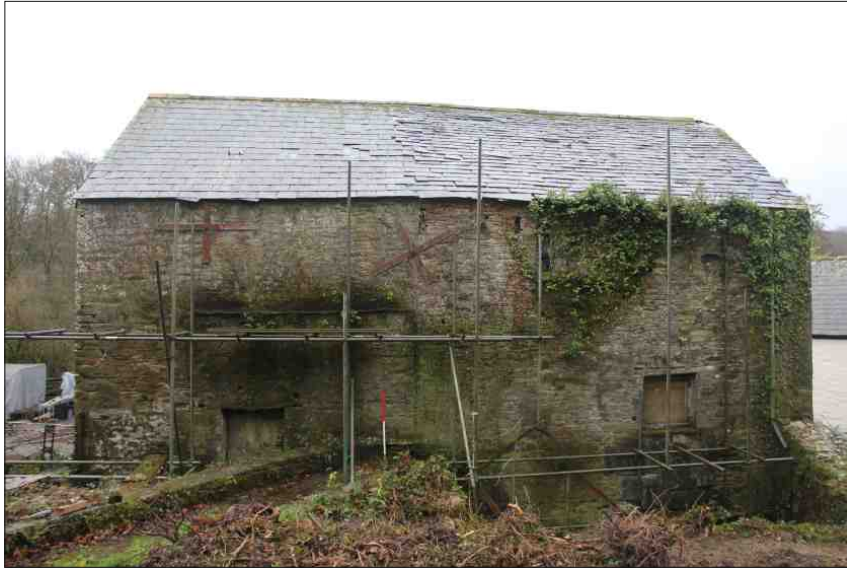
Corresponding with the vertical break in the north elevation, the west elevation also displays a vertical break at first- and second-floor level, with the later masonry to the north at first-floor level masonry projecting forward very slightly and topped with slates (Plate 7). Above, within this later masonry, there is a pair of braces at the end of tie rods. There are single door and (two-light casement) window openings on the first floor. The doorway provided access from the mill into a now removed toilet outhouse.

Plate 7: The west elevation, looking east (1m scale)

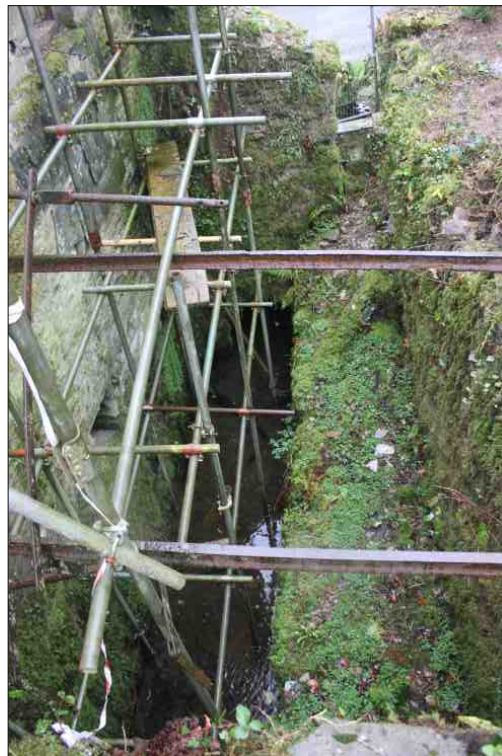
At the south end of the west elevation is the west wheelpit (Plate 8). This measures approximately 6.5m long by 2.3m wide. Below the first-floor window opening are hung slates presumably placed to protect the wall from water splashing off the top of the wheel. Below the window, at ground-floor level, is a hole for the wheelshaft. The bearing for the other end would have been situated on a plinth in the wheelpit; the bearing itself has been removed. To the north of the wheelshaft opening is a vertical break visible only at ground-floor level within the wheelpit.

Plate 8: The west wheelpit, looking south

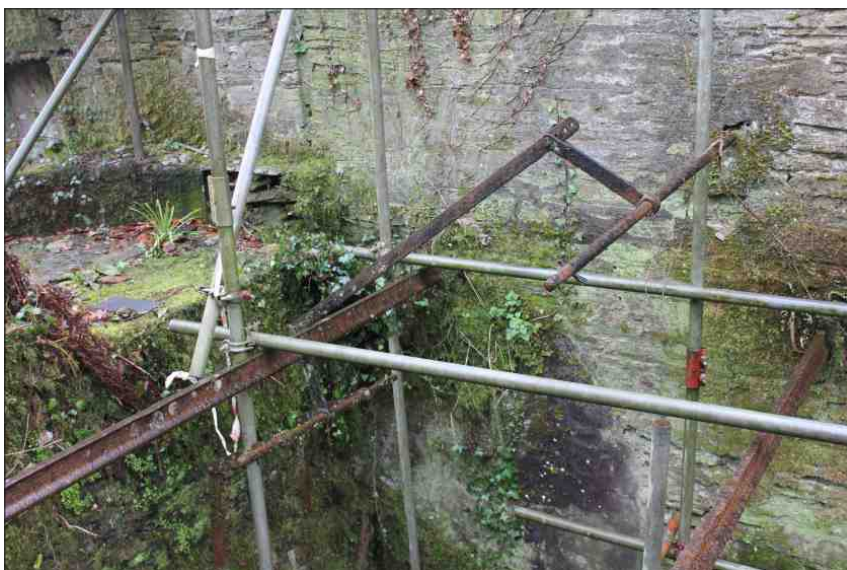
The western wheel was of the overshot type and was fed by a leat at a height above first-floor level. At approximately 8.25m away from the mill the leat splits with one section feeding the western wheel and the other feeding the northern wheel. Both sections are constructed with slate walls and lined with concrete. Two reused railway lines that supported the penstock survive *in situ*, along with an iron arm with fittings that controlled the sluice (Plate 9).

Plate 9: Fittings for the penstock and associated sluice over the west wheelpit, looking northeast

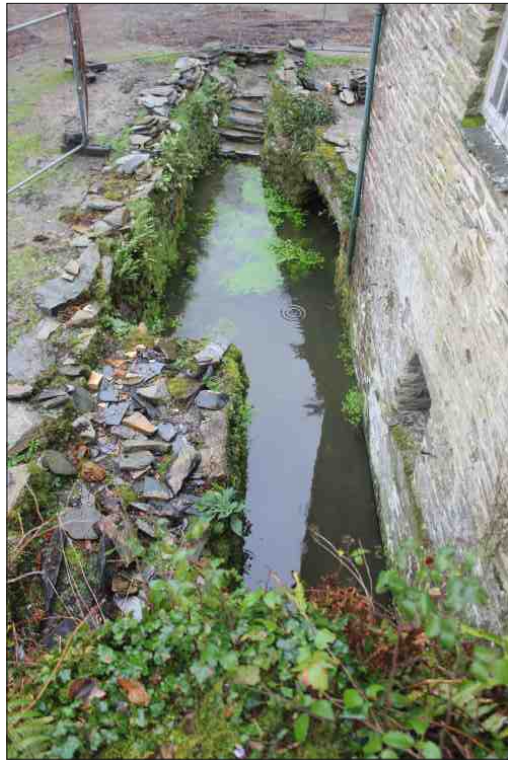
The northern wheelpit measures approximately 11.5m long and 1.25 - 2.5m wide, and contained an overshot waterwheel. As with the western waterwheel, the end of the wheelshaft was supported on a plinth within the wheelpit (Plate 10). The bearing has also been removed, and there is also no surviving evidence for the penstock (cf a photograph in Yates 2018, 32 that shows the wheel in action). Waste water from the wheelpit flows through a tunnel running obliquely under the yard to the east of the mill. Within the northeast side of the wheelpit there is a butter well store (*ibid.*, 38) reached by slate steps forming the east side of the structure. It was not visible during the visit due to high water levels.

Plate 10: The north wheelpit, looking east

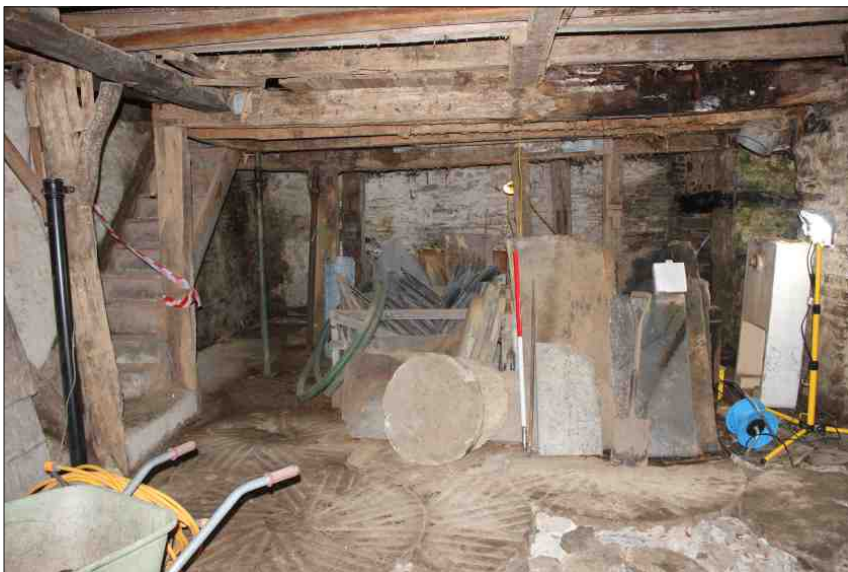
The central part of the floor has been covered with old granite millstones set with their grinding faces up (Plate 11). The rest of the floor is covered with irregularly-laid flagstones and concrete. All three below-ground chambers for the pitwheels have been infilled.

Plate 11: General view of ground floor, with millstones set into the floor in the foreground and north hurst frame to the rear, looking north (1m scale)

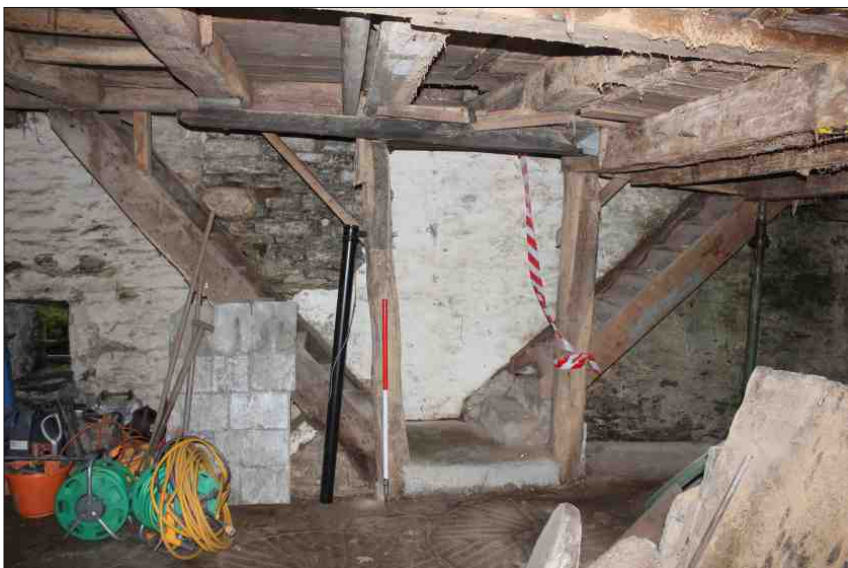
Plate 12: View of staircases on the ground floor with the break in the west wall behind, looking west (1m scale)

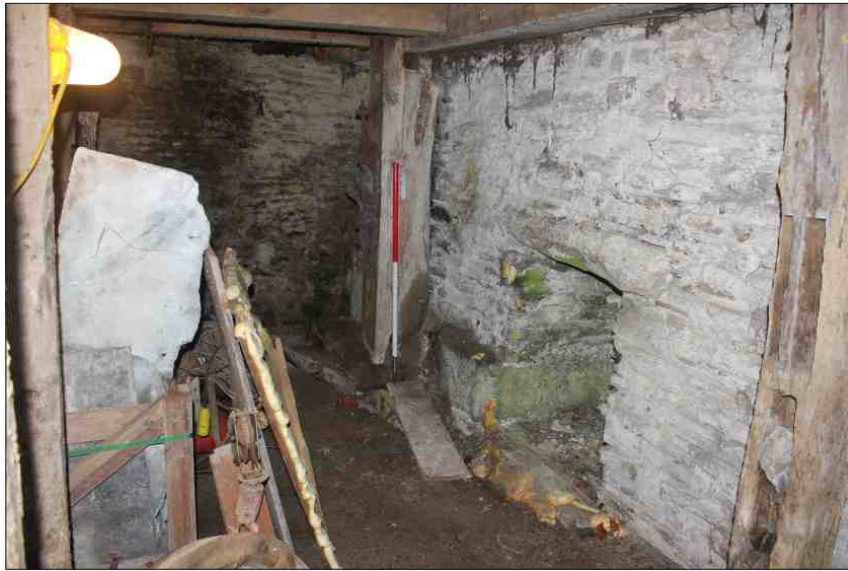
At the northwest end of the room are four vertical posts (along with two additional posts) that form the remains of the hurst frame; the posts have sockets for removed horizontal timbers (Plate 13); these feature a mixture of wooden peg joints and joints with bolts. They are set into and appear to be integral to the first-floor structure. The

northwest post incorporates a bracket and lock for a horizontal beam that would have formed part of the tentering process allowing the gears to have been engaged/disengaged. The southwest post has a hand-operated wheel that may have been associated with this process. Immediately to the west of the hurst frame is a short length of overhead lineshaft supported on two bearings attached to the floor above. It features a single small belt drive allowing power to be transferred to the first floor.

Plate 13: View of wheelshaft hole, hurst frame and fittings at the north end of the ground floor, looking northwest (1m scale)

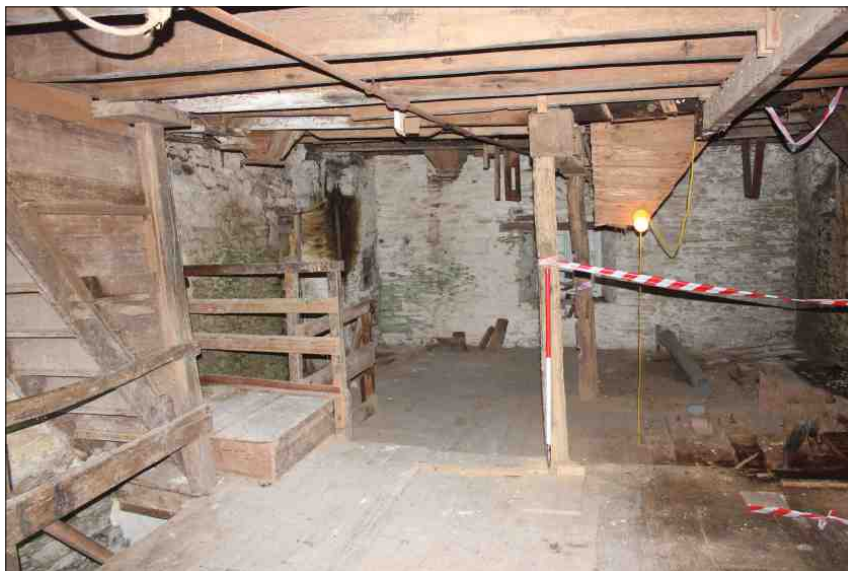
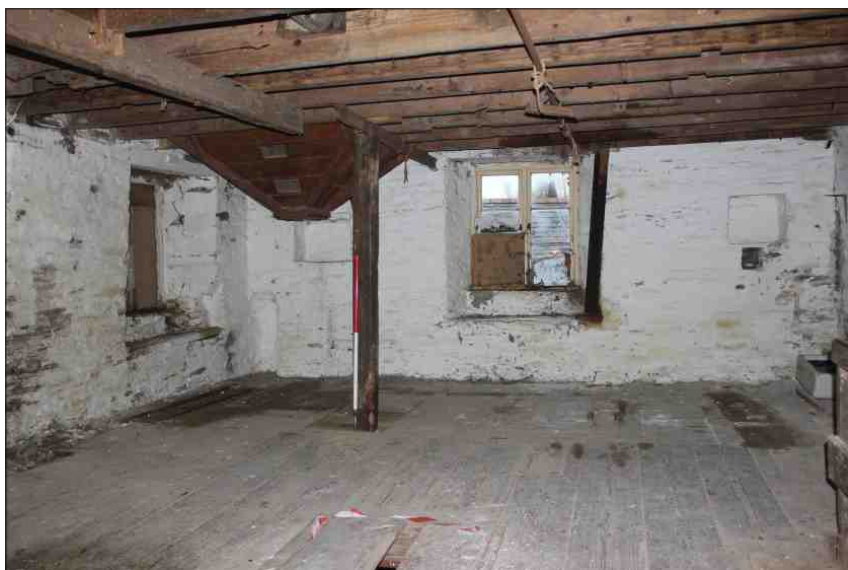
As noted from the floor below, the first floor is on two levels with the section to the south being slightly higher (Plates 14-15). Both sections are covered with floor boards of varying dimensions, with the far southern section (over the ground-floor hurst frame) having been relaid after the millstones were removed. Also set within the floor of the southern section is a central hatch forming one of a series of hatches or sack traps in the building associated with the early (i.e. pre-mid 19th-century) corn milling. Above the hatch, attached to the floor above, is an associated wooden roller. Other features at this end of the building include a pair of recesses in the south wall, and an iron handle for controlling the penstock sluice, with a wooden peg board below (Plate 17).

Plate 14: General view of the first floor, looking north (1m scale)

Plate 15: General view of the first floor, looking south (1m scale)

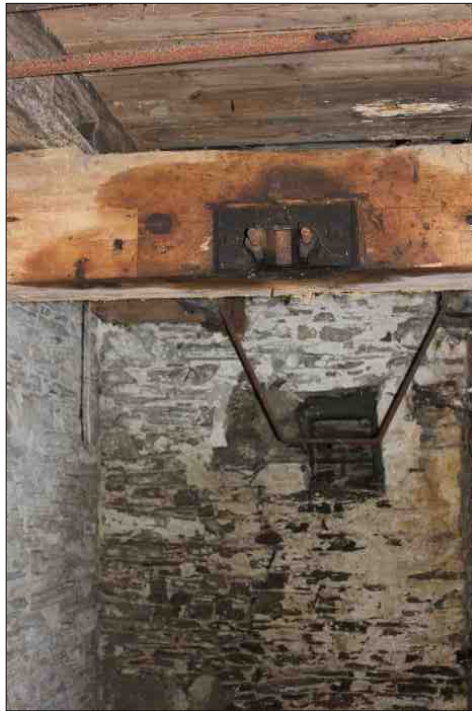
Plate 16: View of end bearing box and other lineshaft brackets at the northeast side of the first floor, looking east

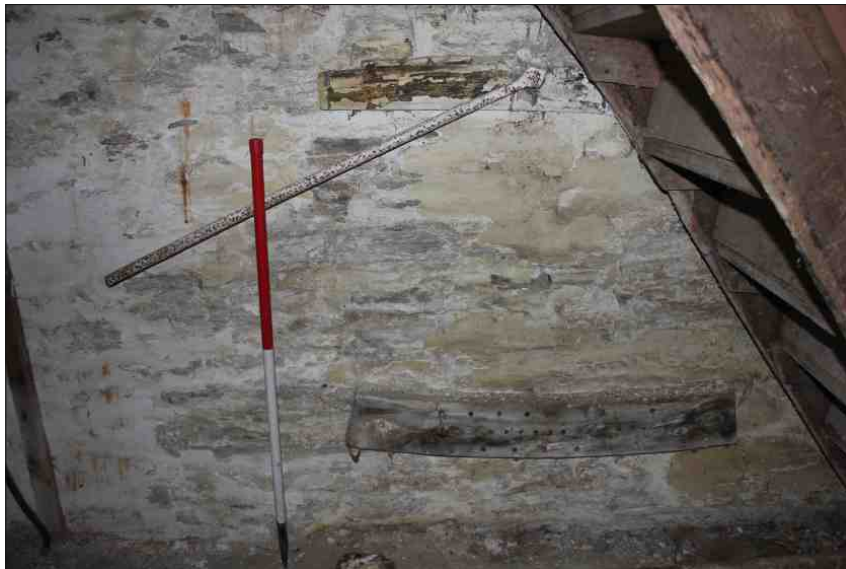
Plate 17: View of penstock control gear and peg board, looking west (1m scale)

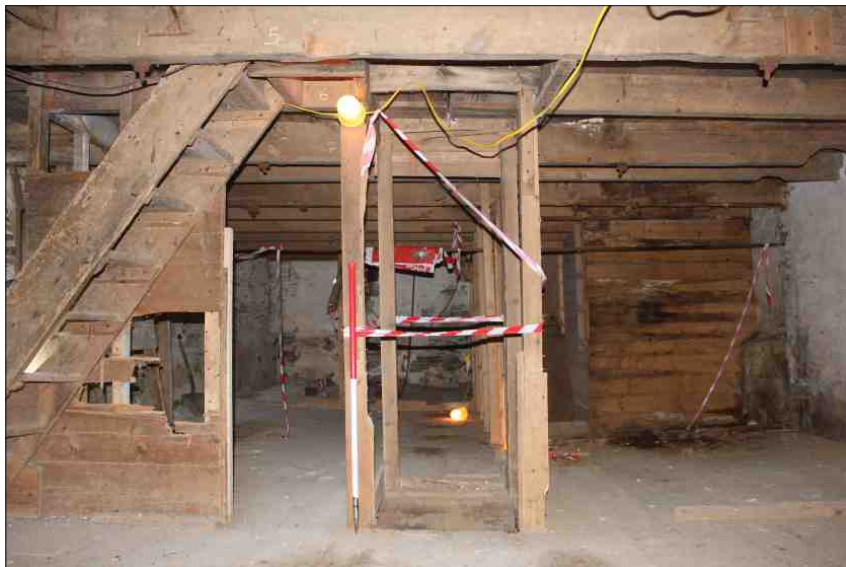
Plate 18: General view of the second floor, looking north (1m scale)

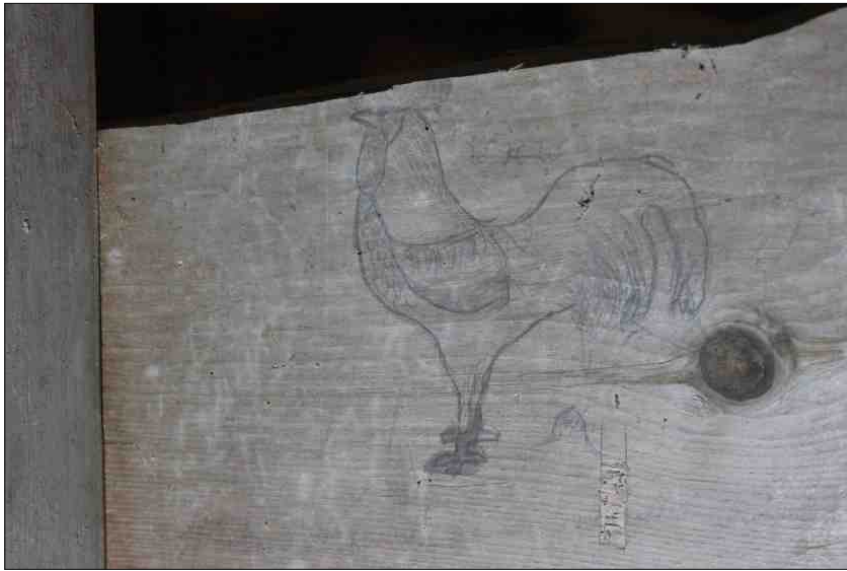
To the south of these grills, adjacent to the west wall, are the stairs from the first floor. These turn a right angle and continue up to the third floor. The inner sides are lined with planked partitions, and onto these are various marks and drawings in pencil, mainly on the west face. There is a drawing of a cockerel and a face and the names Zenie, Deacon and Bailey along with other writing which is not decipherable (Plates 19-20). On the southern side of the stairs is a scorch mark from a candle; this may be accidental or more likely an anthropomorphic mark since these are common in 'agricultural' contexts where grain and animal feed has been stored.

Plate 19: Cockerel graffiti on the stairs leading to the third floor, looking east

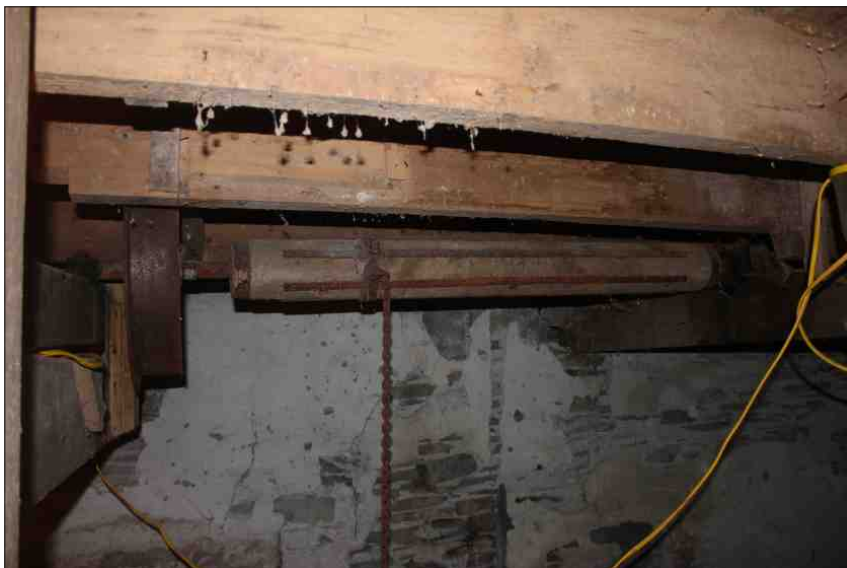
The northern end of the room is currently open to the central section but may formally have been enclosed. Here, attached to a timber frame is a central roller with an attached chain (Plate 21). The lineshaft has a belt wheel, which would have been powered via a belt passing from the floor below through a hole in the floor to the south.

Plate 21: View of wooden roller and belt drive at northern end of second floor, looking north

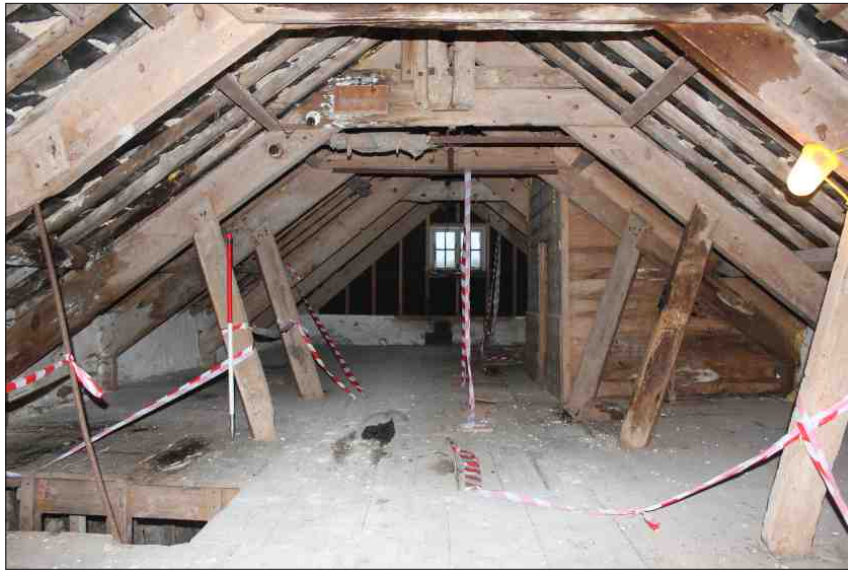
Plate 22: General view of the third floor, looking north (1m scale)

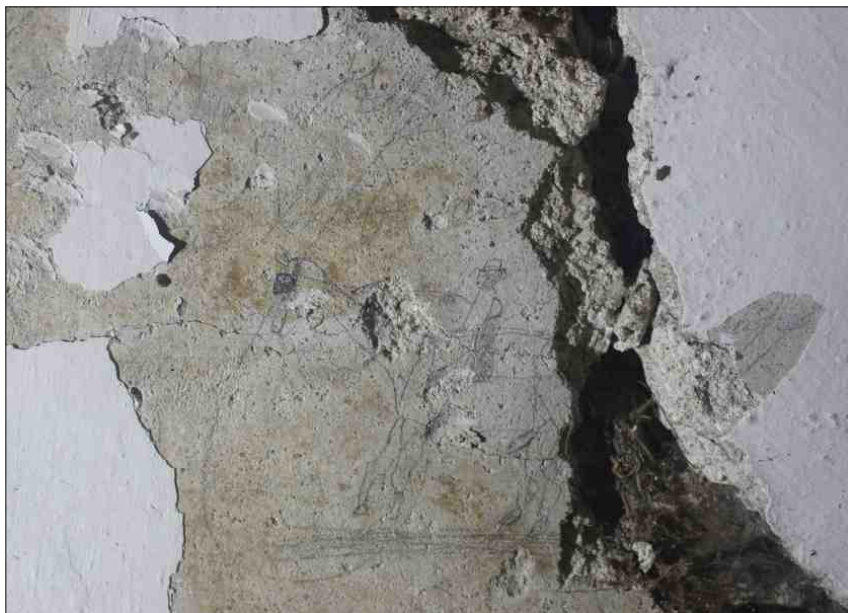
The use of this floor for storage is a late addition to the building, perhaps after the mill was extended to the north in the mid-late 19th-century. The floor joists have been cut away to allow the insertion of stairs up to this floor. There is a mixture of floor boards with those in the central southern end being wider, like those on the second floor, and incorporating a hatch above those on the floors below. There are also numerous other hatches, a couple of which match chutes recorded on the floor below (Plate 22). On the south wall below the limewash finish some graffiti including a horse has been drawn onto the plaster (Plate 23).

Plate 23: Horse and rider graffiti on south wall of the third floor, looking south

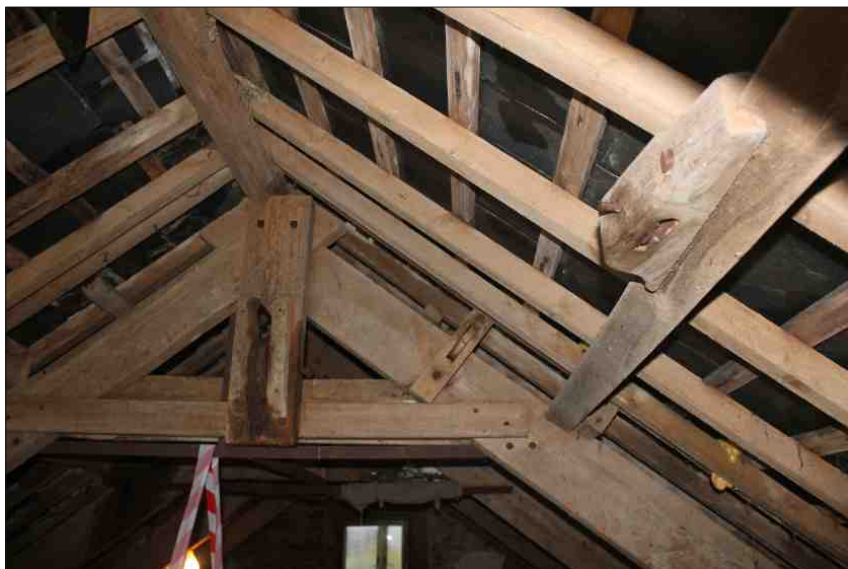
Associated with the principal near central hatch in the floor is a pulley attached to a batten below the ridge purlin. There are three further associated pulleys and a roller attached to truss collars to the north (Plate 24). On the northwest side of the roof there are two further pulleys perhaps associated with one of the western hatches in the floor below.

Plate 24: Pulleys for sack hoists on the third floor, looking south
