# MOUNT WISE AREA D (PHASE B), DEVONPORT, PLYMOUTH

Results of an archaeological watching brief

Plymouth City Council planning reference 17/00134/FUL,  
condition 4

Document No: ACD1965/2/0

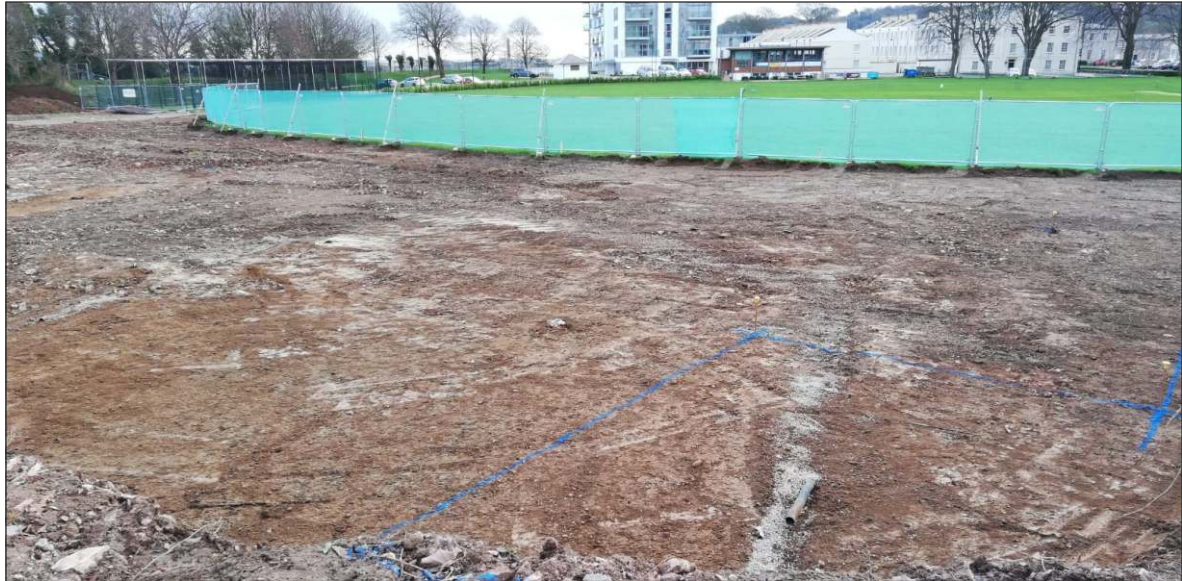
- 4.2** Following removal of modern deposits an area measuring up to 21m long by 20m wide was bulk reduced within the footprint of the new apartment block (Plate 1). This was undertaken to remove a 'soft spot' consisting of natural clay overlying solid bedrock and the infilled Dock Lines ditch. Due to the deep excavations recording was limited, but detailed observations of the Dock Lines ditch were made.
- 4.3** The full profile of the upper section of the ditch (F100) was recorded in the north section of the excavation (Plate 2) where it had been dug through the natural yellow clay (108) and a buried firm dark-brown silty clay subsoil (111). The top of the ditch

Plate 1: The footprint of the apartment block after initial removal of modern deposits, looking southwest. The ditch of the Dock Lines is the dark strip to the left of natural orange-red clay. The Dock Lines have previously been recorded under the apartment block in the centre of the photograph

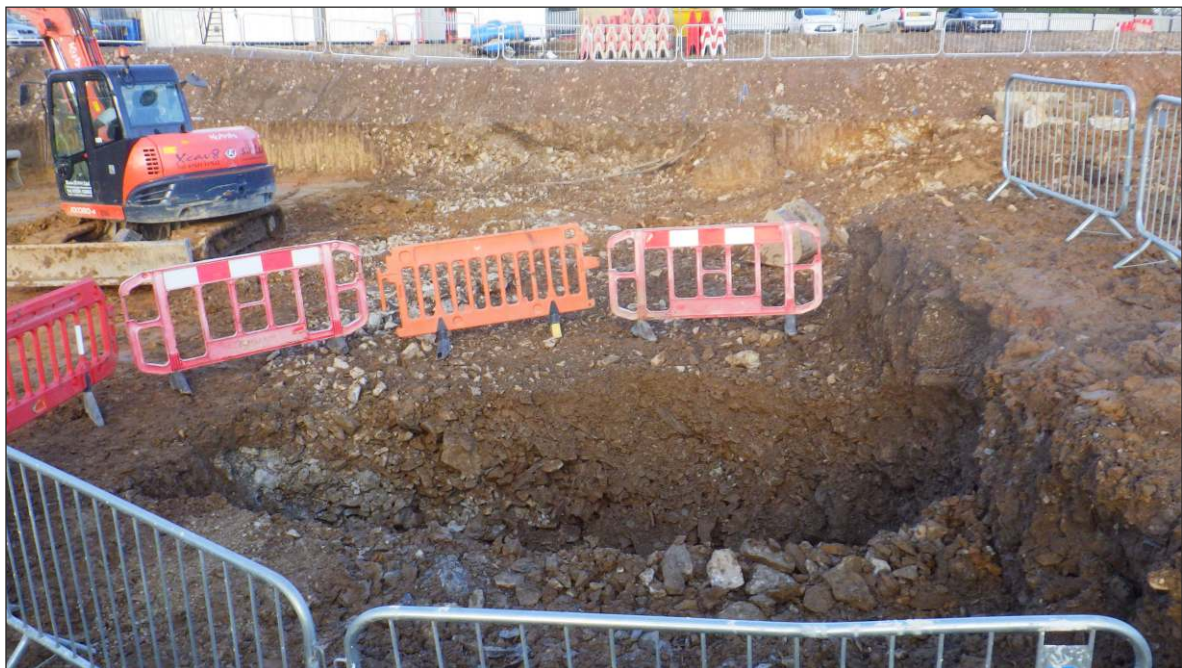
Plate 2: View following the initial bulk reduction showing the location of the test pit, looking northwest. The upper fills of the Dock Lines ditch can be seen in the section of the excavation beyond the test pit

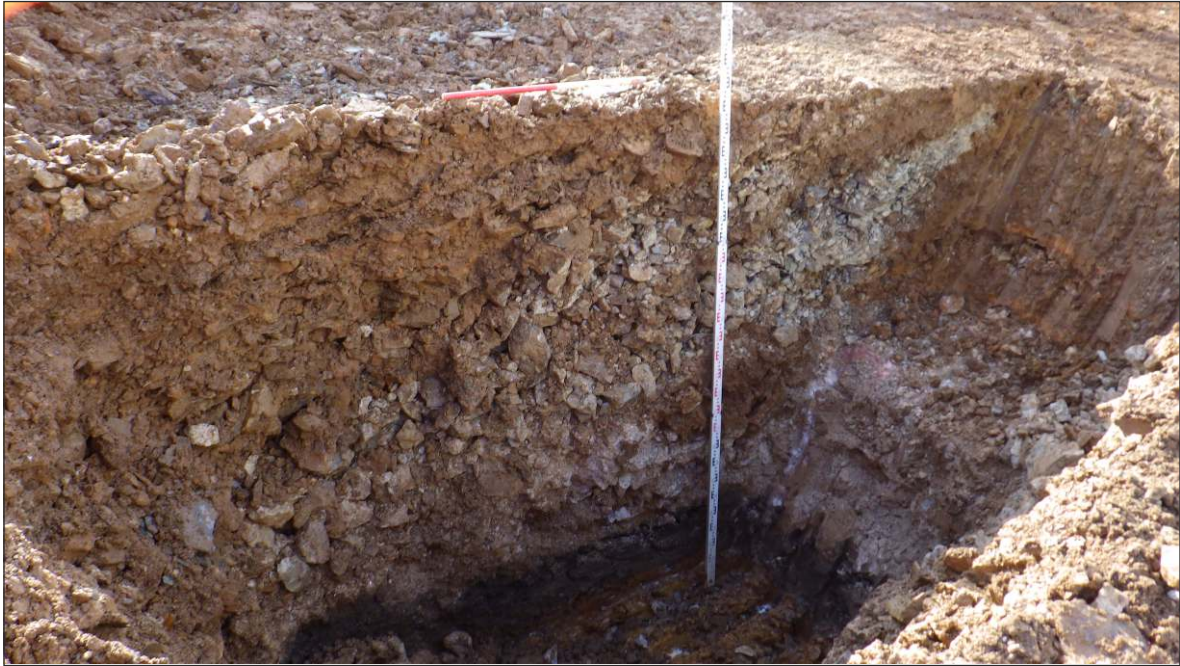
- 4.4** The lower deposits were partially exposed in a test pit below the level of the initial ground reduction (Plate 3). Here upper fills 105, 106 and 107 equated to contexts 110, 117 and 112, respectively. Fill 105 overlaid a compact deposit of rubble limestone and mortar (103). This abutted the remains of a mortar-bonded limestone wall S104 forming a revetment to the west side of the ditch (Plate 4). The wall had been partially historically dismantled, and on average it measured 0.90m wide with a maximum surviving height of 1.20m, and with a vertical or near vertical outer face. The wall was constructed onto a compact dark-grey silty clay (102) that probably represents a primary construction deposit, perhaps a clay 'puddling' lining.

Plate 3: The test pit showing the western half of the Dock Lines ditch, looking southwest. The scarp wall S104 is visible to the right of the survey scale. (1m scale and survey scale in 1m coloured sections)

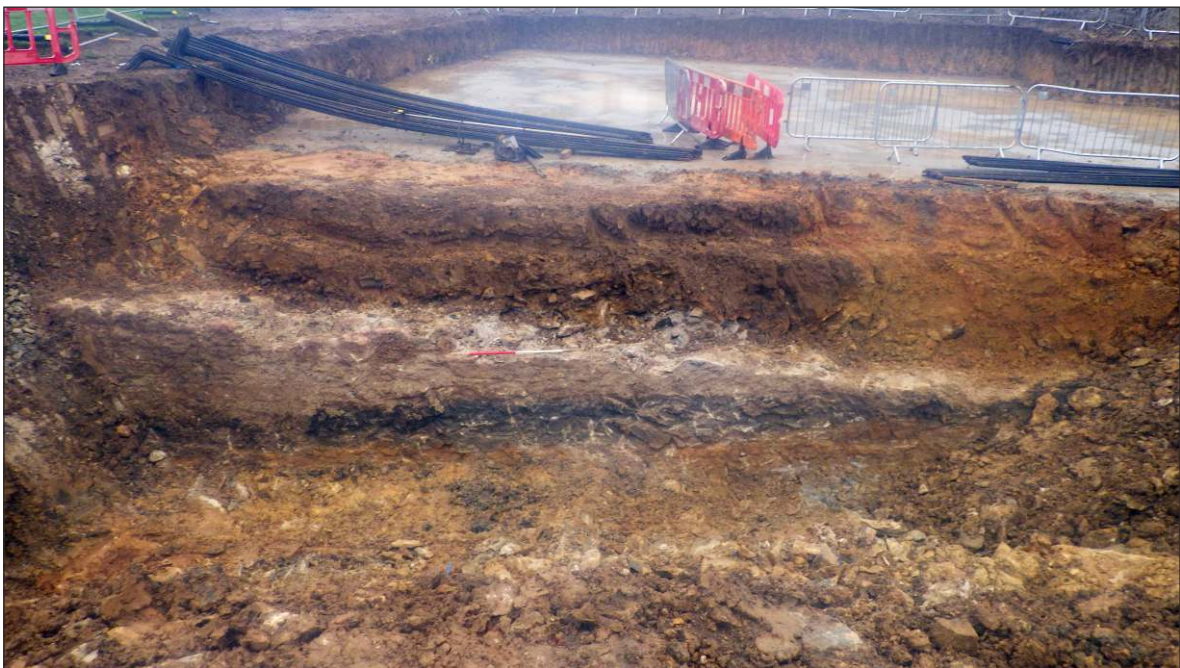
- 5.3** Research into the Dock Lines to the north of Devonport Hill (e.g. Pye and Sage 1995) has identified that the initial mid 18th-century defences were relatively slight, and were strengthened in the 1850s with the enlargement of the ditch, which was provided with masonry scarp and counterscarp walls, and with new ramparts and a higher counterscarp bank. Similar upgrading took place to the south of Devonport Hill, which is recorded on the military version of the Ordnance Survey 25-inch First Edition map (Fig. 2). It is almost certainly this 1854 phase of the Dock Lines that have been recorded within Area D. The vertical scarp wall has parallels with the documented and excavated walls of this period (*ibid.*, fig 12).

Plate 4: Scarp wall S104, looking northwest. (1m scale)

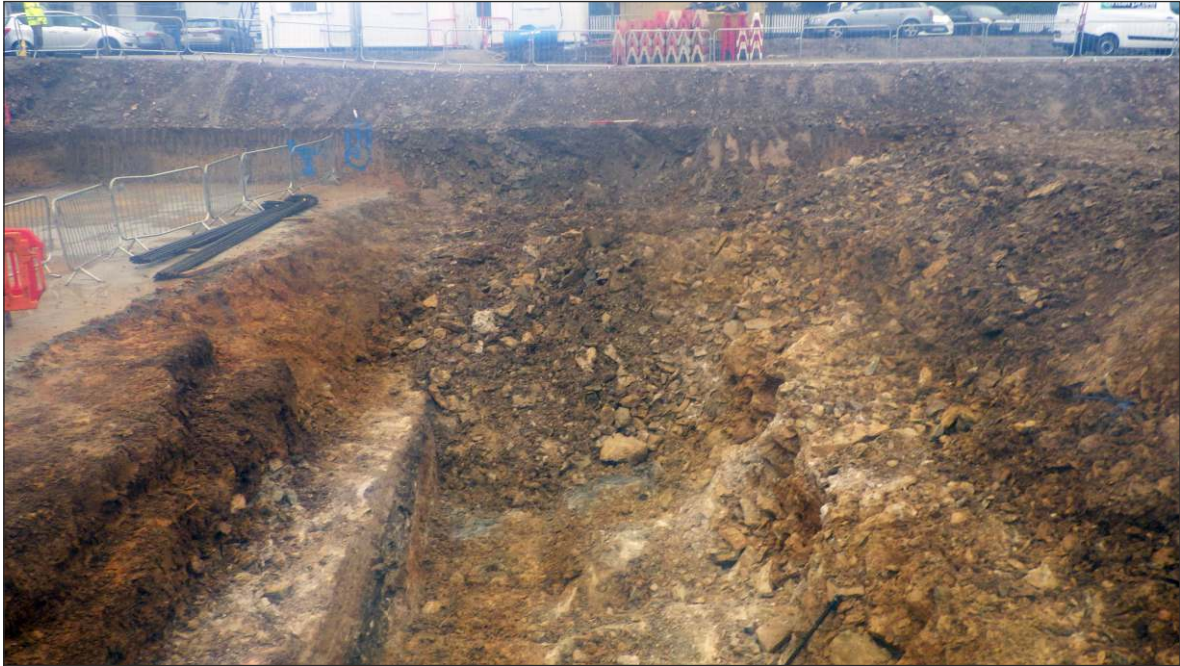
- 4.5** Subsequent removal of the ditch fills (Plates 5 and 6) confirmed that the recorded sequence of deposits infilling the ditch was consistent across the footprint of the new building. Scarp wall S104 was present across most of the width of the excavation, although it had been fully removed in two places.

Plate 5: The Dock Lines ditch (part backfilled) during bulk reduction, looking northeast. (1m scale)

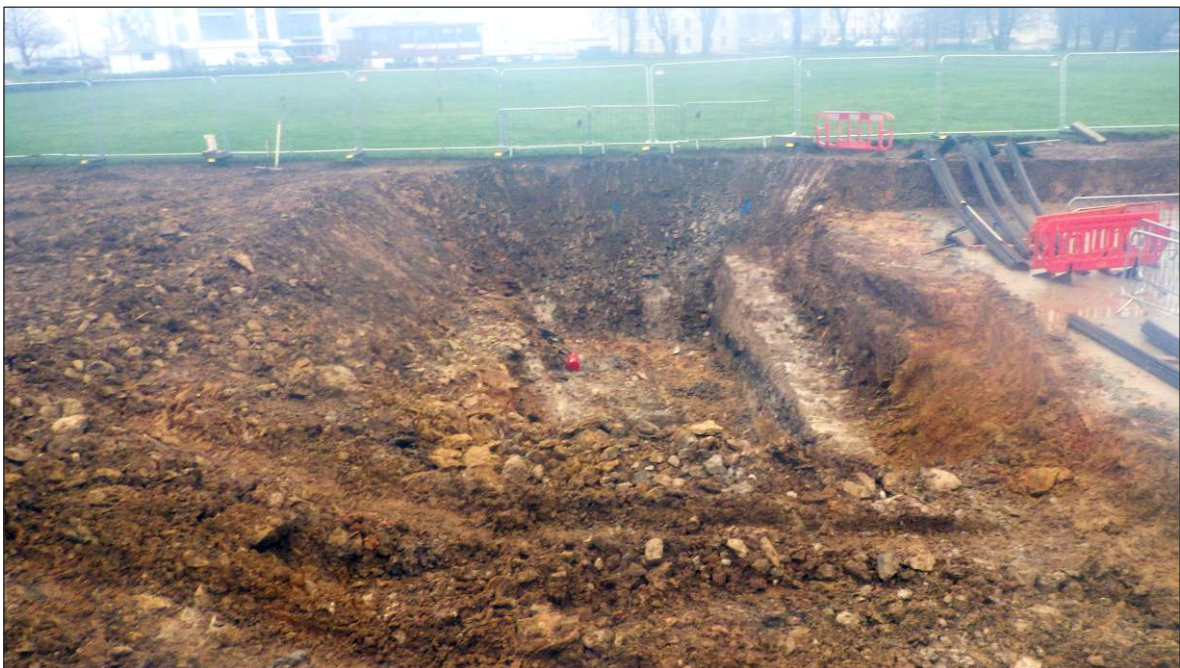
Plate 6: The Dock Lines ditch (part backfilled) during bulk reduction, looking southwest
