# HAY PARK, CANAL HILL, TIVERTON, DEVON

Results of an historic building appraisal and  
archaeological trench evaluation

Mid Devon District Council planning reference  
18/02038/FULL

Document No: ACD2007/2/0

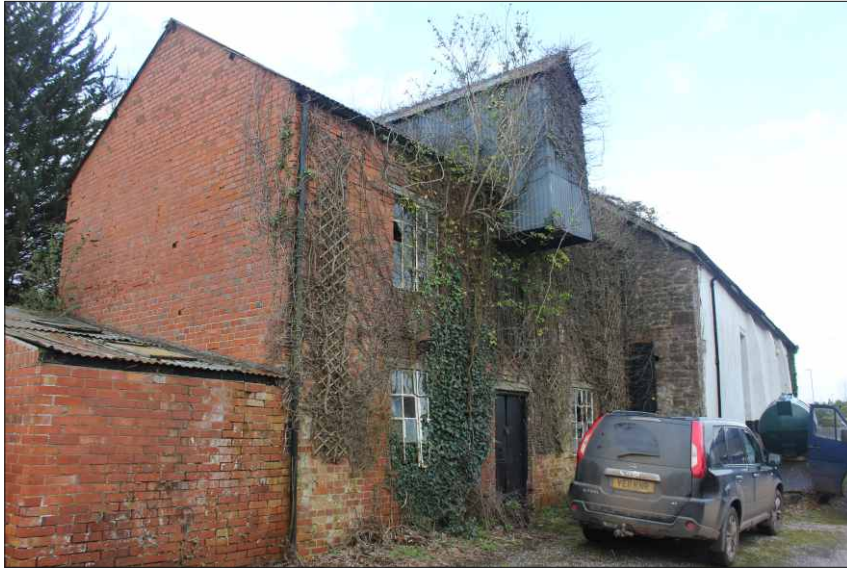
Plate 1: Unit 1, the north elevation, with Units 2-3 beyond, looking southwest

- 4.1 The building is an animal feed mill that was built between 1903 and 1933 adjacent to the earlier threshing barn (Units 2 and 3). Its construction blocked openings in the east elevation of the barn. It is a three-storey building (including loft accommodation) under a pitched corrugated iron sheet roof, and is constructed of red brick laid in English bond (Plates 1 and 2). There is a contemporary L-shaped range of single-storey stores attached to its east side, which can be entered externally, and internally via two doorways.

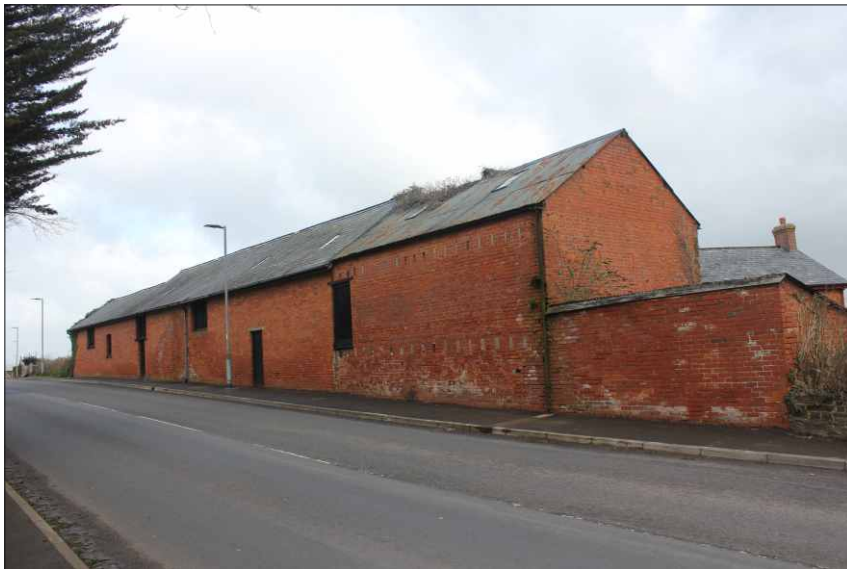
Plate 2: Unit 1 (foreground), with Units 2-4 beyond, looking northwest from Canal Hill

- 4.2 The principal façade is to the south, onto the yard, which contains central loading doors at ground- and first-floor level both flanked by crill windows to either side (Plate 1). All openings have concrete lintels. There is a lucam for a sack hoist at second-floor level. The only opening on the south elevation is a first-floor loading door, set high above the current road level (Plate 2).

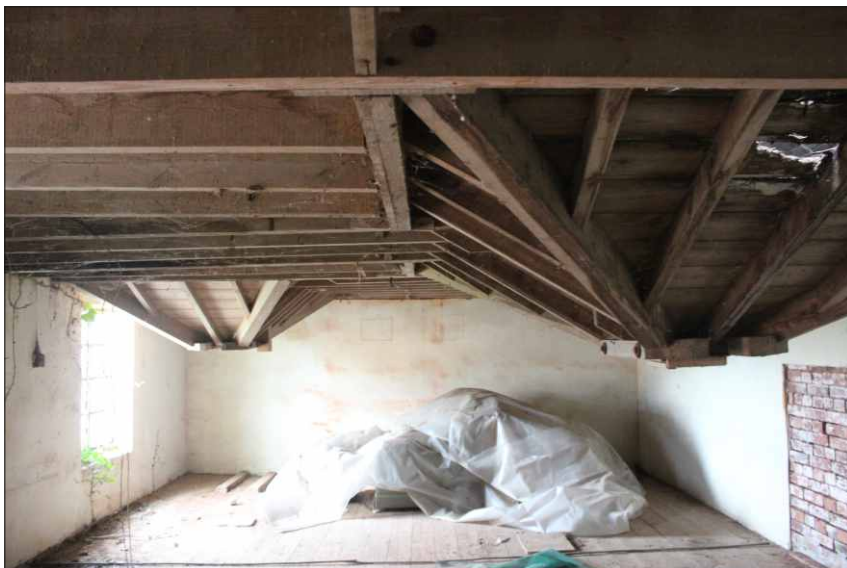
Plate 3: Unit 1, the hoppers extending down from the second floor to the first floor, looking southeast

- 4.3 Internally, the upper floors are accessed by wooden ladders, and are generally in a poor and unsafe condition. The second-floor incorporates two large wooden hoppers down to the first floor (Plate 3). These are the only surviving architectural fittings associated with the use as a feed mill. The roof covering is supported on a primitive ad hoc arrangements of timbers, including half trusses with purlins, and purlins supported on vertical posts instead of trusses.

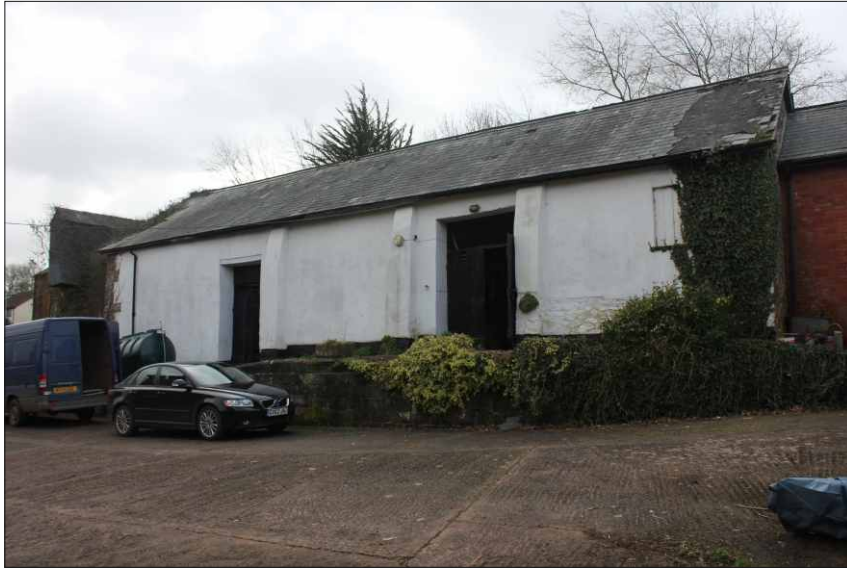
Plate 4: Units 2-3, the north elevation, looking southeast

- 4.4 This building is a former threshing barn that can be identified on the 1842 Tidcombe tithe map. It was originally single storeyed, but now has a 20th-century first floor, and is under a pitched slate roof. The north, east and west elevations are constructed of rendered stonework. The north elevation contains a pair of loading doors leading out onto a terrace above the yard (Plate 4). These incorporate the remains of shallow porches, typical of these buildings. The doors and fittings are early 20th-century replacements. On this elevation there is also a high-level smaller opening at the west end. There are three openings at various heights in the east elevation. These have arched brick heads, and are probably late 19th- or early 20th-century additions.

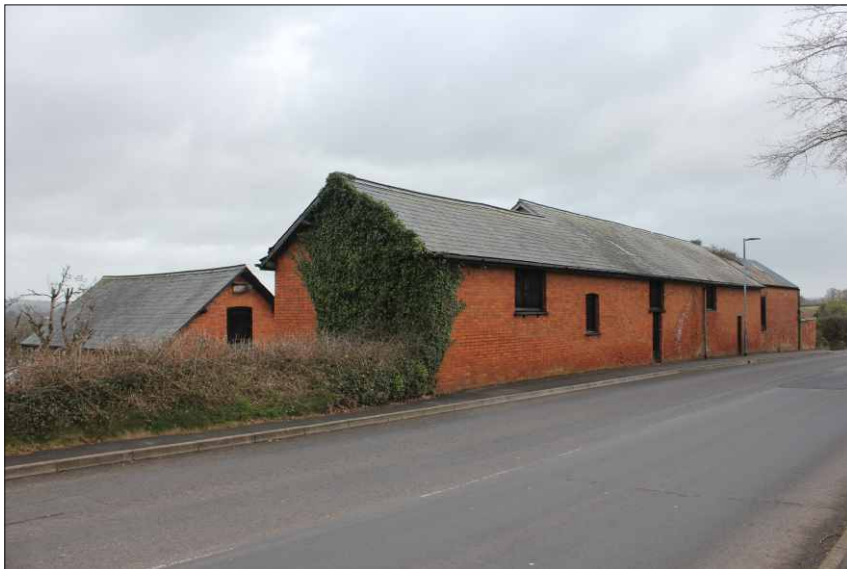
Plate 5: Unit 4 (foreground), with Units 1-3 beyond, looking northeast from Canal Hill

- 4.7** This is a two-roomed structure representing a rebuilding, between 1888 and 1903, of earlier structures attached to the earlier threshing barn. It is constructed of red brick laid in Flemish bond under a pitched slate roof (Plate 5), although the north elevation of the western room is finished with weatherboarding to either side of a central post (Plate 7). Although not depicted as such on the Ordnance Survey maps, as with Unit 5 (see below), this room may have originally been open fronted.

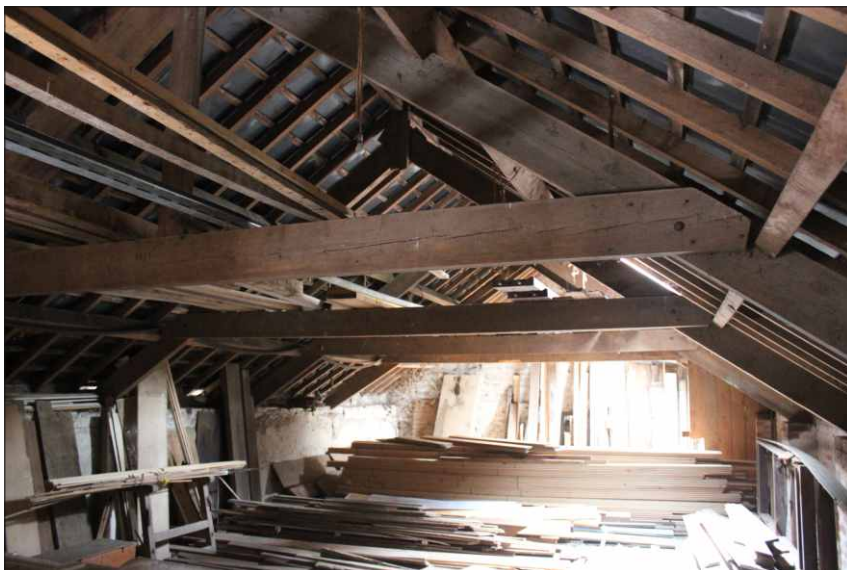
Plate 6: Unit 3, the first floor showing the roof structure supported on the south elevation, looking southeast

- 4.6** Internally, the building has a concrete surface on the ground floor and a wooden first-floor that was probably added when the south elevation was rebuilt. The roof structure was probably replaced when the south elevation was rebuilt, as the feet of the trusses rest on brick piers integral to that wall (Plate 6). The trusses are A-frames with bolted and nailed applied collars, with trenched purlins.

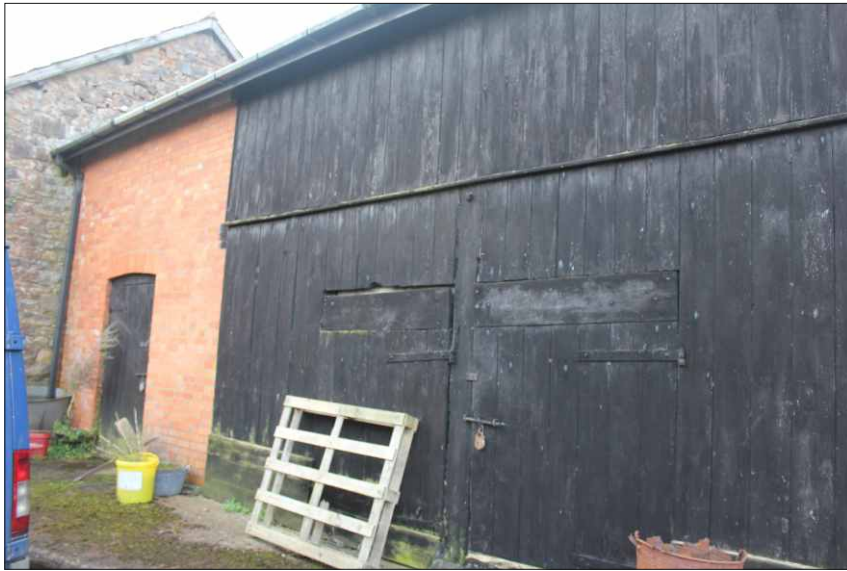
Plate 7: Unit 4, the north elevation, looking south

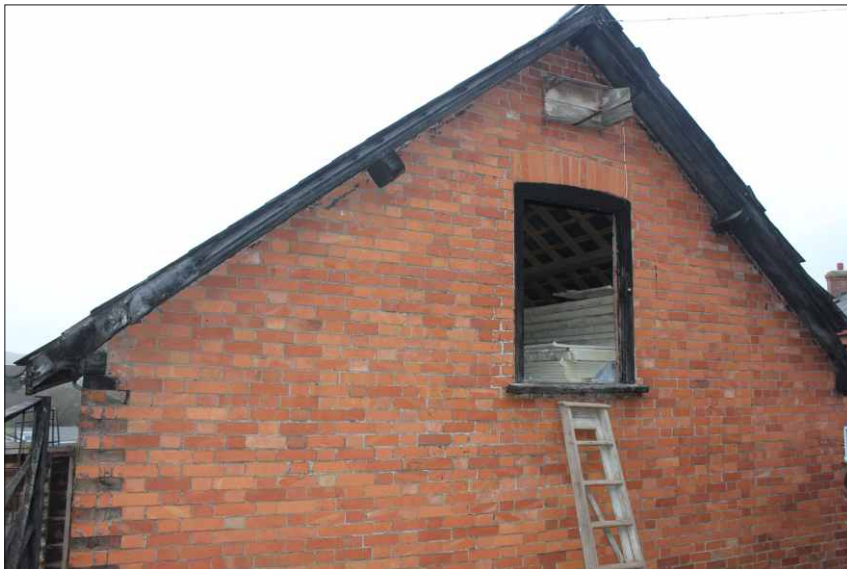
Plate 8: Unit 5, the south elevation showing the first-floor access and scar of former boundary wall, looking north

- 4.9** This building is single storeyed but with loft storage accessed via an opening in the south elevation (Plate 8). The building is constructed of red bricks laid in Flemish bond. It is open-fronted to the east, onto the yard (Plate 9). There were originally three bays divided by wooden posts, but the east bay has been enclosed with panelling and doors to form a garage. Both sections have concrete floors. The first-floor structure is integral to the design with bridging beams set into the front posts. The roof structure comprises A-frame trusses with lapped apexes to the rafters supporting the ridge purlin. The side purlins rest on the back of the trusses.

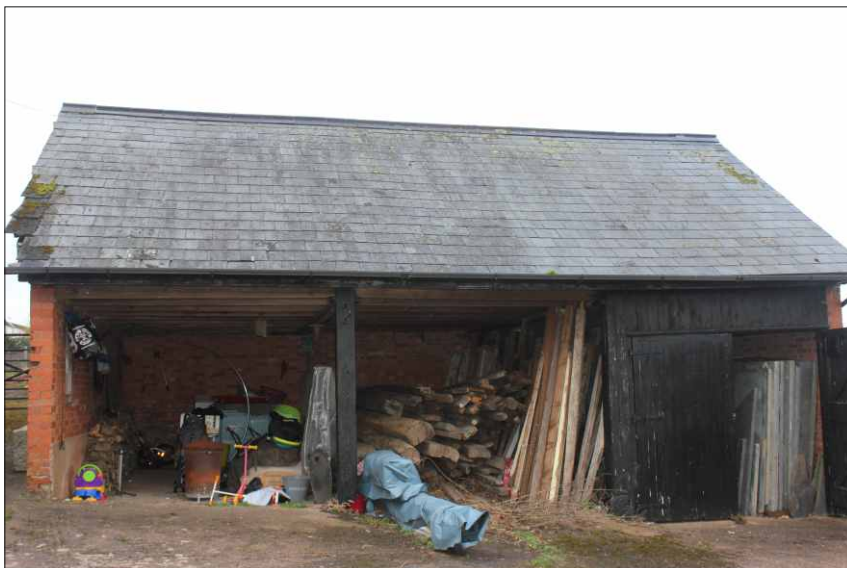
Plate 9: Unit 5, the east elevation, looking northwest

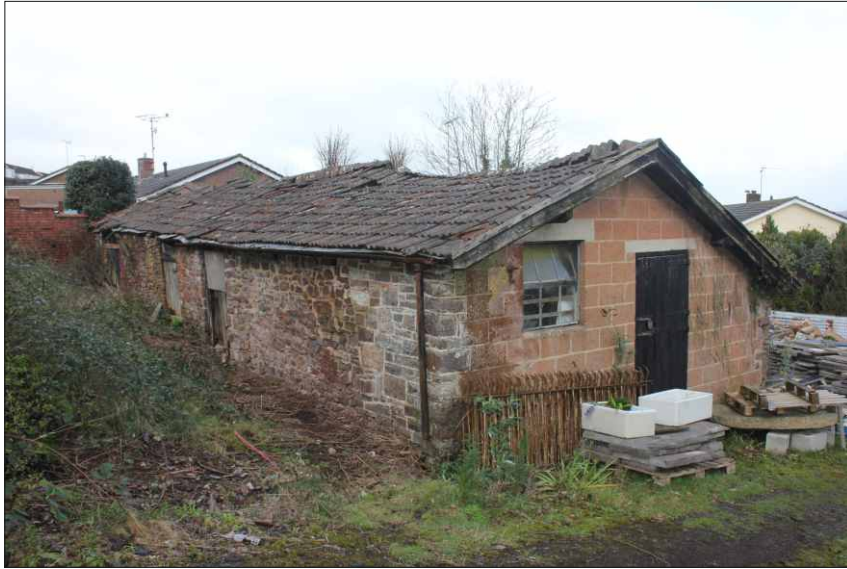
Plate 10: Unit 5, the south elevation and fully rebuilt east elevation, looking northwest

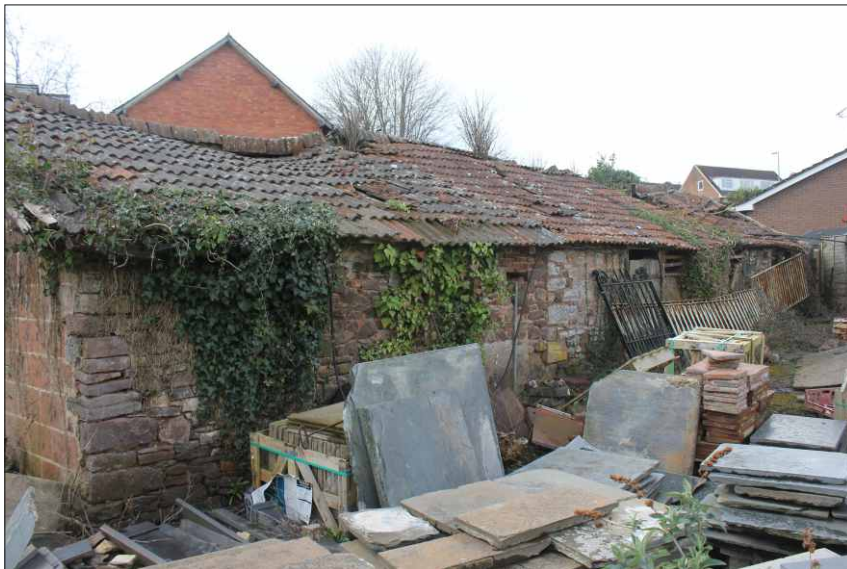
Plate 11: Unit 5, the north elevation, looking southwest

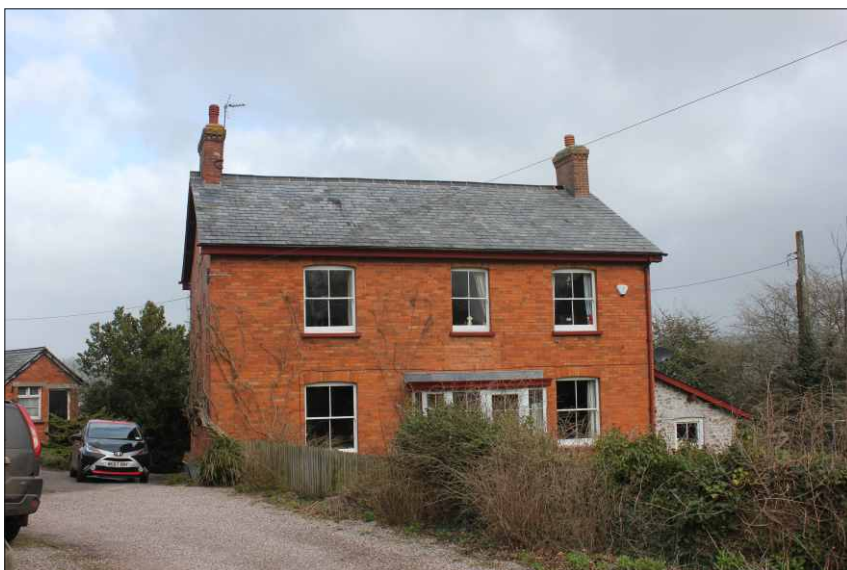
Plate 12: The front southeast elevation of the farmhouse, looking northwest

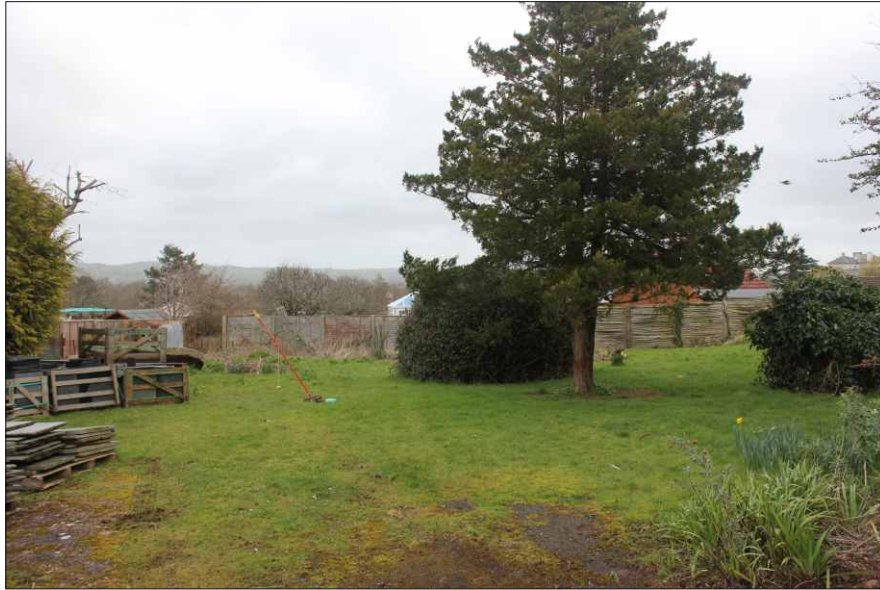
Plate 13: The location of Unit 7 (behind the tree), looking northeast

**5.1** A total of two trenches was excavated within the footprint of Unit 7; trench locations targeted the position of the building depicted at this location on the tithe map, and were placed to avoid local obstacles such as trees (Plate 13).

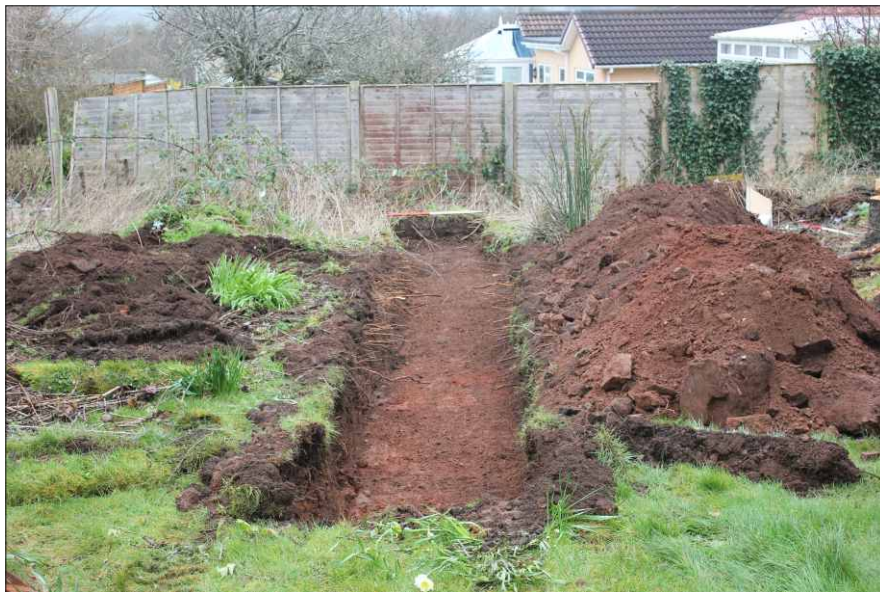
Plate 14: Trench 1, looking northeast. 1m scale

**5.2** This trench measured 10m long by 1m wide, and was aligned northeast-southwest across the width of Unit 7 (Plates 14 and 15). No archaeological features or deposits were exposed, and the trench contained the following deposit sequence:

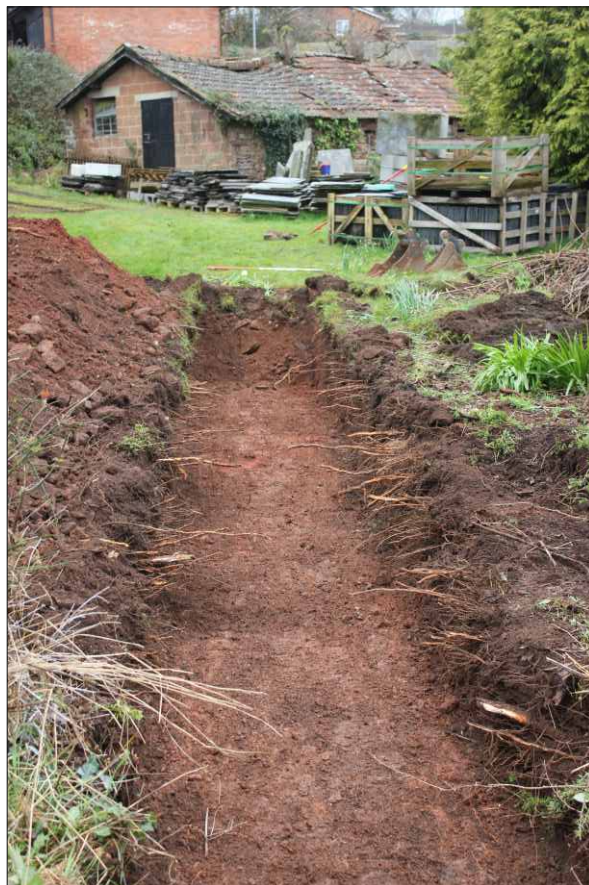
Plate 15: Trench 1, looking southwest. 1m scale

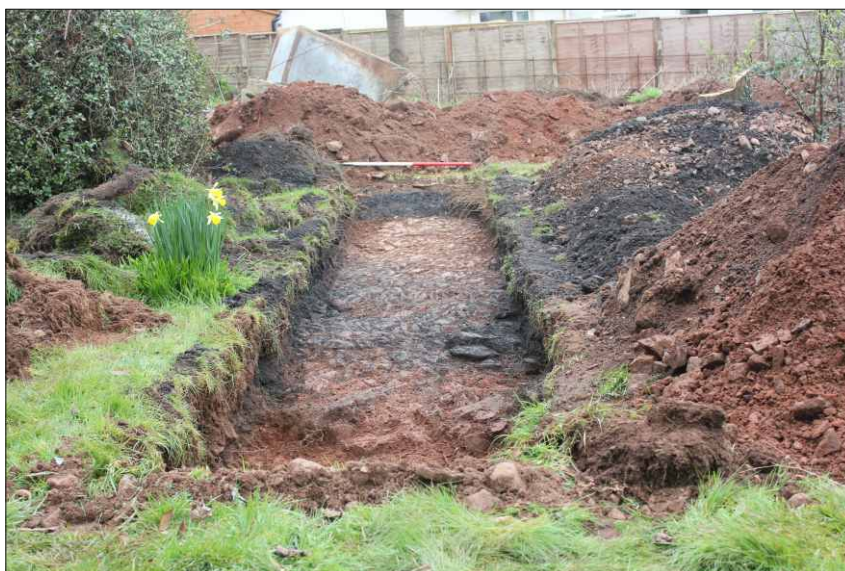
Plate 16: Trench 2, looking northwest towards trench 1. 1m scale

**5.3** This trench measured 7m long by 1m wide, and was aligned northeast-southwest along the southeast side of Unit 7 (Plate 16).

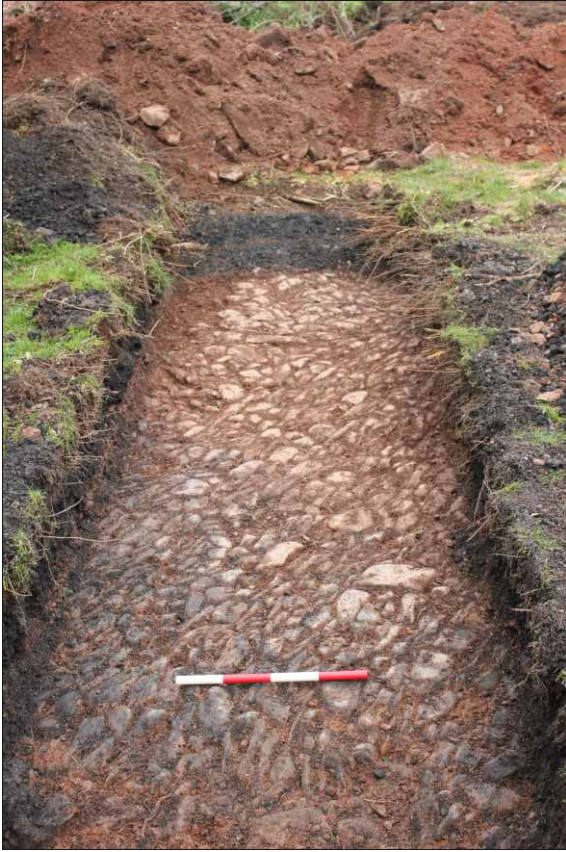
Plate 17: Trench 2, cobbles 202 looking northwest.  
0.40m scale

**5.5** Across the majority of the trench modern tarmac surface 201 overlaid a cobbled surface (202), which was not excavated. The cobbles were generally laid on edge in a north-south direction, although the cobbles at the northwest corner were laid less regularly (Plates 17 and 18). At the southeast end of the surface there were areas of disturbance where a bedding layer of very soft reddish-brown sandy clay (204) was exposed. This contained pottery of 18th- to 19th-century date. The cobbles abutted the foundations of a northeast-southwest aligned wall (S203), which was constructed of blocks of a local sandstone or siltstone bonded in reddish-brown clay with rare lime fragments, and measured on average 0.75m wide (Plates 18 and 19). On its southeast side the wall was set into a foundation trench F209 (cut into the natural (207), description as 102) that had been backfilled with a mid grey silty clay with rare small charcoal and slate inclusions.

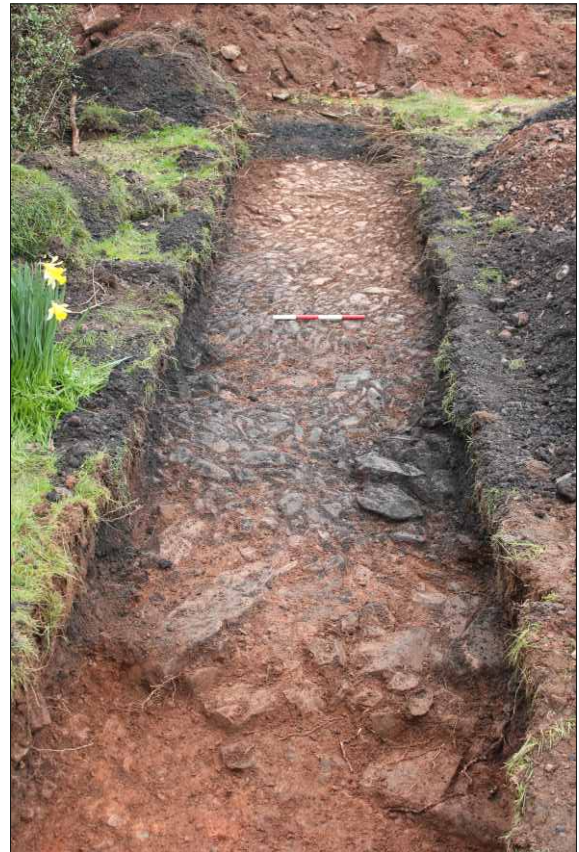
Plate 18: Trench 2, cobbles 202 with wall S203 in the foreground, looking northwest.  
0.40m scale

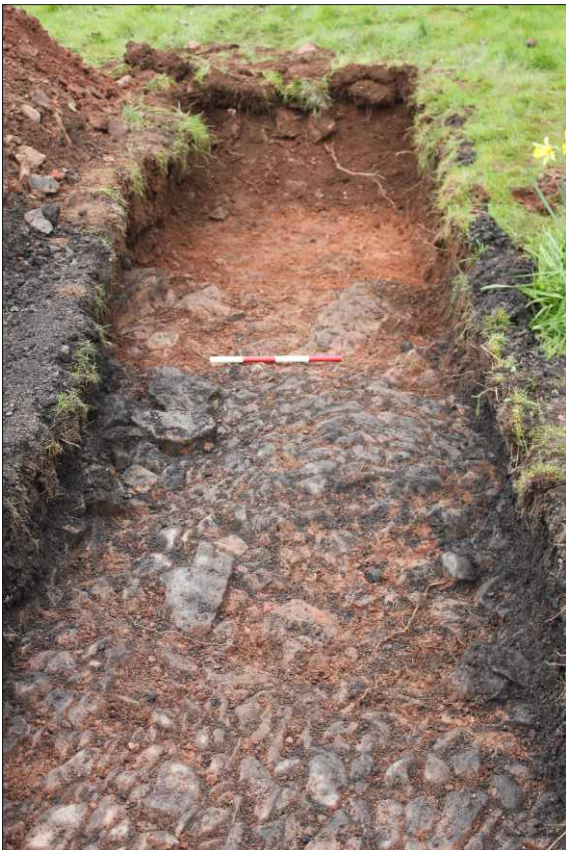
Plate 19: Trench 2, wall S203 with cobbles 202 in the foreground, looking southeast. 0.40m scale

**5.6** The southeast side of wall S203 had been cut away by a flat-based pit (F205) that extended to and beyond the southeast end of the trench. This contained a single fill of dark brown soft sandy loam (206) with stone rubble, frogged brick fragments, and occasional slate, mortar and sub-angular pebble inclusions. It also contained 19th-century pottery, as well as residual earlier (17th or 18th-century) pottery, roof tile and floor tile.
