# HAY PARK, CANAL HILL, TIVERTON, DEVON

Results of archaeological investigations

Mid Devon District Council Planning ref. 18/02038/FULL  
(condition 20)

Document No: ACD2030/2/1

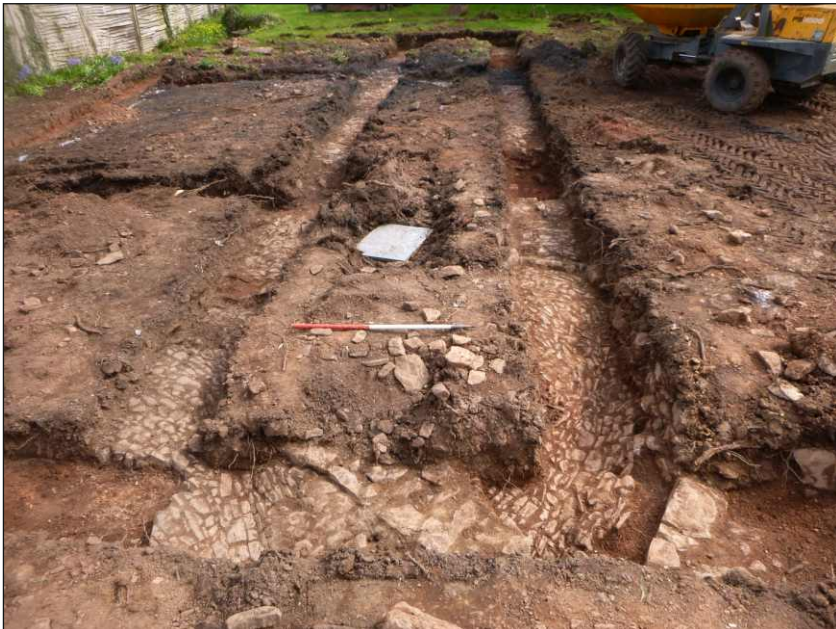
Plate 1: General view of investigated area. Looking southeast with walls S308 and S309 in foreground (scale 1m)

The excavations consisted of three northwest-southeast aligned footings trenches interlinked to four perpendicular trenches. A further trench was excavated on the line of a proposed service connection that extended 6m to the southwest. The natural subsoil (context 301), which consisted of a mid-brownish red sand with occasional sub-rounded pebble inclusions was present at a depth of between 0.4m and 0.6m below existing levels.

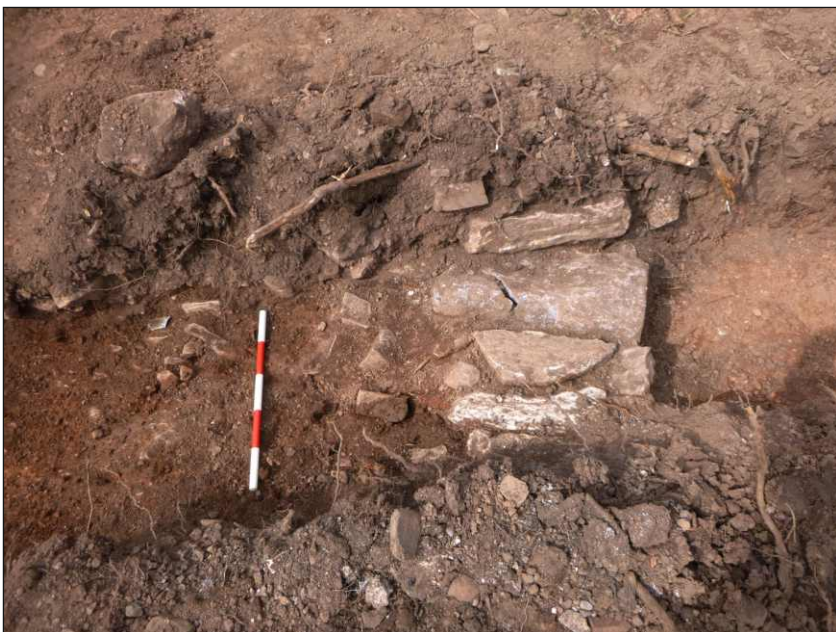
Plate 2: Wall S304, view to northwest (scale 0.5m)

Wall footings S304, S308, S309 and S320 were exposed in the northwest portion of the investigated area and measured a maximum of 0.15m high. Each were comprised of a mix of sandstone and limestone blocks and rubble in a sandy clay bond. Wall S304 measured 0.5m wide and was within a construction cut (F305) backfilled with a mid to dark brown sandy silt loam backfill (306). One sherd of 17th to 18th century pottery was recovered from fill 306. Walls S308 and S320 were 0.5m wide and had been constructed on top of cobbled surface 303, while wall 309, which measured 0.4m wide, was set directly on top of the natural subsoil.

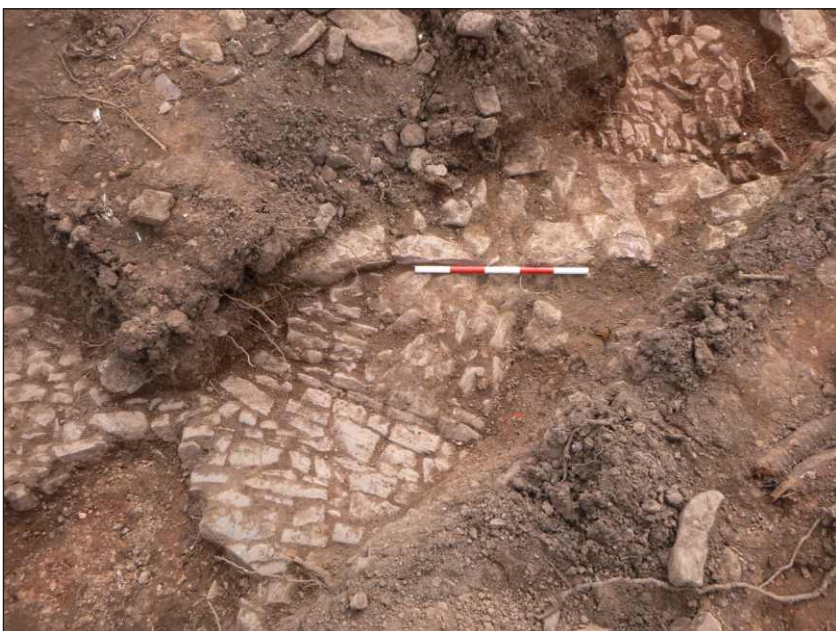
Plate 3: Showing wall S308 and cobbled surface 303 with drain 318 in foreground. View to south (scale 0.5m)

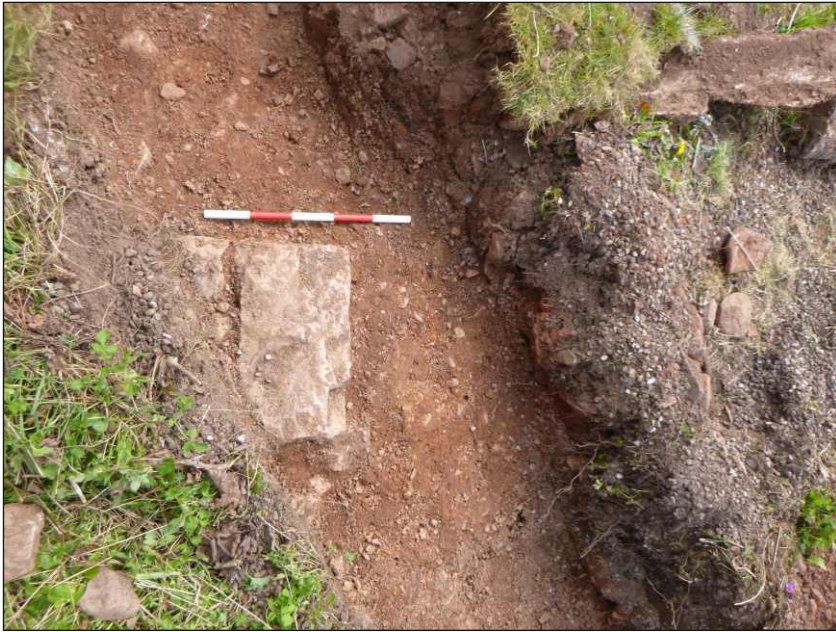
Plate 4: Wall S310, view to southeast (scale 0.5m)

**5.4** Footing S310 was exposed in the southeast portion of the investigated area. It measured 0.5m wide and was comprised of two limestone blocks set directly onto the natural subsoil. The wall footing, which measured 0.15m high was not continuous across the trench.

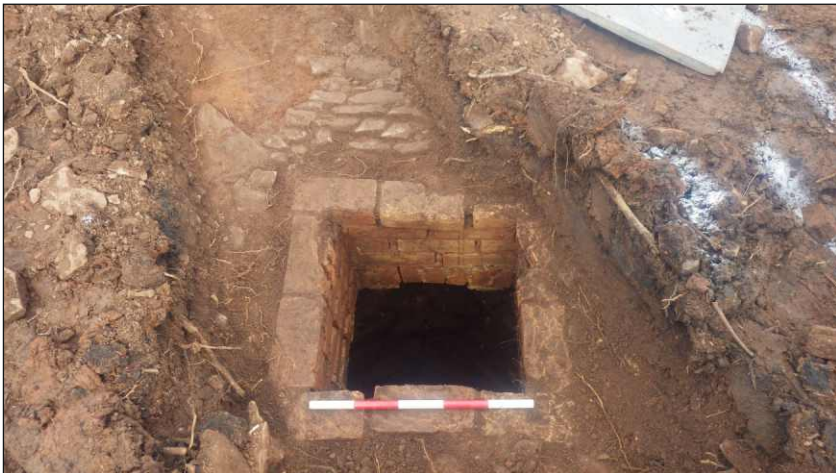
Plate 5: Well S307, view to southeast (scale 0.5m)

Well S307 was also located in the northwest portion of the investigated area. It comprised a rectangular brick-built collar measuring 0.8m by 0.6m, which had been constructed over a wider stone-lined cylindrical shaft below. This was water filled and at least 5m deep. A pipe for a pump had been inserted into the well, with this set within the brick collar. Cobbled surface 303 overlay the shaft and abutted the brick collar and the shaft had been capped with a slate slab.

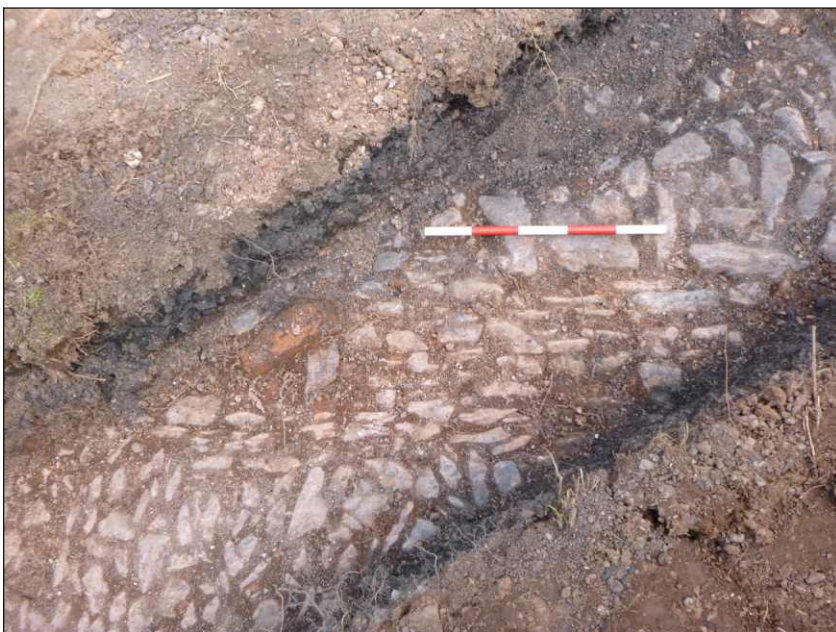
Plate 6: Showing drain 314 and surface 303. View to east (scale 0.5m)

Surface 303 was exposed across most of the southwest portion of the area investigated. It was comprised of water worn and sub-angular pebbles and cobbles of between 0.05m to 0.15m in length, which were set within a reddish-brown sandy clay bedding layer. The surface generally did not appear to have been laid in a regular pattern and may have represented several phases of addition or repair. A range of finds of various dates were recovered from the surface of surface, with these consisting of medieval and post-medieval pottery, a 1971 penny, vessel and window glass, a brick fragment, a piece of animal bone and a bone handle.

**5.7** The six drains (S311, S312, S313, S314, S317 and S318) were incorporated into the construction of cobbled surface 303 and were generally around 0.4m wide. Except for drain 312, which also incorporated brick and tile, they were construction from the same mix of water worn and sub-angular pebbles and cobbles. Drains 312 and 313 appeared to have been arranged around adjacent well S307.
