SILVERTON PAPER MILL, BROAD CLYST, DEVON

**Historic Building Assessment &
Recording**

The National Trust

2017

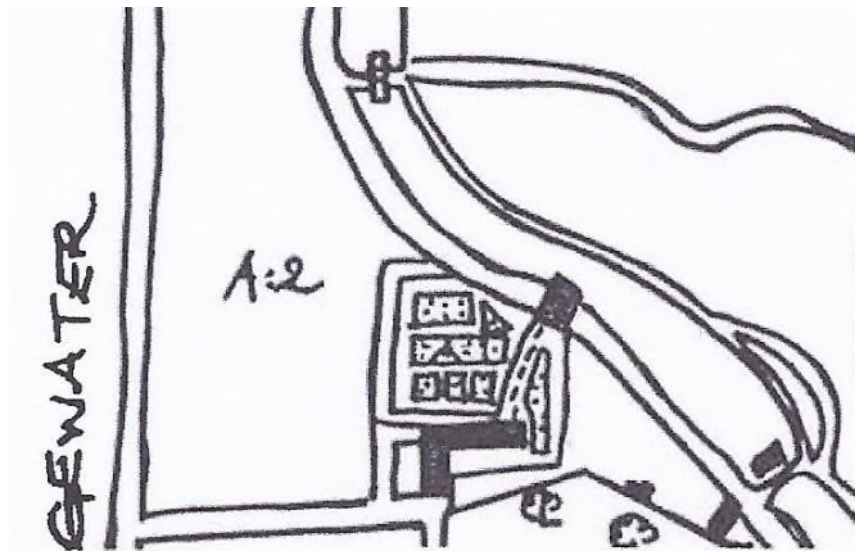
Figure 1
Undated 18th century map

2.3 The earliest map available is an undated 18th century map which shows a building standing across the mill leat which runs approximately parallel to the river and two buildings either side of the leat further east (Figure 1). This map also shows an L-plan building or range of buildings close to the sharp turn in the road at the present day entrance to the mill. It should be noted that the extract of this map provided cuts off most of the garden and site of Bridge House.

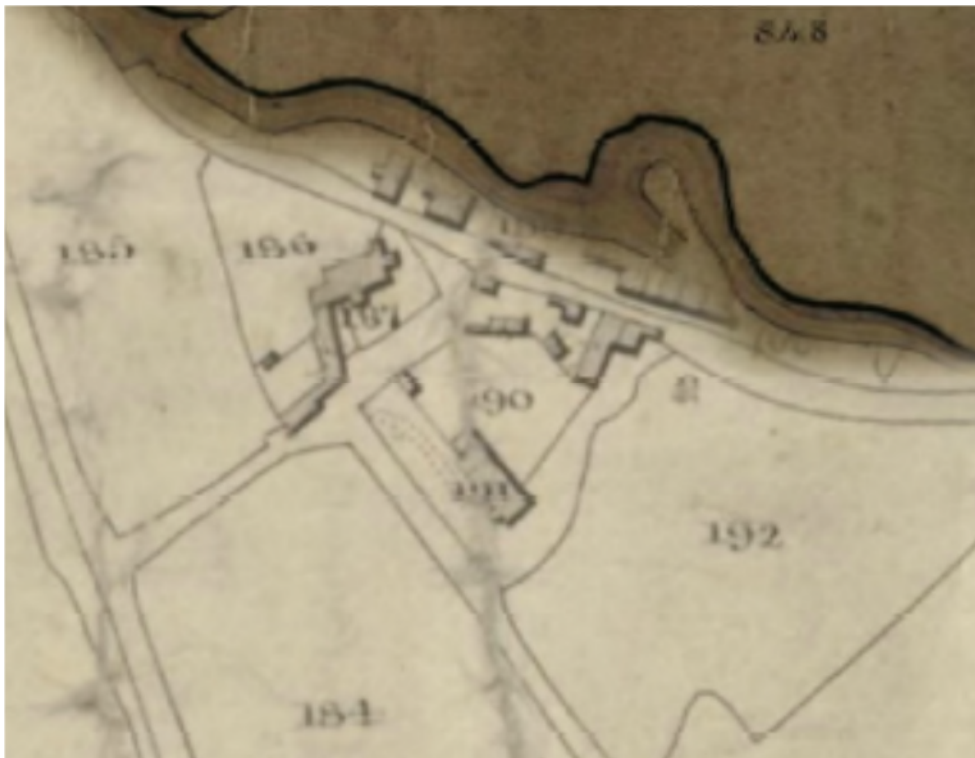
The Broadclyst Tithe map of 1842 show an L-range near the entrance and a series of buildings built along the strip of land between the mill leat and the river with a group of buildings on the south side of the leat between the channel and the boundary of the garden of Bridge House (Figure 2). Two of the buildings alongside the leat may correspond to buildings shown on the 18th century map but there is no building straddling the leat. Figure 2 is a compilation of both the Broadclyst map and Silverton Tithe map – the latter shows that there were no buildings to the north of the river. A hand drawn version of a map which is titled as being the Tithe map was incorporated in Killerton Estate Vernacular Buildings Survey. This version shows the presence of a long angled range that extended across the river Culm and suggests a greater level of building than the original Tithe map and seems to show that much of the length of the leat through the mill was culverted. Although the plot numbering on this map corresponds to the Tithe map, the numbering was also used on a map of 1879. It is considered that the hand drawn version may be a later version of the Tithe map.

Figure 2 A montage of the Silverton (north) and Broadclyst (south) Tithe maps provided by the Devon County Council Historic Environment Record © Devon Records Office. These maps show that in the mid-19th century the mill buildings were principally located along both sides of the mill leat with no structures across or to the north of the river.

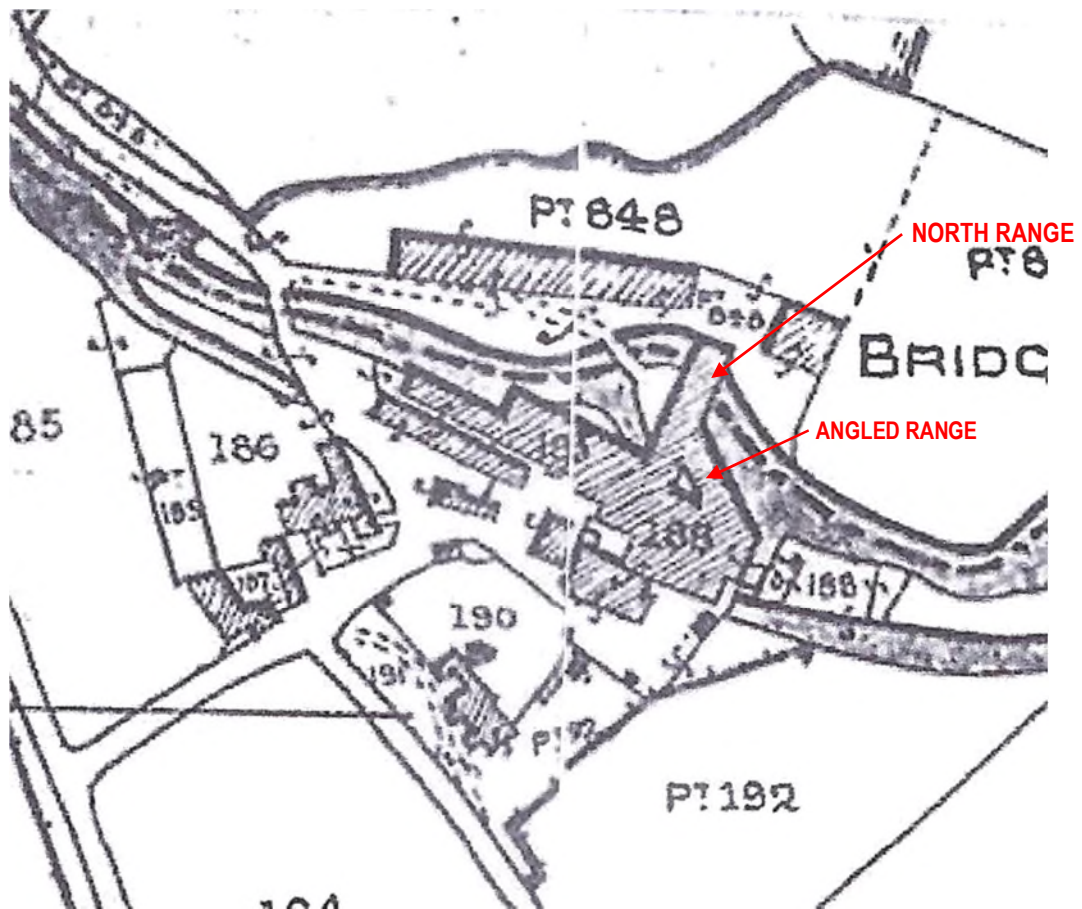
Figure 3
Killerton Estate map 1879

In the second half of the 19th century the mill underwent considerable growth as evidenced by an estate map of 1879 (Figure 3) a plan associated with the sale of the property in 1885 (Figure 4) and the 1st Edition Ordnance Survey 25" map of 1889 (Figure 5). The estate map shows the angled range and a further long building to its west which extended across the river channel (here called the north range). The largely detached structures that stood within the island between the river and the leat had either been replaced or consolidated to form a block with the angled range and the new north range across the river. This map also shows a long range and a square building on the north side of the river but as these lay within Silverton parish they would not have been shown on the Broadclyst Tithe map. None of the hand drawn versions make reference to the Tithe map of Silverton although the version that is possibly later does show boundaries and tracks on the north side of the river. The 1st Edition 25" map shows little change from the 1885 plan apart from some alteration to the south-east part of the complex where there were some minor alterations made.

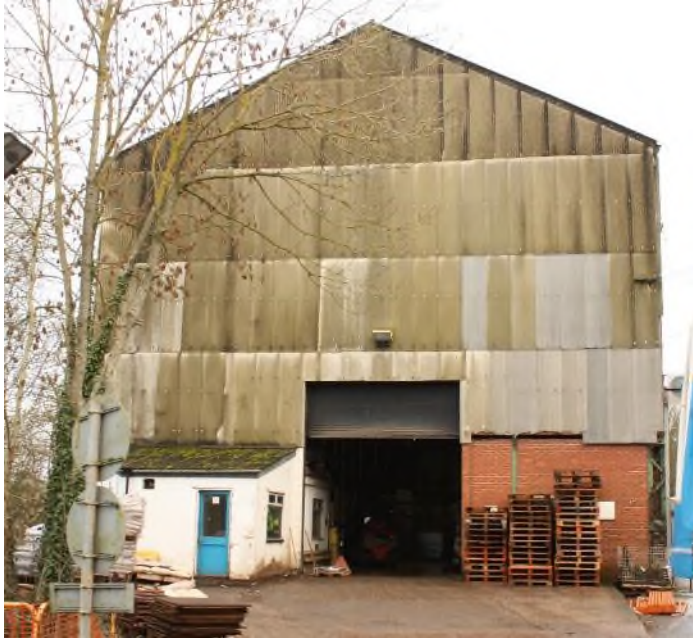
This steel-framed building set upon a brick base, except at the west end where the side walls are brick to full height, was used for the storage of torpedoes during WWII and may date from that period. It is a single space open to the roof. Latterly the building was used as the Finished Paper Warehouse.

Building 2 West elevation. (8274).

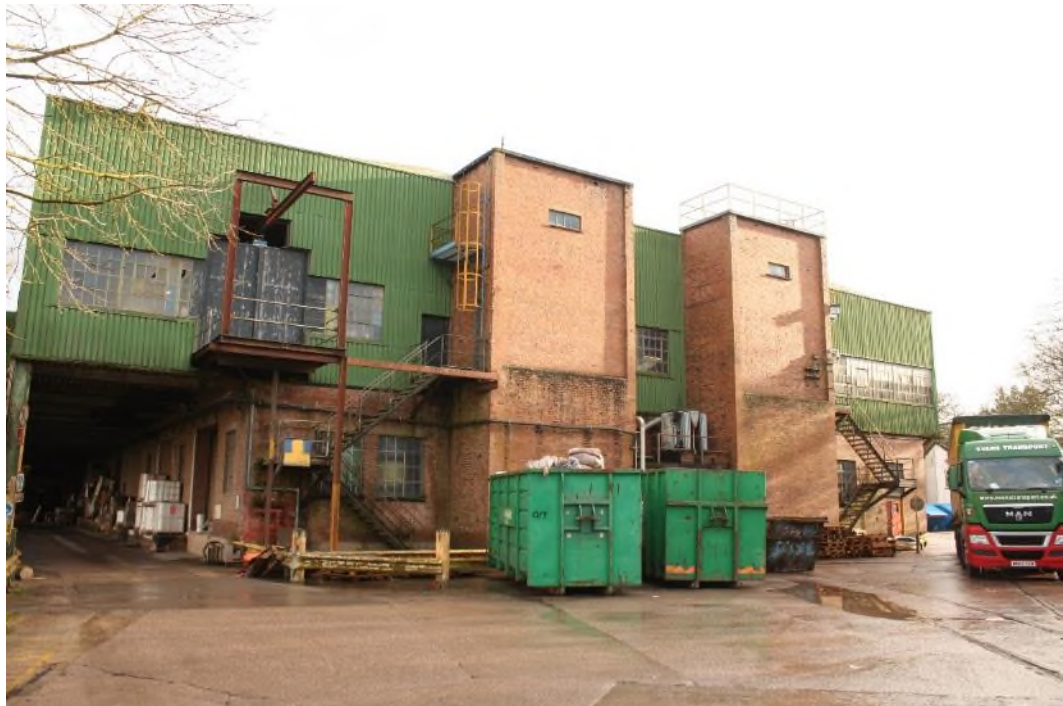
Buildings 3 (left) and 4 (right), west elevation with the covered way along the north side of Building 3. (8288)

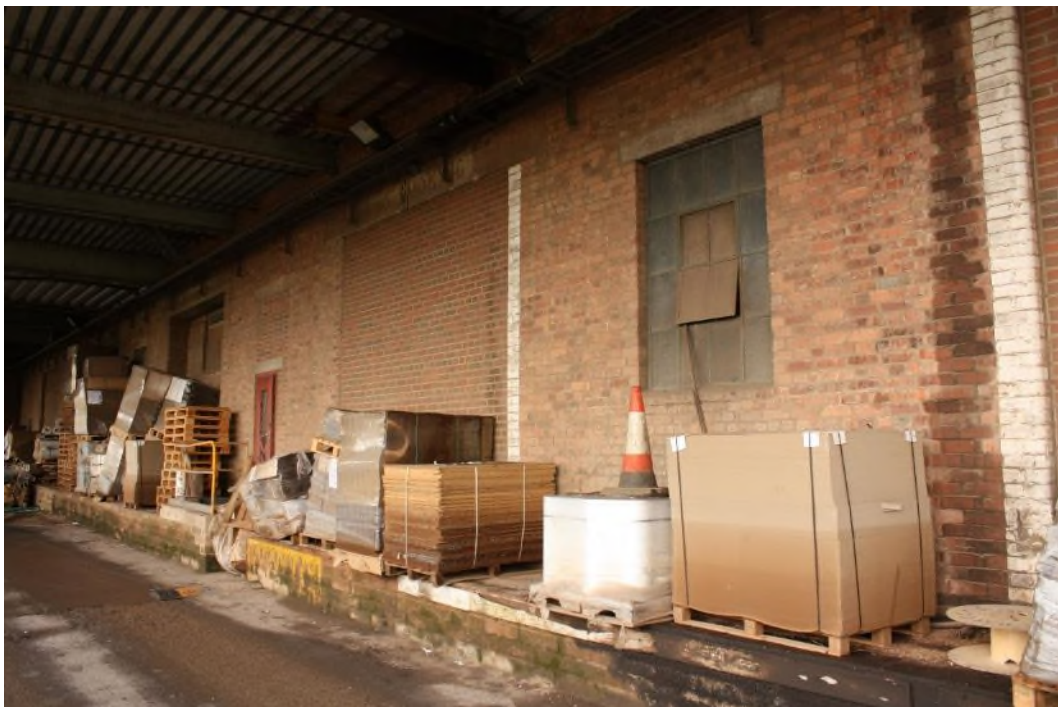
Building 3 North elevation – probable earlier (but probably post 1904) section of the north wall beneath Covered way, facing south-east. (8285)

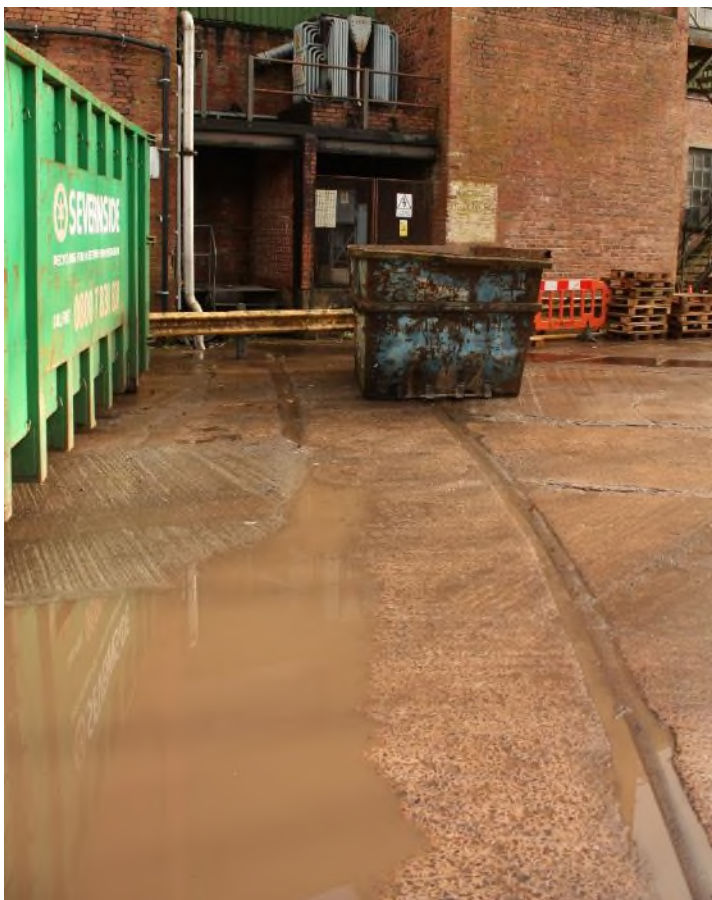
Rail tracks to the west of Buildings 3 and 4 leading towards the Tunnel Passage between Bdg.3 and Bdg.6. (8290)

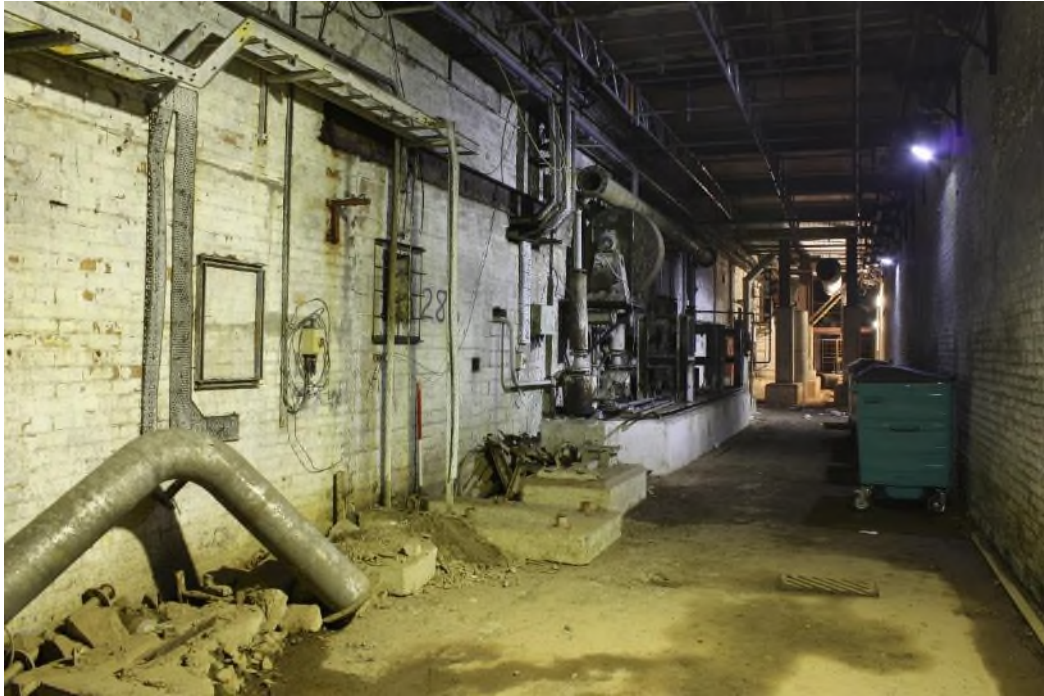
View along the Tunnel Passage to the west. The north wall of Bdg.6 is to the left and the south wall of Bdg.3 to the right. (9586)

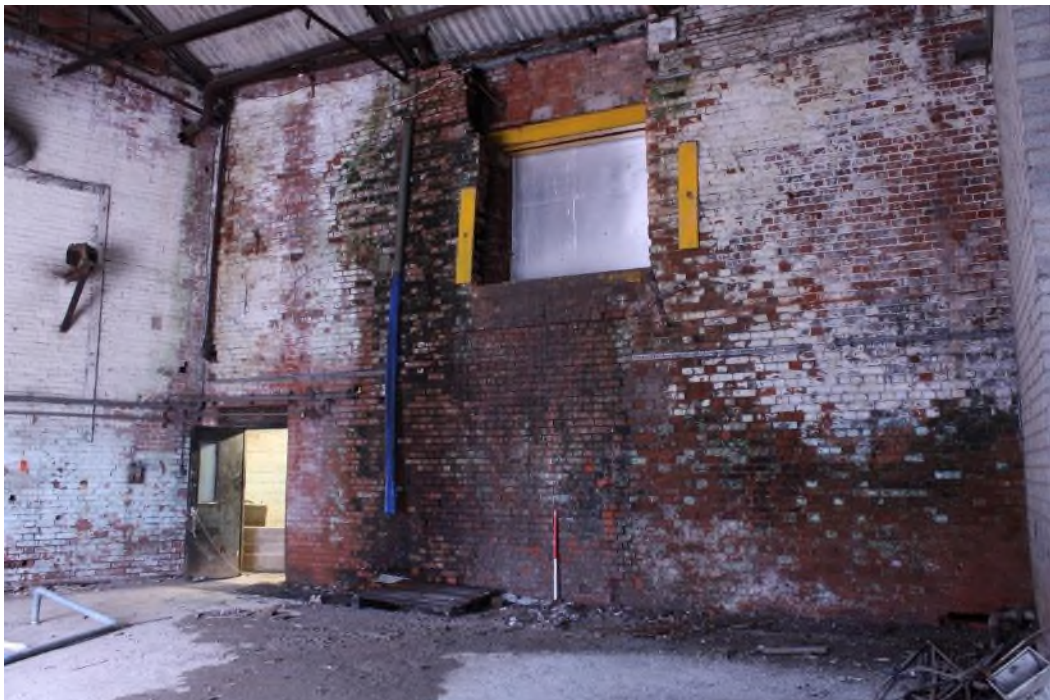
Interior of Building 8, south wall. The double skin of brickwork can be seen above the large opening at higher level. (9582)

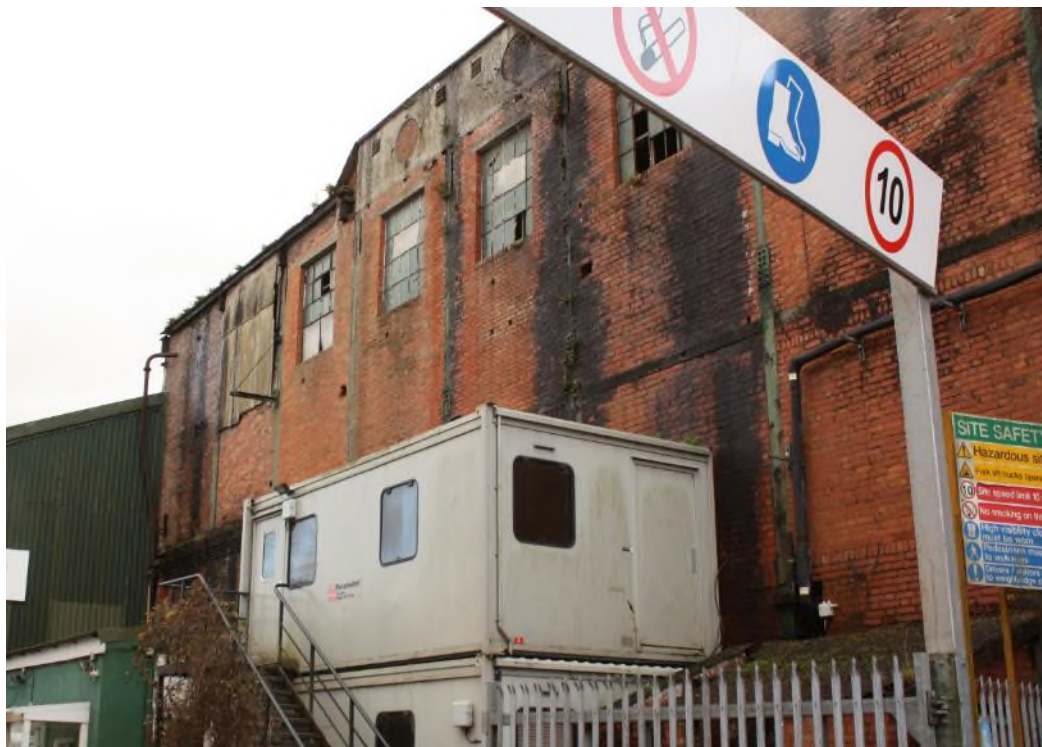
The north elevation above Buildings 9 and 10 with the modern green metal clad steel-framed Building 11 just visible to the left of the picture. (8284)

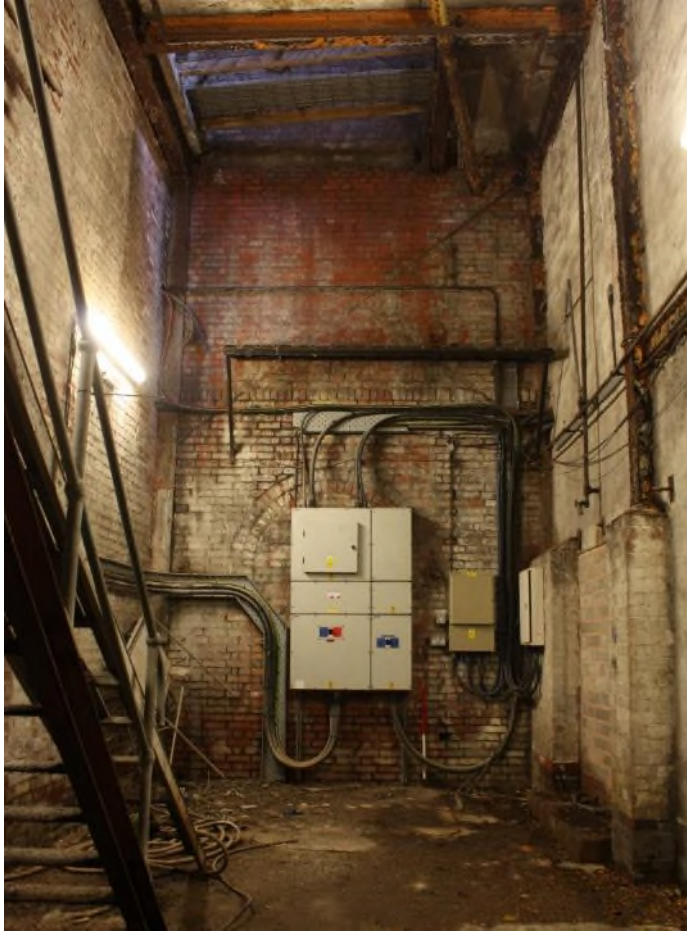
Together with Buildings 8 and 9 to the west, this element was probably added in the 1920s when it was built against the north wall of the narrower range along the north edge of the site built between 1889 and 1904. There is a blocked arched opening in the north wall and nine courses of brick above the opening there is a course of header bricks laid on edge.

Building 10 North wall of the Grass Boiler Room showing blocked arched window.

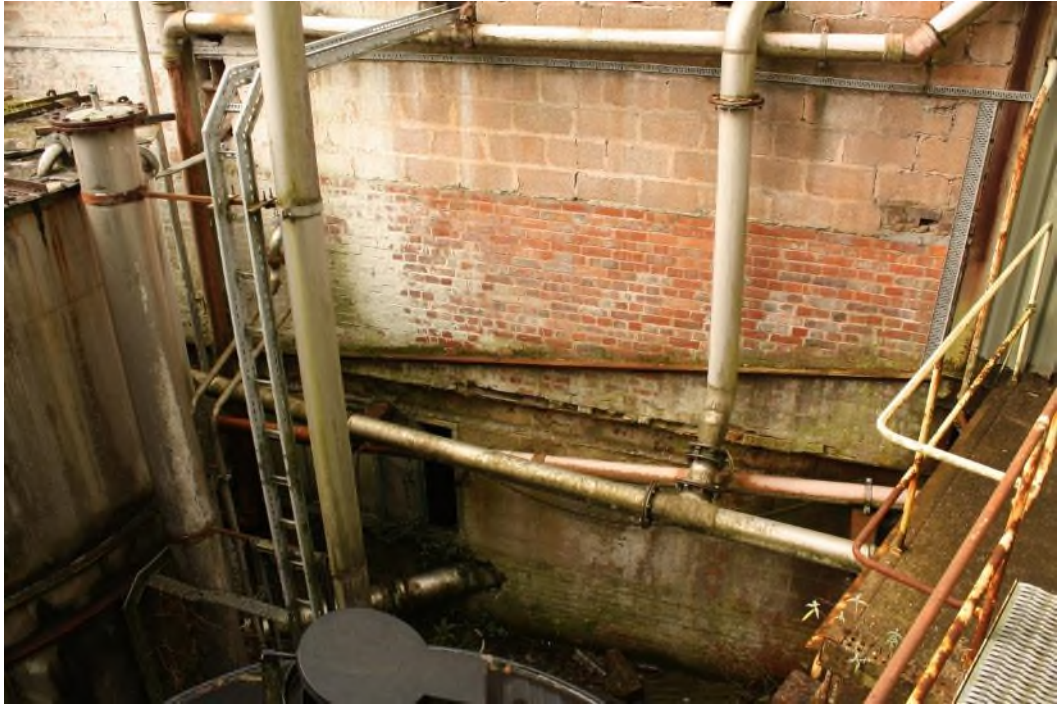
Post 1904 but heavily altered with areas of blockwork visible in the east elevation.

Building 12. East elevation. (8235)

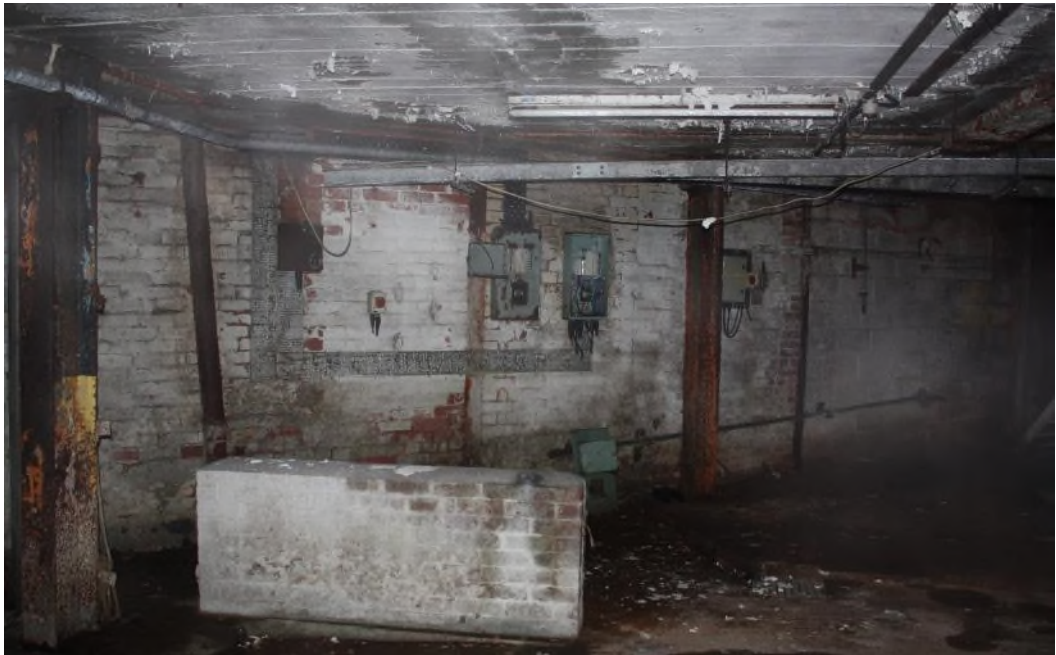
Building 14 South part facing towards the north-east elevation of the earlier angle range. (8111)

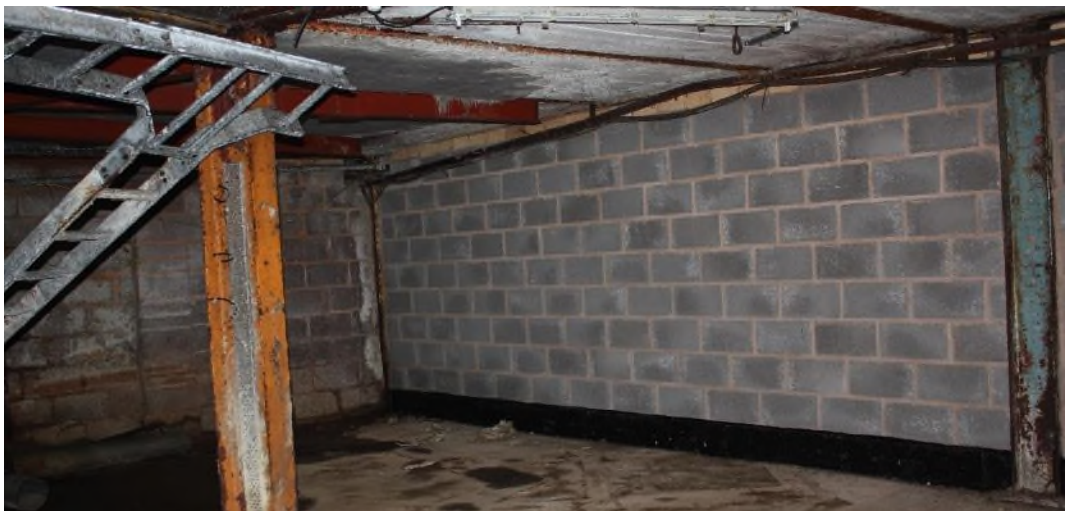
South part of the area of Building 14 with modern blockwork wall dividing the space. (8116)

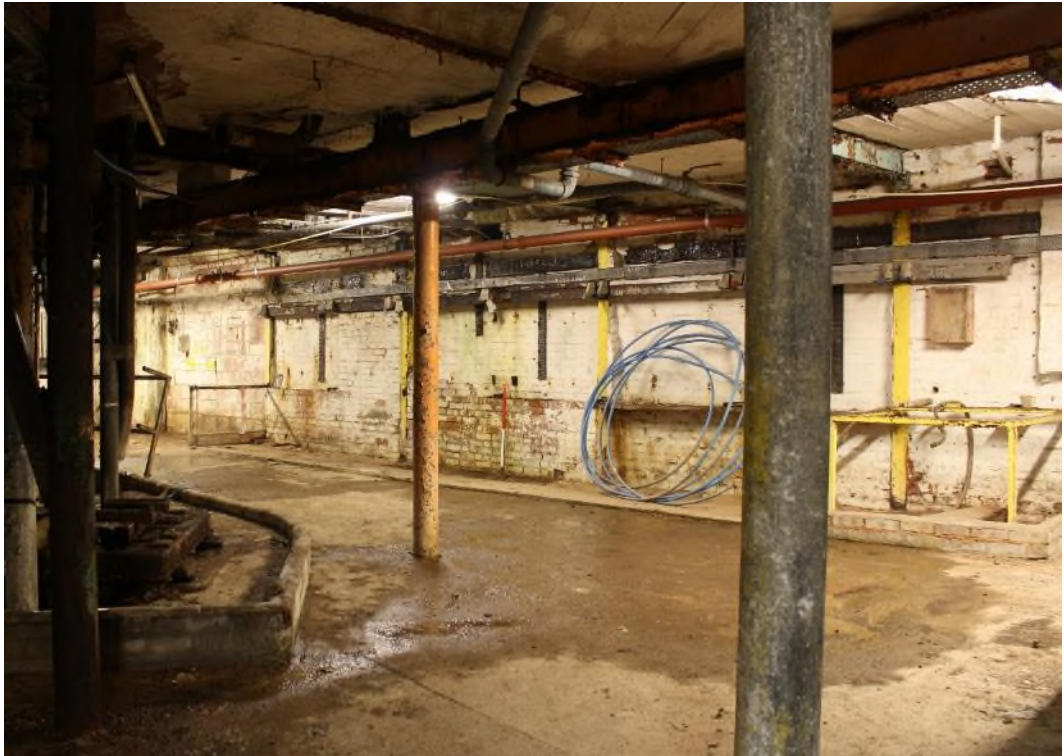
Building 15 North-east wall of the former angled range, originally built between 1842 and 1879 although the present wall may be a later rebuilding. Facing north. (9427)

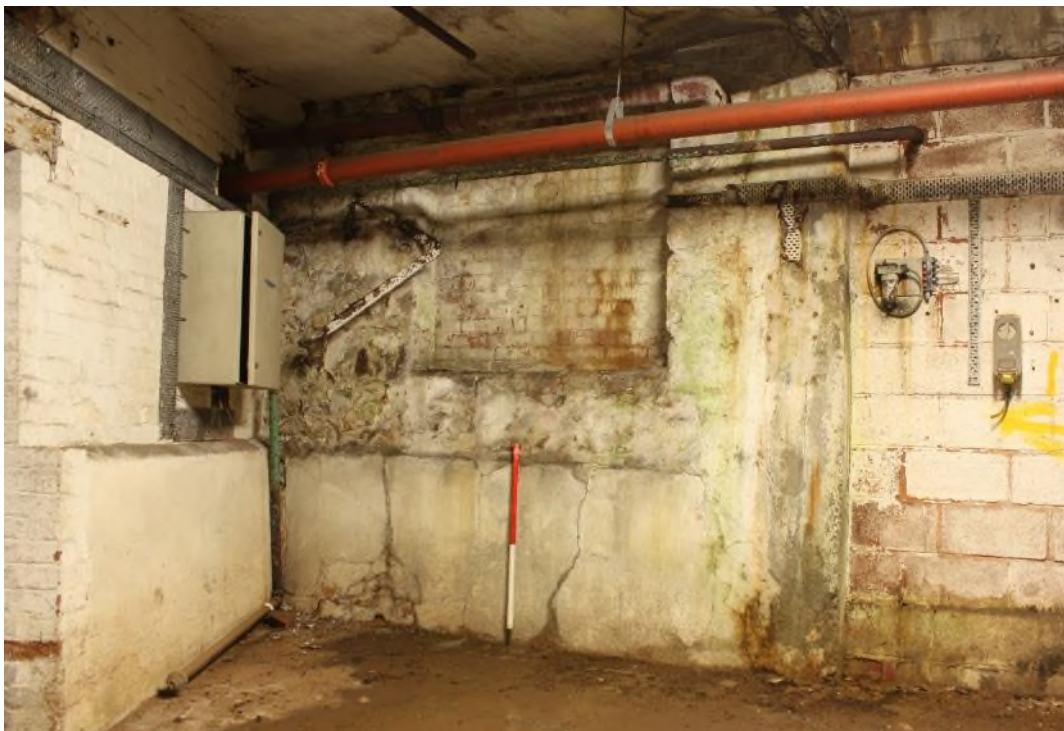
Building 15 North-east wall of the former angled range built between 1842 and 1879 showing an element of stone rubble masonry at the north-west end. Facing north. (9436)

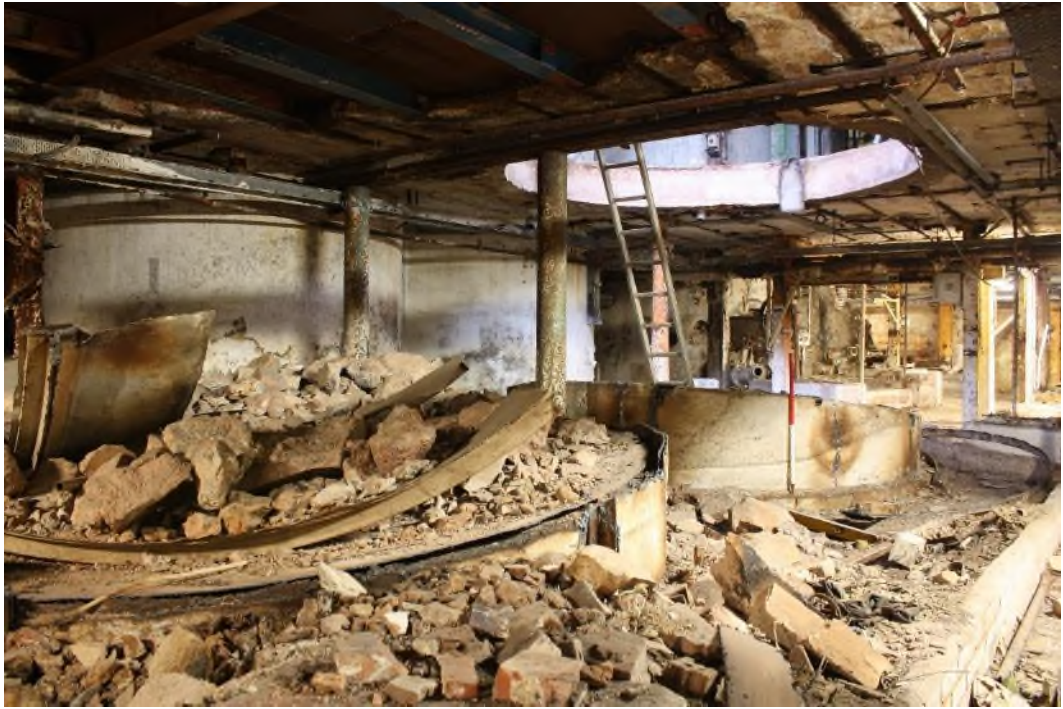
Building 15 General view of the interior at ground floor level, facing south-east with remains of pulping vats. (9418)

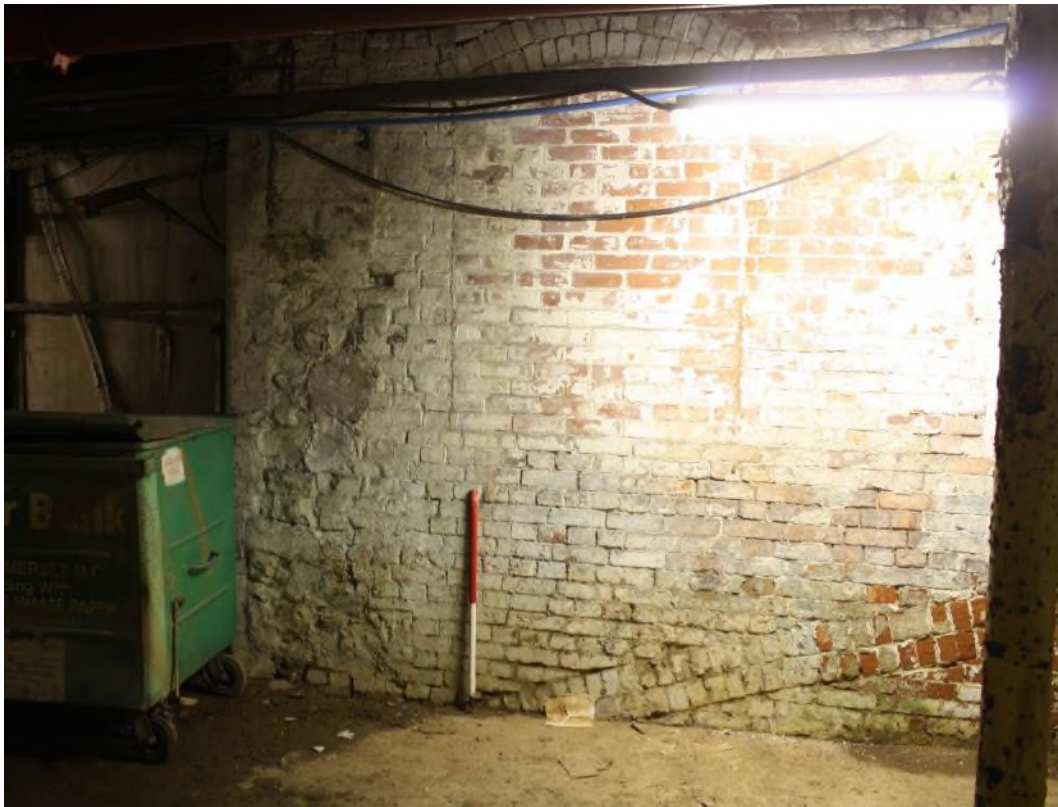
Building 16 The south end of the east wall is showing an area of rubble stonework, the beginning of the low arch spanning the river and a blocked window. Facing west. (9548)

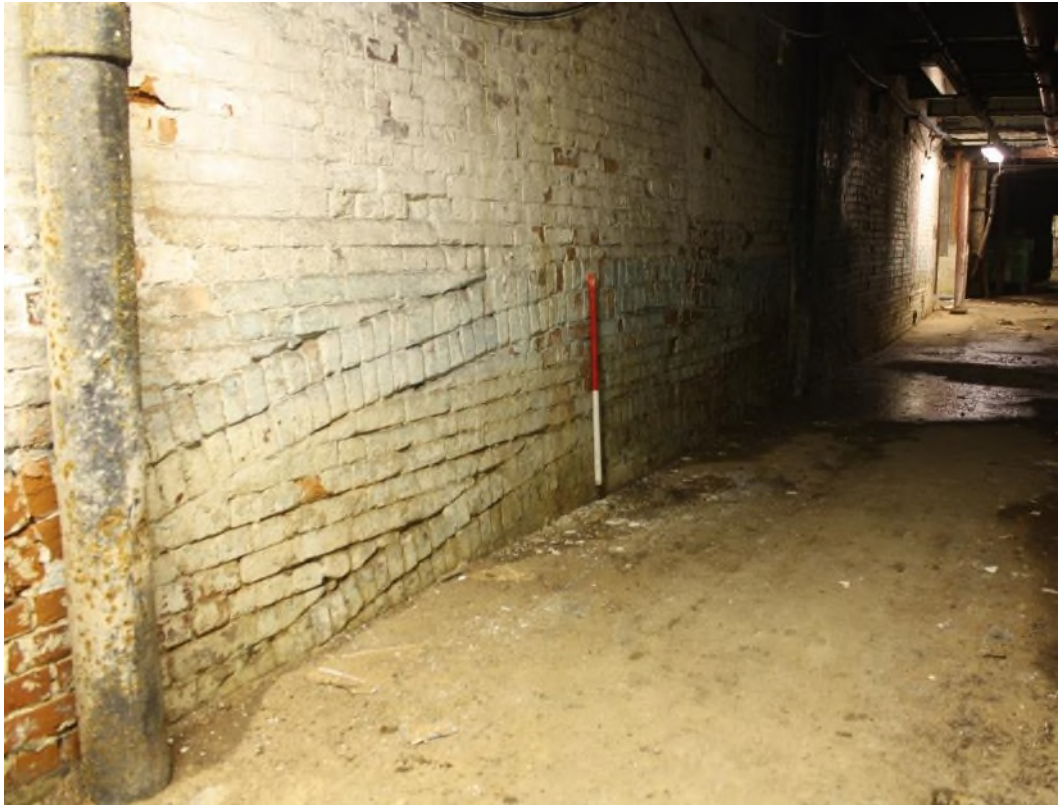
Building 16 South-east elevation, facing north showing the wide, low arch spanning the river. (9565)

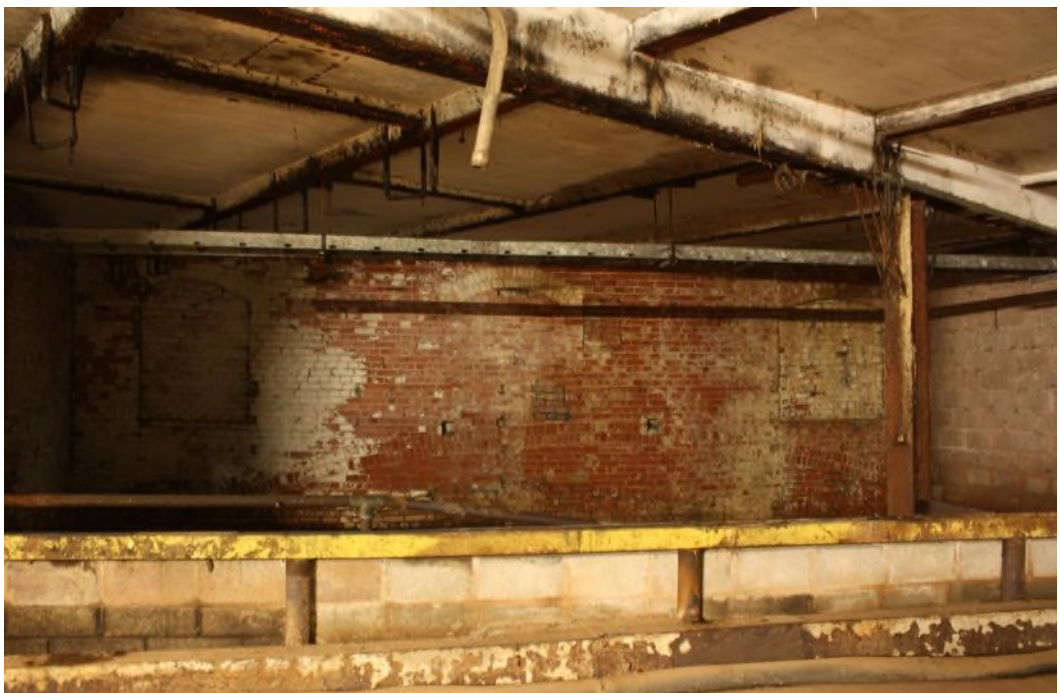
Building 16 South-east wall, inner face (north-west) showing blocked window openings. Facing south-east. (9478)

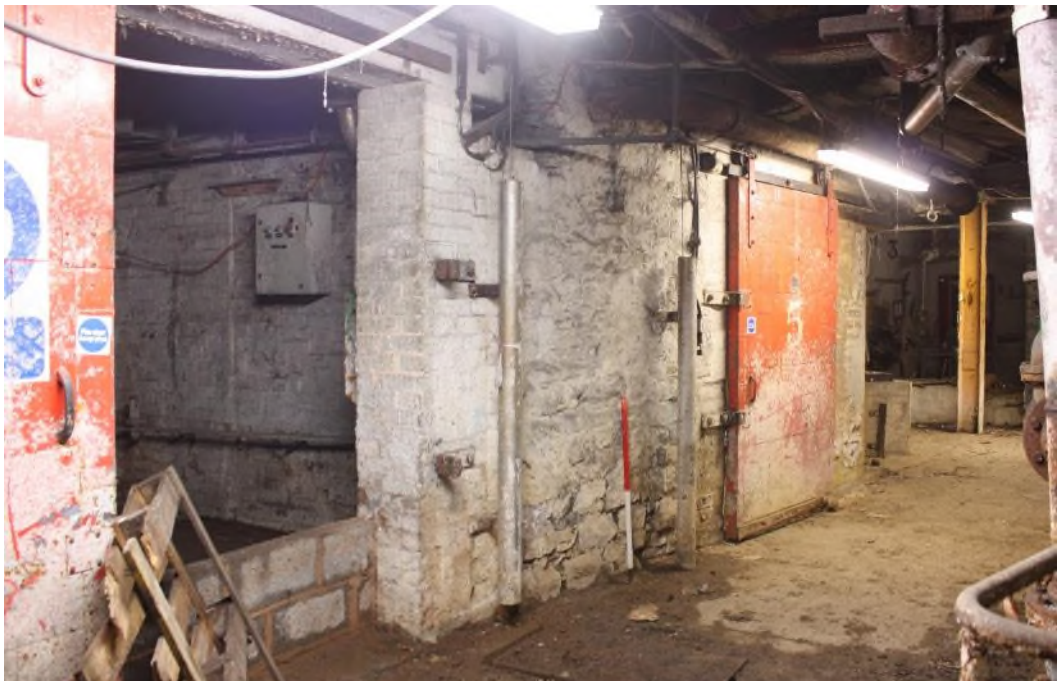
Building 16 South end of the north range showing a section of stone rubble walling in the south-east wall. The corridor to the right of the picture is a gap between Bdgs. 16 and 15. (9486)

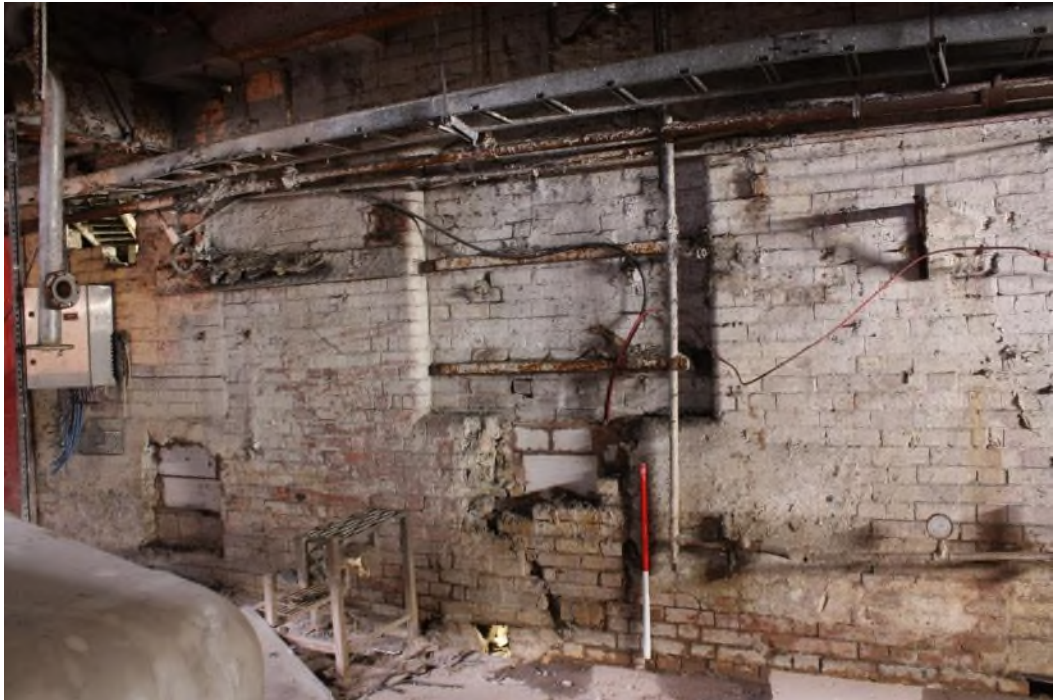
Building 16 South elevation facing into gap between Bdg. 16 to the north and Bdg. 23 to the south showing one of several blocked windows. Facing north. (9491)

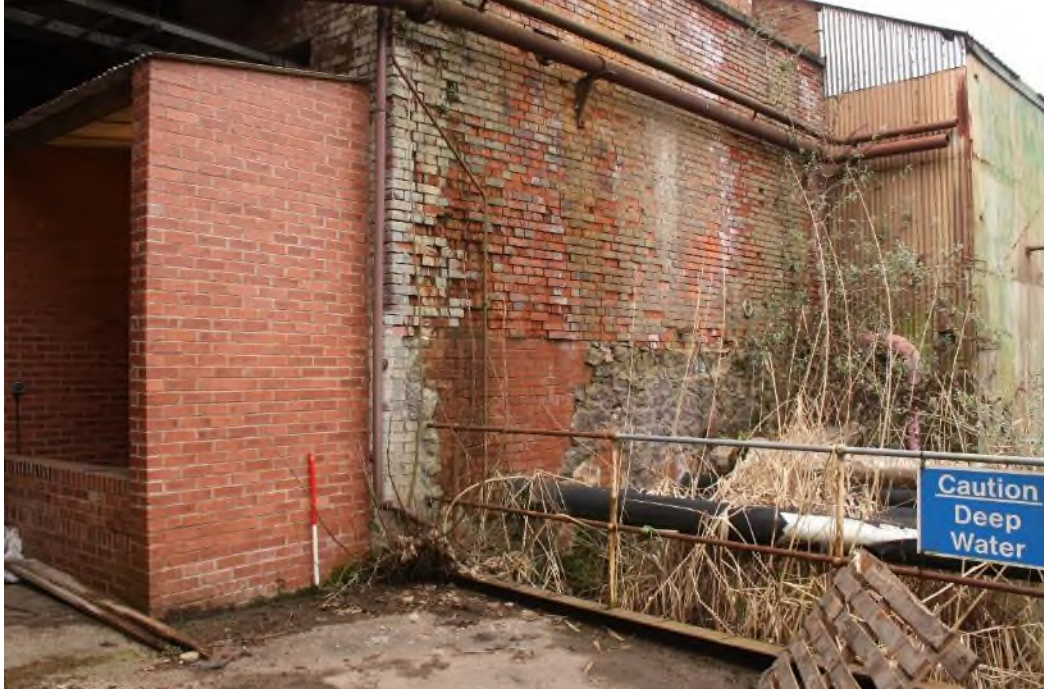
This structure contains some rubble masonry in its walls which are presumably part of the structure and possibly built in 1889 which incorporated a vertical-shaft water turbine. The brickwork suggests that the building was subsequently extensively remodelled.

East elevation of the Pump House (Bdg.17) showing the lower section of stone rubble walling with brickwork to the south and above. (9532)

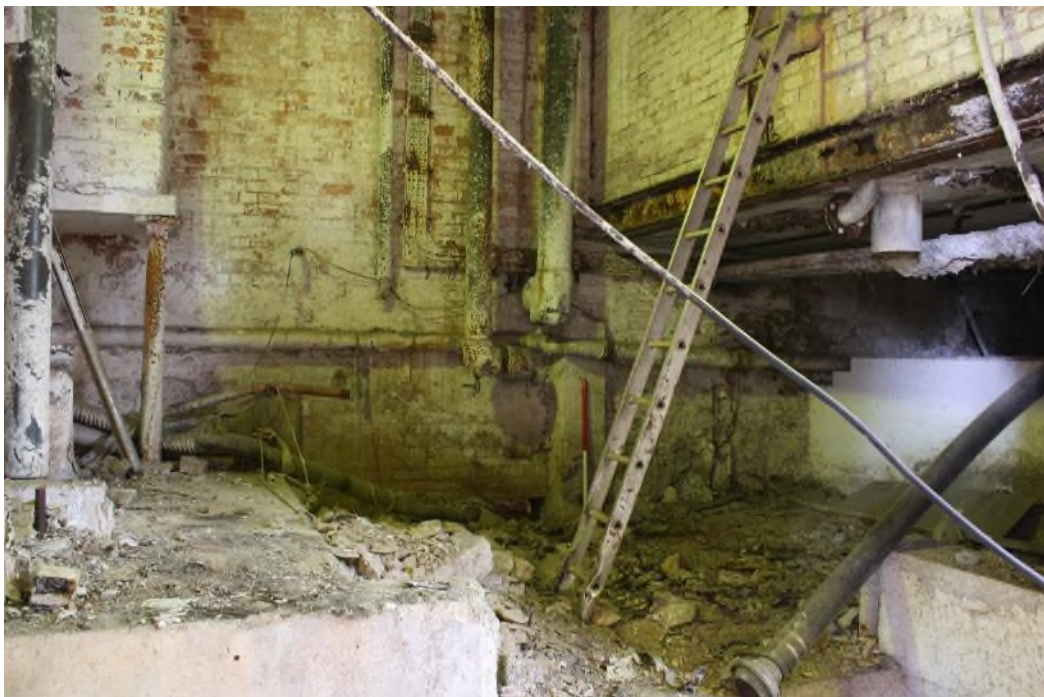
Interior of the Pump House, south part facing north-west – the turbine pit is located beneath the jettied structure, top right. (9514)

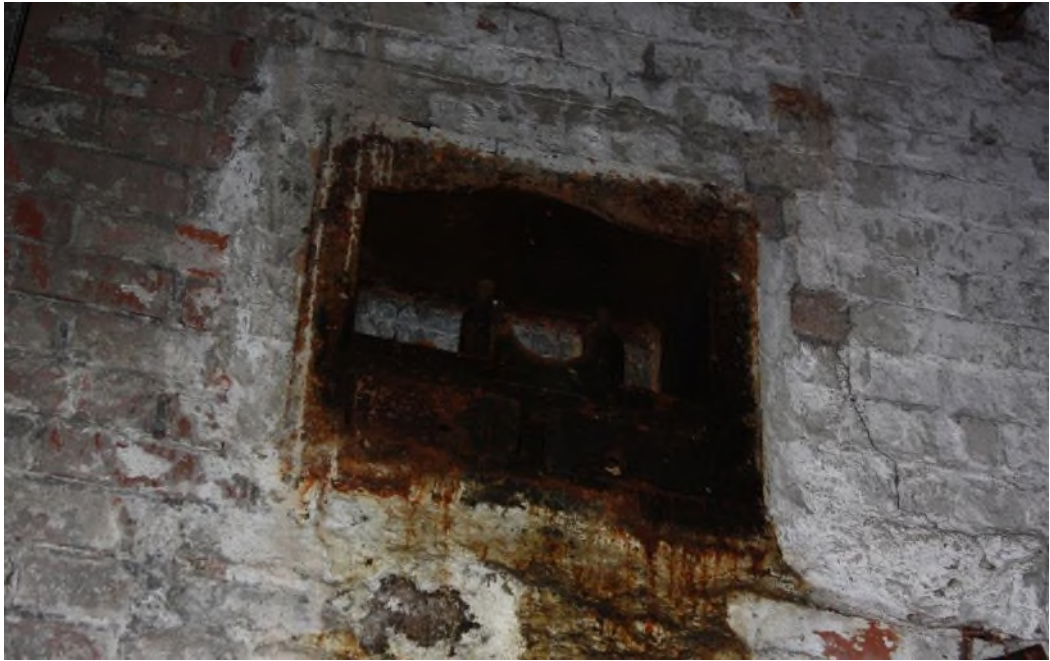
Figure Drive shaft bearing in the west wall of the northern part of the Pump House (8499).

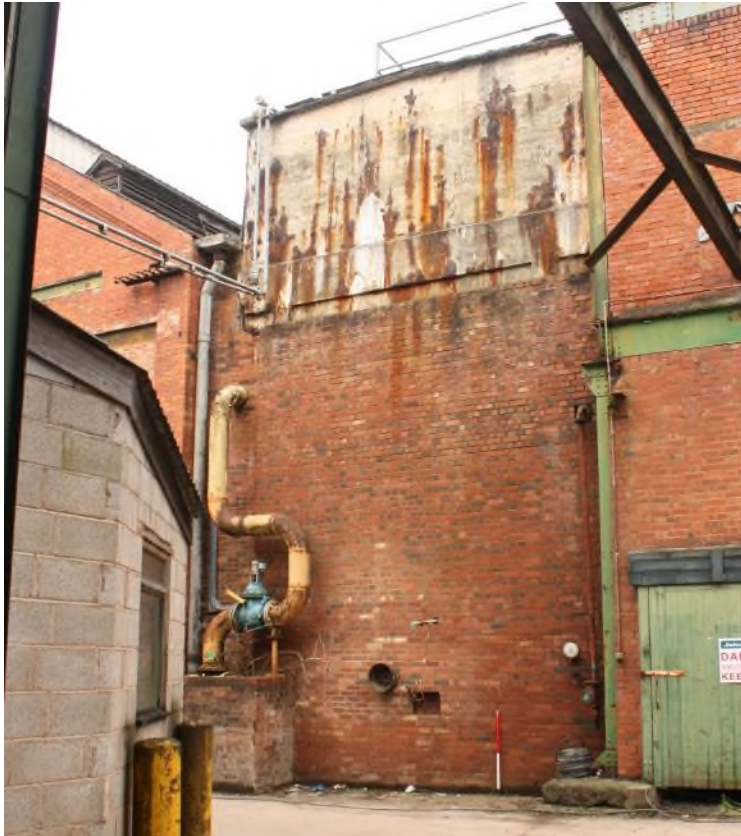
Building 20, south elevation, east part showing the later infill section with a tank on the flat roof. (9534)

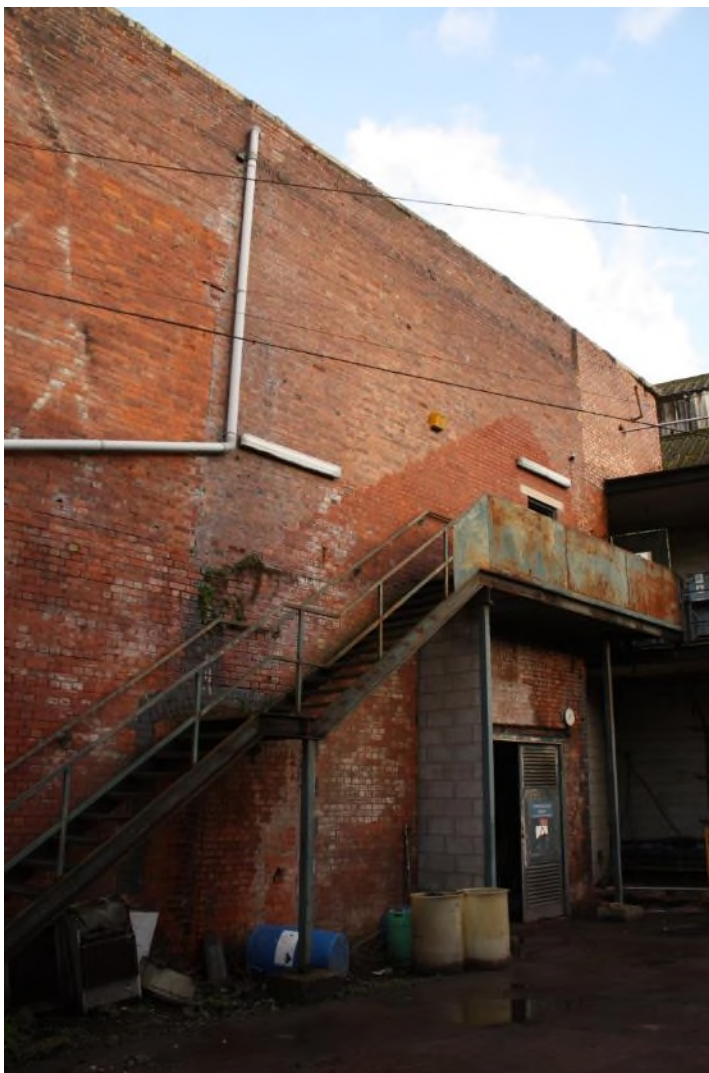
The 1904 map shows a building in this area which may relate to the lower gables that are visible in the brickwork with the raising of the building height possibly forming part of the 1920s works to the mill.

Building 21 Compressor Room, south elevation facing north-east. The gable of an earlier, lower building can be seen which is similar to another gable within the wall of the Reactor Room to the west, illustrated below. (8340)

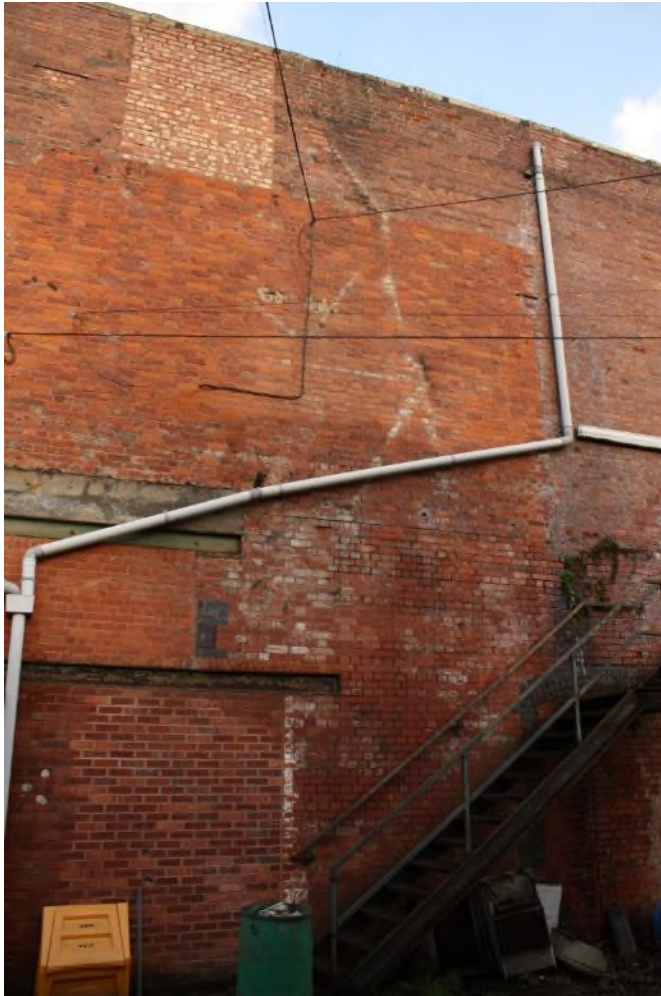
Building 22 Reactor House, south elevation, east part facing north-east. This shows a much altered brick elevation with a vertical joint in the brickwork to the left of the downpipe. (8339)

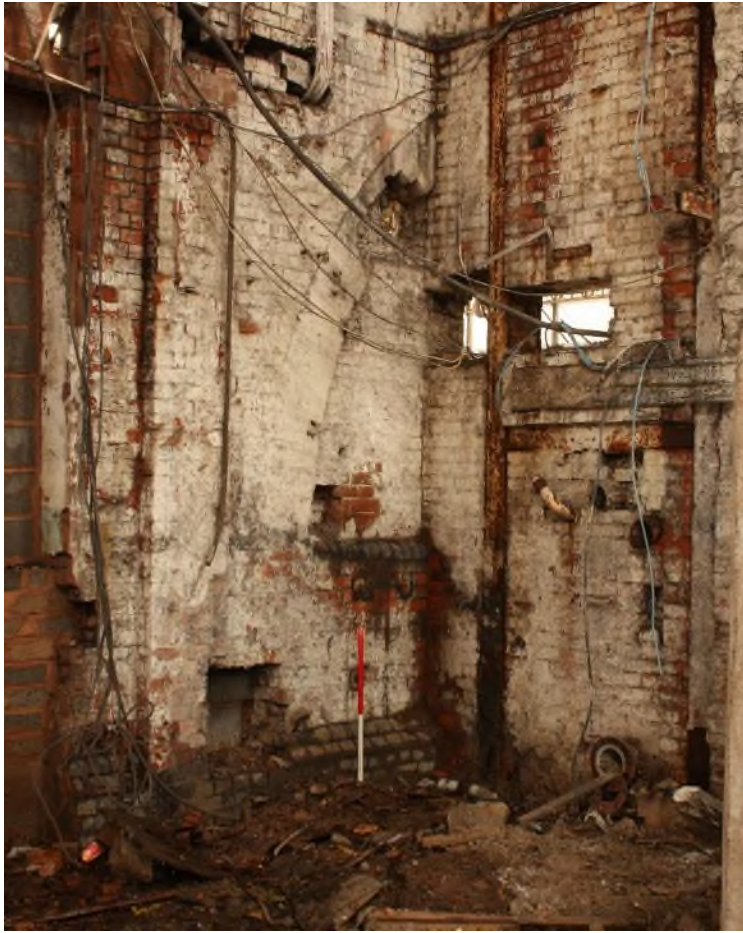
In the west wall adjacent to the north-west corner there is a remnant of a brick archway, now blocked, which extended beyond the line of the present north wall.

Building 22 North-west corner of the Reactor House showing the arch cut by the north wall of Bdg. 22. (9545)
