SILVERTON PAPER MILL, BROAD CLYST, DEVON

**Historic Building Assessment &
Recording**

The National Trust

2017

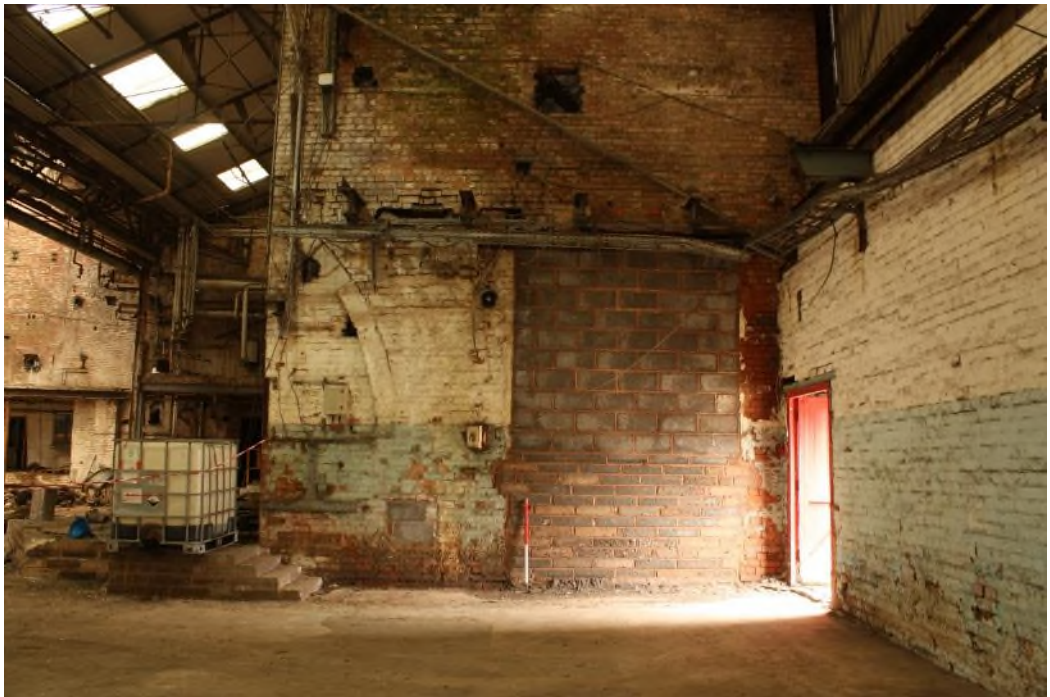
Building 22, west wall showing the partial arch taken from within Bdg. 23, facing south-east. (9550)

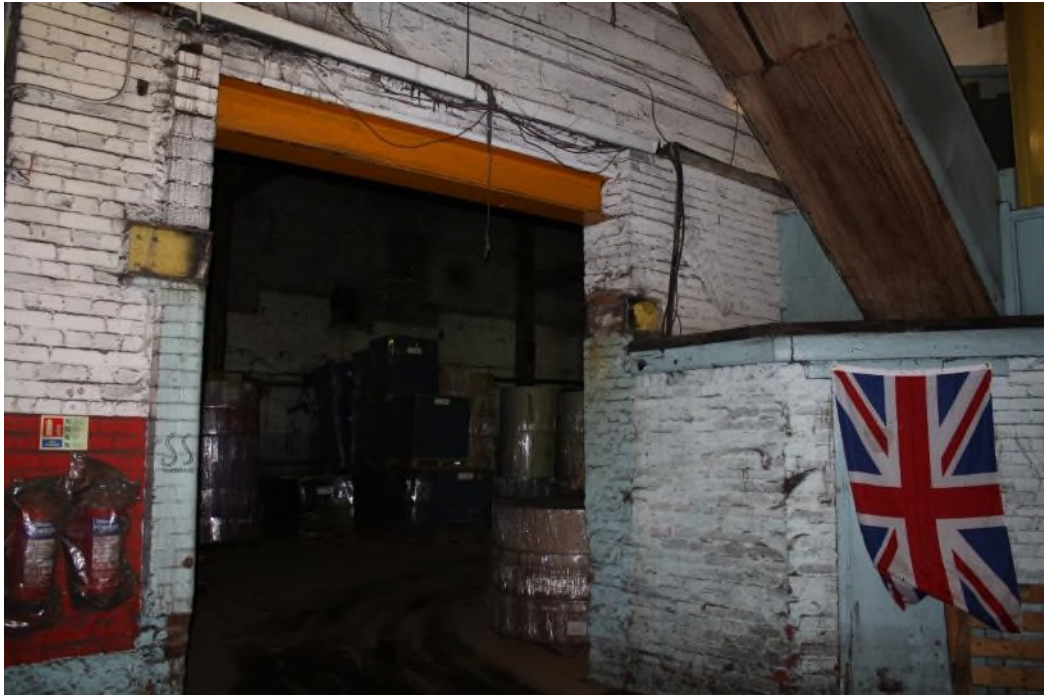
Building 23 Interior, north-west corner looking north into Bdg. 6. The brickwork of an arch-headed window can be seen to the right of the inserted opening. At the higher level the wall is constructed in blockwork.

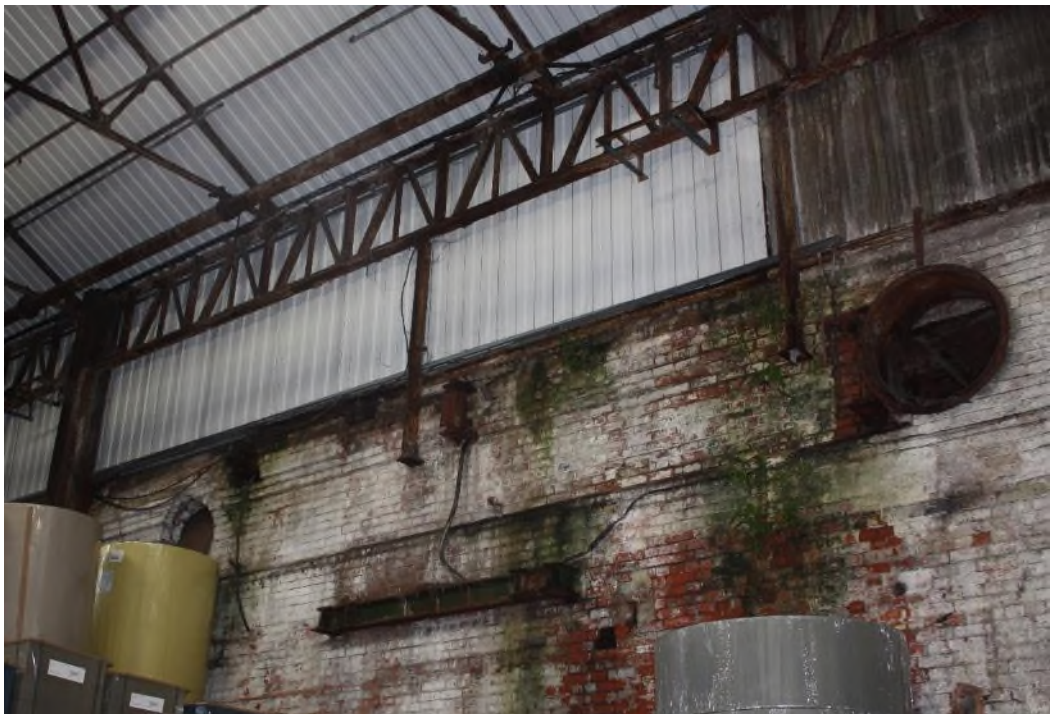
Building 23 Interior, north wall, central section facing north-west showing circular openings in the upper part of the wall. (8336)

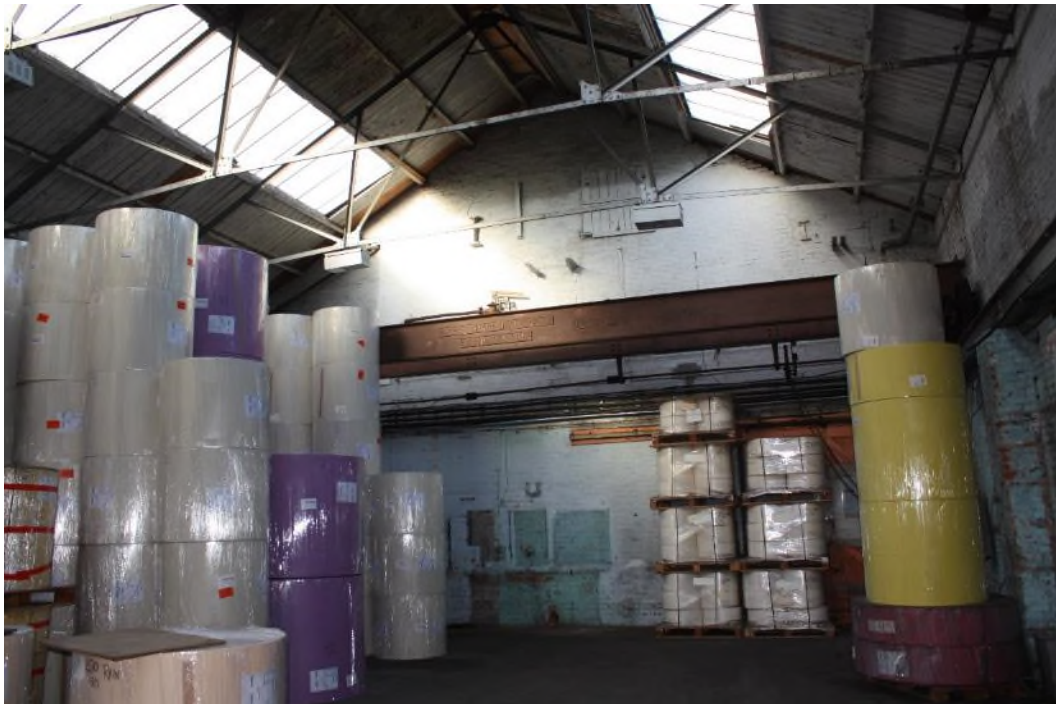
Building 28 Interior facing north showing the crane running on rails against the side walls. (8368)

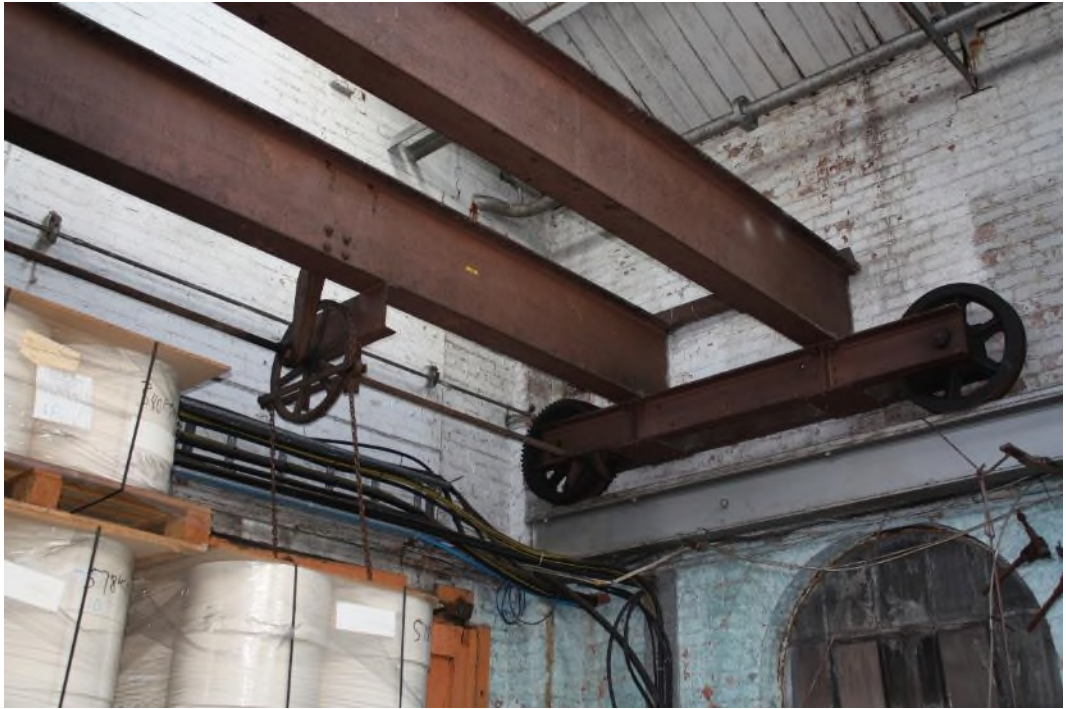
Building 28 Travelling hoist.

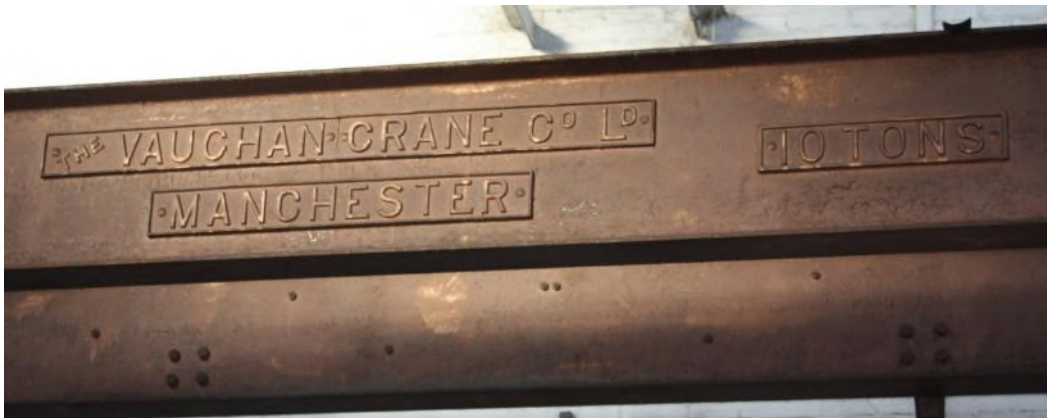
Building 28 Travelling hoist manufacturer's name in iron beam.
