# SILVERTON MILLS, HELE, EXETER, DEVON

## Results of Archaeological Monitoring and Recording

Report No: ACD1019/1/1

Date: July 2019

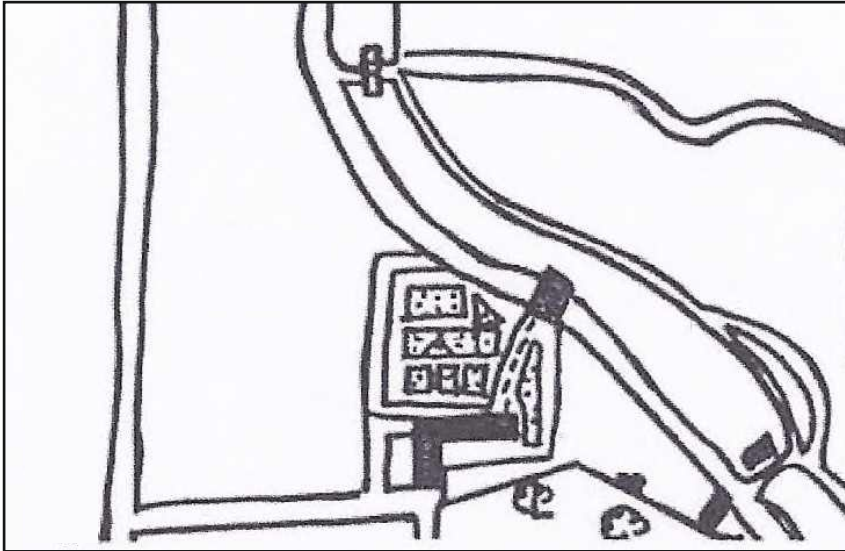
a. Undated 18th century map  
(Source Edwards 2017)

- 2.4** A copy of an undated 18th century map shows the site as comprising of a mill building spanning the leat with probable yards and an L-shaped range to the south (Fig. 2a, Edwards 2017). To the east of this, two further buildings are shown either side of the leat and adjacent to a channel, probably comprising of a sluice and wheel pit linking via a tailrace to the River Culm to the west. Part of the L-shaped range is likely to correspond with the current 'Cottage Office Block' (MDV65051). This building consists of what was originally a three-cell cross passage house of 17th century origin (National Trust 2000). Following a series of 19th century alterations and partial demolition in the 1970s it was converted into mill offices.

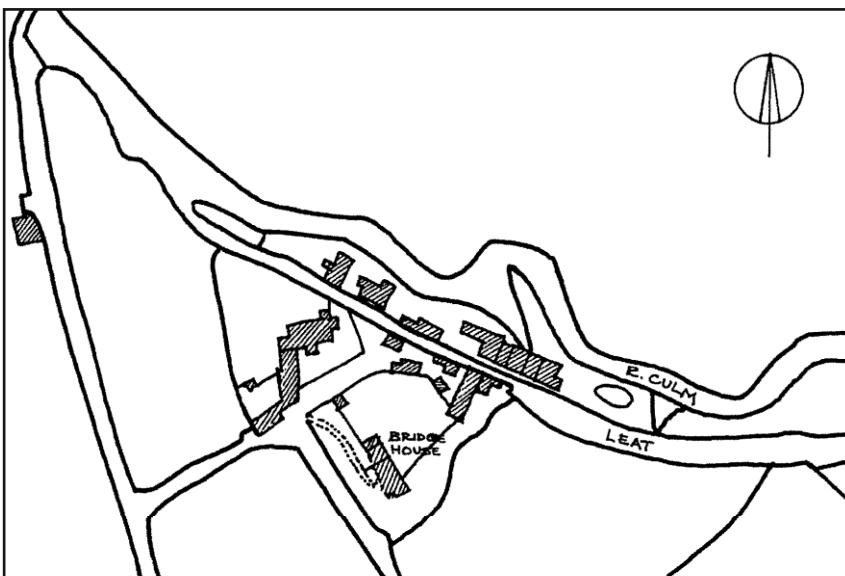
b. Bridge Mill, Broadclyst: Taken from the Broadclyst Tithe Map of 1842  
(Source Watts & Watts, 2000)

- 2.5** Bridge House, which probably replaced the existing 'Cottage Office Block' as the main mill residence, was built in 1828 and marked the start of rapid growth of development to the operations. The 1842 Broadclyst parish tithe map shows Bridge House and the 'Cottage Office Block' as well as some additional buildings either side of the leat, possibly including those previously shown adjacent to the leat, although no building is depicted as spanning the leat channel (Fig. 2b).

- 7.3** Wall S112, which corresponded with the tailrace channel linking the leat with the river as shown on historic mapping, indicates that a channel was present from at least the 18th century (Fig. 2a). However, it is not clear whether it would have been revetted at this point. Nevertheless, as the 1842 Broadclyst parish tithe map shows an expansion of mill buildings in the area to the northeast of the leat, it is likely that revetments to both the tailrace and river would have been needed to protect the structures from erosion at least from the early 19th century (Fig. 2b).

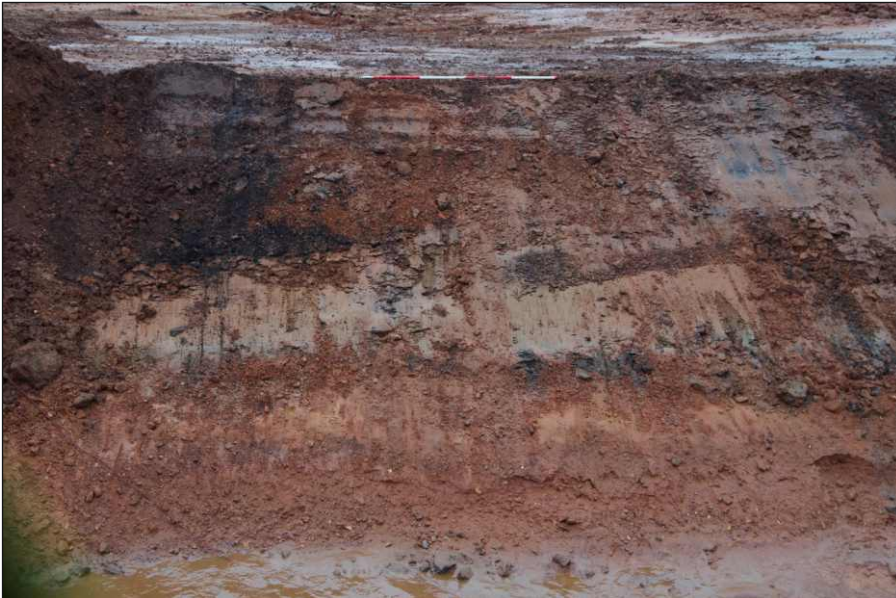
Plate 4: Showing river gravels, alluvial clays and overlying made ground exposed in temporary river diversion channel. View to northeast (scale 2m)

- 5.1 Introduction** (Plan Fig. 3; Plates 1-4)  
Monitoring and recording was undertaken following the demolition phase and subsequent to the commencement of groundworks. The excavation of the temporary river diversion channel exposed river gravels at a depth of approximately 3m below existing levels. These were overlain by bluish grey to grey alluvial clays beneath a maximum of 1.5m of made ground (Plate 4).

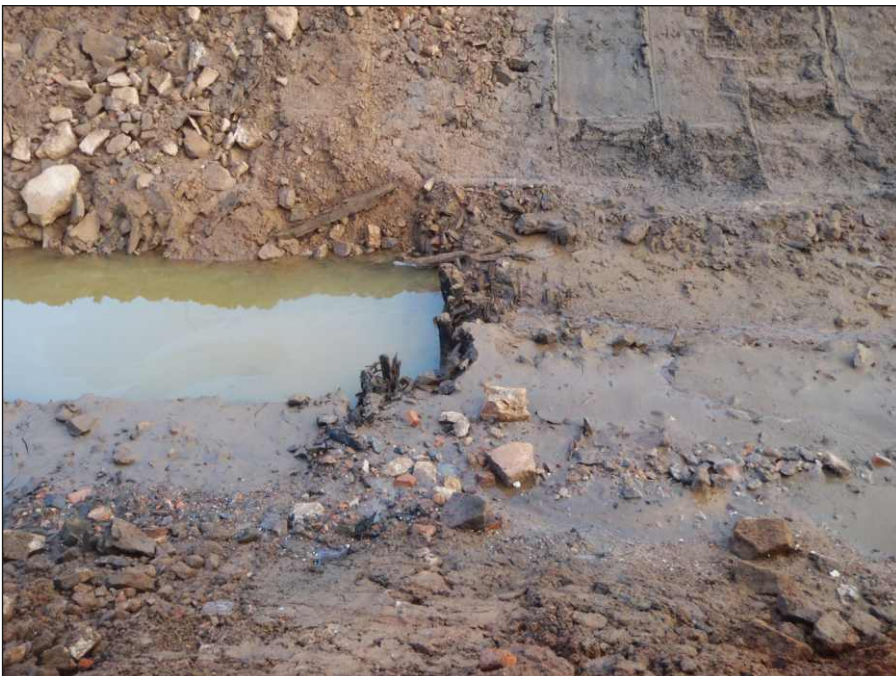
Plate 5: Timber piles in base of mill race channel. View to northeast

- 5.3 Mill race** (Plan Fig. 3; Plates 1 and 5-7)  
Most of the temporary river diversion channel was excavated along the route of the mill race but with a broader profile. The base of the channel contained a series of timber piles that were driven into the river gravels (Plate 5). These measured up to 2.3m long and 0.4m in square and were machine sawn (Plate 6). Although most of these had been removed prior to the commencement of monitoring, a surviving section showed that they were set throughout the channel and were likely to have supported an overlying stone base to the mill race (also removed). At the northwest extent of the temporary channel, the continuation of the mill race was partially exposed and comprised of stone walls and an arched span sealed by made ground (Plate 7).

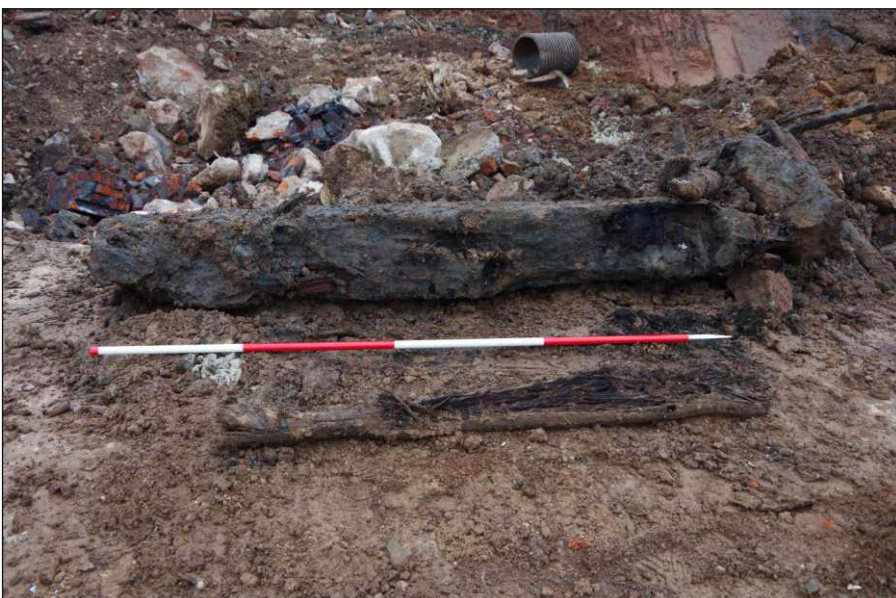
Plate 6: Showing example of displaced mill race timber piles (scale 2m)

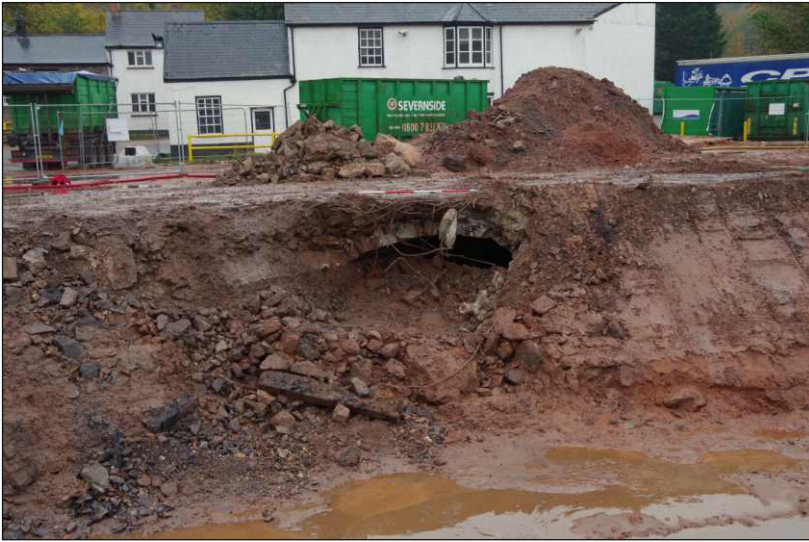
Plate 7: Showing partially exposed mill race culvert. Looking southwest towards Cottage Office Block (scale 2m)

- 7.1** Groundworks had started prior to the involvement in the project by AC archaeology, with these commencing with the excavation of the temporary river diversion channel broadly along the line of the existing mill race. Despite these excavations having already removed this part of the site ahead of site attendance, the surviving element of the mill race structure consisted of the abundant timber piles driven into the river valley alluvial deposits. As had been recorded within the Higher Leat at Cricklepit Mill, Exeter, timber piles had been used to support a post-medieval flagstone base (Passmore 2010). It was not possible to investigate the leat channel as it exited the site from the northeast end of the temporary river diversion channel to confirm this, but based on discussions with the site contractor, this construction methodology had also been evident in the Silverton Mills mill race. Historic mapping indicates that the leat was culverted in the period between the 1842 Broadclyst parish tithe map and the 1888 First-Edition Ordnance Survey map. It is likely that the culverting of the leat would have comprised the upgrading of its base and walls in order to support the arched span.

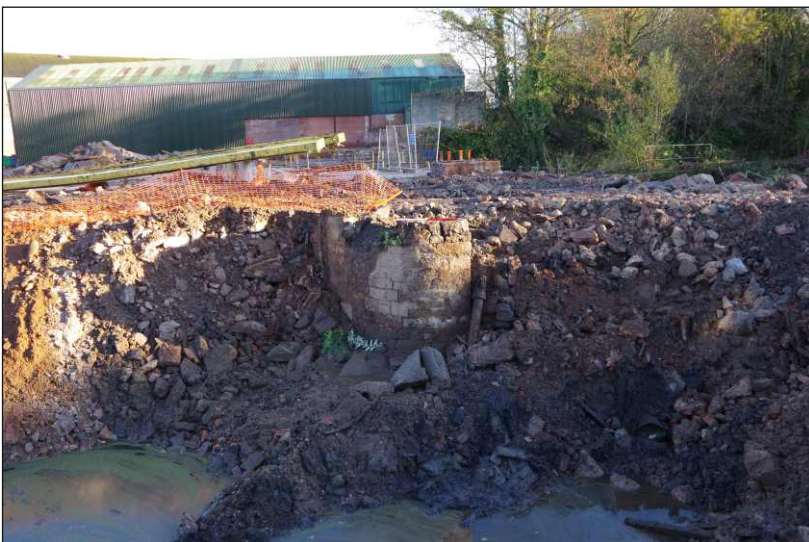
Plate 8: Sluice channel wall terminal S104. View to northeast (scale 1m)

At the southeast end of the temporary river diversion channel were the remains of a 3.7m wide north to south aligned sluice channel that had fed into a wheel pit and later a turbine pit (Watts and Watts 2000), with the channel then debouching into the River Culm. This was principally comprised of two roughly faced 0.9m thick lime mortar bonded block walls (S104 and S113). Wall S104 terminated to the south with a curved terminal, a quoined southeast corner and a flat east face (Plates 8-9). This design suggests that it functioned as both the mouth of the sluice channel and perhaps either the transition from an unrevetted mill race channel extending from the head weir or a further sluice arrangement as the mill race entered the site. Adjacent to the curved terminal and on the west face was a sluice gate slot. On the southeast side of wall S104 was an integral semi-circular structure (Plate 10). Wall S104 was abutted by a circular stone rubble and concrete bonded wall (S103), while the channel was blocked by a brick wall to the northeast and a cast concrete wall to the southwest (Plate 11). These additional structures corresponded with the location of a late 19th and 20th century pump house with turbine pit and an associated water chamber for the pumps.

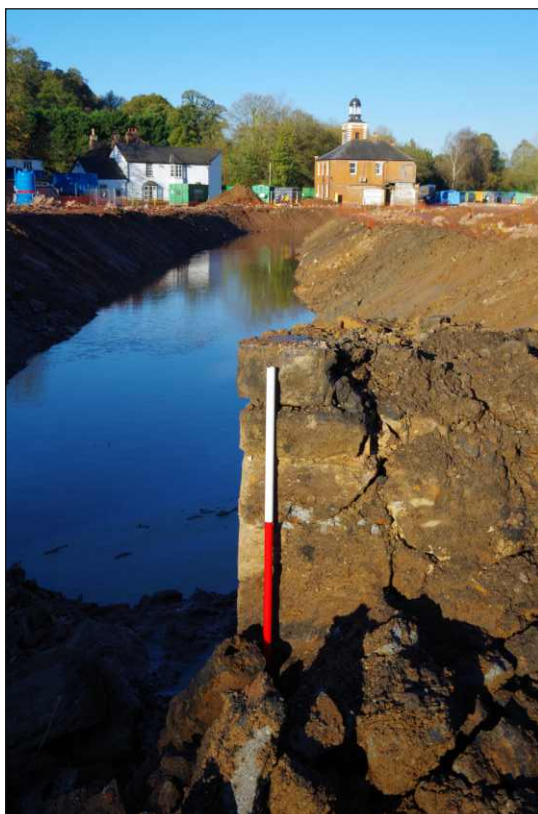
Plate 9: Sluice channel wall terminal S104. View to southwest (scale 1m)

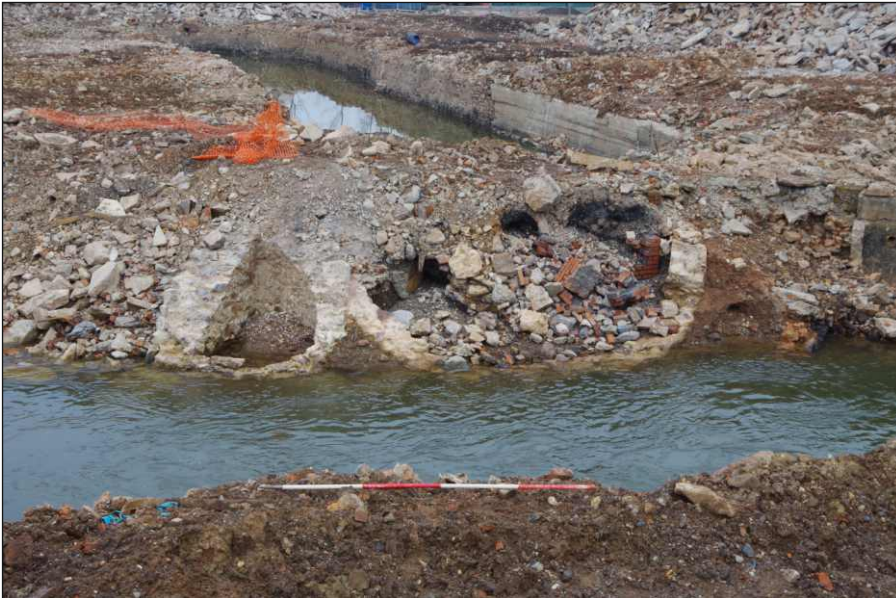
Plate 10: Sluice channel wall S104 and wall S103 with River Culm revetment S115 to the rear. View to northwest (scale 2m)

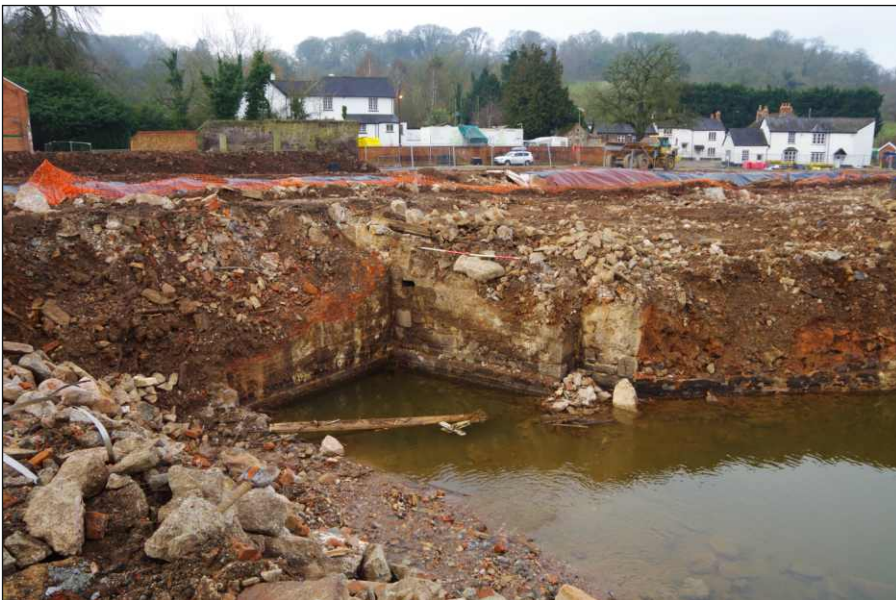
Plate 11: Sluice channel wall S113, wall S118 and river revetment S114. View to southwest (scale 2m)

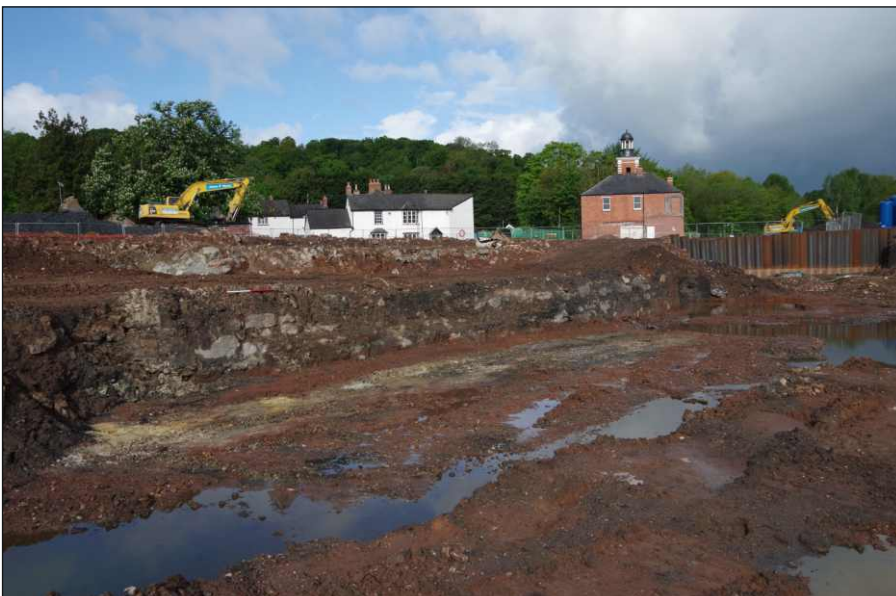
Plate 12: Tailrace wall S112. View to southeast (scale 2m)

**5.5** The groundworks exposed most of the south wall to the tailrace exiting from the sluice channel in the southeast of the site (Plates 12-14). Tailrace wall S112 measured 0.6m thick, approximately 1.3m high and was constructed from roughly faced unbonded stone blocks measuring between 0.4m to 0.9m in length. It was constructed on the underlying river gravels and retained the overlying alluvial clays. It was abutted by a phase of the river revetment wall (S119) to the west, while to the southeast it curved south into an area undisturbed by deep groundworks. The north wall of the tailrace channel was not exposed during the monitoring, although a quoined terminal (S118) that was abutted by channel wall S113 may have formed part of this structure.

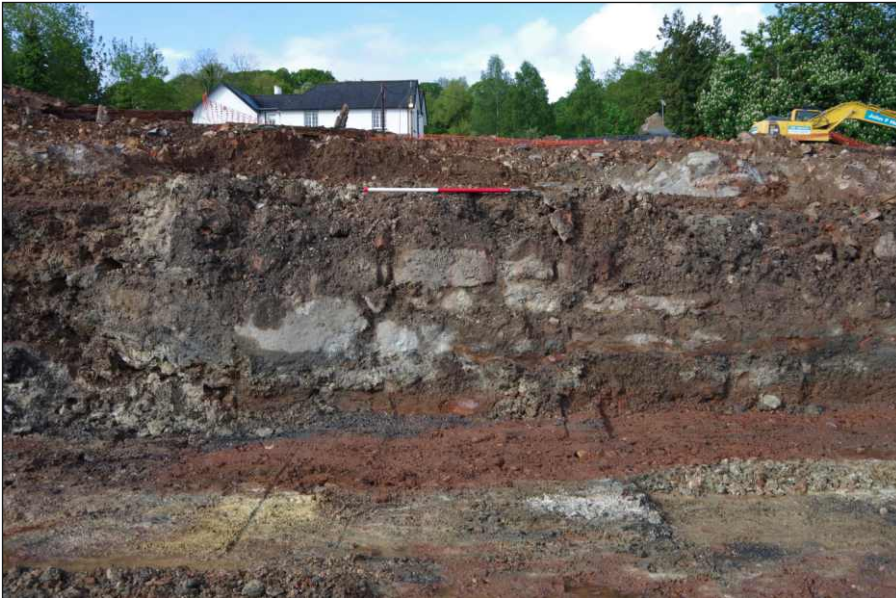
Plate 13: Detailed view of tailrace wall S112. View to southeast (scale 1m)

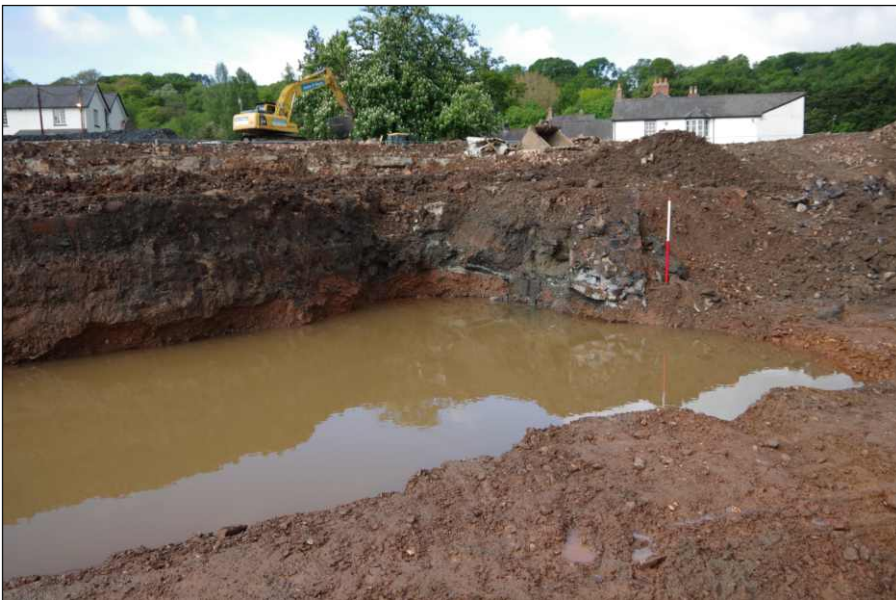
Plate 14: Showing tailrace wall S112 with river revetment S119 in section. View to west (scale 1m)

blocking of the tailrace would also have coincided with the construction of a section of river wall S119 to the west. Based on the historic mapping, this would have occurred at the end of the 19th century, a date that perhaps coincided with the installation of a vertical shaft water turbine around 1889 (Watts and Watts 2000); a development that would have replaced what would probably have been an earlier wheel pit.

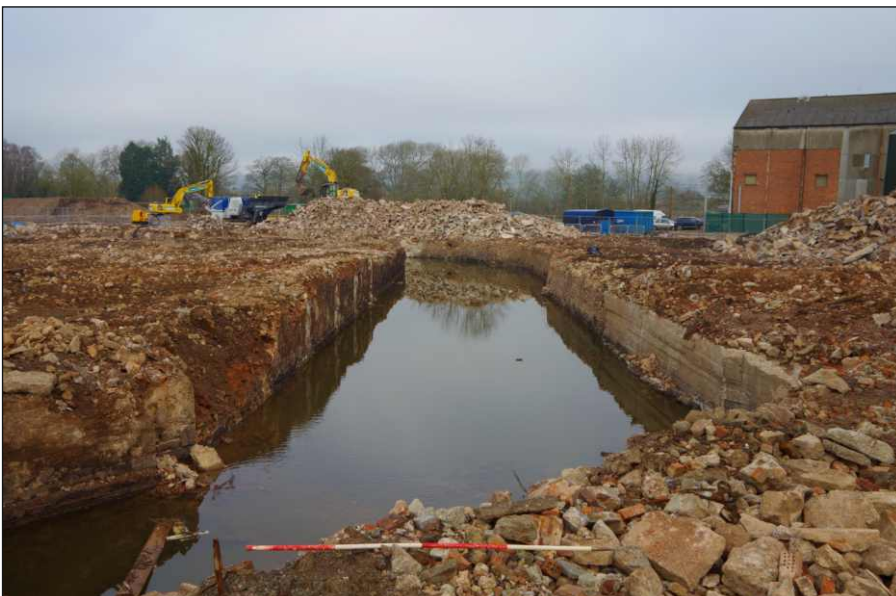
Plate 15: River Culm revetment walls S114 and S115. View to northwest (scale 2m)

**5.6** The River Culm channel was bounded by revetment walls S114 and S115 that formed a 9.5m wide river channel to the east, while to the west it broadened to 15m (Plates 15-19). The curved alignment of wall S114 extended a maximum of 21m north of wall S112. Apart from some sections that had been replaced with cast concrete or modern blockwork, the walls were constructed from lime mortar bonded random roughly faced stone blocks with a rubble core. The southeast end of wall S114 abutted quoined terminal S118 (Plate 11). The east end of wall S114 was abutted by the further section of wall S119, which extended across what would have been the exit point of the mill race (Plate 20). A single slot representing part of a possible sluice arrangement was present in wall S114 close to its north extent and in the approximate position where the north range had extended (Plate 21). Within the east portion of wall S115 was a 5m wide break that was infilled with stone blockwork (Plate 22). The function of this was not clear and did not correspond with any features shown on the historic mapping.

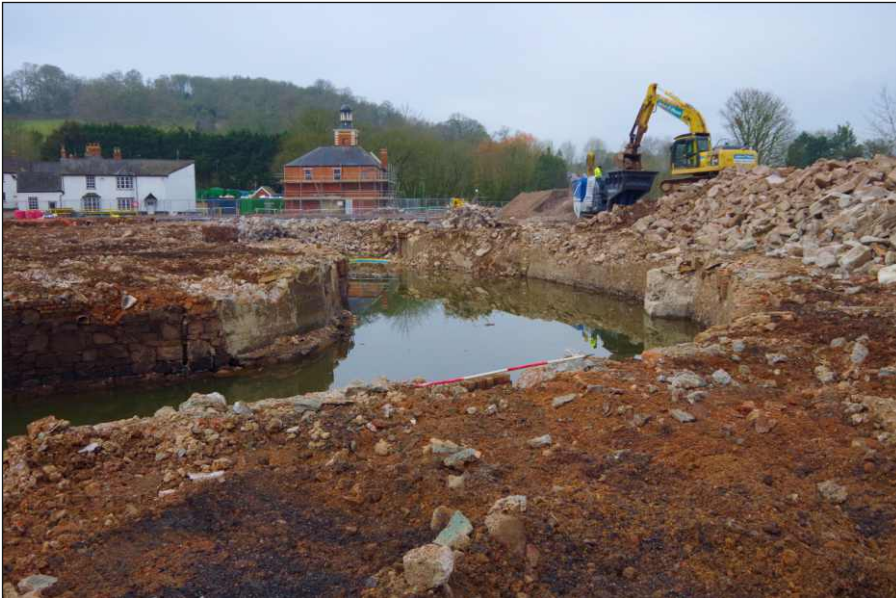
Plate 16: River Culm revetment walls S114 and S115. View to southwest (scale 2m)

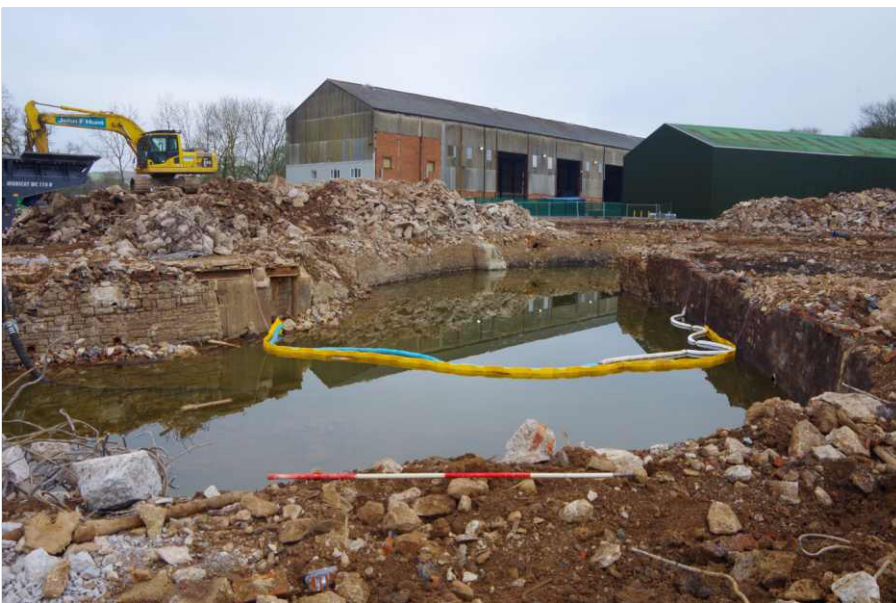
Plate 17: River Culm revetment walls S114 and S119. View to east (scale 2m)

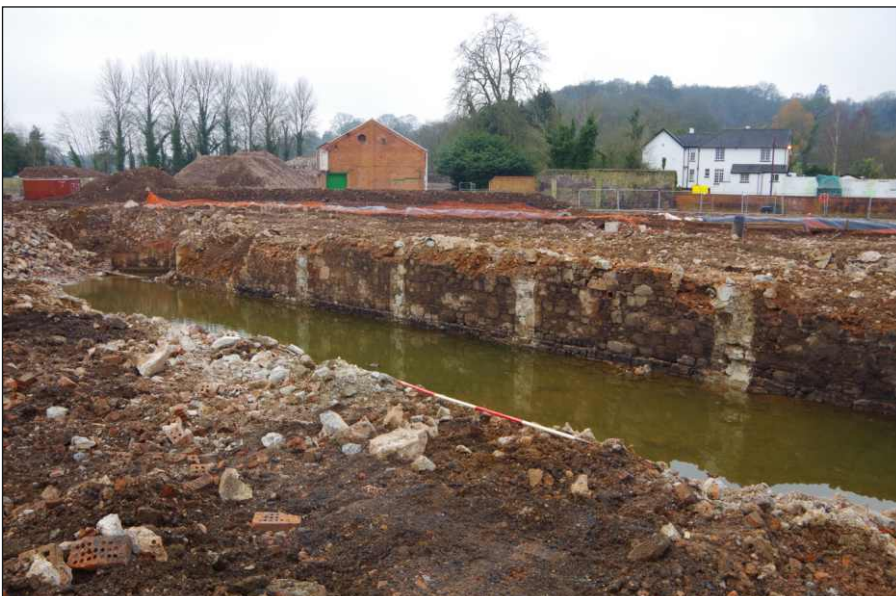
Plate 18: River revetment wall S114. View to south (scale 2m)

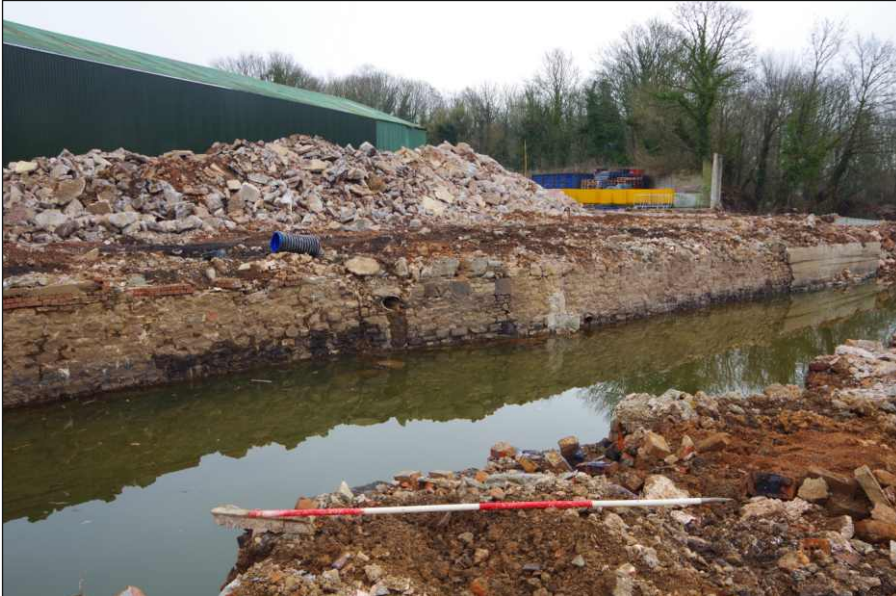
Plate 19: River revetment wall S115. View to east (scale 2m)

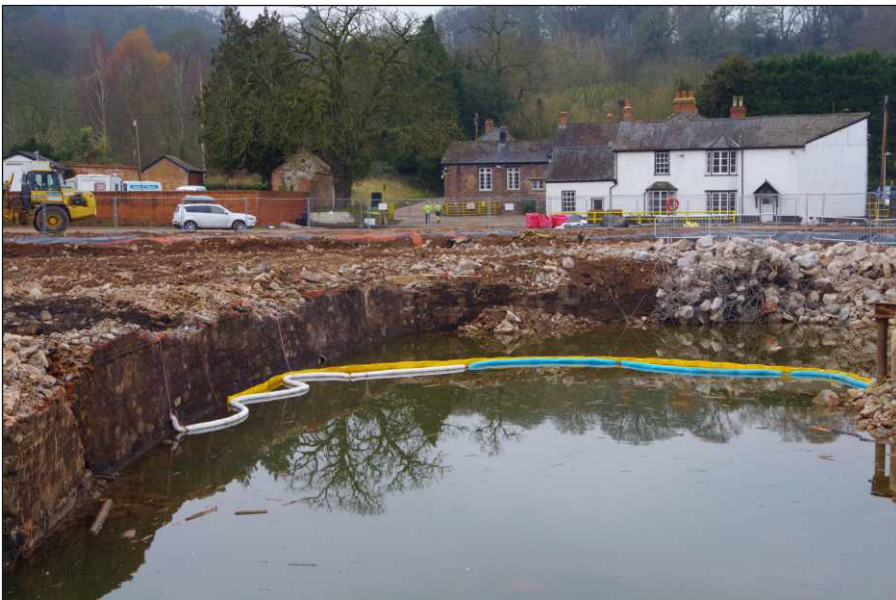
Plate 20: Showing river revetment wall S119 between wall S114 to left and tailrace wall S112 to the right. View to south (scale 2m)

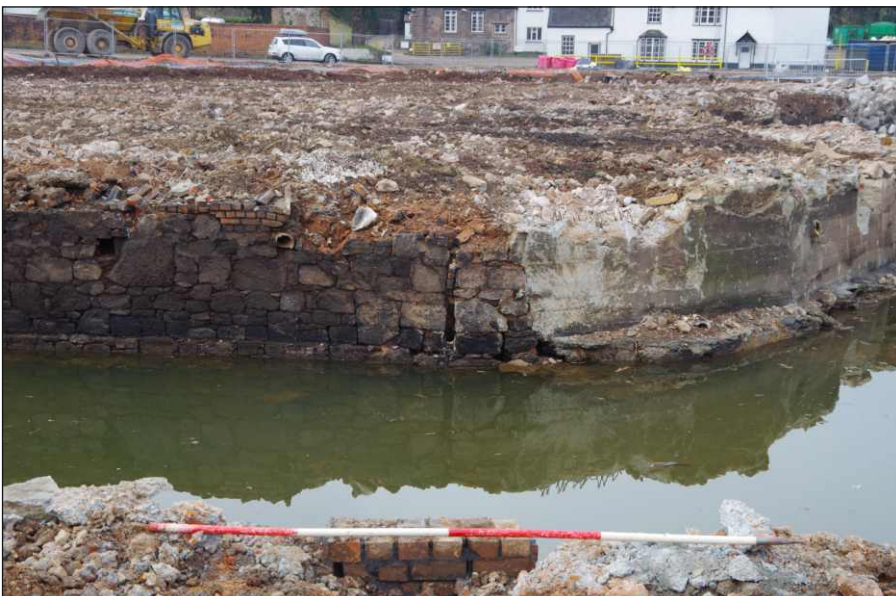
Plate 21: Showing slot in river revetment wall S114. View to southwest (scale 2m)

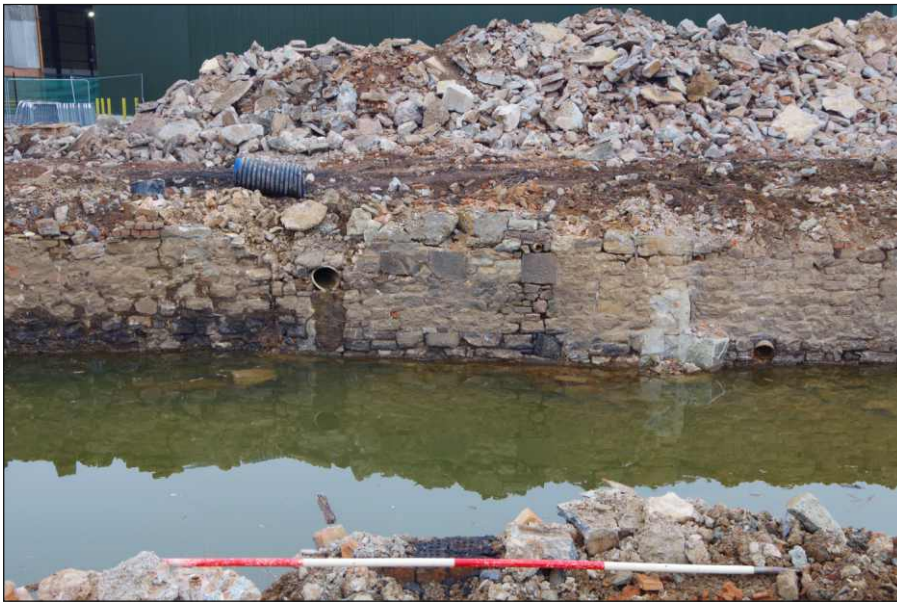
Plate 22: Showing possible blocked opening in river revetment wall S115. View to northeast (scale 2m)

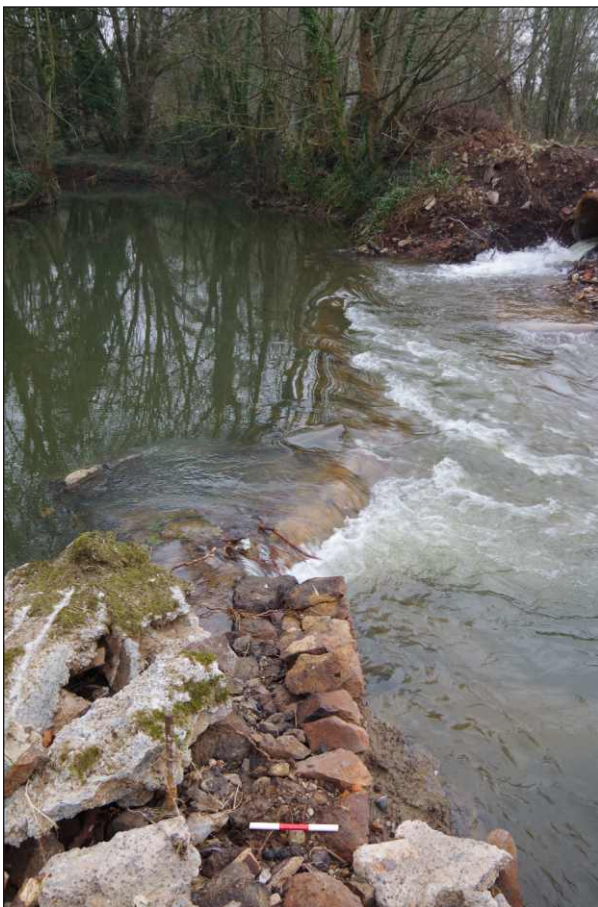
Plate 23: River revetment wall S105. View to east (scale 0.3m)

**5.7** Approximately 18m to the east of the sluice channel formed by walls S104 and S113 was a short section of river revetment wall (S105). This measured 0.65m wide and was comprised of roughly faced stone blocks in a lime mortar bond (Plate 23).

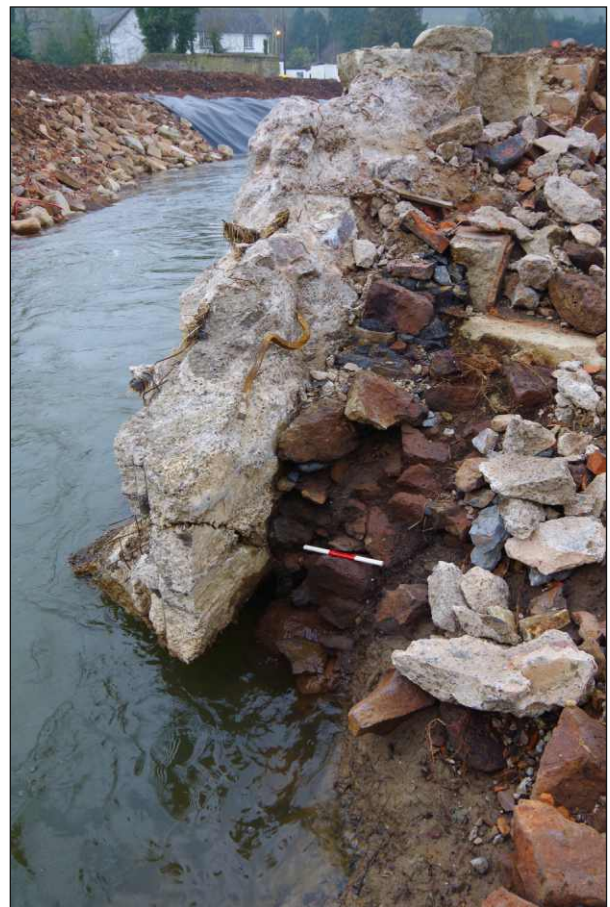
Plate 24: Wall S106. View to west (scale 0.3m)

**5.9** Walls S106 and S107 measured approximately 0.5m wide and were constructed from roughly faced blocks and rubble (Plates 24 and 25). Wall S106 had been partially encased in a reinforced cast concrete wall. Wall S108 was northwest to southeast

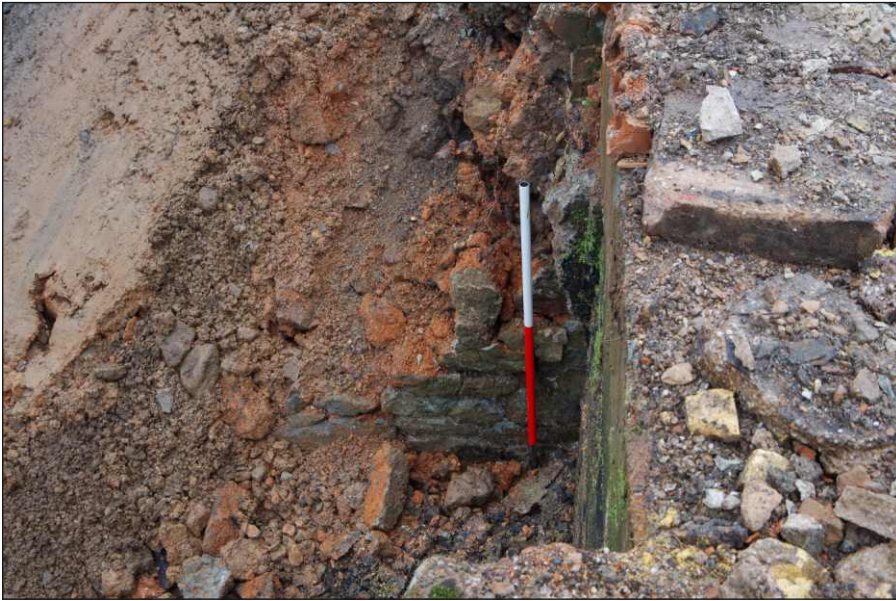
Plate 25: Wall S107. View to west (scale 1m)

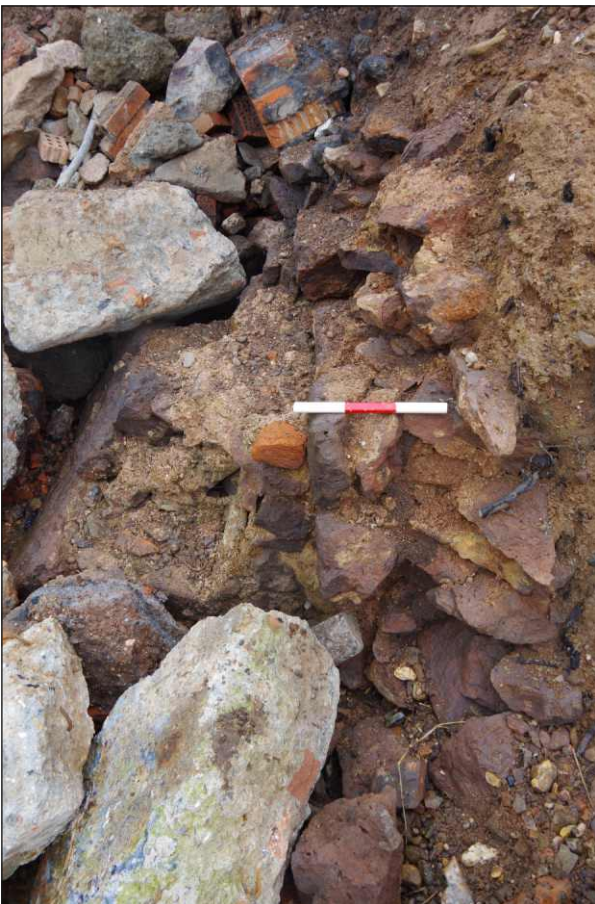
Plate 26: Wall S108. View to east (scale 0.3m)

aligned and had an angled buttress on its northeast side (Plate 26). It was set within a construction cut that had been excavated through the alluvial clays and backfilled with light reddish-brown silty-sand. A fragment of 18th to 19th century clay tobacco pipe was recovered from the construction cut backfill.

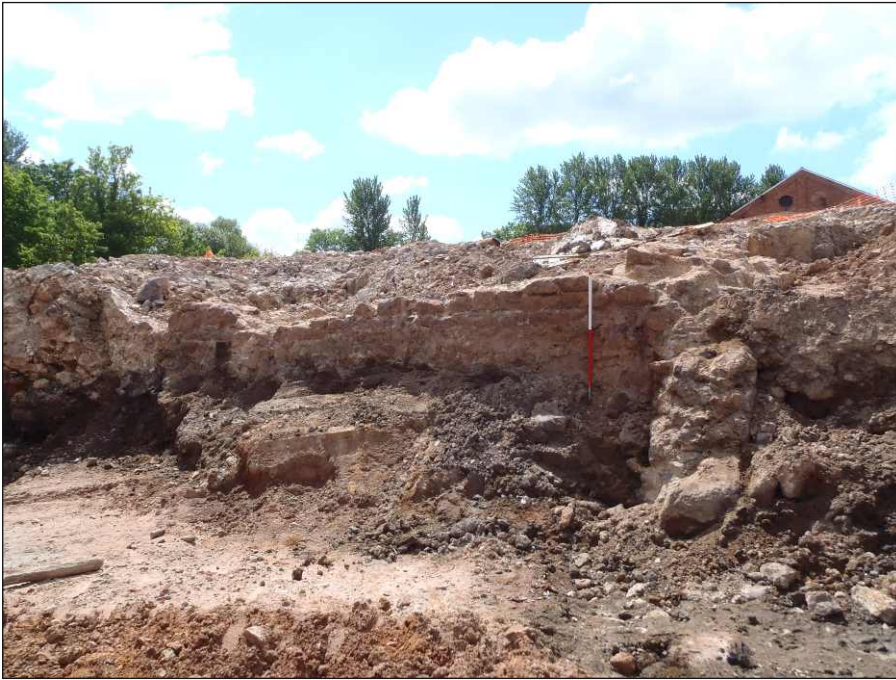
Plate 27: Tailrace wall S112 with walls S111 and S116. View to south (scale 1m)

- 5.10** Partially exposed walls S111 and S116 abutted the northeast and southwest side of millrace wall S112 and broadly corresponded with the site of mid to late 19th century North Range (Plate 27). Comprised of roughly faced lime mortar bonded blocks the walls measured 1.15m wide, with wall S111 possibly returning into a square terminal to the southwest. Here a probable step threshold was present comprised of rendered stone (Plate 28). To the southeast, wall S117 was only partially exposed, with this likely to have formed part of the same overall structure.

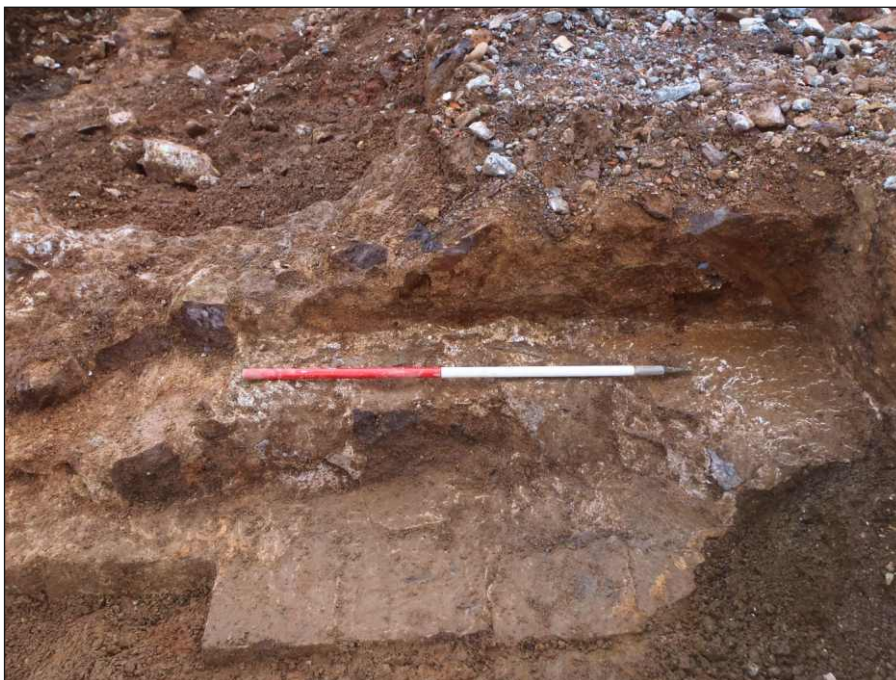
Plate 28: Showing possible steps in wall S111. View to east (scale 1m)
