# LAND AT CURRYPOOL FARM, CURRYPOOL LANE, CANNINGTON, BRIDGWATER, SOMERSET

Results of Archaeological Monitoring and Recording

Sedgemoor District Council Planning Reference:  
45/18/00004

Report No: ACD1830/2/0

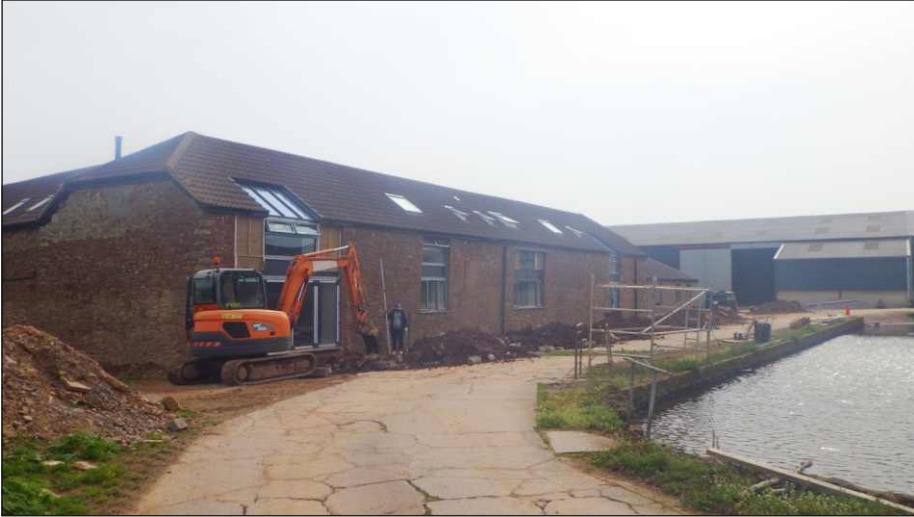
Plate 1: General working view of site looking southeast with L-shaped pond in foreground

- 5.1** The drainage trench extended along the west side of the barn and was excavated to a depth of 0.65m below existing levels (Plates 1-3). Natural subsoil, which consisted of abundant gravels in a mid red sandy-loam matrix was exposed at a depth of 0.3m below existing levels (Plate 4). It was overlain by a mid brownish-red sandy-loam subsoil, which was 0.2m thick. This was sealed by a mid brown silty-loam topsoil.
- 5.2** No archaeological features or deposits were exposed by the work and no finds were recovered.

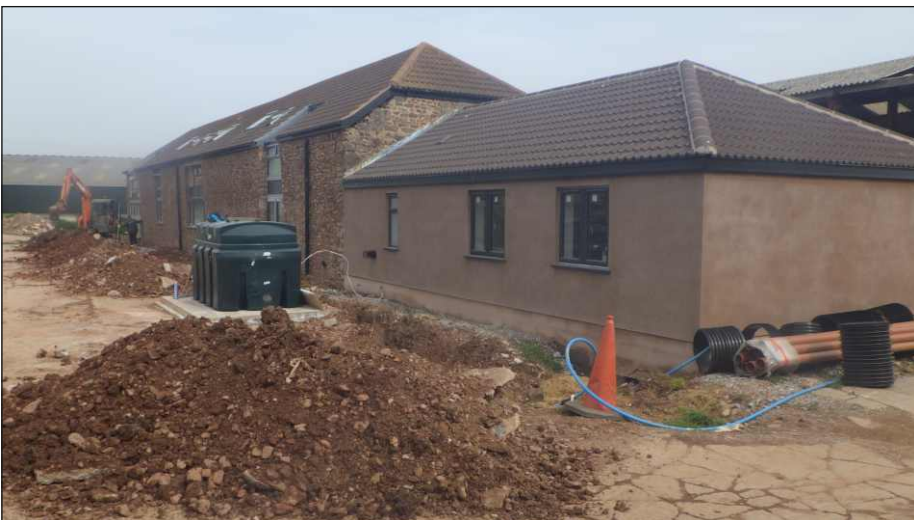
Plate 2: Working view of groundworks, looking north

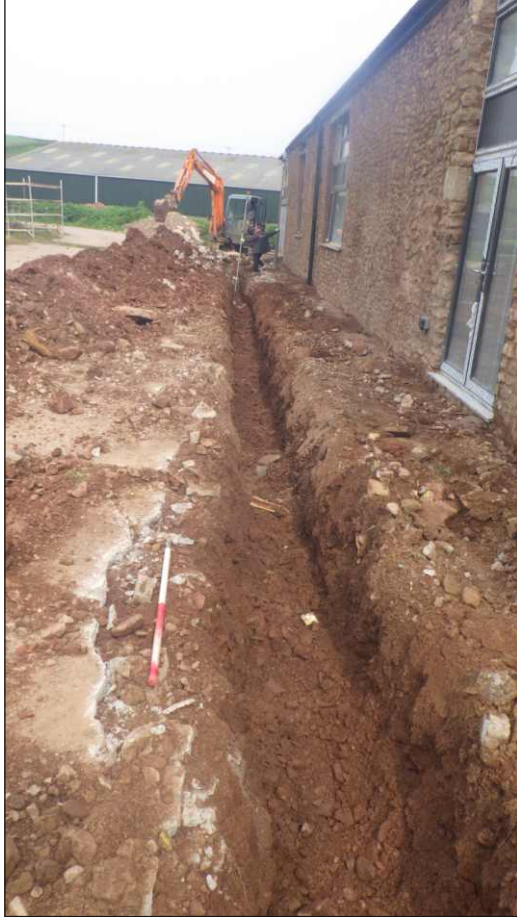
Plate 3: View of excavated trench, looking northwest (scale 1m)

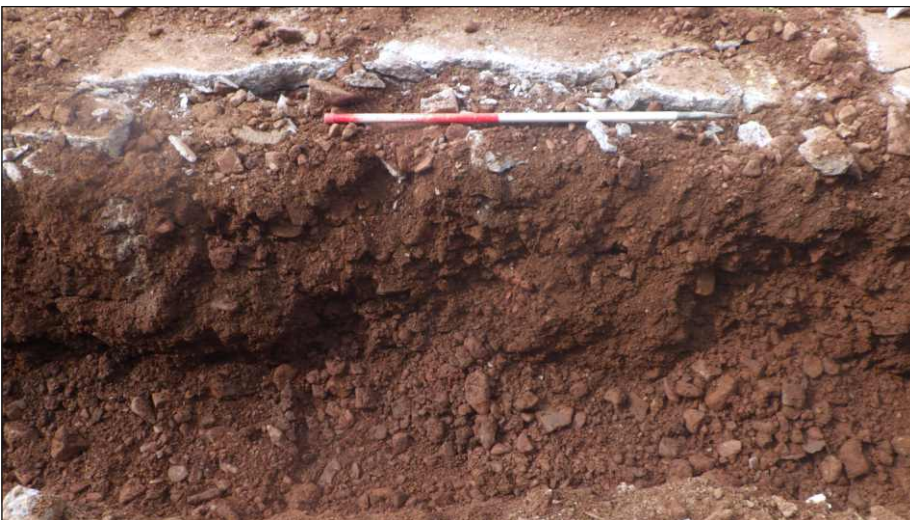
Plate 4: Showing representative section of excavated trench (scale 1m)

- 6.1** The groundworks exposed a simple sequence of topsoil and subsoil overlying the natural subsoil. Despite the location of the site as potentially within a possible deserted medieval village, the limited groundworks did not exposed any evidence for earlier settlement.
