ST KATHERINE'S CHURCH, HOLT, WILTSHIRE:

Results of an archaeological watching brief

Document No: ACW1219/1/0

Date: September 2019

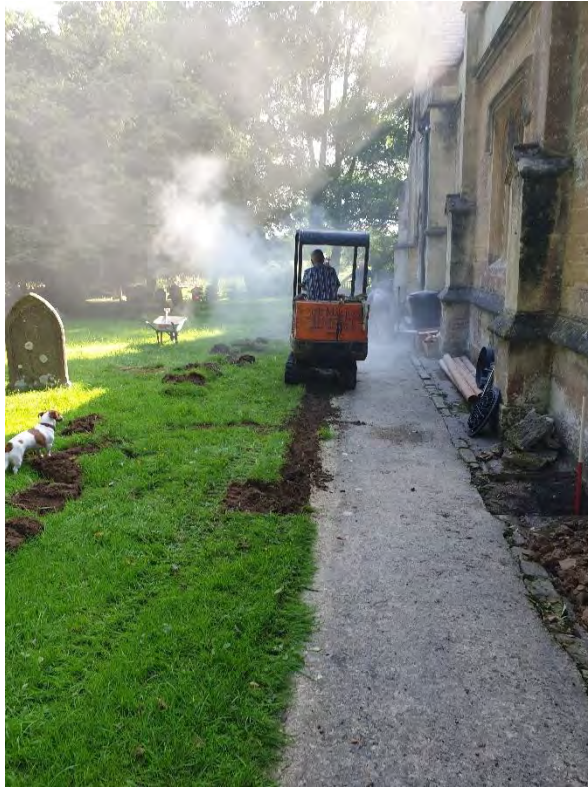
Plate 1. View to the east following removal of the turf

This report describes the results of an archaeological watching brief undertaken August 20th during the installation of new a drain along the north side of St Katherine's Church, Holt, Wiltshire. The works comprised the mechanical excavation of a 0.2m wide east-west trench for a distance of 11m adjacent to the north wall of the nave and two short north-south trenches to connect with existing drains. The east-west trench was 0.3m deep at the west end and 0.45m at the east. Following removal of the turf (Plate 1) the excavation of the trench was monitored by the archaeologist in attendance.

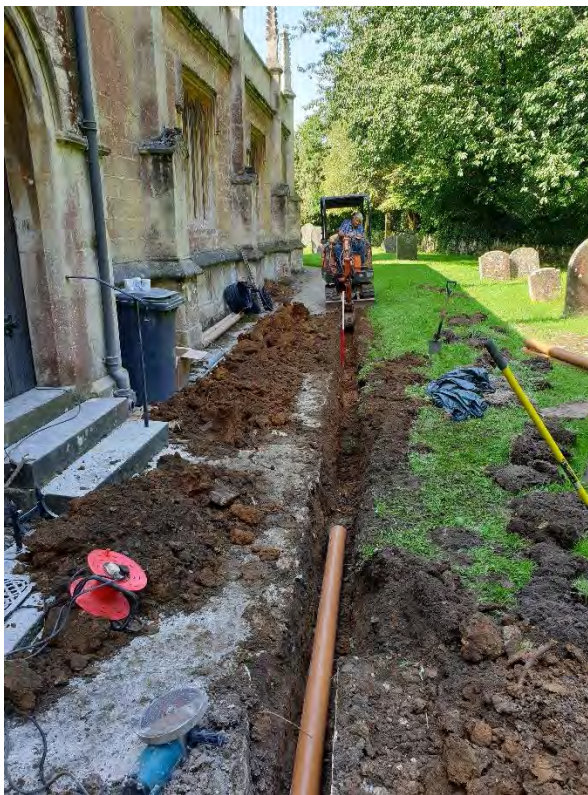
Following the removal of turf and topsoil the subsoil, comprising orange/brown clay, was removed to the required depths (Plate 2). The clay contained fragments of limestone, brick and breeze block indicating prior disturbance and episodes of re-deposition. Excavation of a new pipe junction against the north wall of the nave exposed the foundations of the 1889 rebuild (Plate 3).

Plate 2. View to the west following excavation of the trench

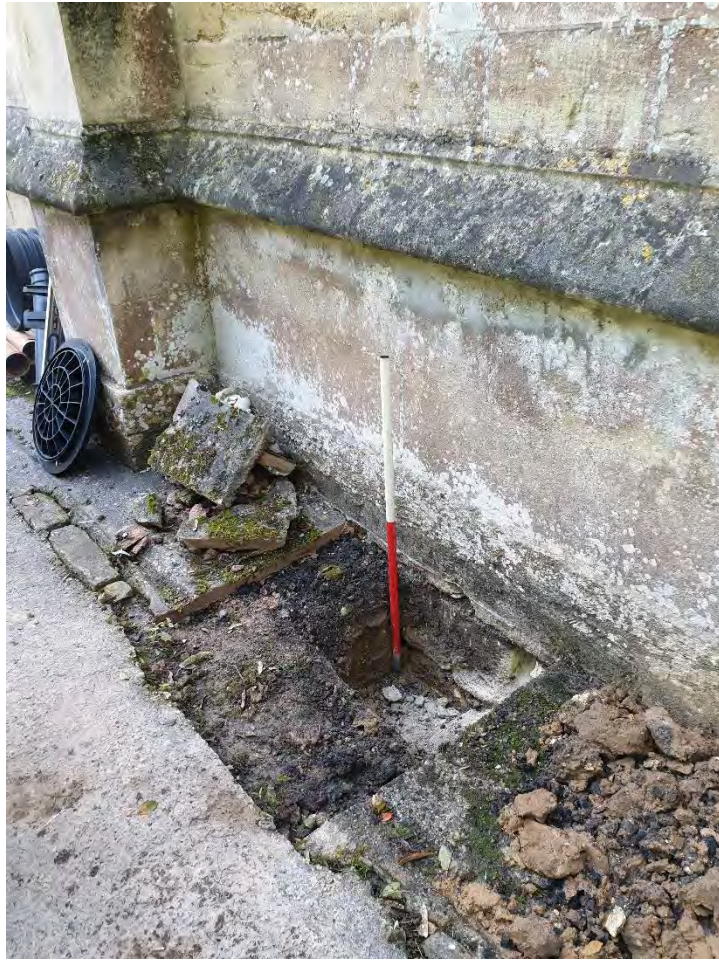
Plate 3. Exposed footings of the 1889 rebuild of the north wall of the nave. View from the north-west
