Land off Station Road, Tidworth, Wiltshire:

Results of an archaeological evaluation

Document No: ACW1213/2/0

Date: August 2019

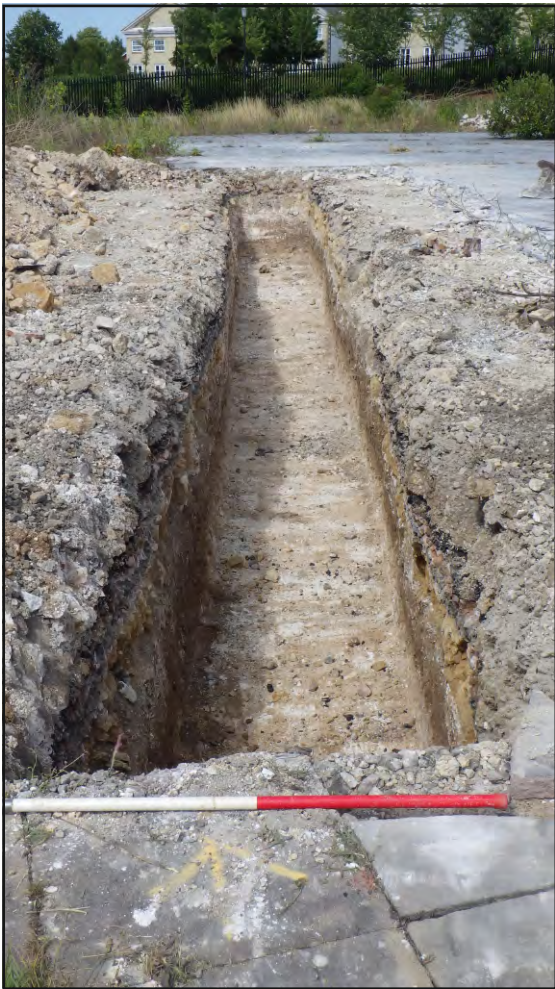
Plate 1: Trench 1, view from the south-west.
(scale 1m)

5.1 This trench measured 20m in length and 1.2m in width and was excavated to a maximum depth of 1.6m. A sequence of modern construction layers, overlying natural sub-stratum, was encountered. No archaeological cut features were revealed anywhere within the trench. The recorded layer sequence is summarised in Table 1.

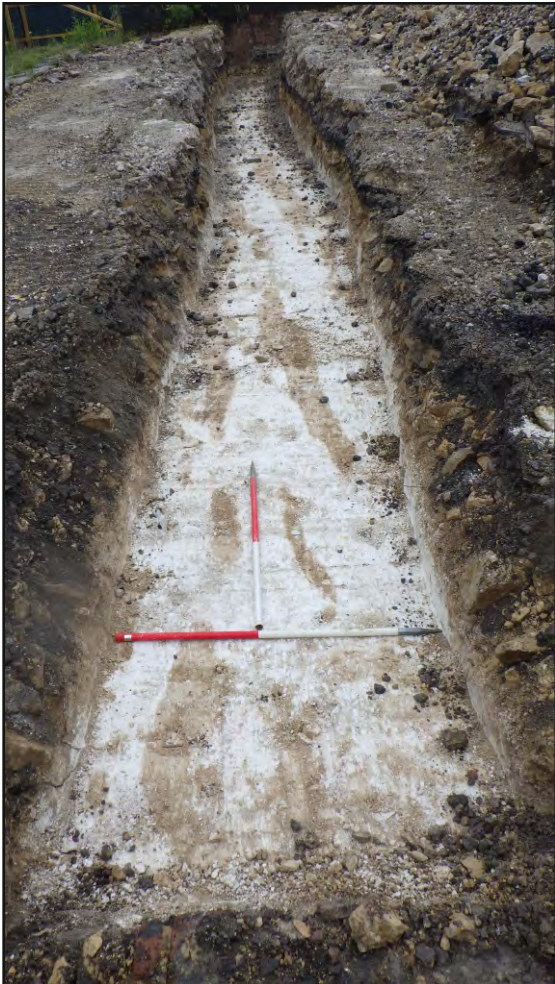
Plate 3: Trench 2, view from the east.
(scale 2x1m)

5.2 The trench measured 20m in length and 1.2m in width and was excavated to a maximum depth of 1.2m. A sequence of modern construction layers overlying natural sub-stratum was encountered. No archaeological cut features were revealed anywhere within the trench. The recorded layer sequence is summarised in Table 2.
