THE FORMER QUINCE HONEY FARM, NORTH ROAD,  
SOUTH MOLTON, DEVON

Results of historic building recording

North Devon Council planning reference 70614, conditions 2  
and 8, and planning reference 70620, condition 2

Document No: ACD2208/2/1

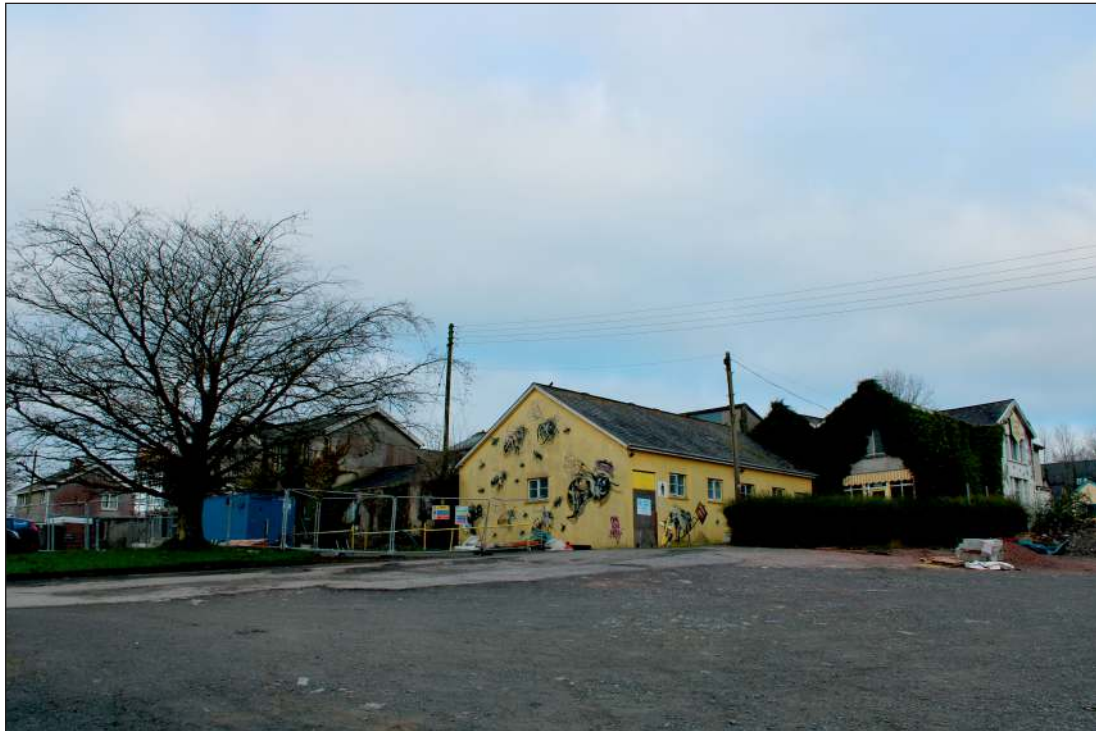
Plate 1: View looking northwest from the car park showing the south range (left), toilet block (centre) and east range (right)

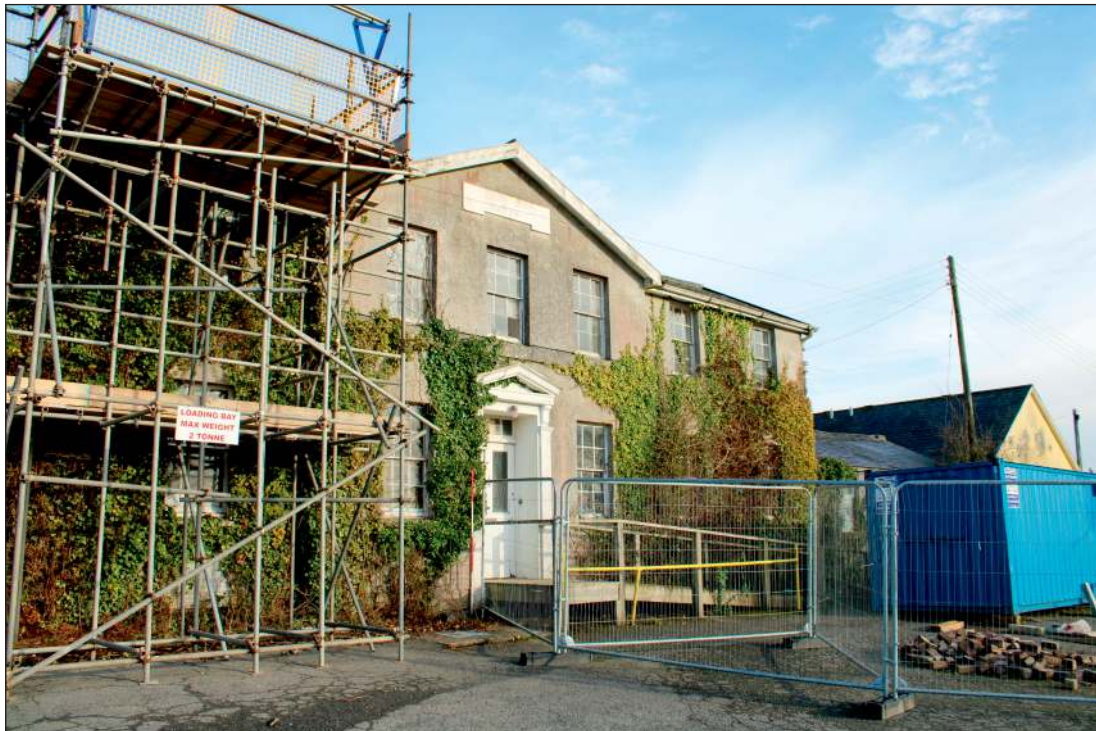
- 4.2 This was the main entrance and contained some of the administrative functions and some of the accommodation for children (Plates 1 and 2). Its principal elevation faces south onto the entrance driveway from North Road. The walls are rendered stonework. The central section survives intact and is two storeyed over a basement with a slightly projecting central bay. To the east there is a single-storey block, then a detached taller single-storey 1970s or 1980s toilet block. Original buildings, along with the early extensions, to the west have been demolished, with only a length of stone wall representing an internal partition surviving.

Plate 2: The central section of the south range, looking northeast (2m scale)

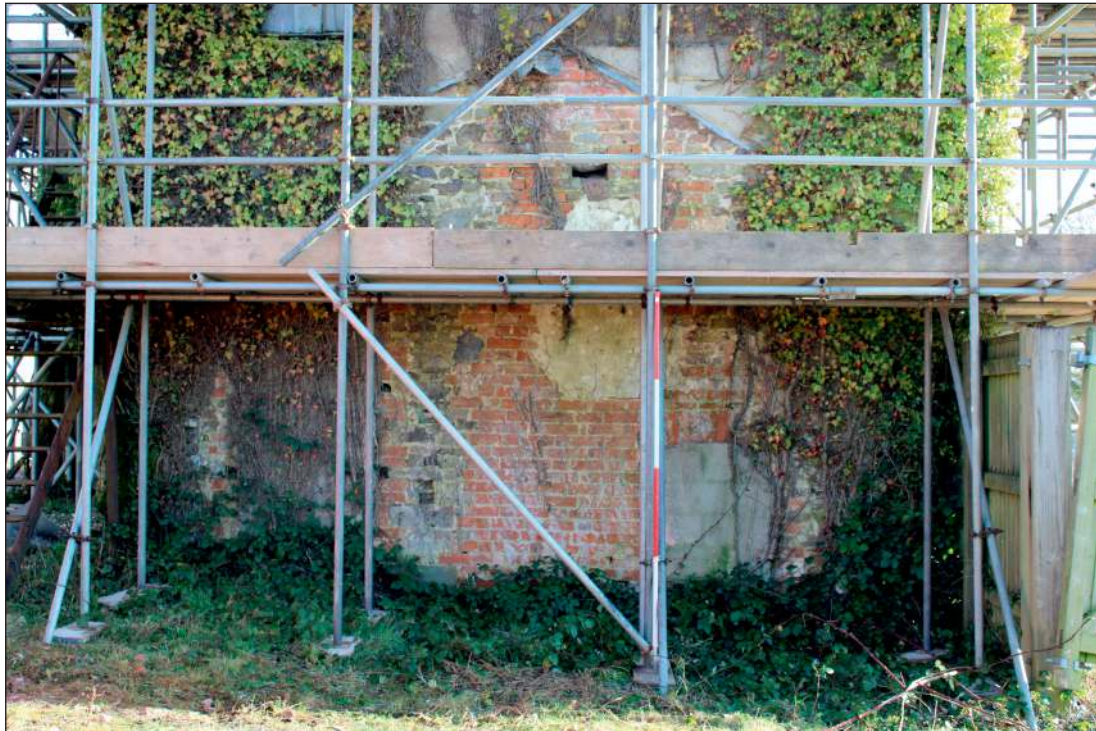
- 4.4 The west elevation of the central section displays a scar of the pitched roof of the demolished lower block to the west, along with scars of its north and south walls (Plate 3). The masonry is mostly brickwork, from a central chimney stack (that is visible in a photograph reproduced at <http://www.workhouses.org.uk/SouthMolton/>). There is a door to the north with brick jambs and a blocked fireplace opening to the south, again with brick jambs and with an arched head. Both have concrete block infilling. Above the roofline there are the remains of a first-floor sash window.

Plate 3: The west elevation of the central section of the south range, looking east showing blocked openings and roof scar (2m scale)

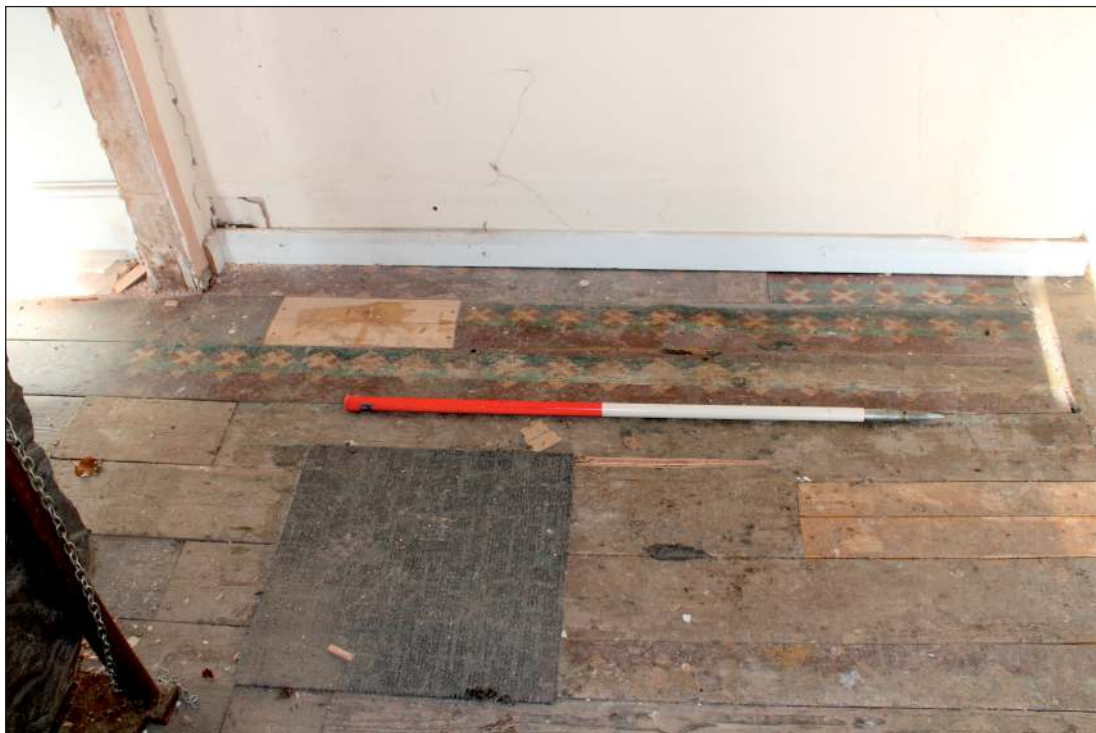
Plate 4: The painted floorboards in the entrance hall of the south range, looking north (1m scale)

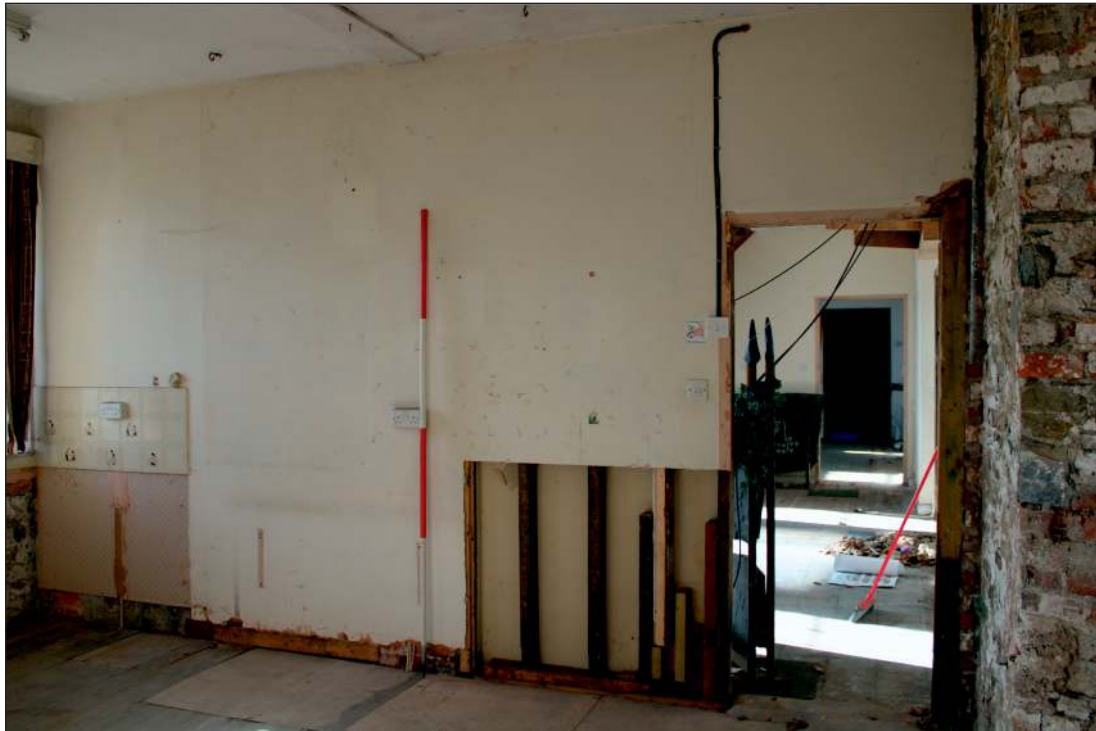
- 4.9** The main front door leads onto the central room where there are modern stairs up to the first floor and below down to the basement. Fixtures and fittings comprise some floorboards, which in part are painted in a Victorian tile design (Plate 4), shutters to the west window opening and some adjacent cornice and dado rail detailing; otherwise, the finish is entirely modern. There is a central doorway to the link to the north, and at the north end doorways into the adjacent rooms. The eastern doorway is a recent insertion replacing a doorway immediately to the south. This partition is constructed of a mixture of stone, brick and a modern timber frame (Plate 5).

Plate 5: The east partition to the entrance hall of the south range, looking west from the adjacent room (2m scale)

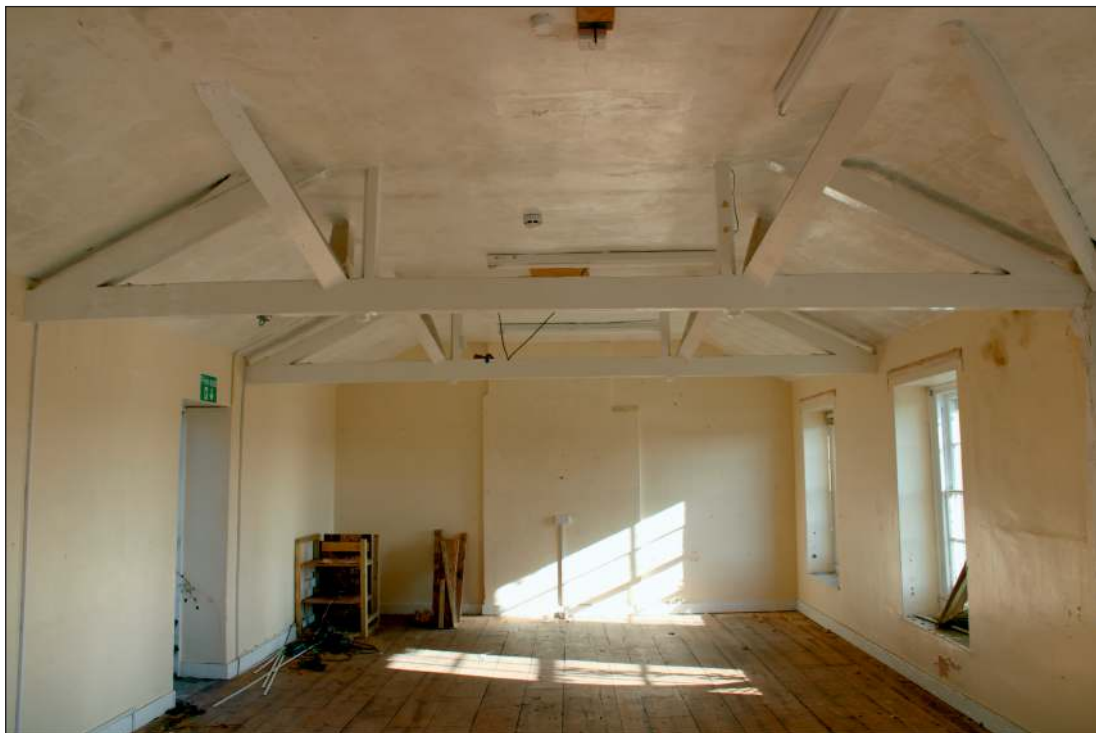
- 4.13** There is a first floor over the central block only and this is currently almost entirely a single space, with a pair of smaller rooms at the west end (Plate 6). These are modern additions with plasterboard partitions. Other than the roof (see below) the only fittings are the wooden floorboards. There is a blocked fireplace in the east wall, and a photograph showing a chimney stack at the west end (reproduced at (<http://www.workhouses.org.uk/SouthMolton/>)) indicates there was another fireplace at this level, probably indicating that this floor was divided into two spaces. The link also had first-floor accommodation, now a single space; formerly it contained the staircase from the ground floor. There were probably other rooms, perhaps, given the small closely-set windows, a series of toilets/washing rooms.

Plate 6: The first floor of the south range, looking east showing the roof structure

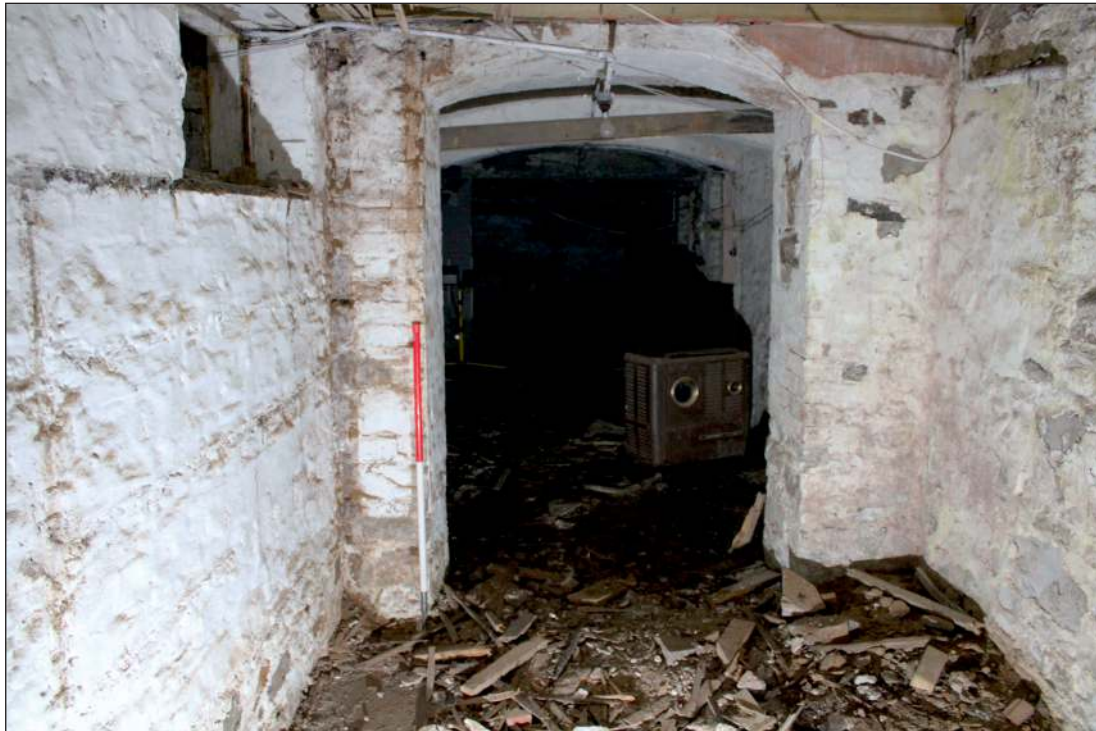
Plate 7: The north rooms with vaulted ceilings in the basement, looking south (1m scale)

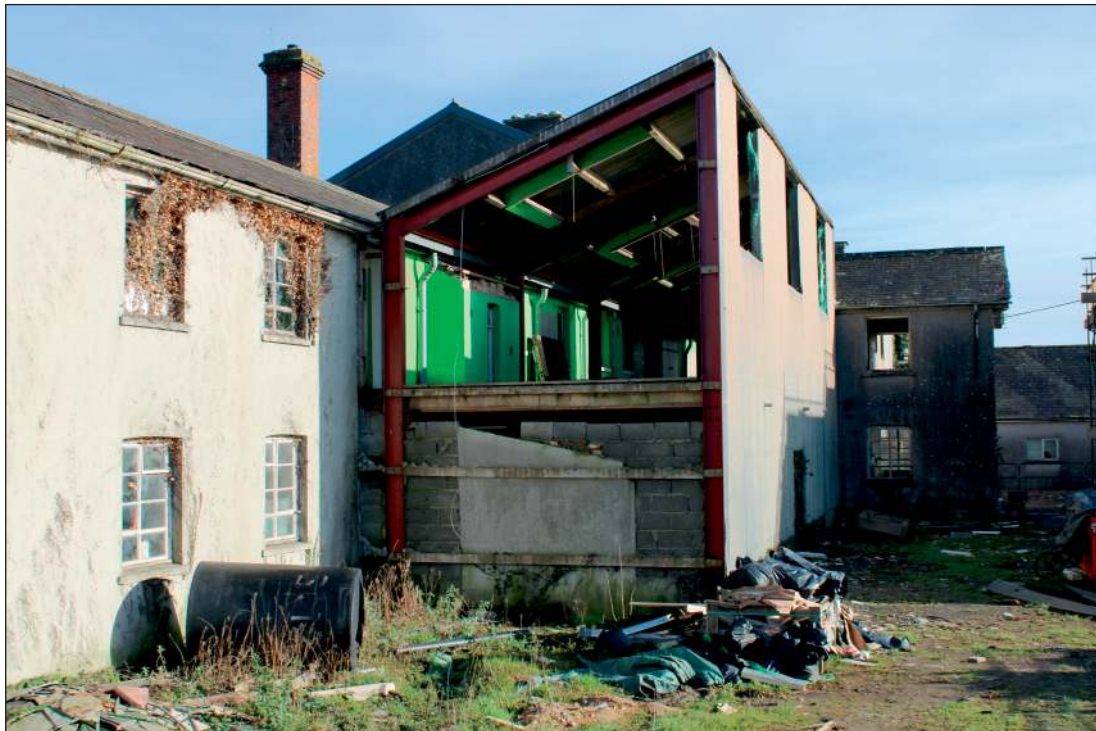
Plate 8: The south elevation at the west end of the central range showing 1970s addition and link to the south range beyond, looking east

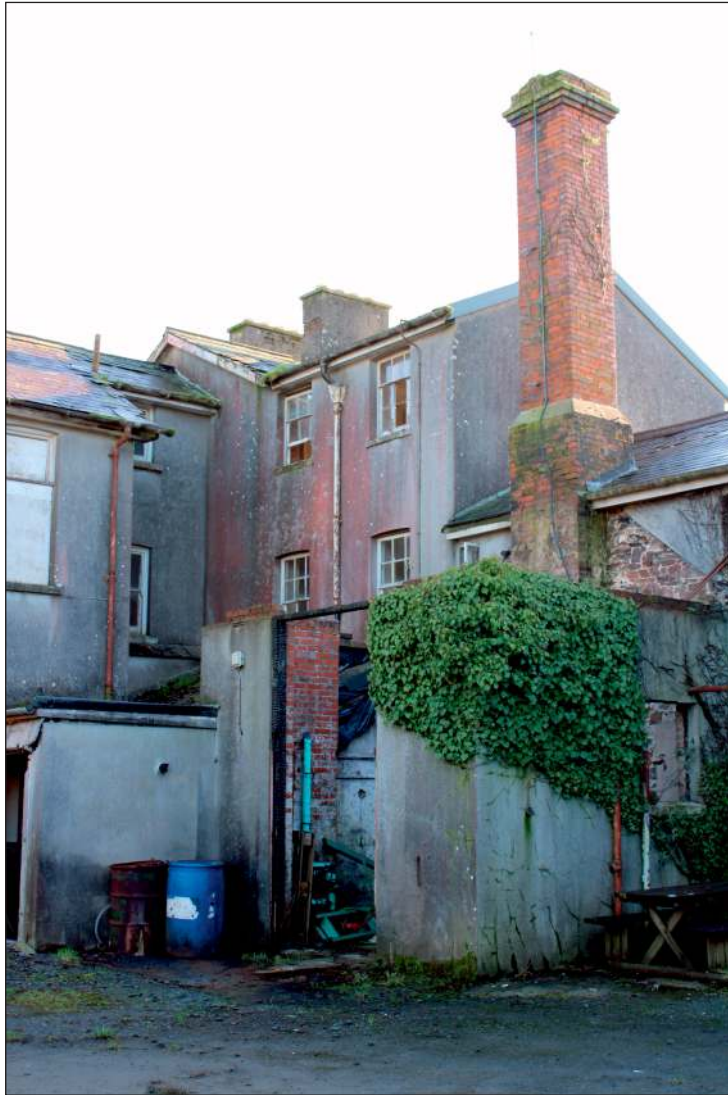
Plate 9: The north elevation of the central range, west section looking southeast showing boiler room and kitchen extensions with the taller central section beyond

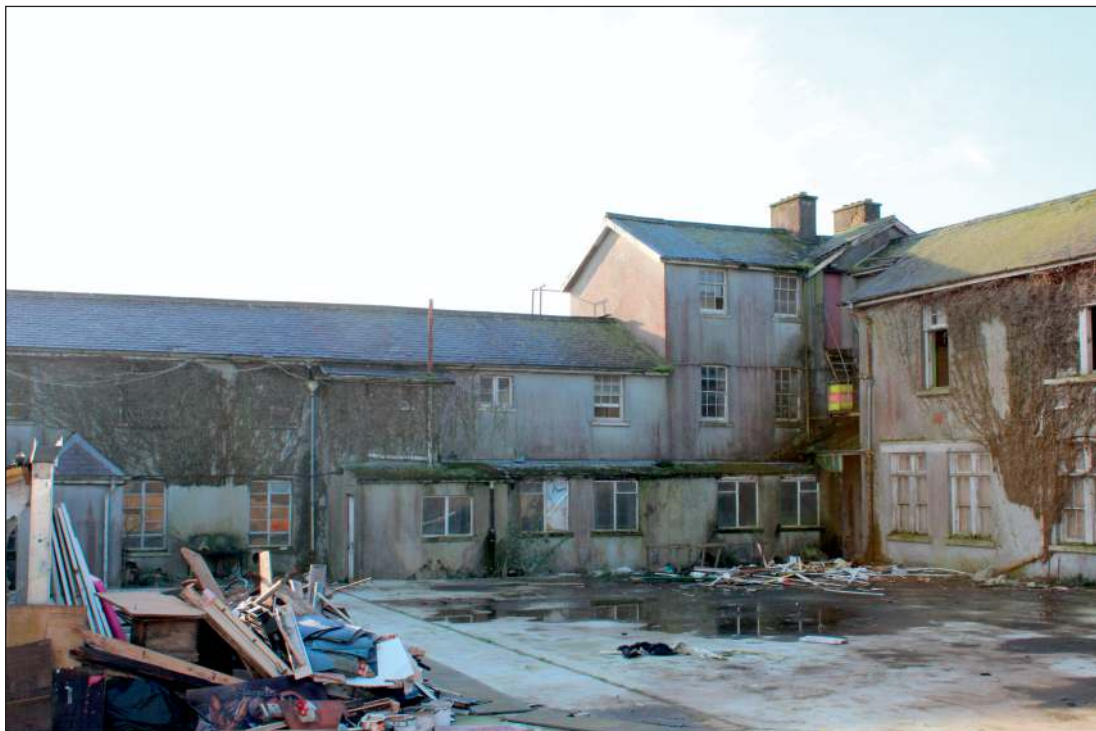
Plate 10: The north elevation of the central range, east section looking southwest also showing the south end of the north range

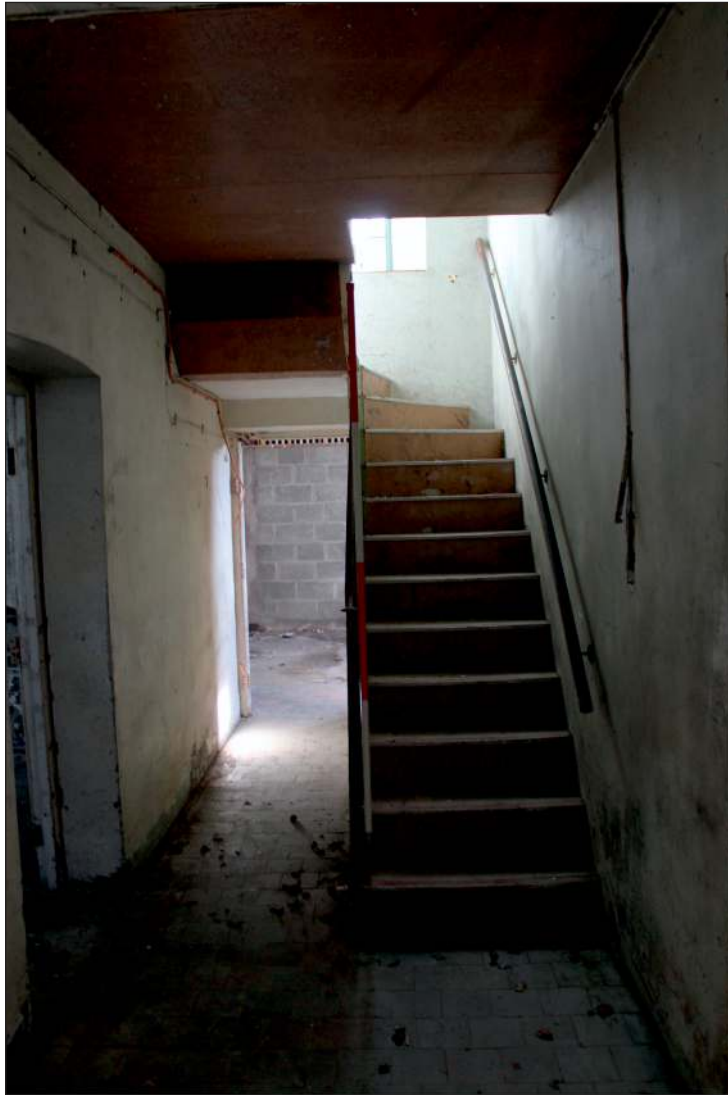
- 4.27** The next space is a former original passage, with a staircase to the first floor (Plate 11). The partitions are brick and the floor is tiled over the original flagstones. The stairs are stone with slender rectangular metal balusters and handrail. There are tongue and groove panels to an understairs cupboard. The next room has been converted into a processing plant and has a modern concrete floor incorporating a trough, and with a freestanding vat. The first-floor structure has been removed and partially replaced. There is a blocked opening in the north wall behind the external stack.

Plate 11: The passage and staircase in the west side of the central range, looking south (2m scale)

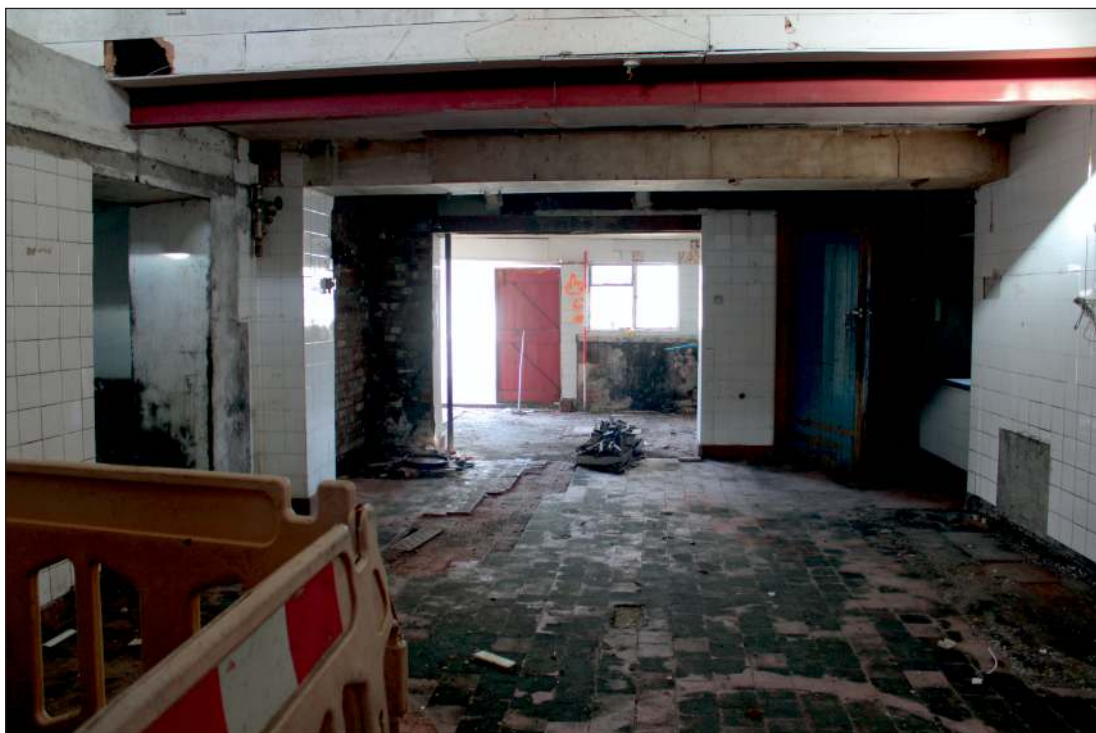
Plate 12: The former kitchen, looking north showing extensions to the rear and blocked fireplace to the right (2m scale)

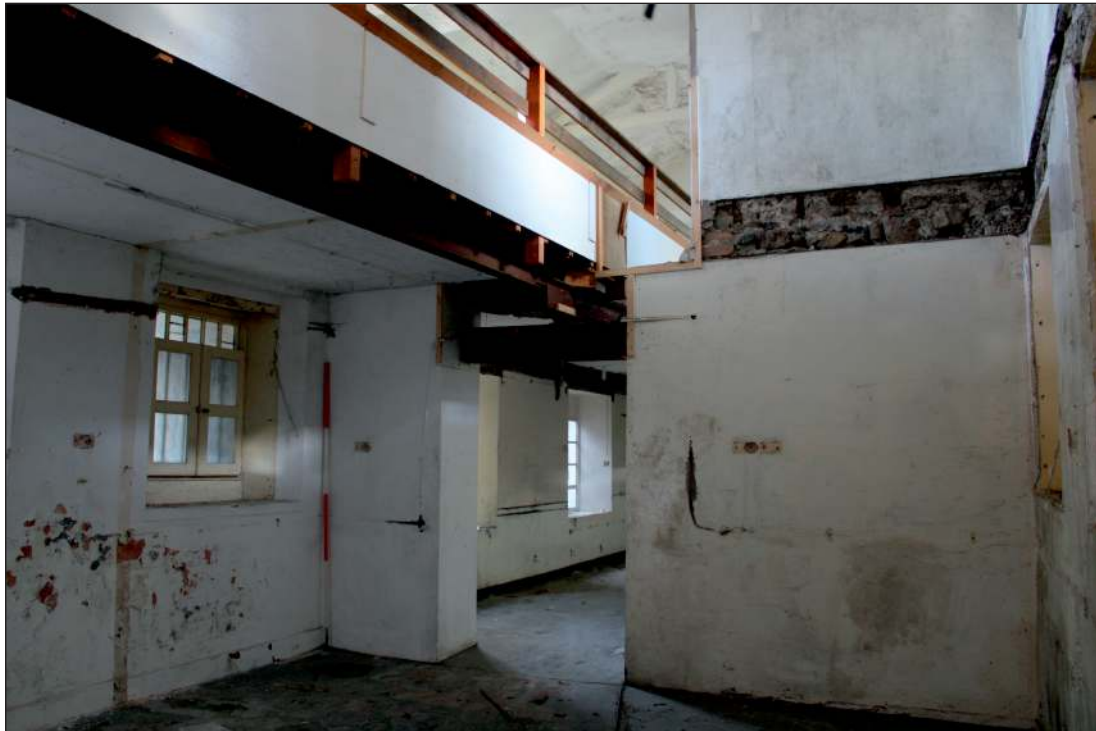
Plate 13: Central and eastern rooms in the central range, showing barred window and replaced first-floor structure, looking northeast (2m scale)

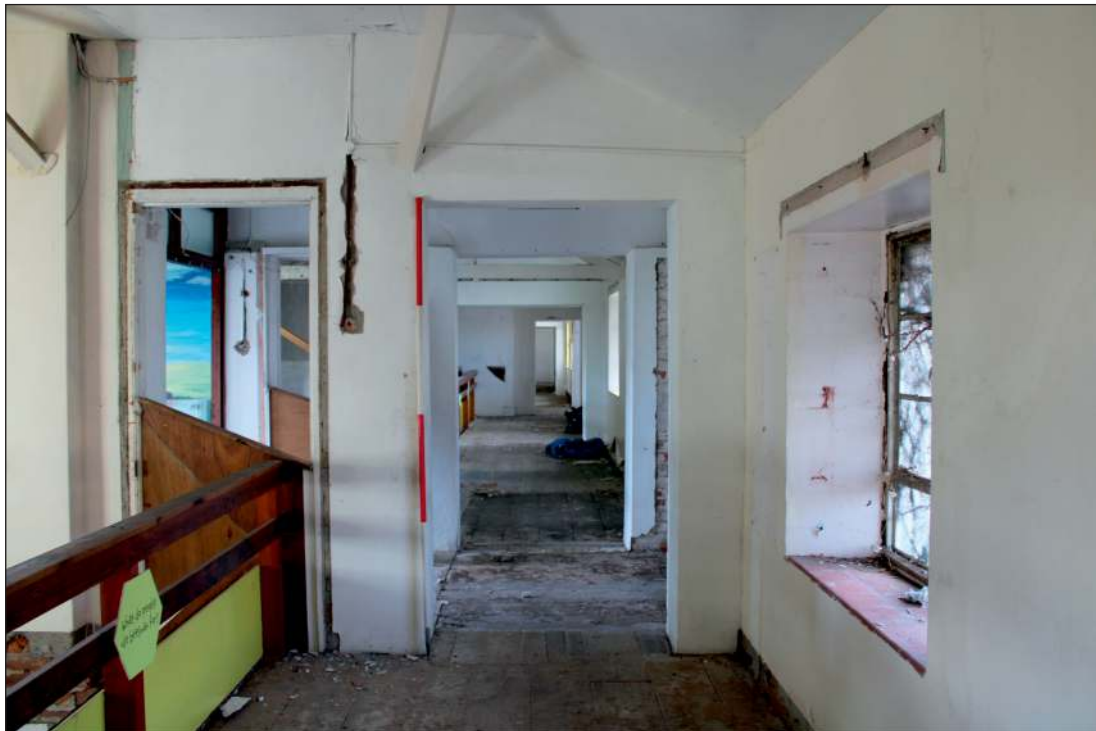
- 4.32** The first floor is now entered from the modern staircase in the east ground-floor room. Almost all the original floors in this range have been removed and replaced with a wide corridor along the north side of the building (Plate 14). This allowed visitors to look down into the rooms below. New openings in the partitions replace, where present, original doorways central to the walls. There is a primary space at the east end originally accessible from the adjacent room by a central doorway, but is now entered through a doorway (in a former window opening) from the 1970s extension to the south. The original door is a four-panel type within a plain frame. The room has a recent partition dividing a toilet from a store containing electrical equipment; other than the door described above all fittings are modern.

Plate 14: General view of the first floor of the central range showing the walkway and viewing platform, looking west (2m scale)

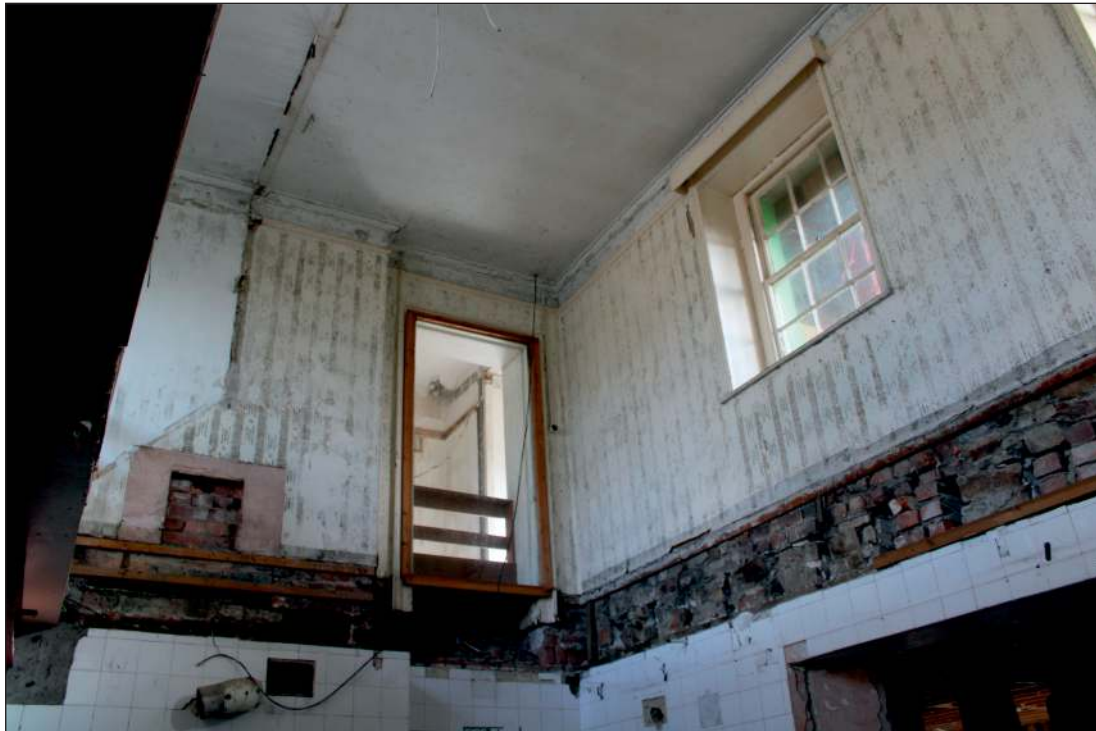
Plate 15: The central western first-floor room of the central range, looking southeast up from the ground floor showing fireplace, cornice, picture rail and sash windows

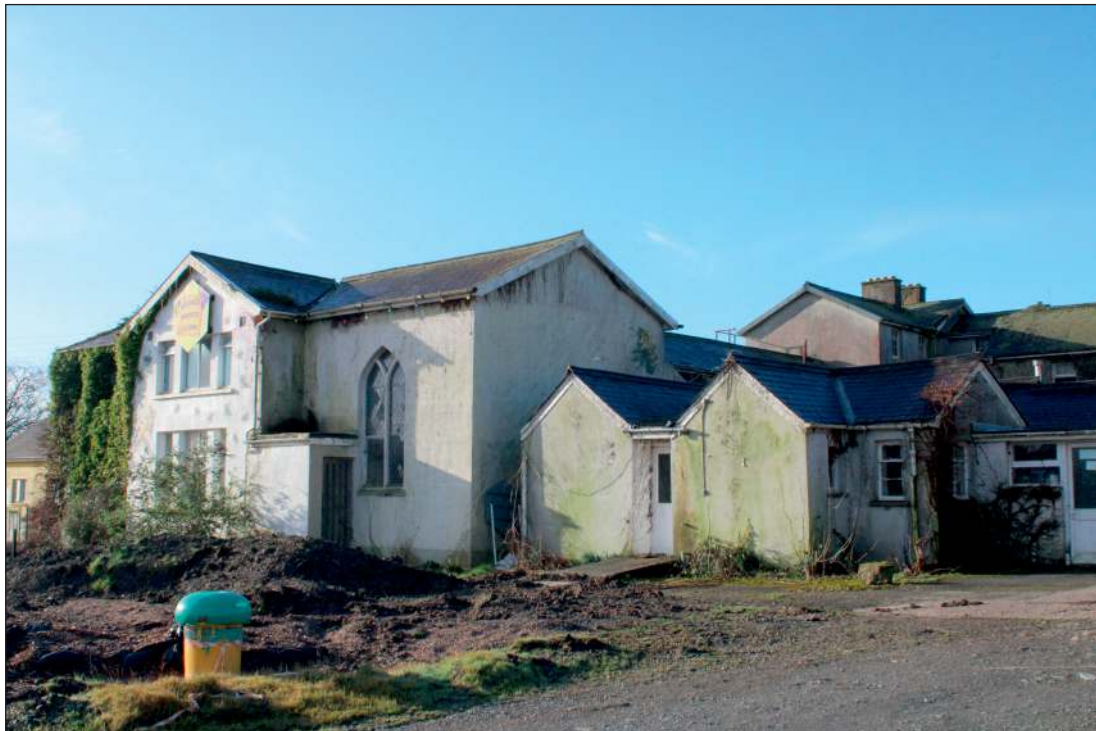
Plate 16: The east elevation of the east range, looking southwest

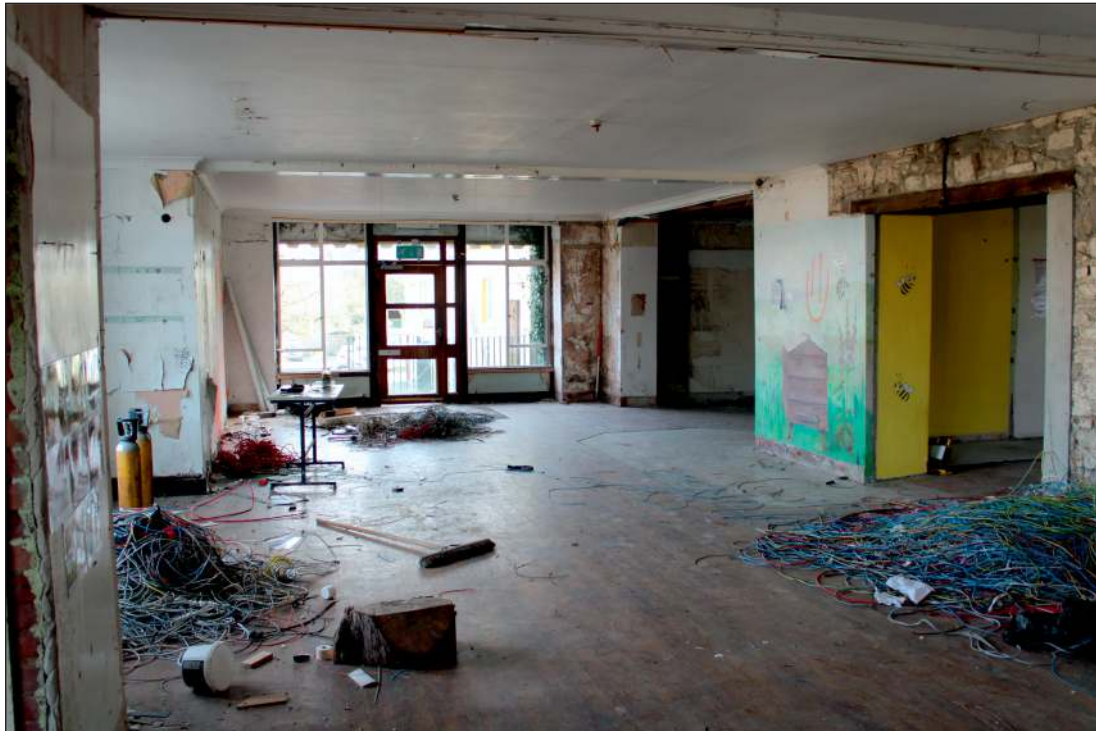
- 4.43** The southern section is a single open space formerly used as a reception area to the Quince Honey Farm (Plate 17). All of the doorways are 1970s insertions. It has a modern floor and ceiling. Against the north wall there is the scar of a removed 1970s (or earlier) staircase to the first floor. The chapel window is a replacement within a deeper brick filled opening with plaster reveals.
- 4.44** The first floor of the southern section is a later 20th-century addition, with a contemporary wooden floor and finishes. The floor cuts across the chapel window opening. In the west wall there is exposed stone masonry with a brick chimney stack that would have served fireplaces in one of the end rooms in the central range and/or

Plate 17: The south (chapel) section of the east range, looking south showing later 20th-century openings (1m scale)

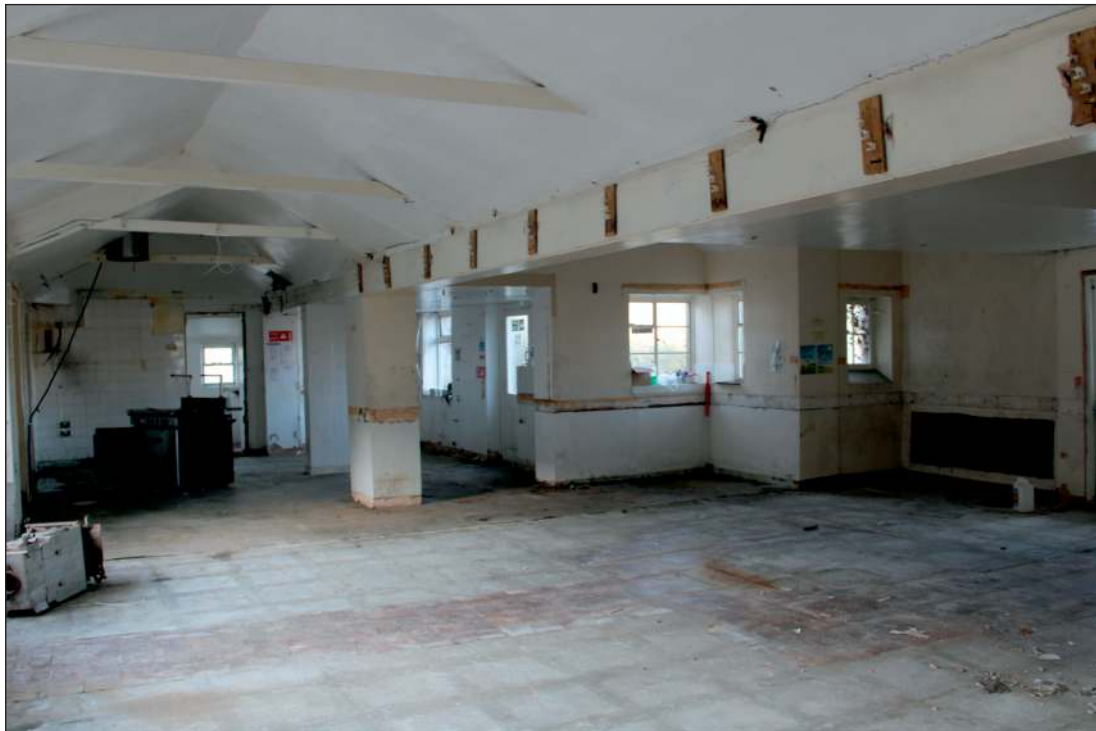
Plate 18: The open-plan north section of the east range, looking north (1m scale)

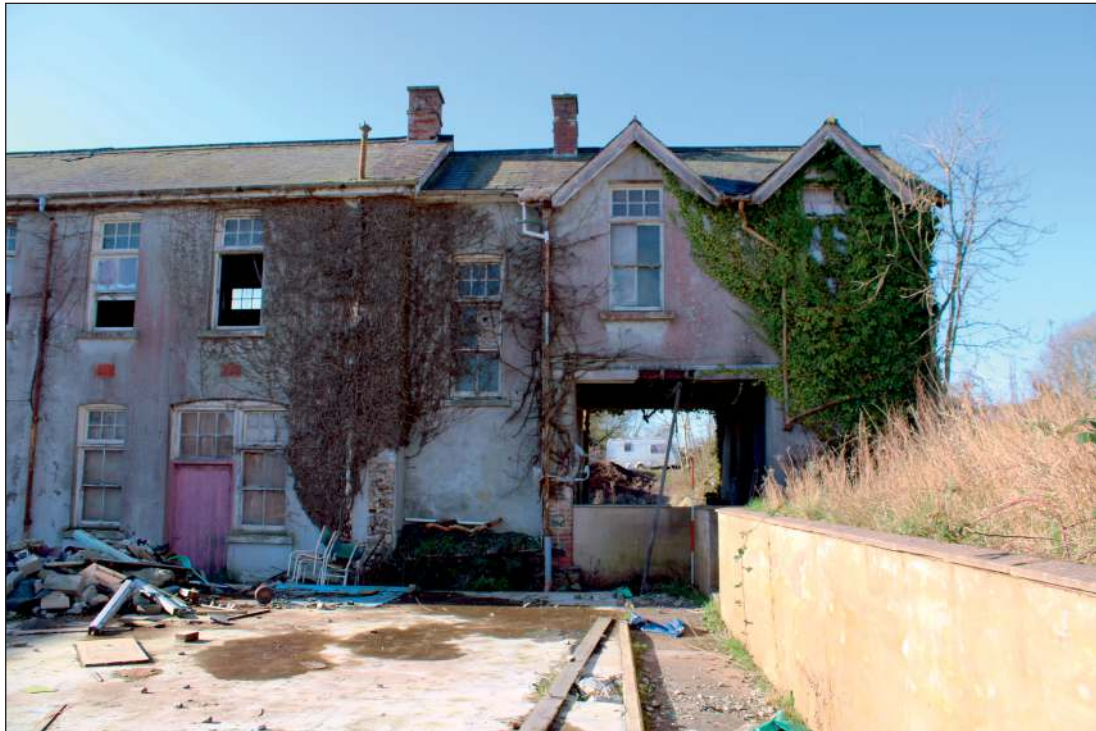
Plate 19: The east elevation of the north range, north end, looking west showing passageway with scar of original yard wall to left of scale (2m scale)

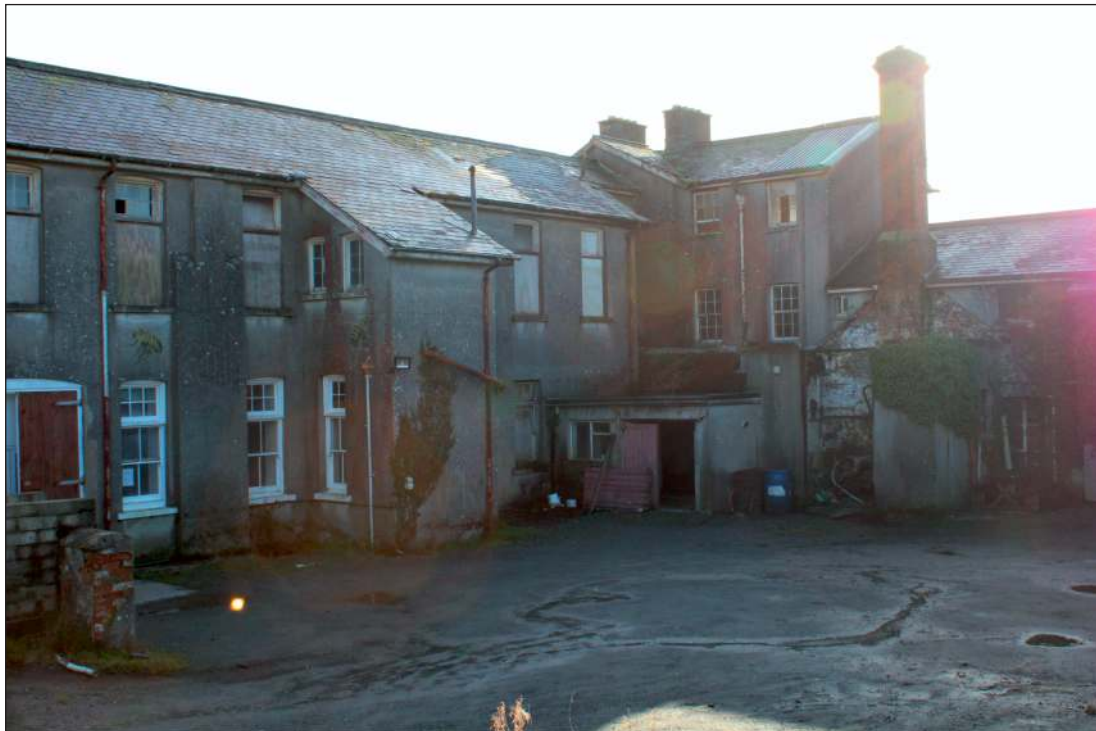
Plate 20: The west elevation of the north range, southern section showing integral service tower and later extensions, looking southeast

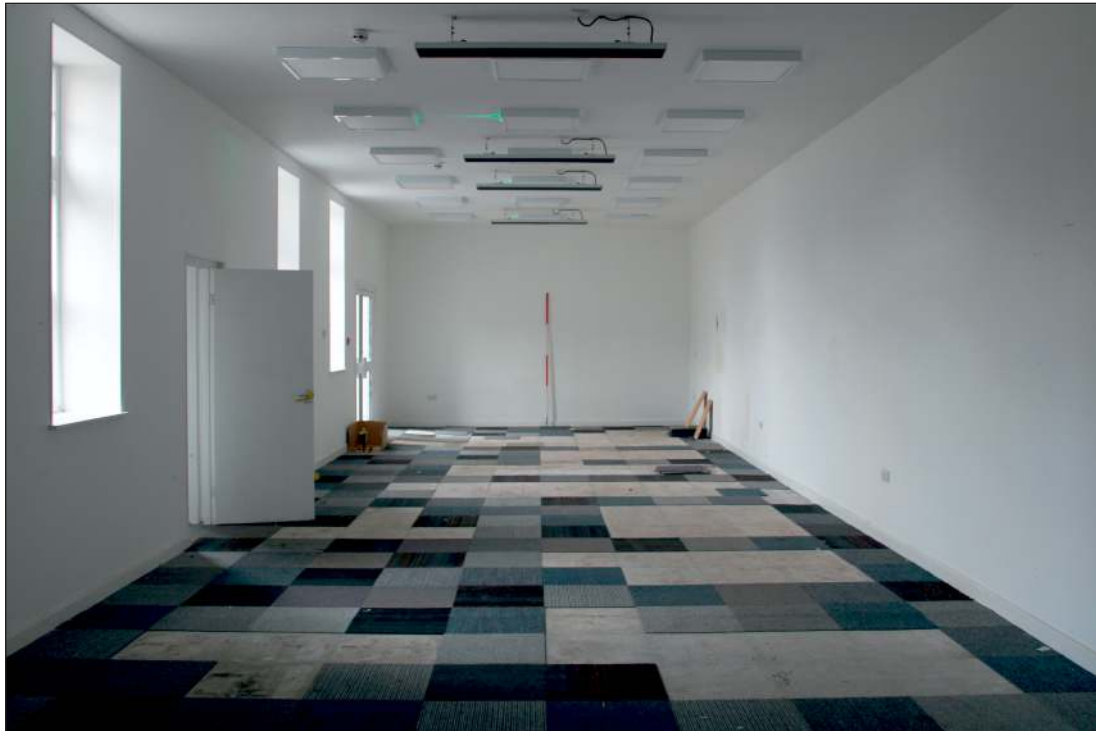
Plate 21: The ground floor of the north range, looking north (2m scale)

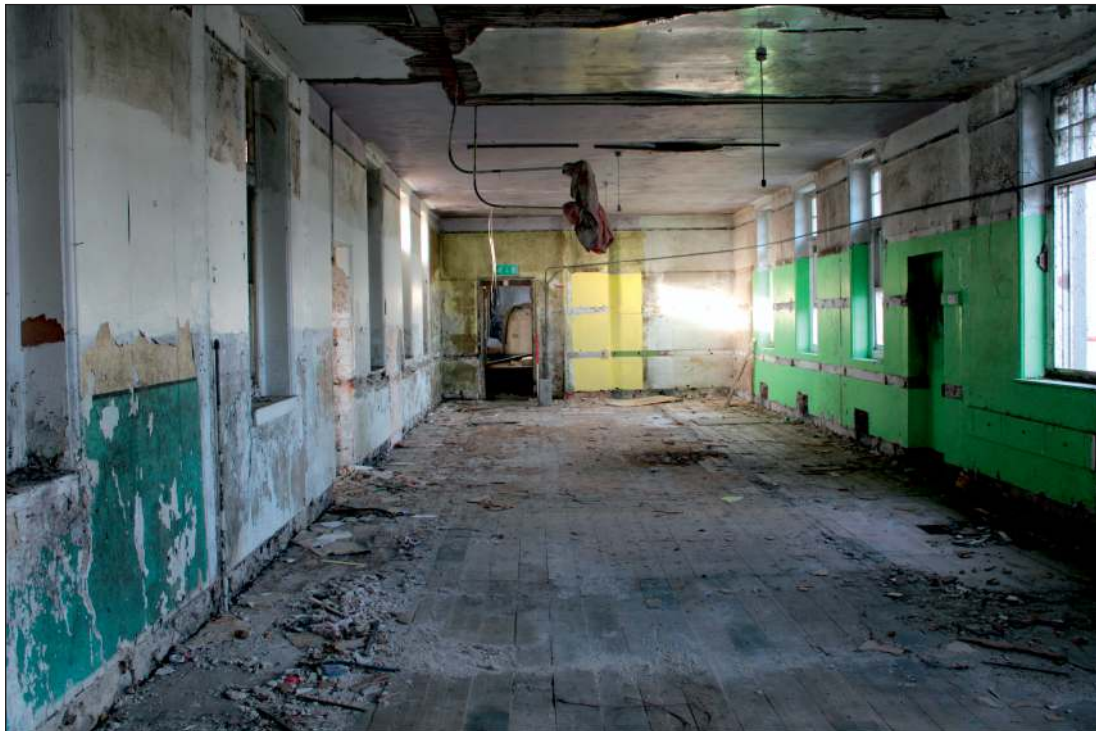
Plate 22: The first floor of the north range, looking north (1m scale)

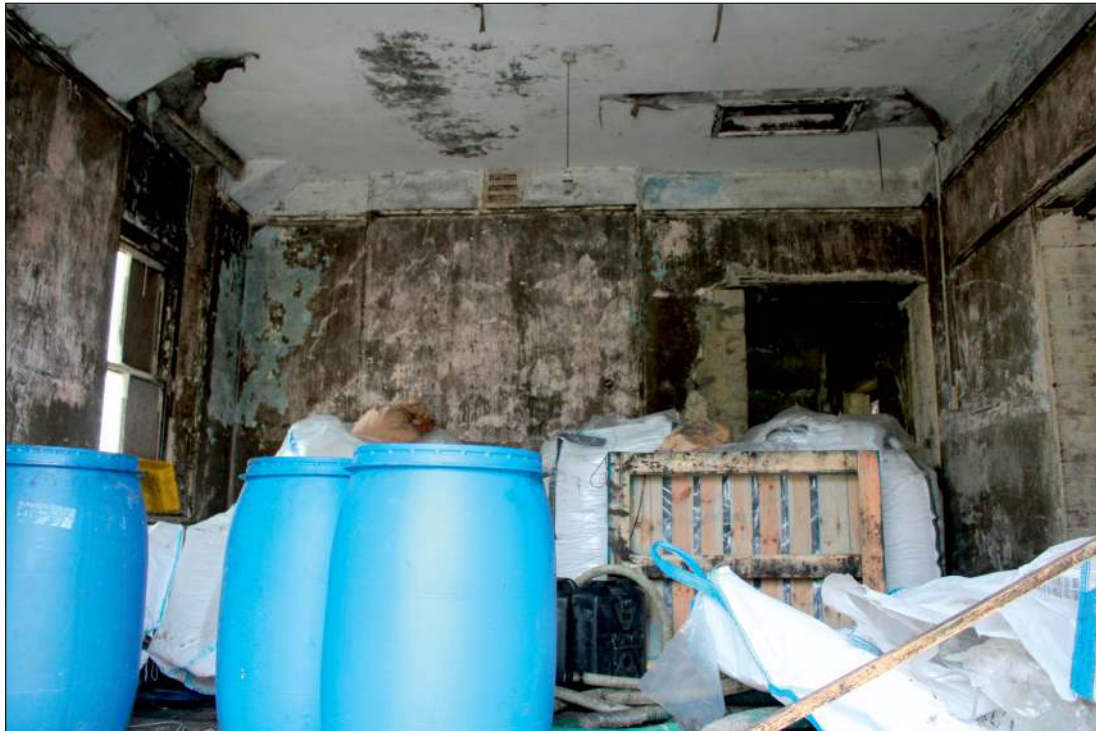
Plate 23: The north room at first-floor level in the north range, looking south

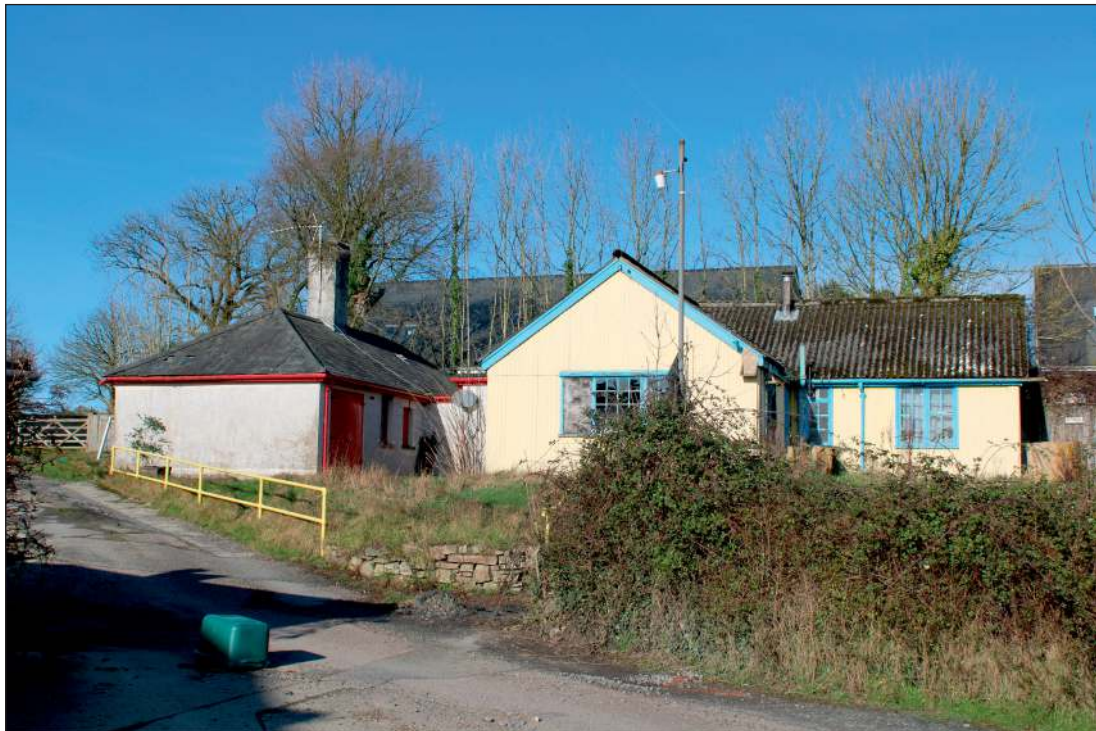
Plate 24: The isolation block, looking north
