NEW SOLAR FARM, BULKWORTHY, TORRIDGE DEVON

Results of an Archaeological Trench Evaluation

Report No: ACD1926/2/0

Date: February 2020

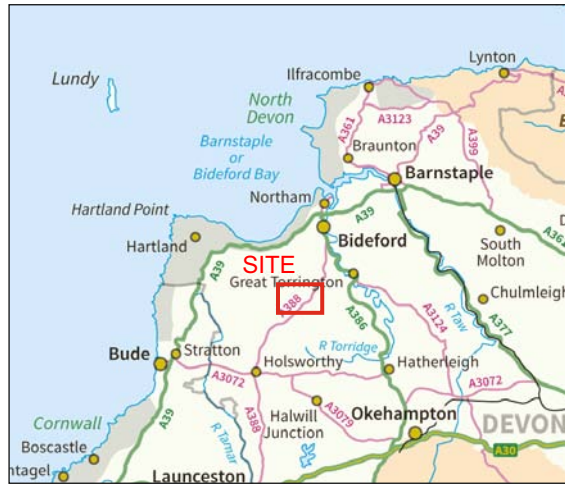
TITLE
Fig. 1: Location of site and trial trenches in relation to the geophysical survey interpretation

Excavated trenches with archaeological features shown

No evidence for archaeology was found during the work, with one of the geophysical anomalies corresponding with the position of a naturally-formed combe and others relating to variations in the natural geology.

- 1.1** An archaeological trench evaluation was undertaken by AC archaeology during January 2020 ahead of construction of a new solar farm on land at Bulkworthy, Torridge, Devon (SS 4047 1476; **Fig. 1**). The investigations were required as a condition (12) of planning consent granted by Torridge District Council, following consultation with the Devon County Council Historic Environment Team (hereafter DCCHET).

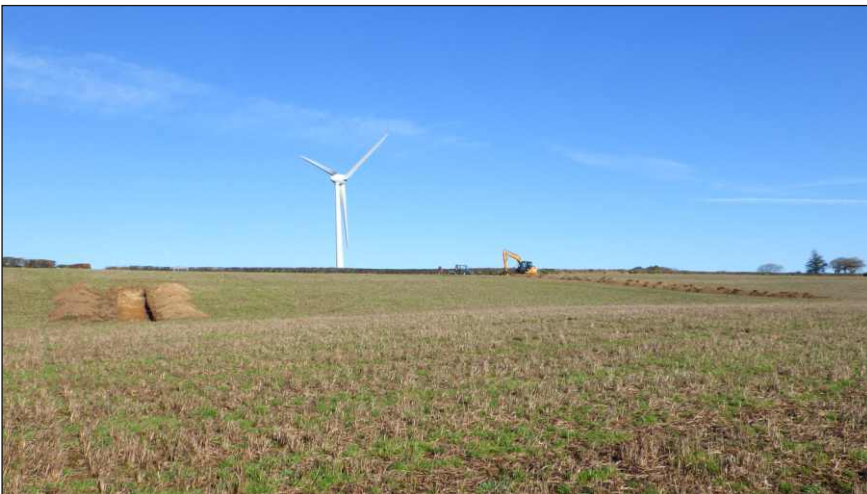
Plate 2: General view of Trenches 6 and 7, looking to north

- 6.1 No archaeological features, deposits or finds were exposed during the evaluation. The geophysical anomaly investigated in Trench 3 proved to be a natural combe that had silted up with greyish brown silty clays. Other anomalies targeted in Trenches 6 and 7 were formed by variations in the natural geology (banding of silty clay and stone).

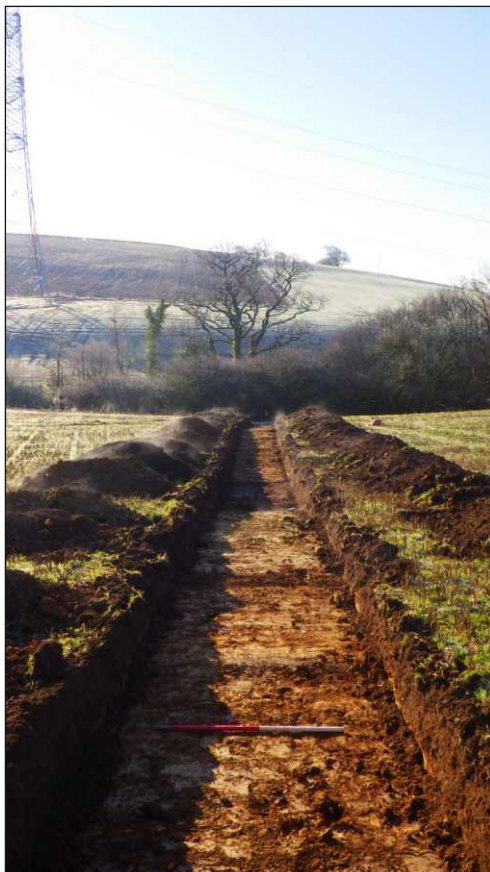
Plate 3: Trench 3 following excavation, looking to south (1m scale)

This trench was approximately north-south aligned and located in the south-west corner of the site at the bottom of the slope. It was excavated onto the light brownish yellow silty clay natural subsoil (context 302) present at a depth of 0.58m, below agricultural subsoil (301) and ploughsoil (300). The natural combe matched the position of a wide linear anomaly identified by the geophysical survey.

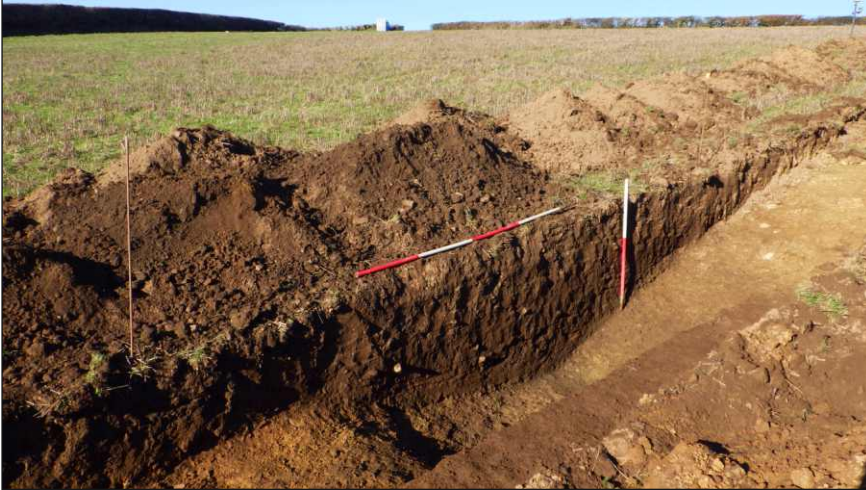
Plate 4: Trench 3, natural combe 303, looking to northwest (2m scale and 1m scale)

Combe 303

This was located in the northern half of the trench and was aligned broadly east to west. It was 4m wide and 0.62m deep, with gradually-sloping even sides onto a slightly rounded base. It was filled with three naturally-formed and sterile greyish brown silty clay soils (304-306) and no artefacts or ecofacts were present.

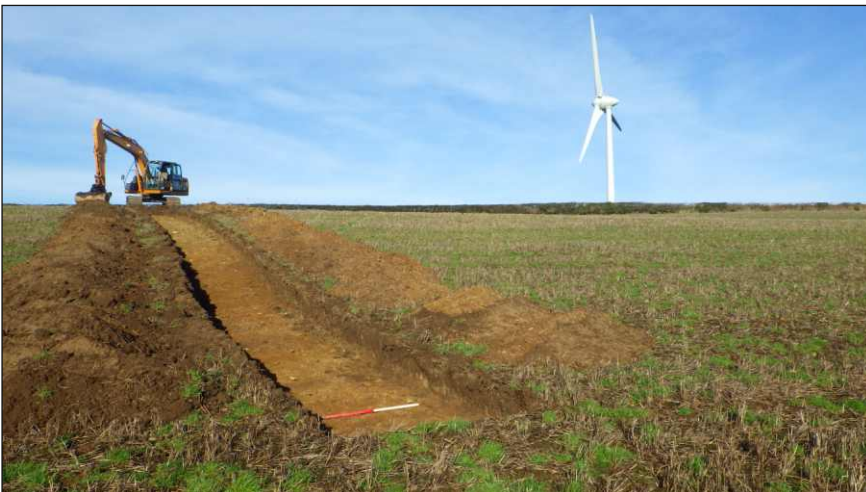
Plate 5: Trench 7 following excavation, looking to north (1m scale)
