LOXBROOK FARM, BROADCLYST, DEVON

Historic Building Appraisal

Document no: ACD1923/1/0

Date: November 2018

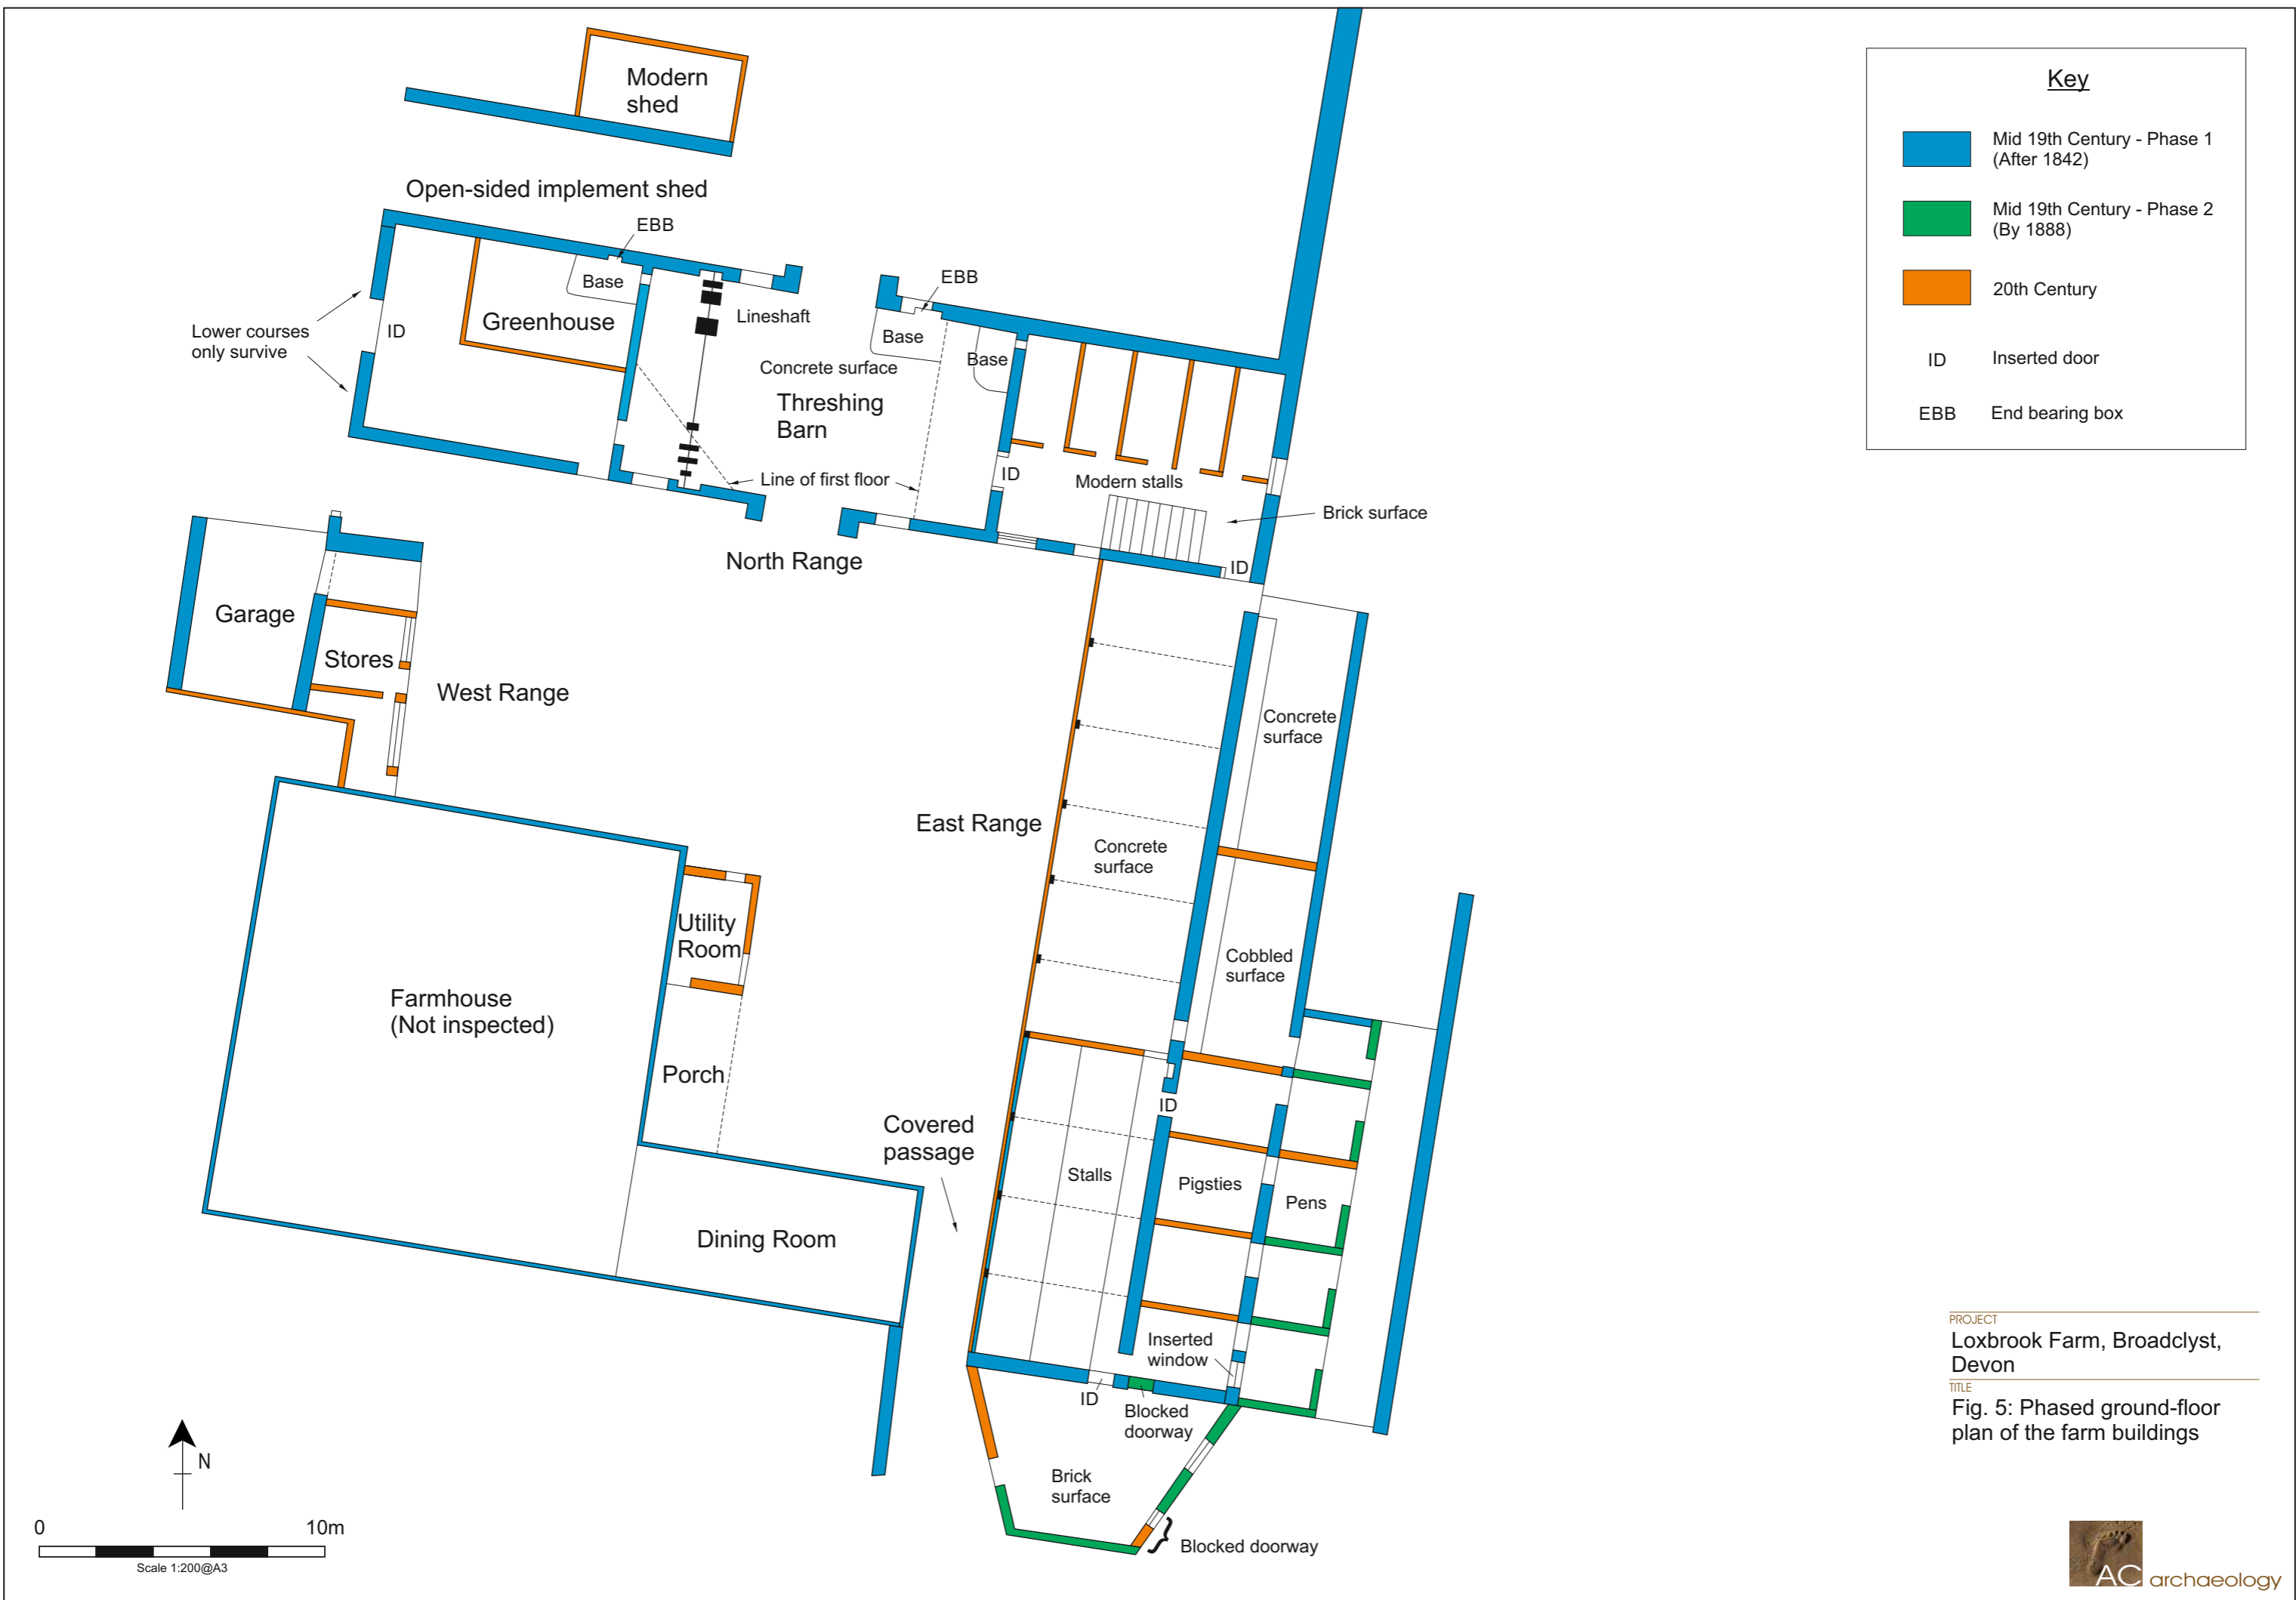
TITLE
Fig. 5: Phased ground-floor plan of the farm buildings

Key	
■	Mid 19th Century - Phase 1 (After 1842)
■	Mid 19th Century - Phase 2 (By 1888)
■	20th Century
ID	Inserted door
EBB	End bearing box

6. DEVELOPMENT OF THE PROPERTY (Fig. 6)

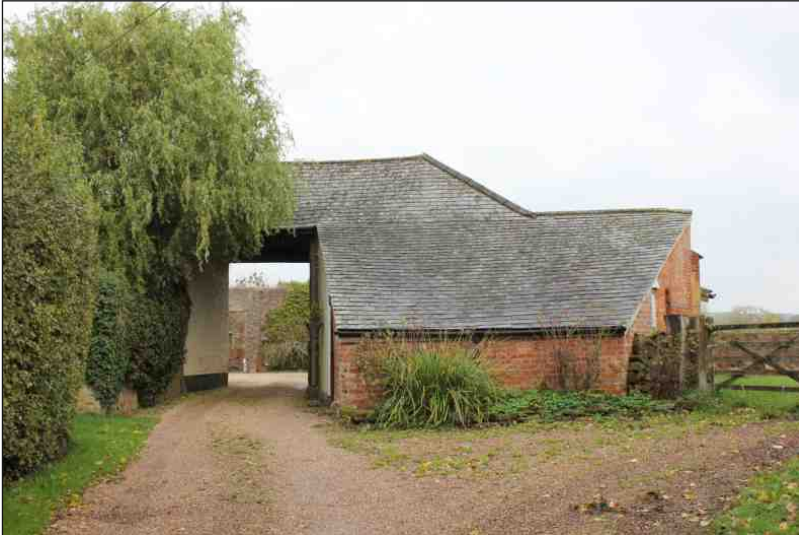
Plate 1: The entrance to the farmyard showing the covered passage and brick extension to the east range, looking north

- 5.2 The property is approached along a short driveway from Burrow Lane, which enters the yard through a tall covered passage situated at the east end of the south range (Plate 1). Buildings of presumed agricultural origin west of this passage have been converted into a dining room accessed from the adjacent kitchen in the farmhouse.

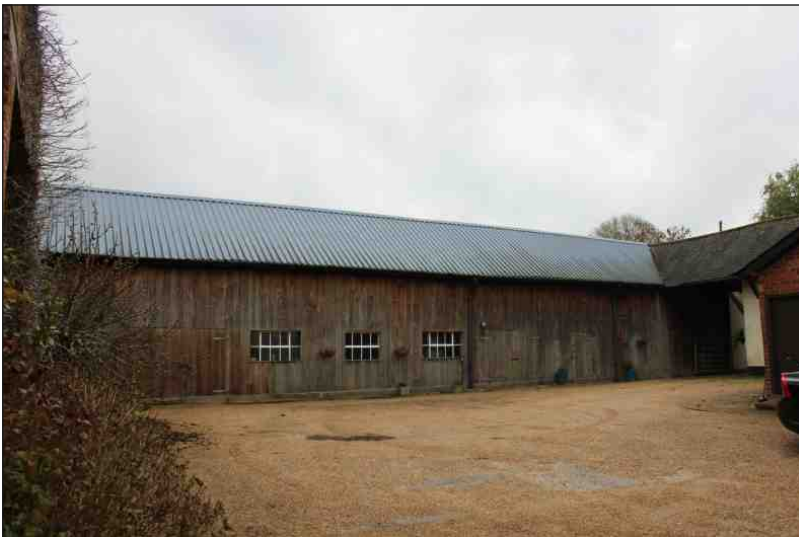
Plate 2: The west elevation of the east range, looking southeast

- 5.3 The east range comprises a main long, narrow former shippen, with contemporary structures on its east side, and a later mid-late 19th-century brick extension to the south. The shippen was originally two storeyed, with a first-floor hayloft. The whole west elevation is currently finished with modern vertical boarding, but evidence of earlier finishes exists (Plate 2). On the ground floor, internally the southern third of the building retains a probably primary timber frame finished with vertical boards, and with each bay containing doorways (Plate 3). On the first floor there are horizontal beams, which are a 'safety feature', to stop hay falling out, rather than structural elements; these indicate the first floor was open fronted. The building is divided into 10 bays by vertical posts that support the roof. The roof trusses are formed from rafters with lap jointed collars, and back purlins (Plate 4). The finish is modern plastic corrugated sheets.

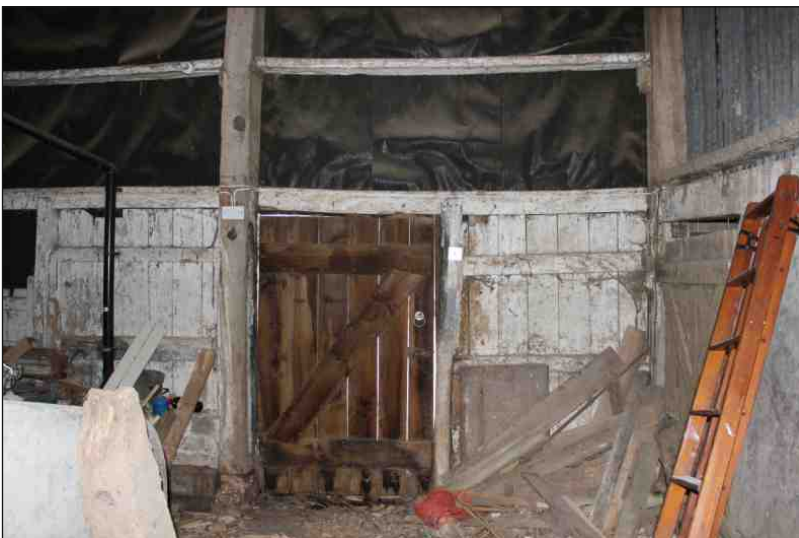
Plate 3: The interior of the east range showing the primary finish of the west elevation, looking west

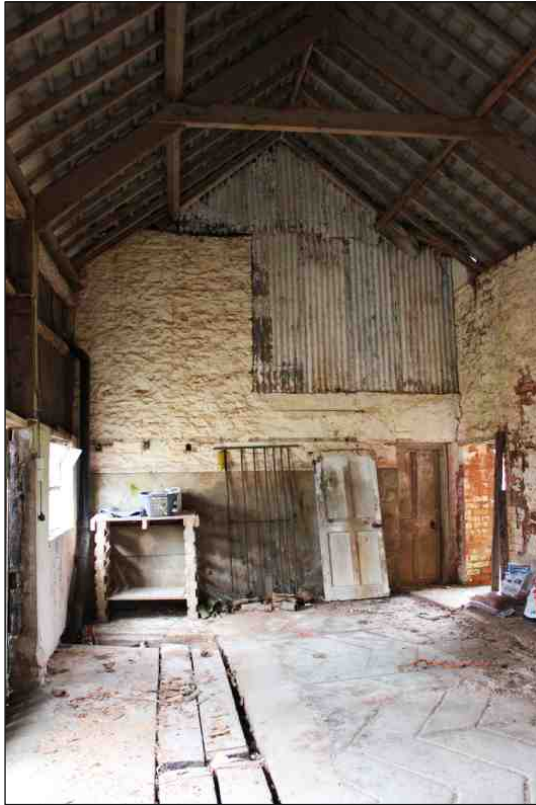
Plate 4: The north end of the east range, showing various openings, the floor, evidence for the former first floor and the roof structure, looking north

- 5.4 In the north elevation there is an inserted ground-floor door to the stable to the north; above this there is a wide opening to the first floor of the stable (Plate 4). Adjacent to the former is an inserted doorway in the east wall leading into the adjacent structure. There are a further three doorways in the east wall; a second (primary) opening into the attached structure, and two doorways into the pigsties. They are all fitted with replacement four-panel doors; the original doors were fixed using strap hinges. The four pigsties were served with feeding doors from the feeding passage in the shippen. These have been blocked and heavily altered, with new, wider recesses created. Within the shippen a single, narrower partially blocked opening remains fully visible. In the south elevation is an inserted ground-floor opening, fitted with a four-panel door, into the adjacent extension, with a primary loading door above; this is of a plank design attached with strap hinges.

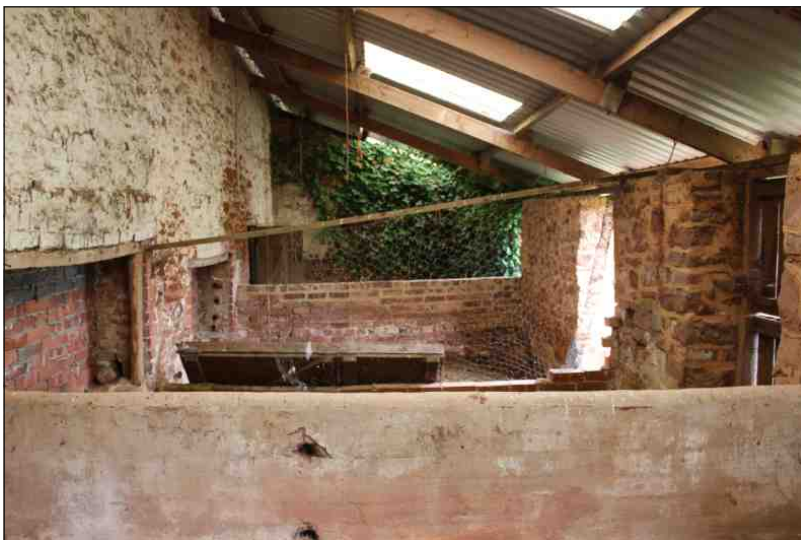
Plate 5: The pigsties, looking north

- 5.6 Attached to the east side of the shippen is a single-storeyed range under a pitched roof; the roof structure is a modern replacement with a corrugated plastic sheet covering. At the south end is a row of four pig sties, with doors opening into outside pens to the east. The sties have been altered, with new brick partition walls (Plate 5), and a window added to the south sty, perhaps indicating a change of use of this sty.

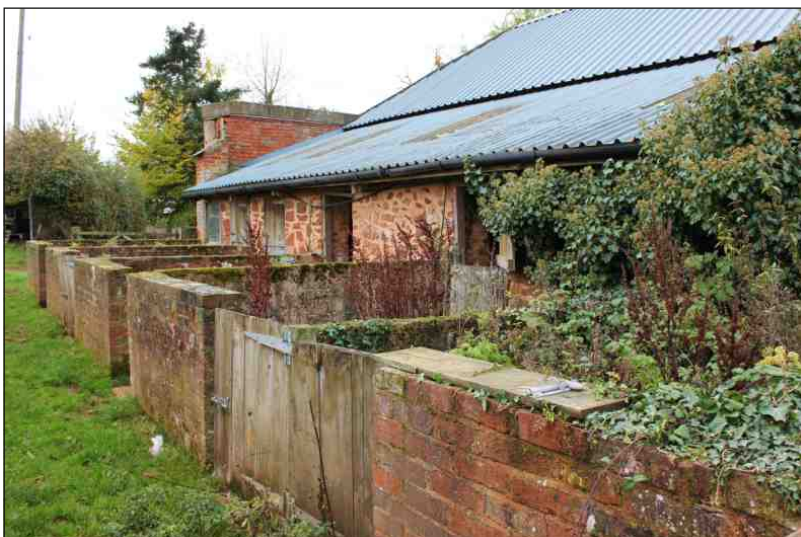
Plate 6: The pens in front of the pigsties, looking southwest

This sty also incorporates a doorway in the south wall, blocked when the adjacent extension was constructed. The pens are served externally by a walkway (Plate 6) defined on its east side by a retaining wall into the rising hillside to the east.

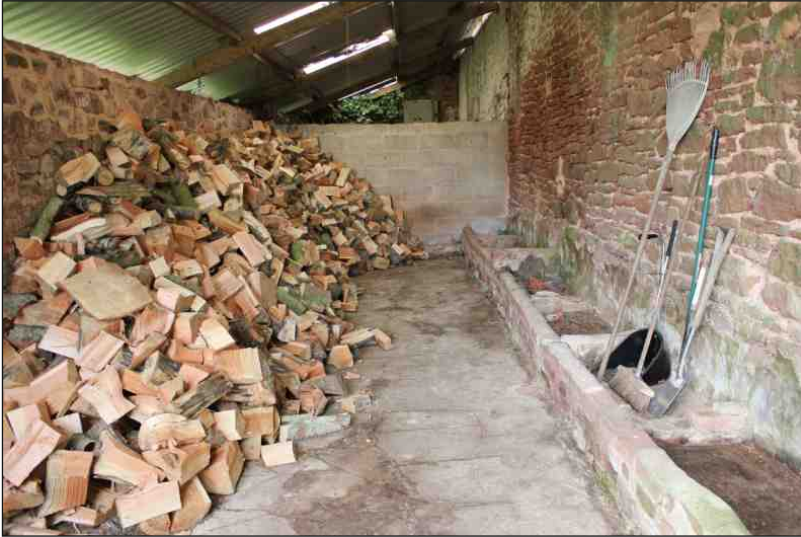
Plate 7: The north end of the attached structure to the east range shippen, looking south

- 5.7** To the north of the pigsties the structure was originally a single internal space, but has been subdivided by a concrete block wall to create two smaller animal houses (Plate 7). A cobbled floor survives in the south room, but the north room has a modern concrete surface incorporating a drain. Modern troughs have been added against the west wall. The retaining wall of the walkway around the pigsties continues north forming a small yard outside the animal house.

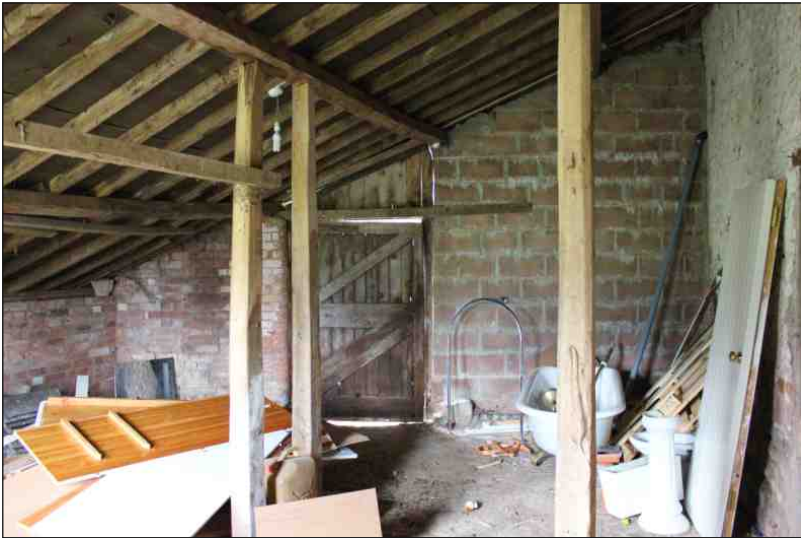
Plate 8: The interior of the brick extension to the east range, showing the east elevation and vertical posts, looking west

- 5.8** The south extension is single storeyed under a pitched roof, and is constructed of red brick, with some bullnose bricks used around the openings and as a string course close to the ground level. The north section of the west elevation has been rebuilt in concrete block (Plate 8). There is a primary doorway in the west elevation, and a second original opening into the field to the east has been blocked and altered to include a small window. To the north of this is a second, primary window. The room has a primary brick floor onto which several posts supporting the roof purlins have been set. Other than these purlins the roof structure is modern.

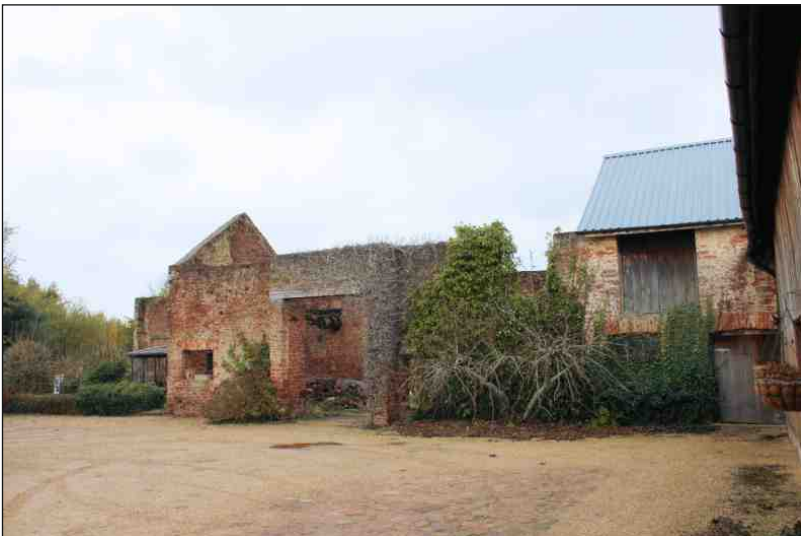
Plate 9: The north range, showing from right to left, stable, threshing barn, and barn with greenhouse, looking north

- 5.10** To the west of the stable is a threshing barn, characterised by wide central doorways set within slightly projecting walls that would have supported porches (Plate 9). The building has suffered a fire, and has lost its roof structure. Parts of the walls at eaves level have been consolidated. In the south elevation there is a pair of ground-floor windows – one to either side of the central doorway – and a single first-floor window on the right-hand side of the elevation. In the north elevation there are two small inserted openings, again to either side of the central doorway. The west elevation incorporates a pair of primary ground-floor and first-floor openings to the demolished adjacent barn (Plate 10). In the east and west elevations there is also a pair of tall inserted brick-lined openings (blocked in the east wall), which appear to be associated with the transfer of power through belt drives (see below). The building was originally largely, open to the roof, but there is evidence in the form of burnt-out beams (and a window described above) for a first floor over the eastern quarter of the building. Additionally there are the remains of a beam in the southwest corner that would have supported a triangular floor in front of the first-floor door to the adjacent barn. The building has a concrete floor. Fixtures and fittings comprise, at the first-floor level in the western part of the building, an overhead lineshaft with belt drive wheels (Plate 10), and an end-bearing box for a second lower driveshaft set within the north wall to the east (Plate 11). There is a concrete pad below this box, and a taller curving brick machine base in the northeast corner. To the east of this box is a small primary, now blocked opening, featuring an arched head.

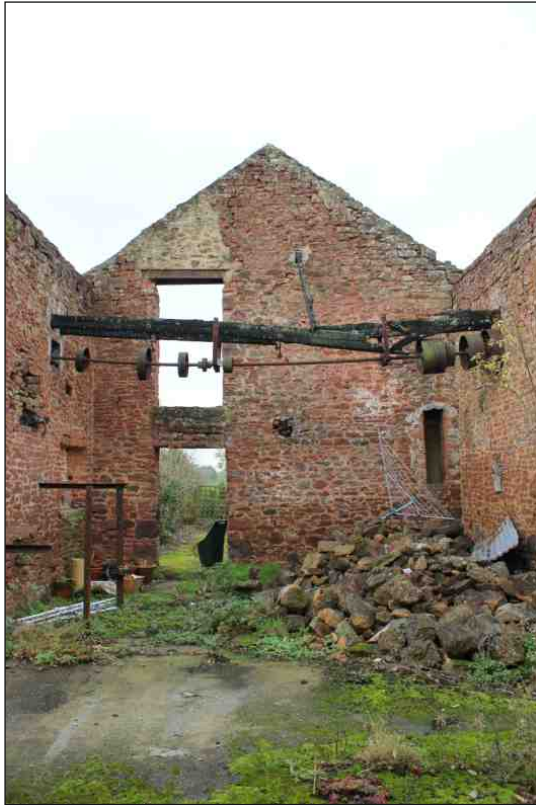
Plate 10: The west end of the threshing barn showing openings, overhead lineshaft, and evidence for a partial first floor, looking west

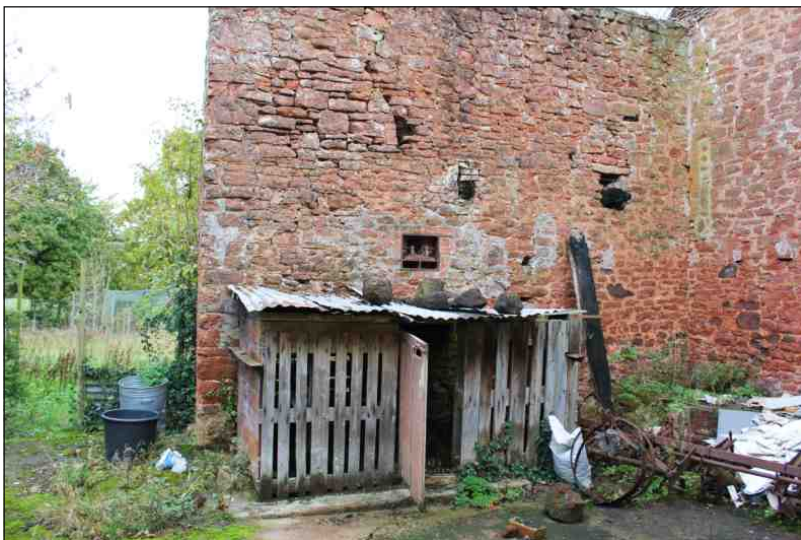
Plate 11: The east end of the threshing barn showing openings, end-bearing box, and evidence for a partial first floor, looking northeast

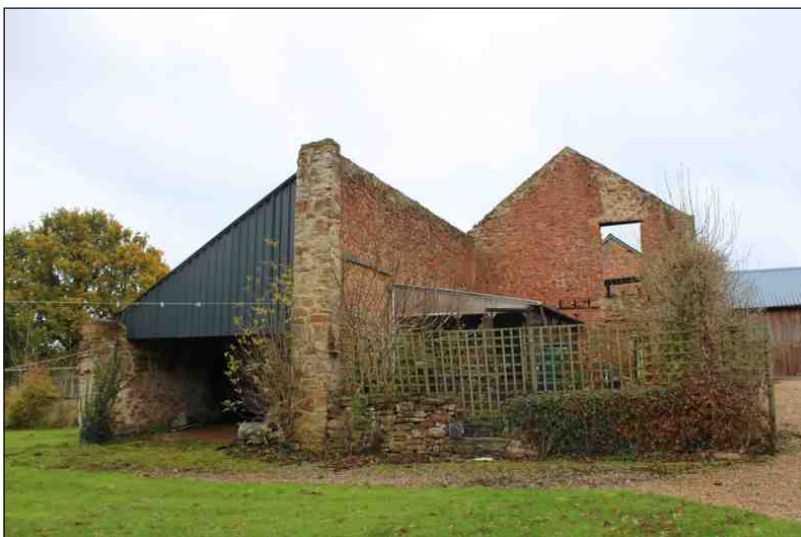
Plate 12: The west barn in the north range and attached implement shed, looking northeast

- 5.11** To the west of the threshing barn are the remains of another barn, which again has been damaged by a fire (Plate 12). The south and west walls have been almost entirely demolished, but there is evidence of a primary doorway at the junction of the two barns. The west wall features a central, probably inserted opening. Joist sockets for a primary first floor survive in the north wall. Overlying these is a scar of a secondary, post-fire structure. This has been replaced by a modern greenhouse. In the northeast corner of the building is an end-bearing box and below this a brick machine base (Plate 13).

- 5.12** Attached to the north of this barn is an open fronted barn, probably a cart or implement shed (Plate 12). Both (east and west) gable ends are open. The modern roof covering is supported on five trusses. Four of these retain their original tie beams and braces, and two of the rafters are also primary.

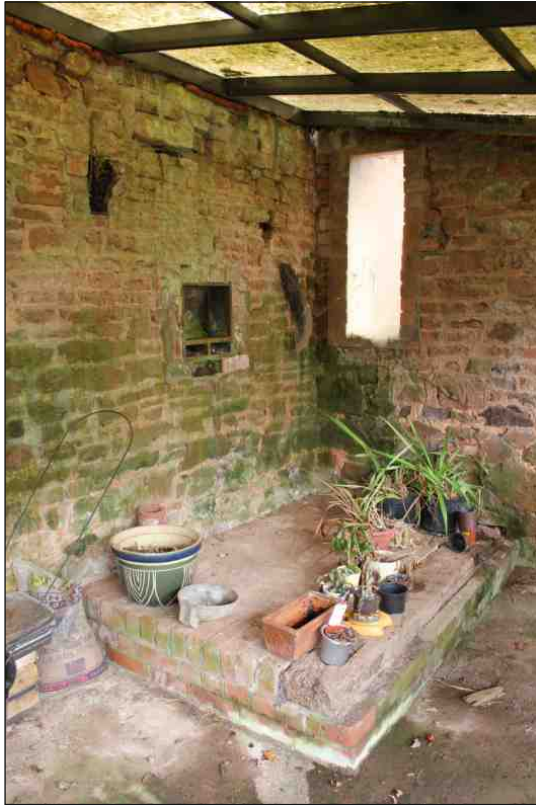
Plate 13: The west barn in the north range showing the end-bearing box, associated opening for a belt, and machine base, looking northeast

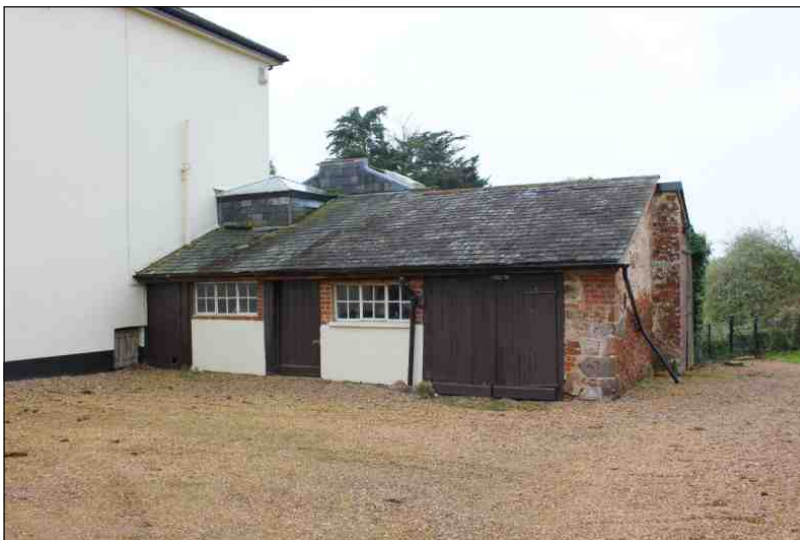
Plate 14: The west range, looking southwest

- 5.13** The west side of the yard, to the north of the house, is defined by a single-storey stone structure, possibly originally open fronted but now infilled with three modern doors and brick walls containing windows (Plate 14). It is divided by modern brick walls into three stores. These walls are located on the line of primary roof trusses and support primary rafters. The roof structure above has been replaced. To the rear is a garage entered from outside the yard and a modern conservatory. Sections of the dividing wall between the garage and stores have been removed to create internal access.
