THE GRANARY, EAST COOMBE FARM, STOCKLEIGH POMEROY, DEVON

Results of historic building recording

Mid Devon District Council planning reference
17/01527/FULL, condition 3

Document No: ACD2244/2/0

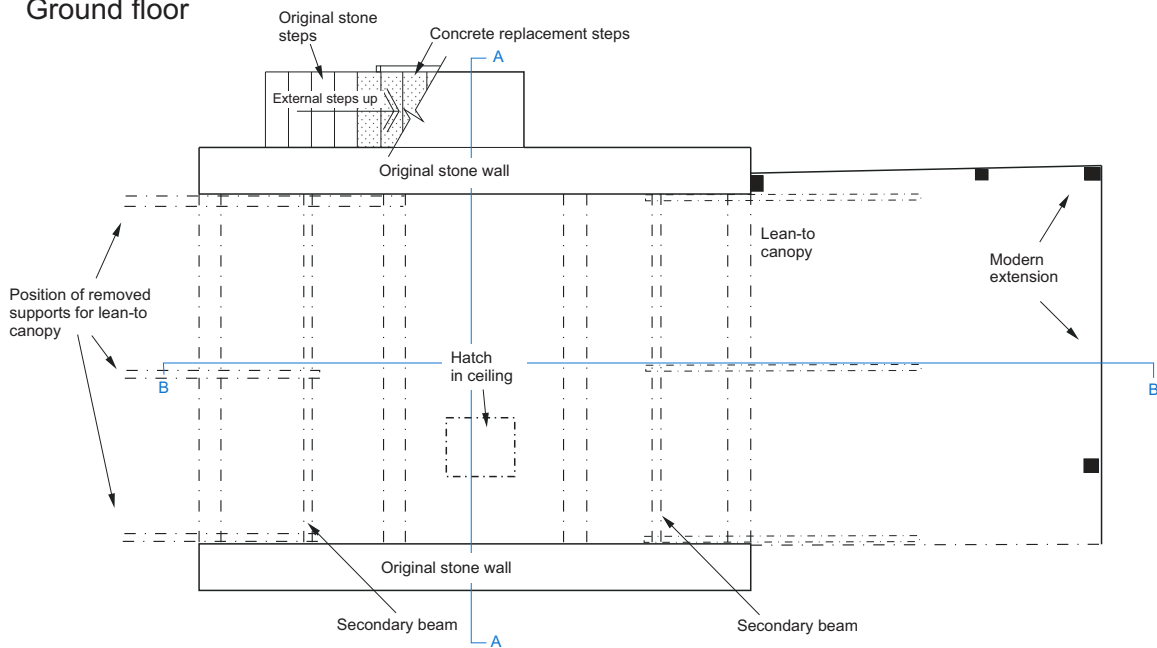
Fig. 2: Ground and upper floor plans

Upper level

Ground floor

- 4.7** The ground floor is a single open space with an earth floor that extends north into the extensions. Externally, to the south is a modern concrete surface representing part of the upgrading of the adjacent access to the farm. The first-floor is carried on four large bridging beams that support closely-spaced joists. The floorboards are large wide planks, that may have been reused, with a second layer of much narrower boards added over the top. In the centre of the building, but offset to the east is a hatch in the floor.

- 4.8** The first floor is an open space with no (non-structural) primary fittings present. As on the outside, the north elevation is plastered. The replacement timber framing and brick infill has been left exposed with no render finish. The replacement brickwork is painted although the southeast corner is partly exposed, possibly indicating it had another, now removed, finish, or was the location of a small grain bin. There is no evidence that the room was originally subdivided or contained grain bins. Recent additions include a pair of fuel tanks in the southeast and southwest corners, and a work table.

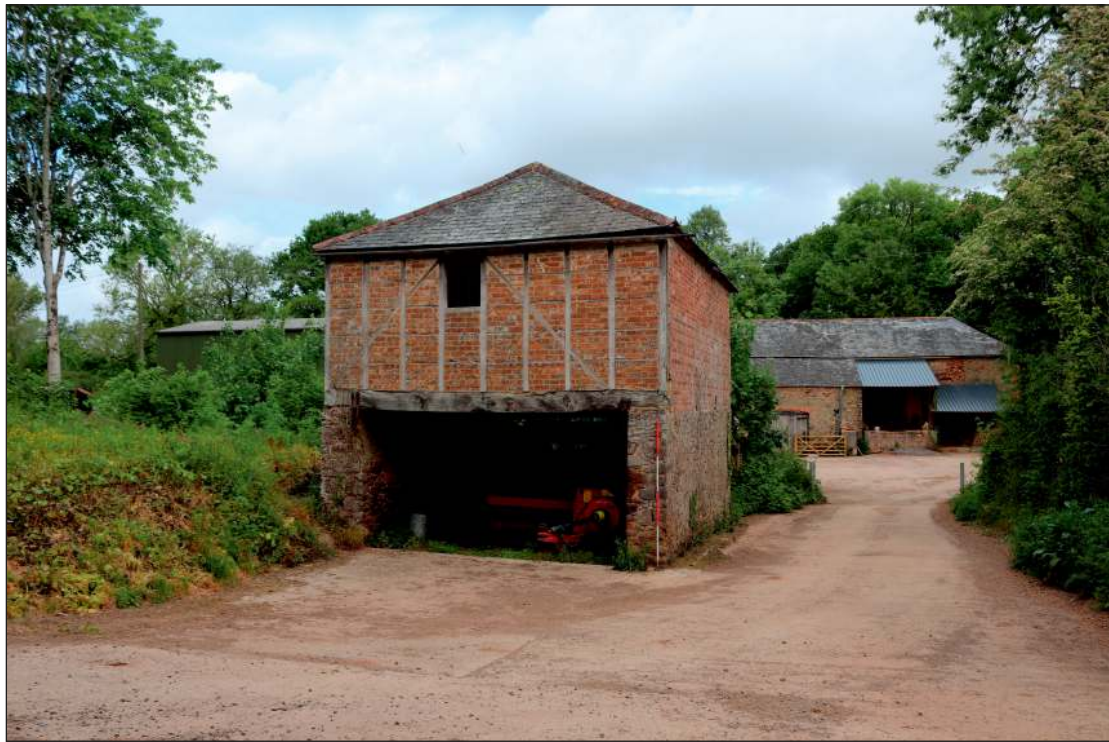
Plate 1: The granary looking north-northwest, also showing the threshing barn in the background (2m scale)

4.1 The granary is a two-storey building with open-fronted ground floors in the north and south gable elevations; the latter elevation fronts an access into the property from East Coombe Lane. The two side walls are constructed of rubble local siltstone with squared-off blocks used as quoins, all bonded in a hard buff lime mortar with charcoal, stone and small lime inclusions.

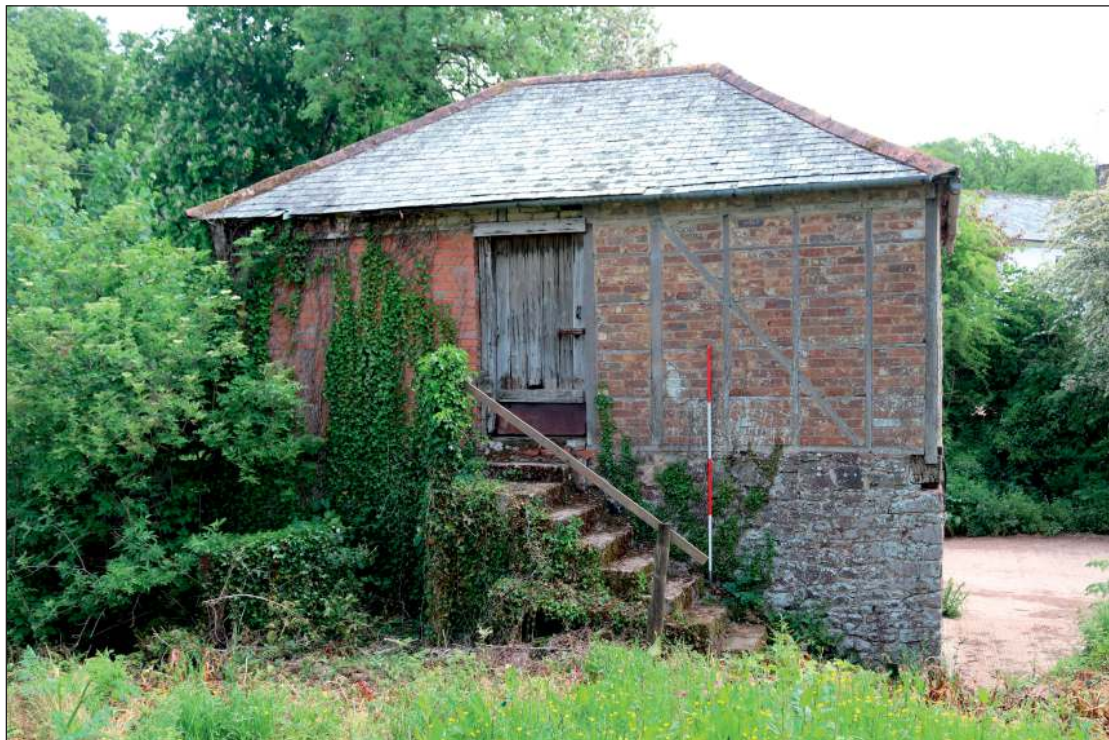
Plate 4: The west elevation looking east, showing the steps to the first floor, and the replacement brickwork and timber framing (2m scale)

4.3 The first floor is entered via a doorway in the west elevation, accessed via a flight of steps from the (now raised) ground to the west of the building. This structure is constructed of local siltstone, and incorporates four visible steps of the same material; the lowest original step is probably obscured. The remainder of the six full and one half steps are cast concrete replacements, whilst the handrail is also modern. The door is of the plank and batten type attached with a pair of older-style lozenge-headed strap hinges. The doorframe is set within the opening, originally behind studs within the timber frame. The south upright of the frame has been removed, as correspondingly has the lock case from the door.

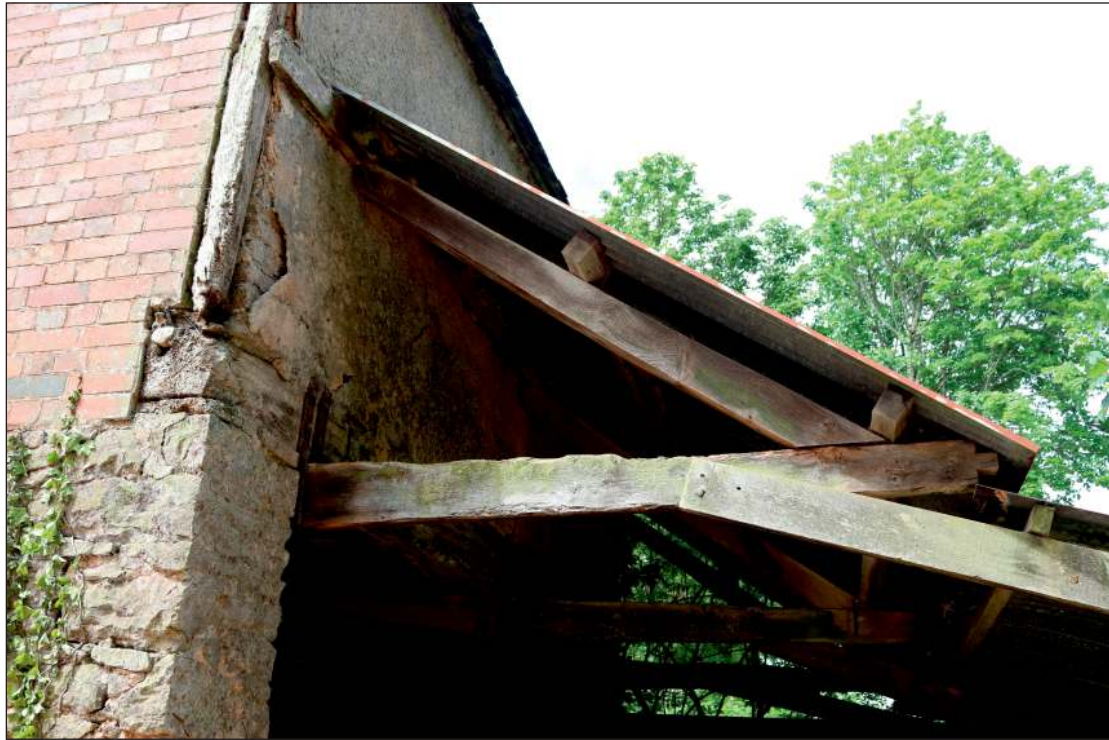
Plate 5: Close-up view of the north canopy looking east, also showing the lath and plaster on the bridging beam for the first floor

4.6 The north extension is in two parts. The earliest is a lean-to canopy supported on three 'tie beams' fixed into iron brackets, of the same style as present on the south elevation. An end rail or head beam joining all three beams, originally attached using mortice and tenon joints, has been removed. The canopy above itself is a modern replacement or addition, with rafters supporting battens and a corrugated iron sheet covering. A later corrugated iron sheet roof extends down to the north, on a slightly shallower pitch doubling the size of the extension. The north and west sides are

- 5.6** Later recent changes include the replacement of the upper part of the east elevation and the northern section of the west elevation at first-floor level, and more recently the rebuilding of the timber frame in the south and west elevations. Based on the limited available evidence, this appears to have been in keeping with the style of the original architecture, although any evidence for original internal and external plaster (as survives on the north elevation) has been lost. Unlike on the north elevation there is however no evidence that a plaster finish extended down over the bridging beam below the timber frame.

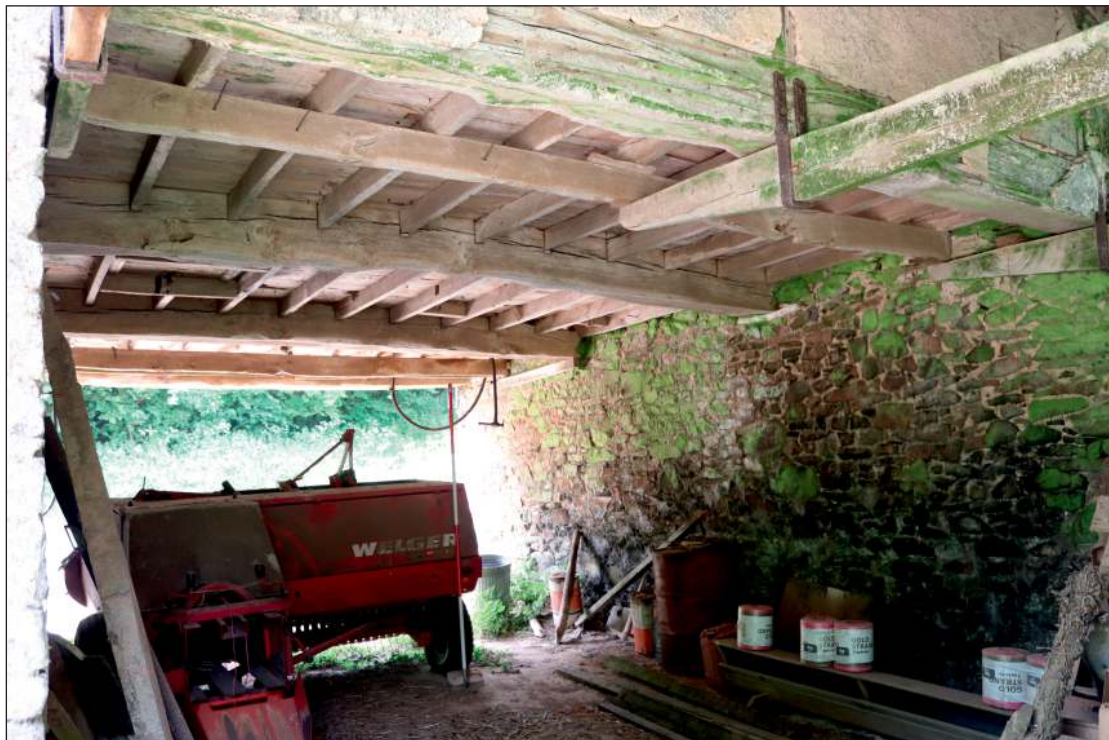
Plate 6: The interior of the ground-floor cart shed looking southwest, showing the hatch (left), bridging beams for the first floor, and brackets and associated secondary beam for the north canopy (2m scale)

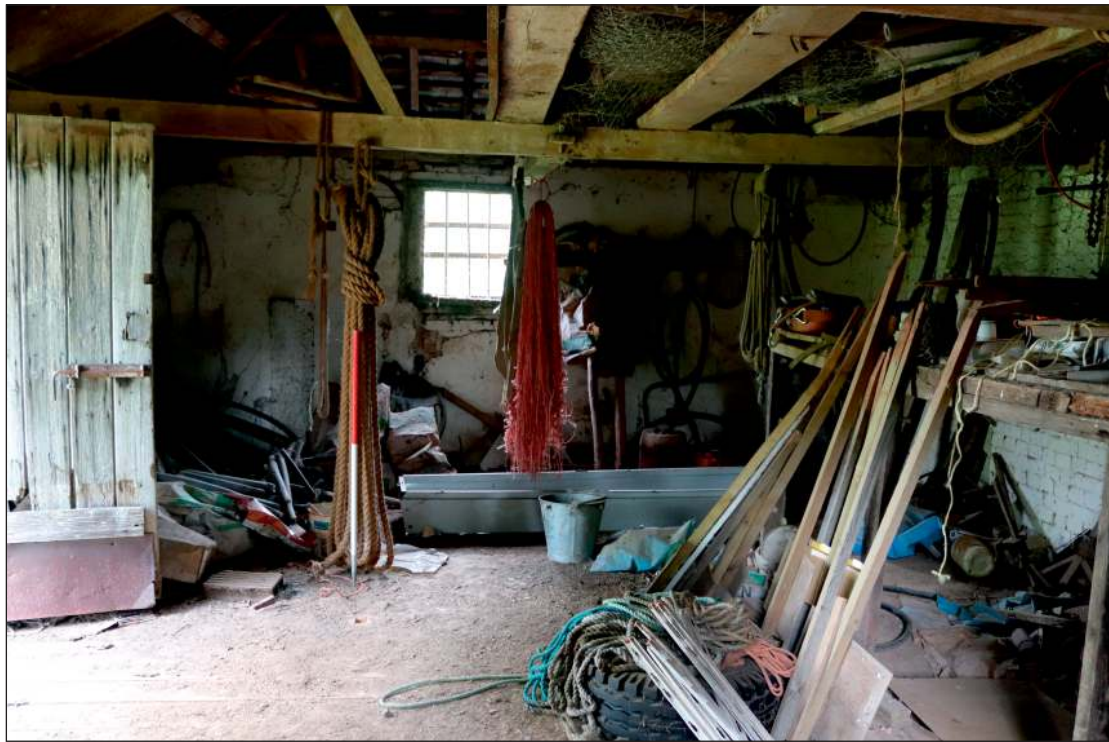
Plate 7: The interior of the first floor looking north, showing the original plastered timber frame of the north elevation and replacement brick east elevation to the right (1m scale)

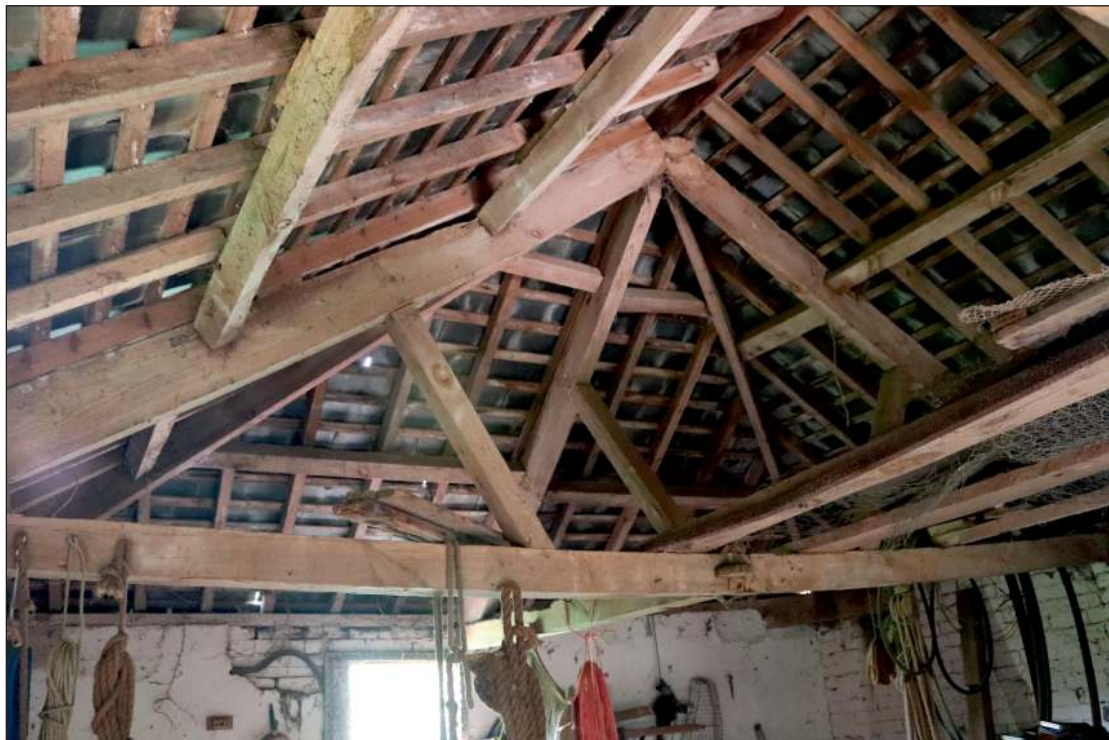
Plate 8: The north roof truss looking north-northeast

- 4.9** The roof structure is fully hipped and is supported on a pair of full trusses with half trusses and hip rafters at the gables. The trusses are tie beams with pegged mortice and tenon joints and lapped apexes to the rafters. There are no collars or posts but the rafters are braced by diagonal struts, again attached with pegged mortice and tenon joints to the tie beams and with notched ends fixed with nails to the rafters. The rafters support two rows of staggered through purlins and a slender ridge set vertically into a notch. The purlins carry battens with a slate roof finish. Each hip rafter is supported on a corner plate laid onto a T-shaped arrangement of timbers set into the walls at 45° to the corners.
