LAND AT LUCOTT FARM, LUCCOMBE, EXMOOR, SOMERSET

Results of Archaeological Investigations

Exmoor National Park Authority Planning Reference
6/19/19/101 (Condition 4)

Report No: ACD2224/2/0

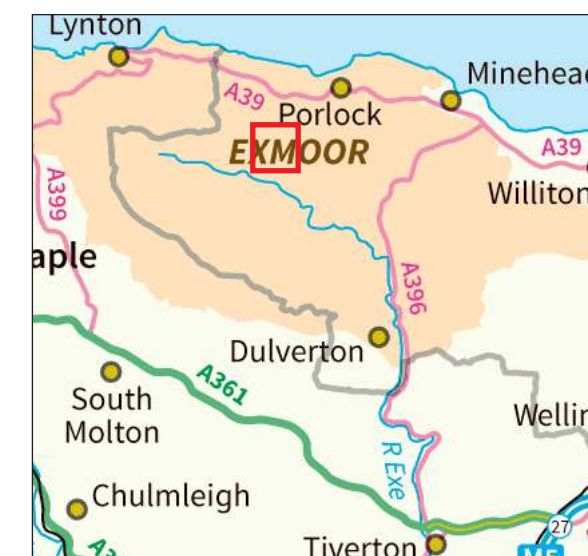
TITLE
Fig. 1: Location of site, trenches and
hedgebank section

5. RESULTS: TRENCH EVALUATION (Fig. 1a; Plates 2-6)

6. RESULTS: HEDGEBANK RECORDING (Section Fig. 1b; Plates 7-8)

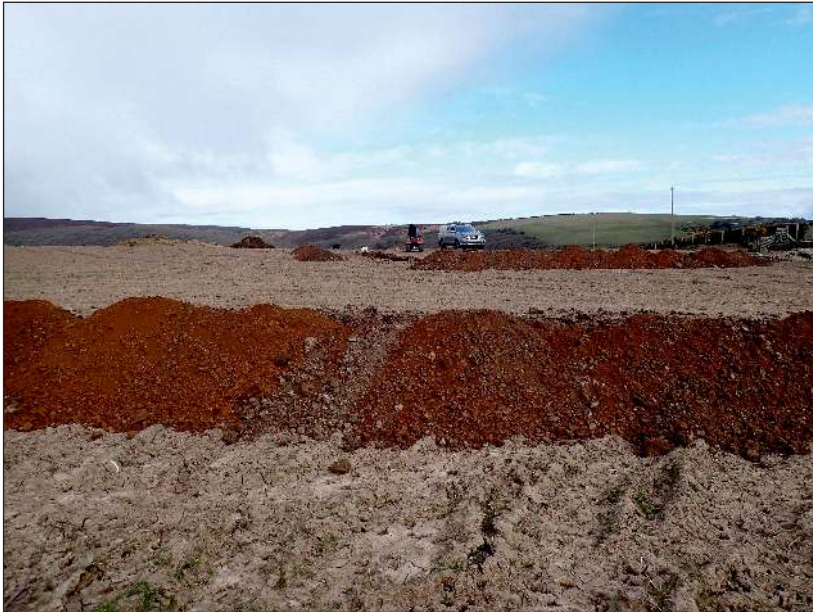
Plate 1: General view of the site with Trench 1 in the foreground, looking northwest

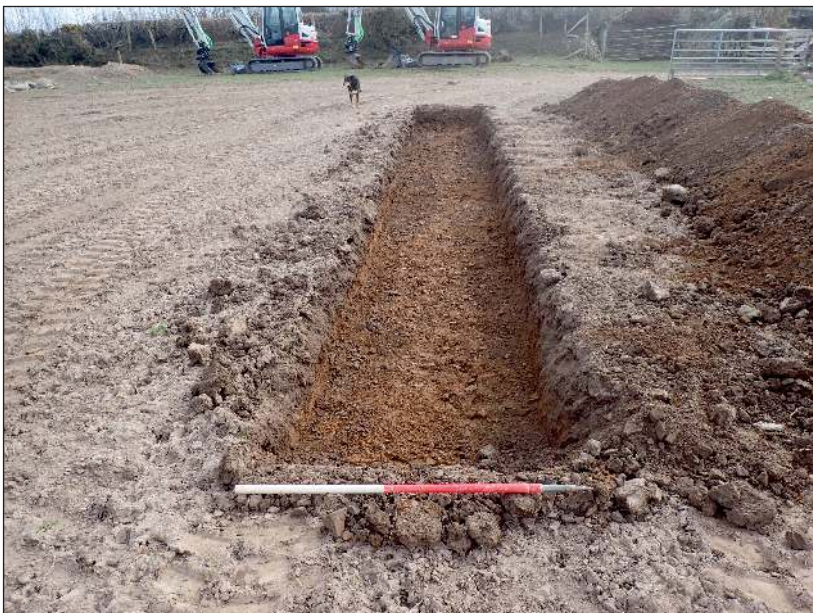
Plate 2: Trench 1, looking northeast (1m scale)

Trench 1		Length 10m	Width 1.2m	Alignment NE-SW
Context	Description	Depth b.g.s	Interpretation	
100	Light greyish-brown sandy silt loam	0-0.3m	Ploughsoil	
101	Mid reddish and yellowish-brown sandy silt loam	0.3m-0.5m	Subsoil	
102	Light yellowish-brown silty sand and gravel	0.5m+	Natural subsoil

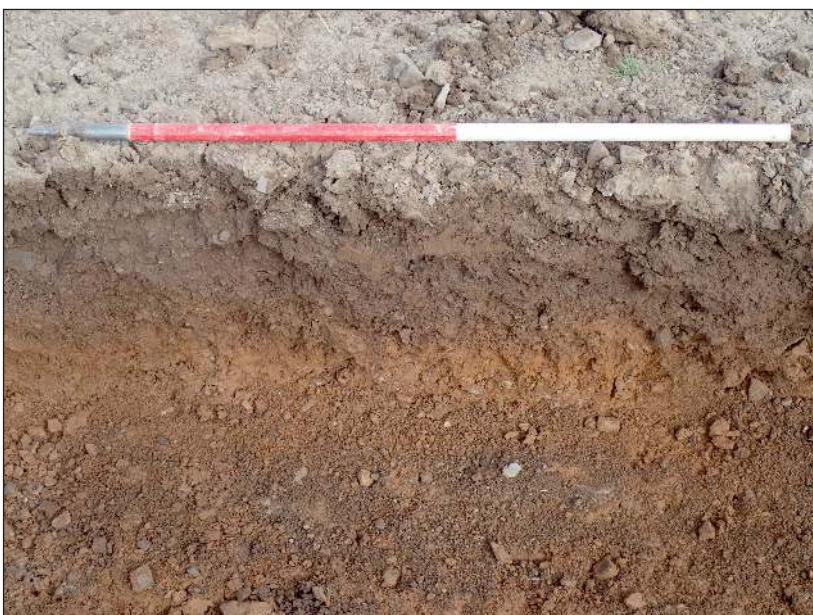
Plate 3: Trench 1, representative section (1m scale)

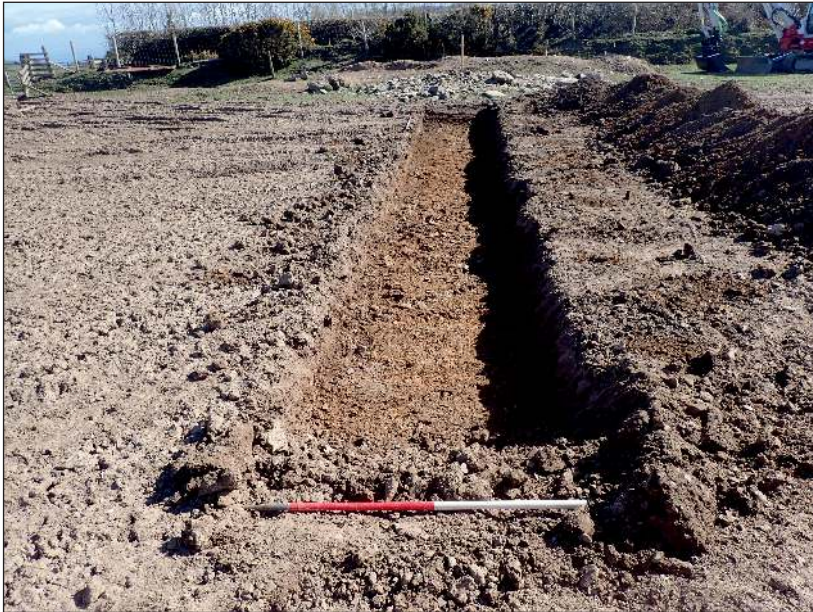
Plate 4: Trench 2, looking northeast (1m scale)

Trench 2		Length 10m	Width 1.2m	Alignment NE-SW
Context	Description	Depth b.g.s	Interpretation	
200	Light greyish-brown sandy silt loam	0-0.3m	Ploughsoil	
201	Mid reddish and yellowish-brown sandy silt loam	0.3m-0.4m	Subsoil	
202	Light yellowish-brown silty sand and gravel	0.4m+	Natural subsoil

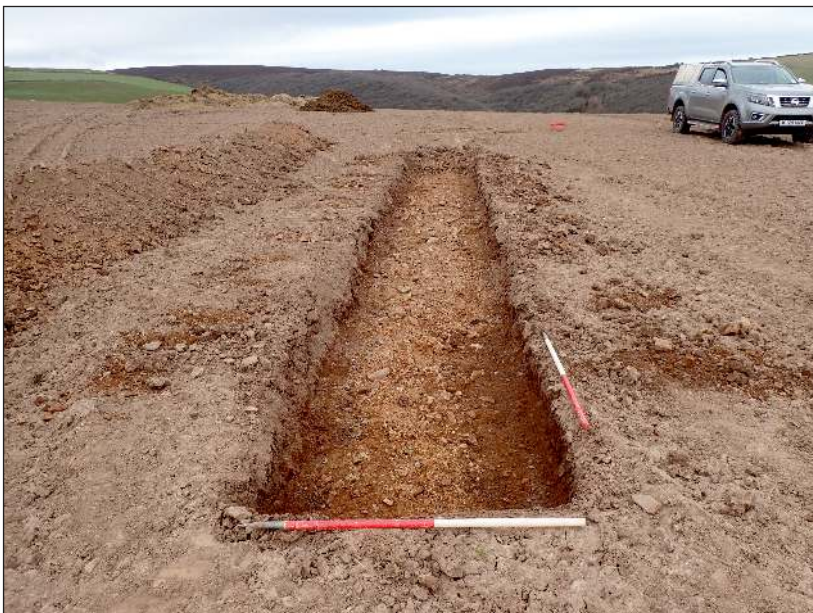
Plate 5: Trench 3, looking northwest (1m scale)

Trench 3		Length 10m	Width 1.2m	Alignment NW-SE
Context	Description	Depth b.g.s	Interpretation	
300	Light greyish-brown sandy silt loam	0-0.3m	Ploughsoil	
301	Mid reddish and yellowish-brown sandy silt loam	0.3m-0.4m	Subsoil	
302	Light yellowish-brown silty sand and gravel	0.4m+	Natural subsoil

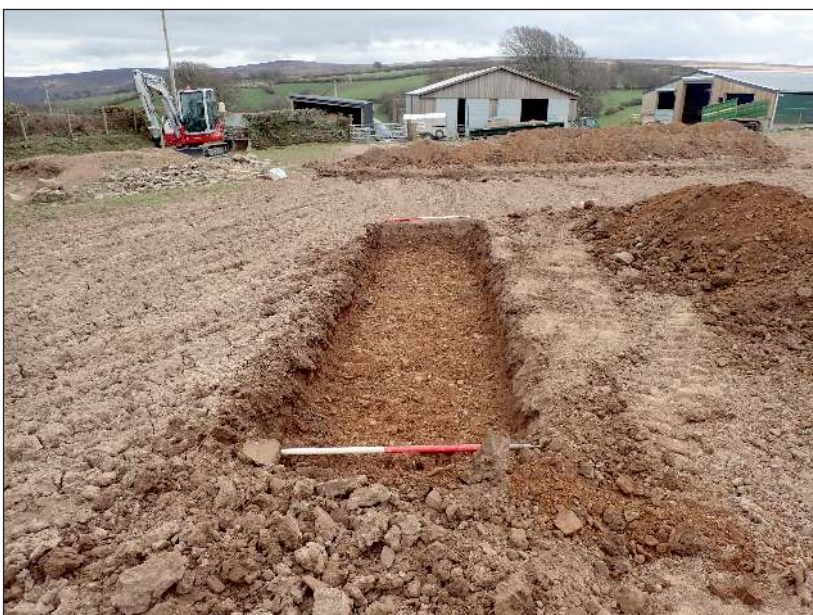
Plate 6: Trench 4, looking southeast (1m and 1m scales)

Trench 4		Length 5m	Width 1.2m	Alignment NW-SE
Context	Description	Depth b.g.s	Interpretation	
400	Light greyish-brown sandy silt loam	0-0.3m	Ploughsoil	
401	Mid reddish and yellowish-brown sandy silt loam	0.3m-0.4m	Subsoil	
402	Light yellowish-brown silty sand and gravel	0.4m+	Natural subsoil

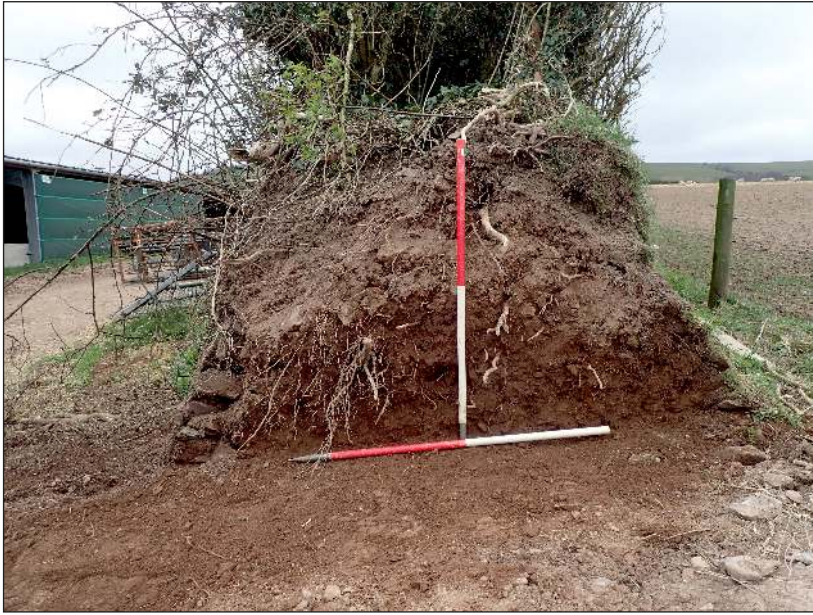
- 6.1** The recorded hedgebank was located at the north extent of the development area. An approximately 25m long section of the hedgebank was removed to the level of the existing ground surface.
- 6.2** The hedgebank measured 1.4m high and was 2.2m wide at the base. It was constructed of light brown sandy silt (context 501), with inclusions of very abundant angular, subangular and occasionally tabular sandstone gravel, cobbles and boulders. It had a facing wall on the southeast side only and this was constructed in a diagonal pattern (502). The bank material was heavily root disturbed and no evidence for a buried soil within the exposed profile was present.

Plate 7: Showing section of hedgebank, view to southwest (1m and 1m scales)

The hedgebank was found to be of simple construction with an earth and stone core and facing stones set in a diagonal pattern on one side. This boundary forms part of a rectilinear field system and continues in a straight line for a distance of approximately 500m to the southwest following the top of a ridgeline. The field pattern of rectilinear fields and with long and straight stretches of hedgebanks is typical of post-medieval enclosure of common land which took place in the 18th and 19th centuries on Exmoor (see Hegarty 2014). This process often resulted in the destruction of archaeological sites where the stone was robbed to be used for the facing of the banks (Riley and Wilson-North 2001, 43). There were no finds associated with the hedgebank, but its morphology and position within the pattern of fields indicates that it is of probable late post-medieval date.

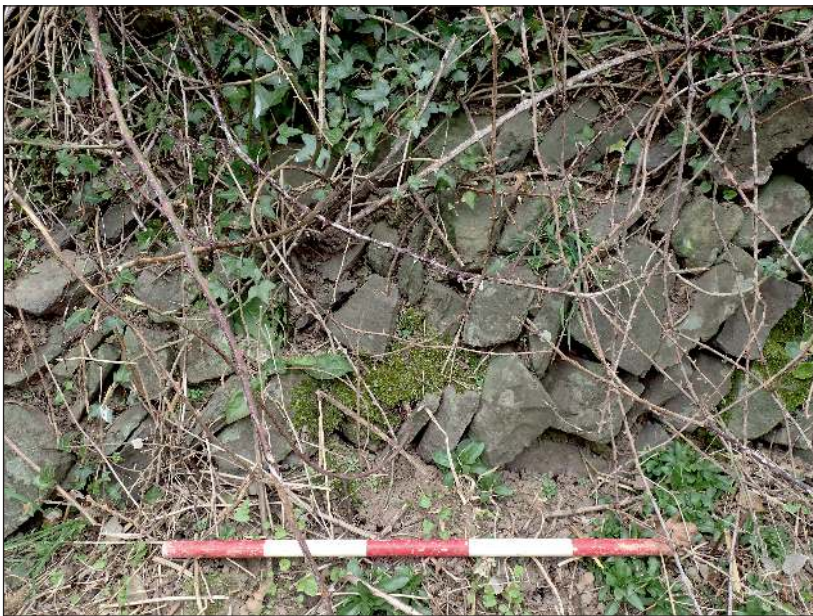
Plate 8: Detailed view of hedgebank facing 502, looking northwest (0.5m scale)
