MCBAINS BUSINESS UNITS, CLYST HONITON, DEVON

Results of historic building recording

East Devon District Council planning reference
16/1578/FUL, condition 4

Document No: ACD2307/2/0

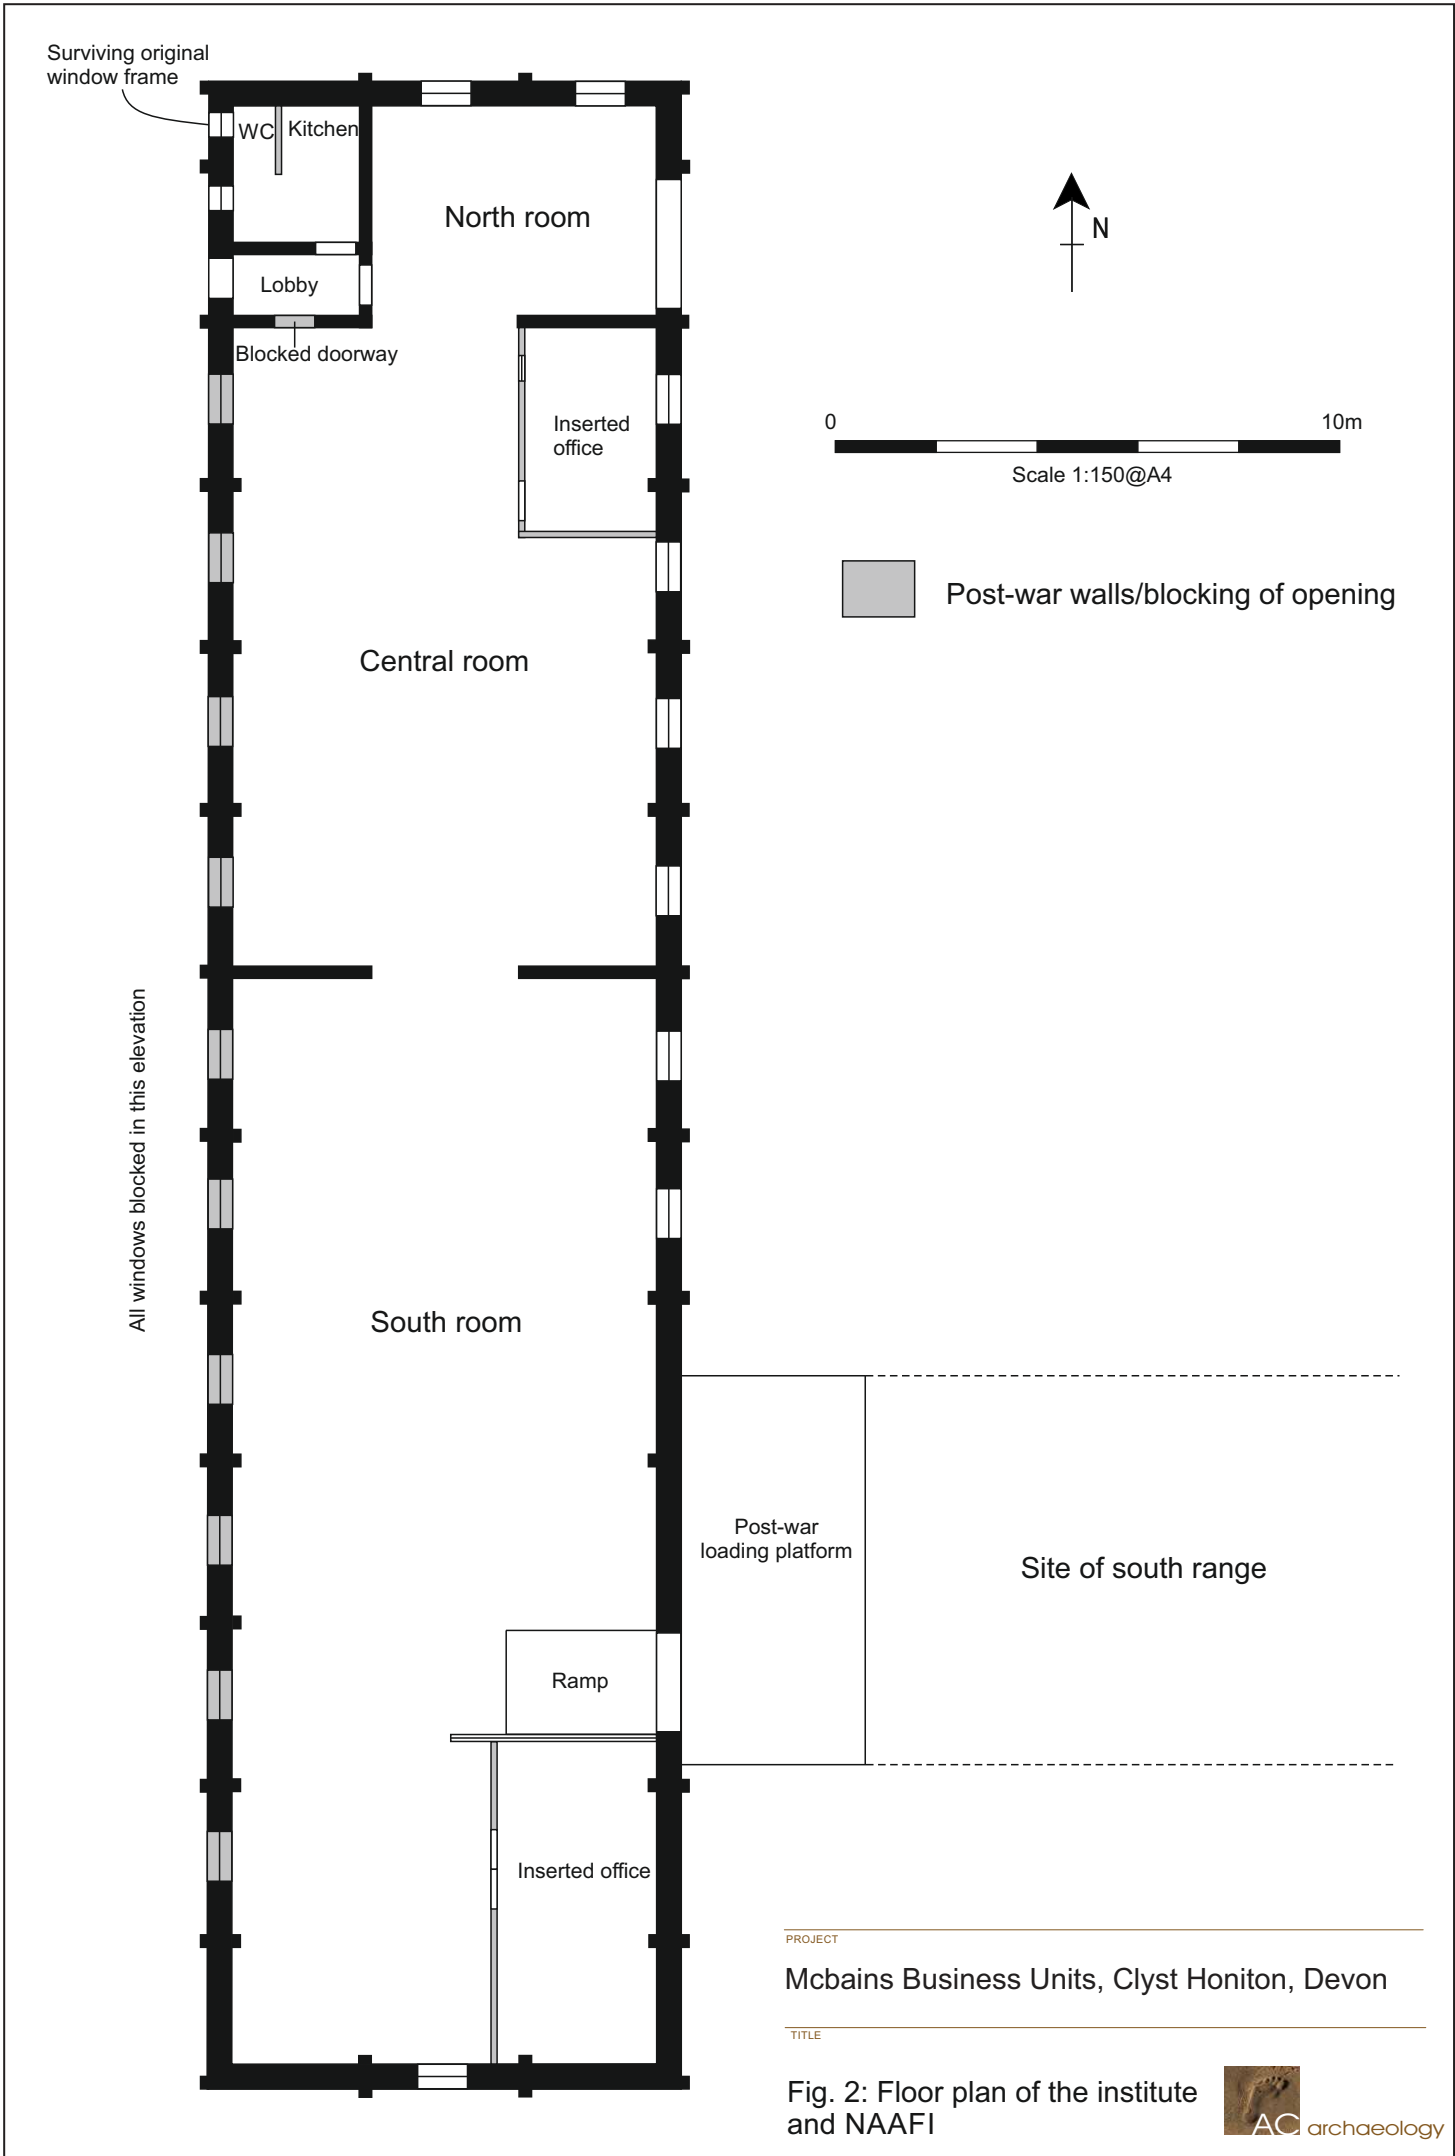
Fig. 2: Floor plan of the institute and NAAFI

- 5.3** The building is currently entered from the door at the north end of the west elevation. This opens into a small *lobby* that gives access to a small *kitchen* and a *WC* to the north; these two rooms have been subdivided from the larger lobby. A blocked doorway in the south wall of the lobby formerly provided access into the *central room*. A door on the east side of the lobby leads into a *north room* in the northeast corner of the building. A large opening, central to the building, provides unobstructed access into the central room. The east side of this opening is currently defined by part of an *office*, inserted into the northeast corner of the central room (Plate 6). The office has a wooden door with an upper glass panel and a window in its west wall. The partition between the central room and *south room* again incorporates a wide, tall unobstructed central opening. In the southeast corner of the south room is another inserted office divided by partitions of wood and glass (Plate 7), and which is entered via a pair of double wooden doors. The only other feature in the central room is a concrete slope down from the double doors in the east elevation. The roof covering throughout is supported on steel trusses constructed of pairs of 'rafters' with and three-part 'tie beams' supported with diagonal struts (Plates 7 and 8). These support a ceiling comprising (?asbestos) panels that obscure the structure above supporting the sheet finish. The feet of the trusses rest on internal brick piers which line up with the external piers.

- 6.2** The recorded surviving part of the institute and NAAFI was originally one of three ranges connected by a front block. This range comprised three principal interconnected spaces. There are no original fixtures and fittings but the wide, doorless openings in the partitions perhaps indicates that these spaces contained recreational facilities associated with the institute.

- 6.3** The fenestration of the building has been significantly altered, with almost all the windows in the west elevation blocked, and others replaced with UPVC frames; only the partial remains of a single original metal-framed window survives. The former probably took place in the 1960s when the adjacent Romney Hut was erected, effectively blocking light from entering the building through these windows. New double doors have been added in the east elevation – one pair probably within an original opening that originally provided access to the now demolished south range. Internally, new offices, a kitchen and a WC have also been added within the pre-existing larger spaces.

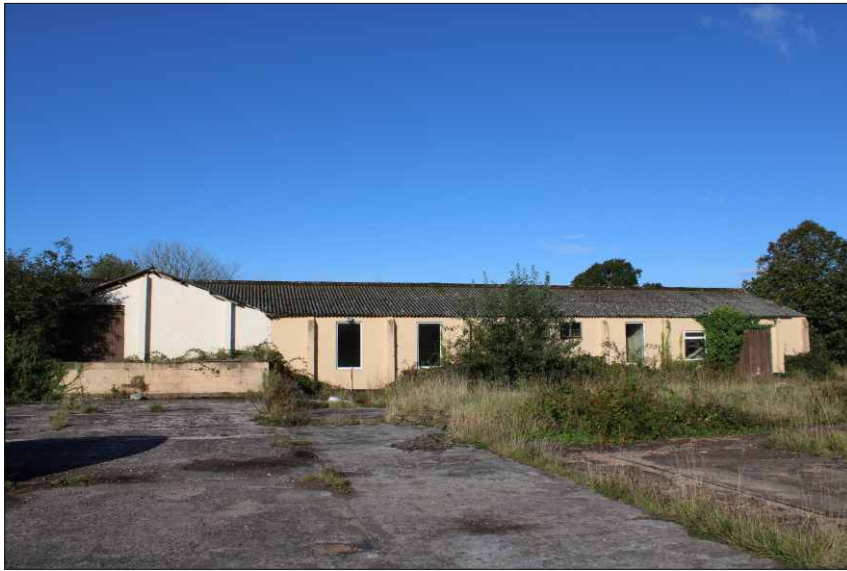
Plate 1: East elevation of the institute and NAAFI, looking west (1m scale)

5.2 The east elevation features double wooden doors located towards each end of the building (Plate 1). The northern opening has an external loading bay defined by concrete blocks that slopes gently down towards the building. The southern opening

is accessed from a raised area, also retained by concrete blocks, located within the footprint of the demolished south range. There are five replacement UPVC windows along with a smaller casement window. The south elevation has lost some of its render exposing the brickwork which is laid in stretcher bond (Plate 2). There is a single central replacement UPVC window. The north elevation has two replacement UPVC windows located in the eastern two bays (Plate 3). The majority of the west elevation is obscured externally by mature vegetation although the piers are visible (Plate 4). At north end there is a single replacement late 20th-century door, a replacement UPVC window and a partially blocked window opening that retains a metal frame with some of its original (8) small glass panes (Plate 5). Other window openings present in all but the southernmost bay of this elevation are visible internally; they have all been blocked in brickwork (see Plate 8).

- 5.6** The concrete surface on the footprint of the south range is of post-war date, and other than the shape of the concrete there is no evidence at ground level for this part of the building. The raised loading area against the surviving west range has been constructed onto this surface (Plate 1).

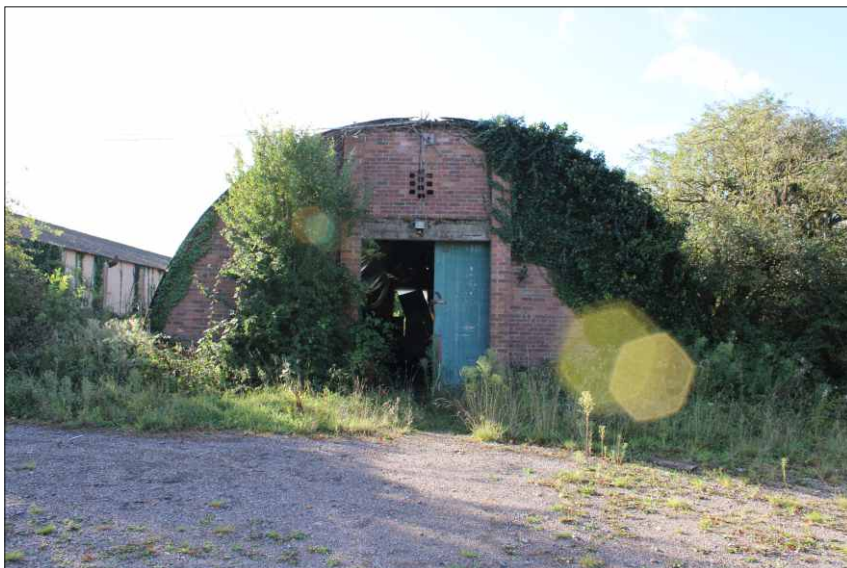
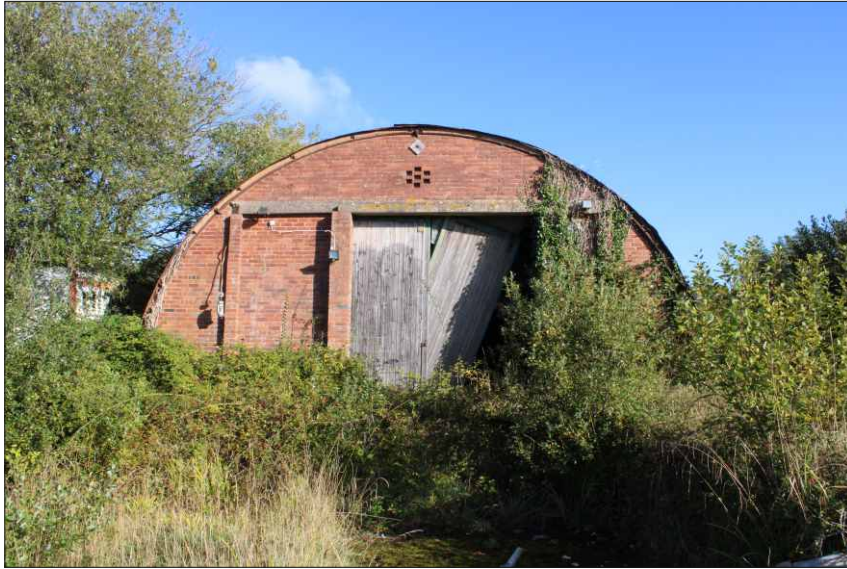
- 5.4** This has a fully curved roof of corrugated metal sheets which extend down to ground level. It incorporates high-level integral roof lights. The north and south gables are constructed of brick laid in stretcher bond. Each have four piers, with the central pair in the north elevation extending to the full height of the buildings; the others terminate at the level of the top of the doors. Both gables incorporate central double height, sliding wooden doors hung from concrete lintels. Above these are ventilation holes of slightly differing designs in each gable (Plates 9-10).

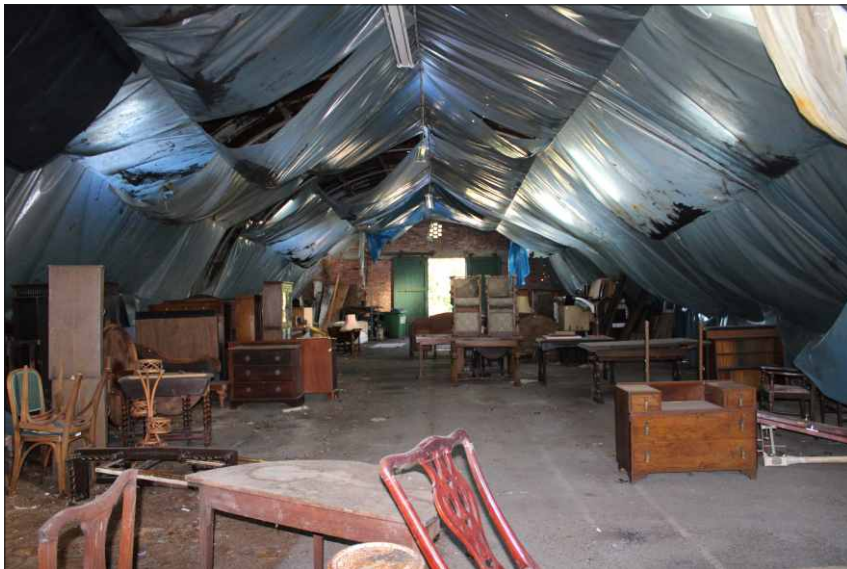
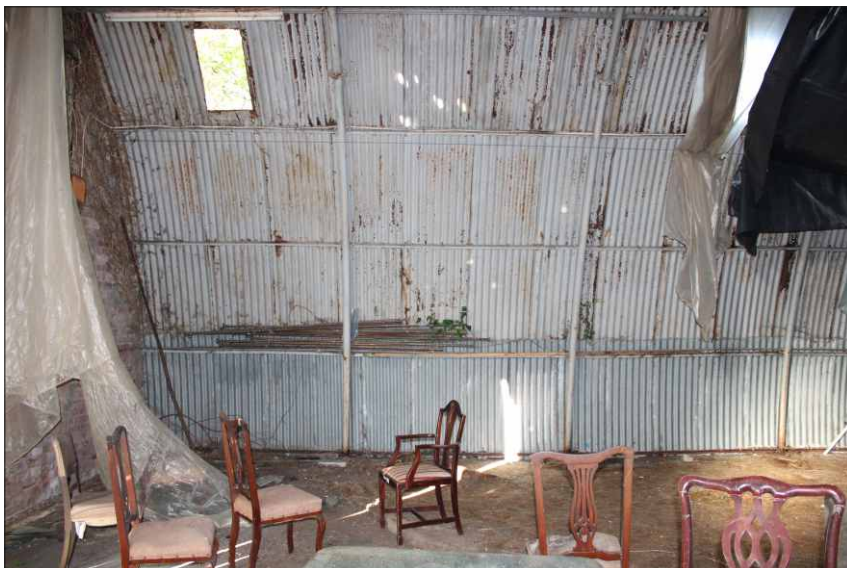
- 5.5** Internally, the structure supporting the roof covering is partially visible behind a modern plastic waterproof lining (Plates 11 and 12). This structure comprises semi-circular metal ribs formed from four circular tubes bolted together at their ends, and set into the concrete surface. To these a series of thinner steel angle-section purlins are attached horizontally, onto which the corrugated sheets are fixed. The only remaining fittings, dating from the period of its erection on the site post-war, are electrical cables, switches and fuse boxes and lights attached to the north and south gable walls (Plates 11-14); some of the cabling and switches are more recent replacements.

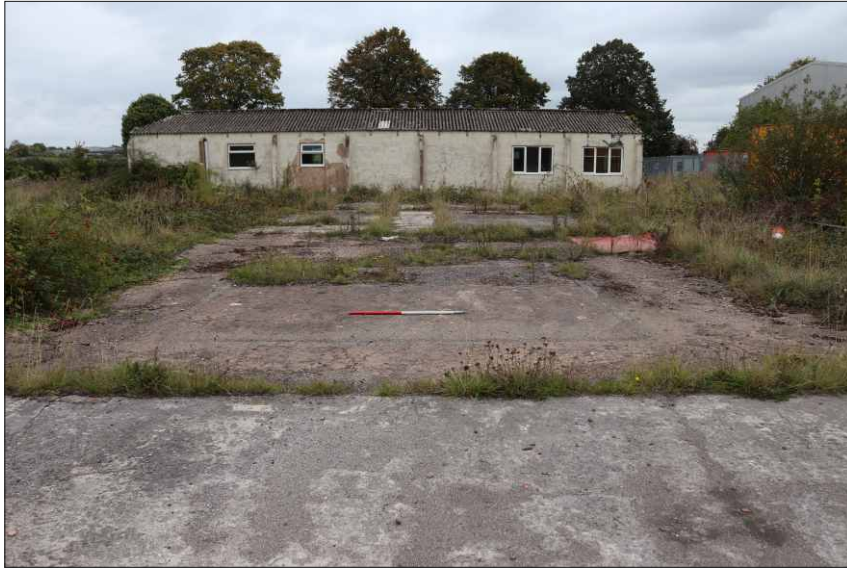
Plate 15: The concrete floor of the demolished central range, looking north (1m scale)

- 5.7** The concrete floor of the demolished central range survives (Plate 15). At the south end is a plain slab, then there is a longer section that incorporates what appears to be the scar of a central room or set of rooms, surrounded by walkways on all sides; the northern part of this area divided into four smaller patches of concrete. Scars of brickwork in between the concrete floors indicate that northern part of the building had a central corridor flanked by three rooms on the east side and four rooms on the west side, all of varying sizes. The smallest room on the west side was a toilet and was partially divided into two cubicles with holes in the floors for sewer pipes (Plate 16). The adjacent end room to the north is also divided into two spaces by a north-south aligned wall.

- 6.4** All that remains of the demolished sections of the institute and NAAFI are the concrete floors of the central range which displays scars of former rooms including toilets and corridors.
