EAST STIBB FARMHOUSE, STIBB CROSS, LANGTREE, DEVON

Historic building appraisal

Torridge District Council planning reference
1/0537/2020/FUL

Document No: ACD2342/1/1

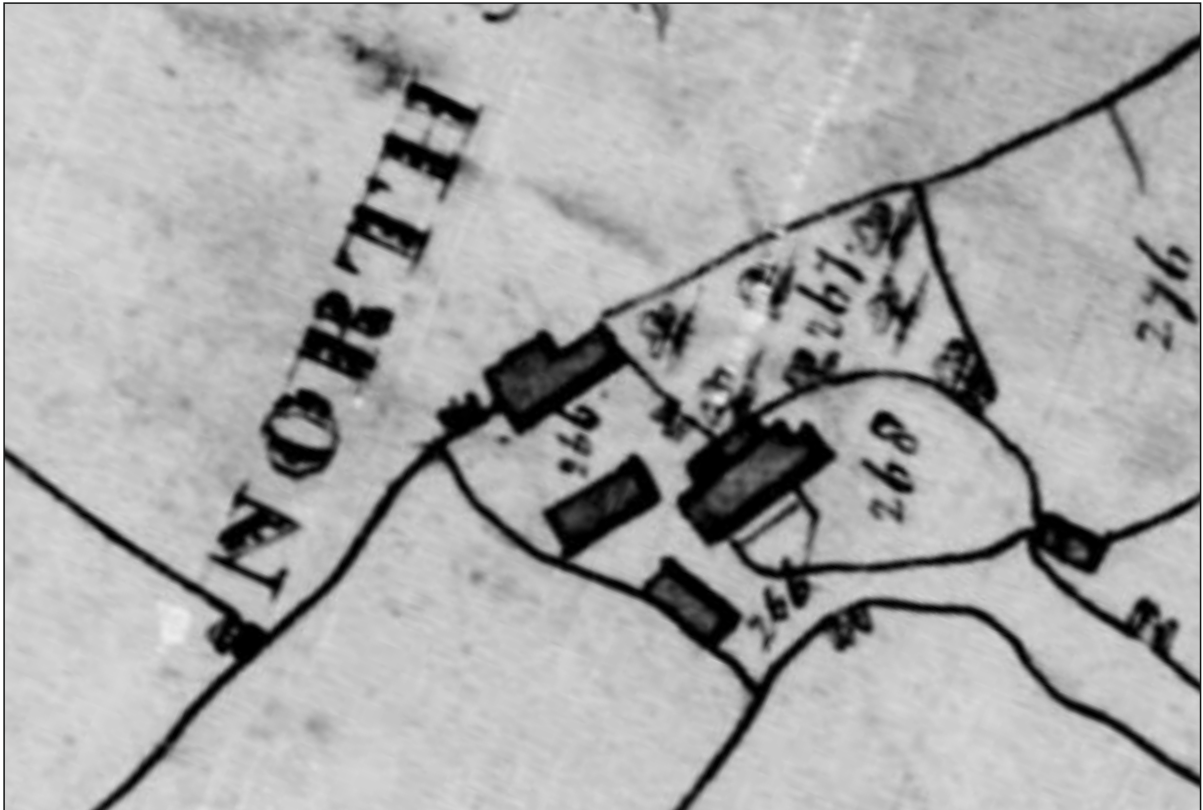
Fig. 2: Extract from the Langtree
tithe map, 1838

4.2 The Langtree tithe map of 1838 (Fig. 2) depicts the property, now called *North Stibb*, in more detail than the 1804 map. The farm complex comprised three plots – 266-268 – owned by John Stoneman and occupied by William Crews; they were described in the accompanying apportionment as ‘Houses and courtlage, orchard and garden’. The farmhouse is depicted as a rectangular range aligned northeast-southwest with a projecting range on its northwest side. To the west are three rectangular structures set within an informal area of yards, and there was a further small rectangular structure to the east. It was accessed via a track from the east. There is no clear correlation between the tithe map and the 1804 Ordnance Survey map, but the former probably records the farmhouse and the southernmost of the three buildings to the west.

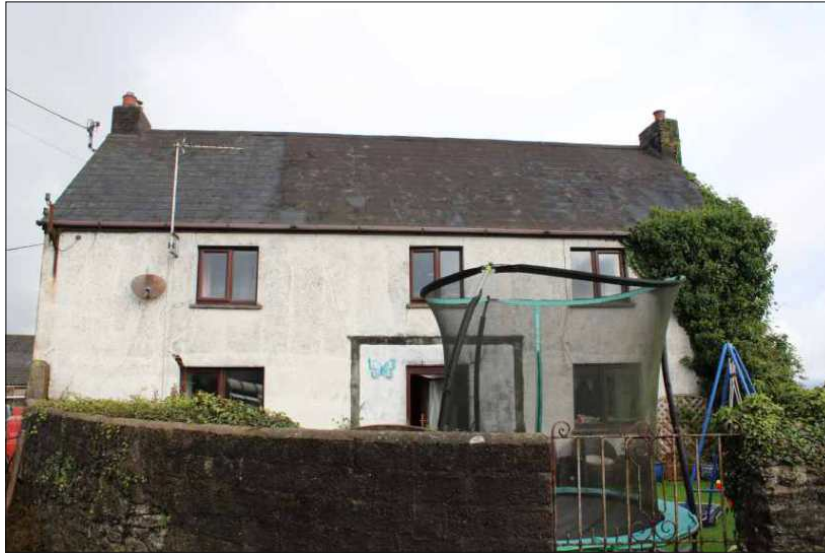
Plate 1: Southeast elevation, looking northwest

- 5.2** The main elevation faces to the southeast with two windows and a doorway on the ground floor and three windows on the first floor; it is asymmetrical with the (near-central) doorway and one window off-set slightly to the northeast. The doorway was formerly covered by a porch but this has been removed (Plate 1). The northeast elevation has two windows on the ground floor and a single window on the first floor, all set towards the rear of the property; one of the ground floor windows is within the rear range (Plate 2). The southwest elevation has a first-floor window towards the rear of the main range and a further window in an extension that projects out from the line of the elevation (Plate 3). On the north elevation (of the rear range) there are three windows and a doorway (Plate 4).

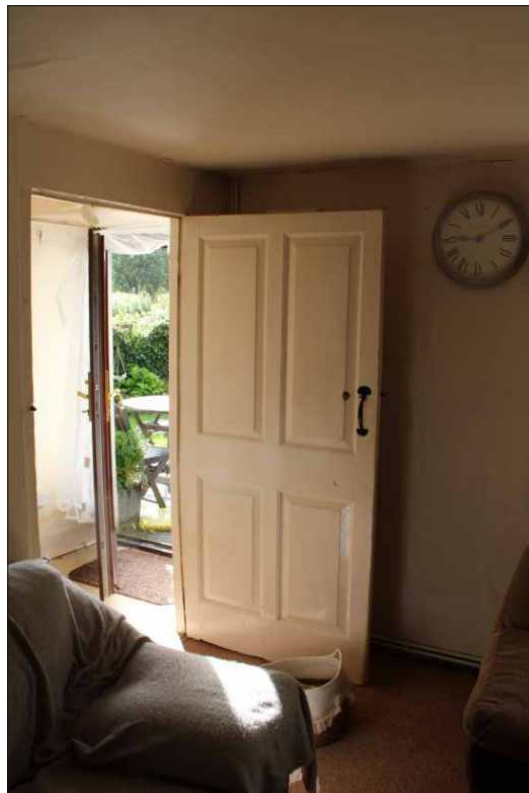
Plate 5: Four-panel door to reception room, looking east

- 5.3** Internally, there are two reception rooms to the front of the property, with the front door opening into a central entrance hall that contains the main staircase. Both rooms have early 19th-century four-panel doors and there is another door of the same design at the base of the enclosed staircase; the upper panels are taller and they have upright door handles with thumb plates and rounded ends (Plate 5). In the northeast reception room there is an early 20th-century surround to the fireplace, whilst in the southwest reception room there is a large fireplace with a wooden lintel, repointed stone work and a wood-burning stove on a modern slate hearth (Plate 6). There is also a niche in the rear wall and a plain four-panel door to a cupboard beneath the stairs.

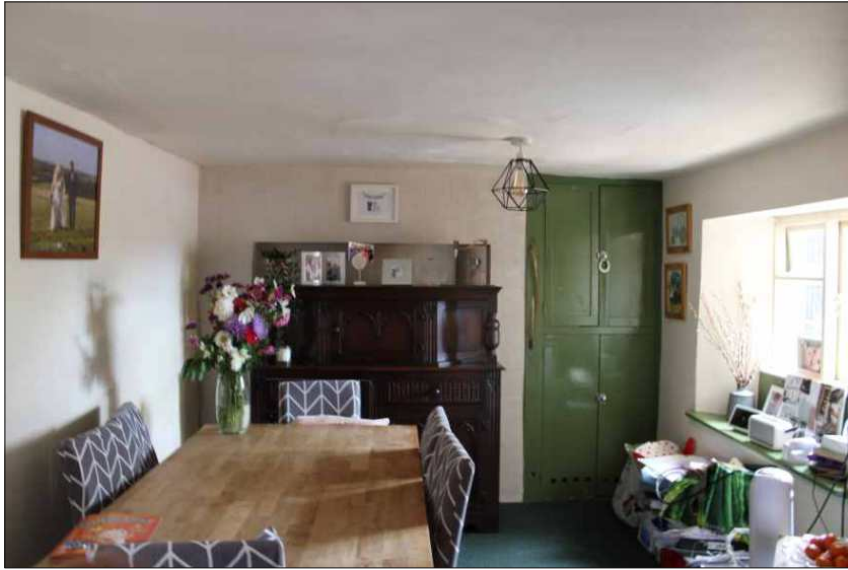
Plate 7: Fireplace and cupboards in dining room, looking southwest

- 5.4** In the middle of the house, behind the reception rooms, there is (from southwest to northeast) a dining room (the original kitchen), a larder/utility room, and a store. The door in the partition from the southwest reception room into the dining room is of a simple plank and batten design. There is a fireplace in the southwest wall of the dining room; in the early 20th century the opening has been finished with tiles (Plate 7). The stack projects into the room, and in the adjacent recess there are cupboards fitted with simple early 20th-century panel doors. The opening from the dining room into the larder has a four-panel door of a simpler design than those in the front of the house and the store cupboard has a four-panel door of horizontal panels. In the rear range there is the (only) bathroom and a kitchen, along with a rear entrance lobby (into the kitchen) that projects out from the line of the southwest elevation. There is a slight slope down to the bathroom from the kitchen. This room has a 20th-century door and fittings. The kitchen also has all late 20th-century fittings.

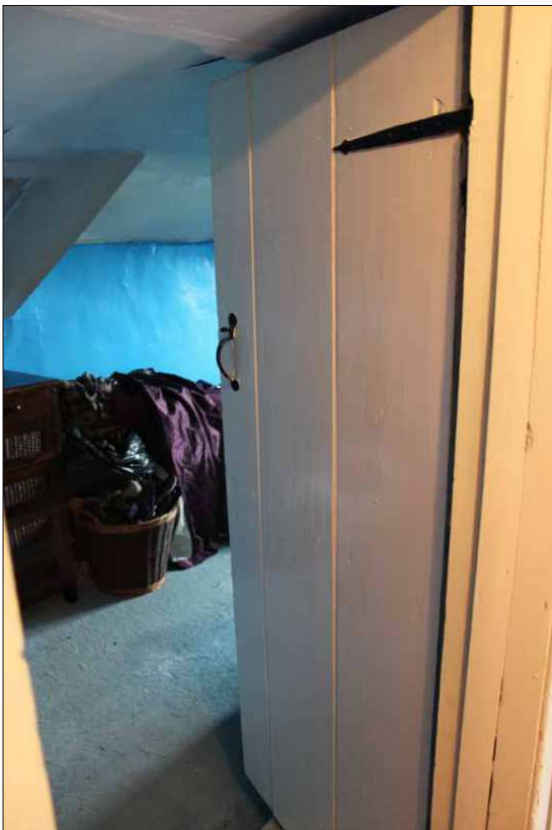
Plate 8: Plank and batten door to a bedroom on the first floor, looking north

- 5.5** On the first floor are five bedrooms, of which three are set towards the front of the house; the other two bedrooms are to the rear and are both narrow rooms under the eaves. All are served by a short central corridor. The rooms all have plank and batten doors with spear ended strap hinges and upright door handles, the latter being of the same style as those on the ground floor (Plate 8). None of the rooms were heated by historic fireplaces. There is a small window above the stairs, which provides light to the enclosed staircase from the central bedroom (Plate 9). The feet of roof trusses are visible at the rear of the house below ceiling level. All but one have the appearance of a 20th-century date, with the earlier rafter displaying pegs from a now removed collar.
