24 HIGH EAST STREET, DORCHESTER, DORSET

Results of a programme of archaeological monitoring,
excavation and recording

Dorset Council planning reference WD/D/19/02927,
condition 3

Document No: ACD2382/2/0

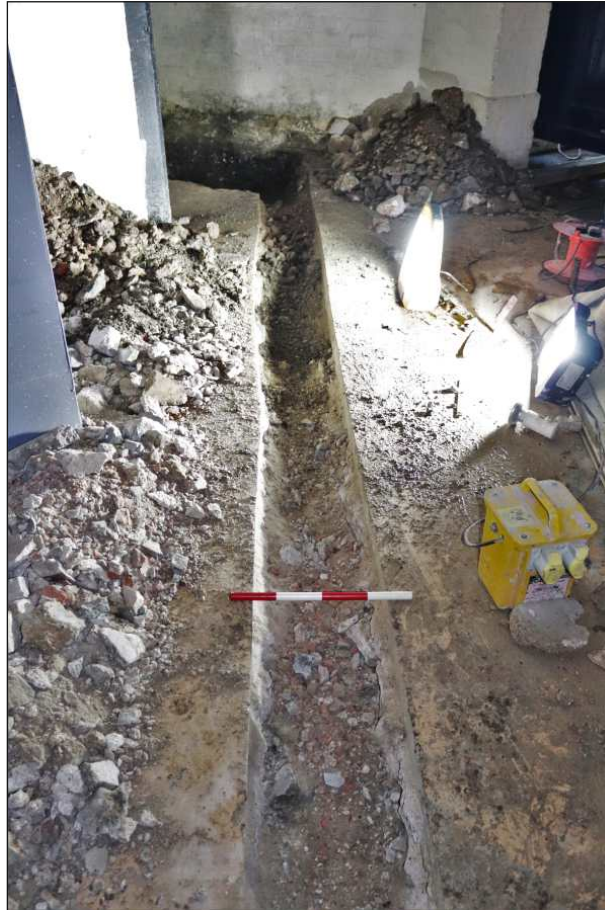
- 5.2 This trench was aligned diagonally across the former showroom and passage on a northwest-southeast alignment. It measured 5.7m long by 0.28m wide, widening at the northwest end, to 0.80m, to allow for a connection under the wall.

- 5.3 The floor surface in the former showroom was a 0.10m thick layer of concrete. This overlaid an earlier surface, consisting of 0.05-0.08m thick limestone slabs. This surface appeared to be identical to the flagstone floor in the showroom to the north. The slabs were laid onto a 0.01m thick bedding layer of very fine gravel. Below this layer the top of an earlier deposit of soft dark grey silt with inclusions of occasional charcoal, slate, and brick fragment, and small chert pebbles was exposed.

Plate 1: The service trench, looking northwest (0.40m scale)

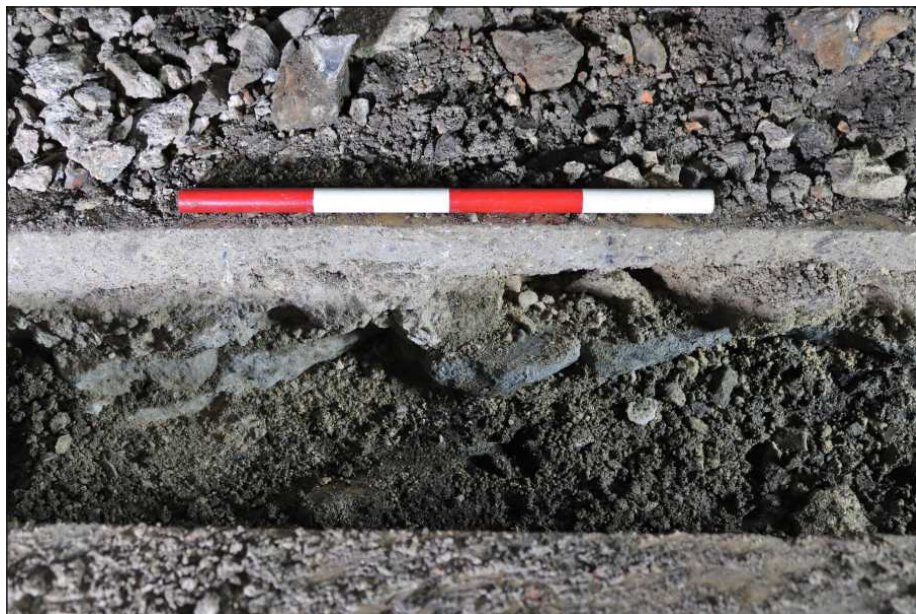
- 6.2 Within the rear warehouse a flagstone floor was exposed, which as with the visible surface in the former showroom to the north, is probably contemporary with the construction of the present building in the period between 1820 and 1840.

Plate 2: Section through the service trench, looking southwest showing the flagstone surface under the modern concrete (0.40m scale)

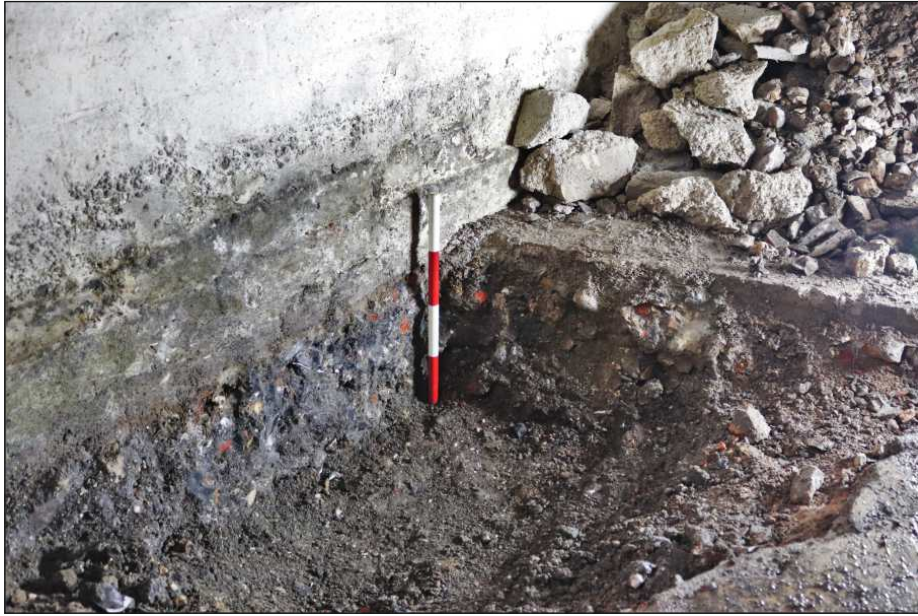
- 5.4 In the passage the concrete surface was 0.05m thick, and overlaid a different earlier surface comprising concrete with brick inclusions, and which measured 0.07m thick. Below this surface a deposit of soft dark grey silt containing very frequent inclusions of brick and tile, and frequent inclusions of slate, glass, lime mortar and stone fragments was exposed; it continued below the depth of the trench (at 0.5m from the surface). This deposit overlaid the foundations of the brick west wall of the passage. They projected out very slightly from the line of the wall, and consisted of concrete with large inclusions of chert, coal and brick.

Plate 3: The northwest end of the service trench within the passage, looking north (0.40m scale)

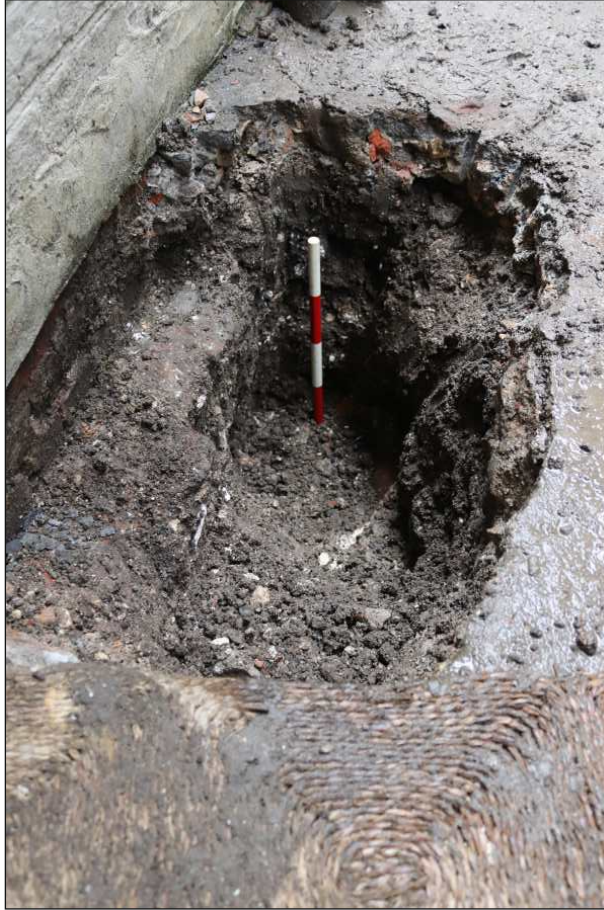
- 5.6 This pit was located against the angled northwest wall of the passage and measured 0.80m long by 0.50m wide. It was excavated to a maximum depth of 0.62m below the surface.

- 5.7 The existing yard surface is concrete, and is 0.12m thick. It had been laid onto a loose brick and stone make-up deposit creating a single thick layer. Removal of the surface exposed a deposit of soft dark grey silt containing frequent inclusions of brick, slate, glass, lime mortar and stone fragments. The deposit extended below the depth of the excavations. It overlaid a ceramic drain that was aligned northwest-southwest, and dropped down from a downpipe in the northwest corner of the yard. The deposit also overlaid the foundations of the passage wall. These measured up to 0.20m wide, 0.60m deep, and were as described in Section 5.4 above.

Plate 5: The connection pit, looking southwest (0.40m scale)
