# LAND AT TUMBLING FIELD LANE, TIVERTON, DEVON

Results of an Archaeological Trench Evaluation

Planning Reference: Mid Devon District Council  
20/01263/MFUL

Report No: ACD2414/2/0

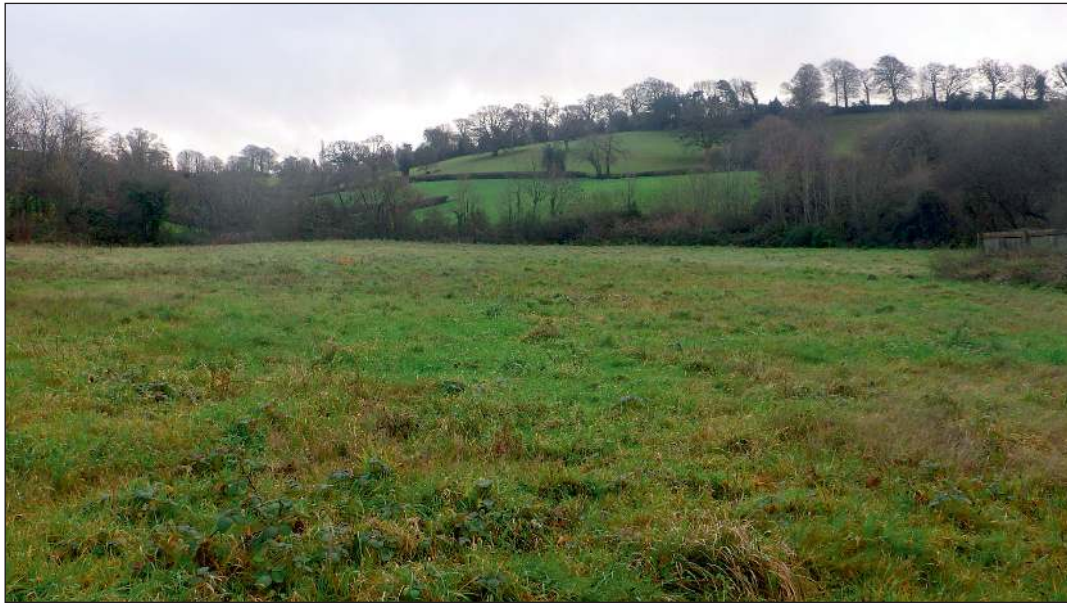
Plate 1: General view looking southeast

- 1.2 The site is located towards the northern end of Tumbling Field Lane and is a single pasture field covering approximately 0.75 hectares, currently an unused paddock (Plate 1). The site's shape is irregular and it is bordered by houses to two sides, Tumbling Field Lane to the northwest and mature hedgerows on the other sides. The site lies on undulating ground at around 68m aOD (above Ordnance Datum), with the underlying solid geology comprising mudstone of the Bude Formation (British Geological Survey Online Viewer 2021).

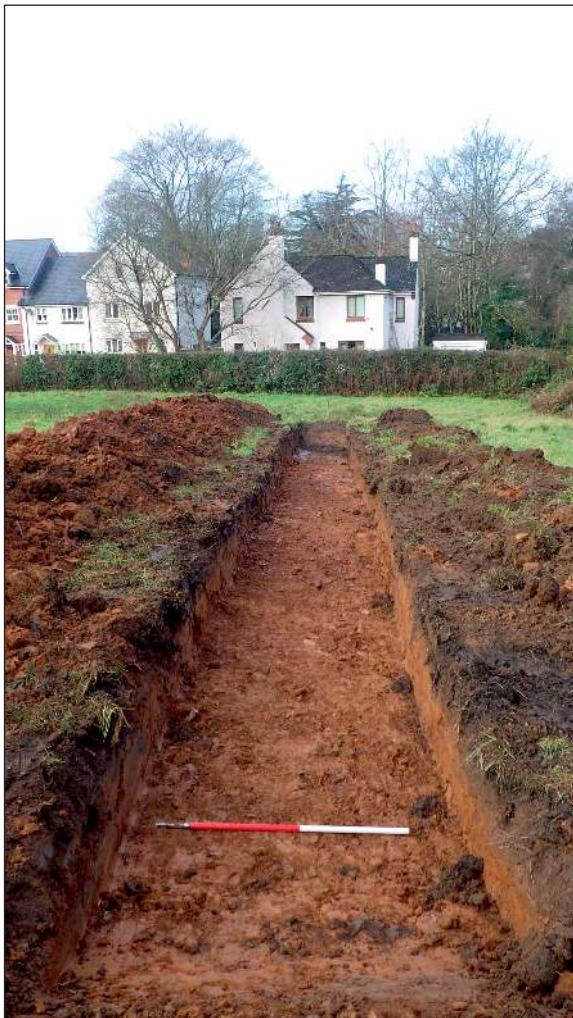
Plate 2: Trench 1 looking northwest  
(scale 1m)

Trench 1		Length 25m	Width 1.5m	Alignment NW-SE
Context	Description	Depth b.g.s	Interpretation	
100	Dark grey silty clay loam	0-0.3m	Topsoil	
101	Light reddish brown silty clay with occasional gravel pebbles	0.3m-0.6m	Alluvial subsoil	
102	Light yellowish-red clay with abundant angular gravel and pebbles	0.6m+	Natural subsoil

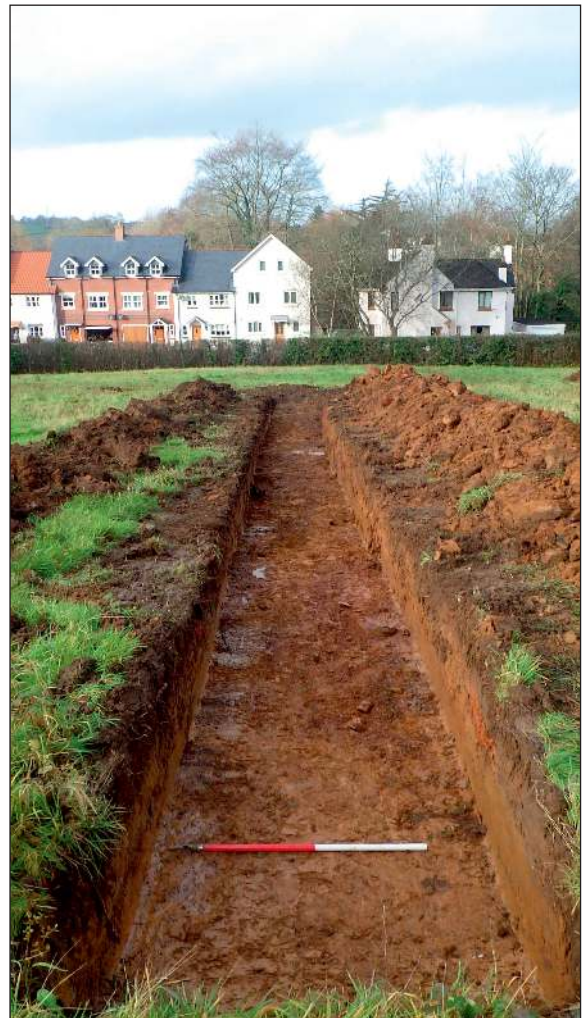
Plate 3: Trench 2 looking northwest  
(scale 1m)

Trench 2		Length 25m	Width 1.5m	Alignment NW-SE
Context	Description	Depth b.g.s	Interpretation	
200	Dark grey silty clay loam	0-0.35m	Topsoil	
201	Light reddish brown silty clay with occasional gravel pebbles	0.35m-0.7m	Alluvial subsoil	
202	Light yellowish-red clay with abundant angular gravel and pebbles	0.7m+	Natural subsoil

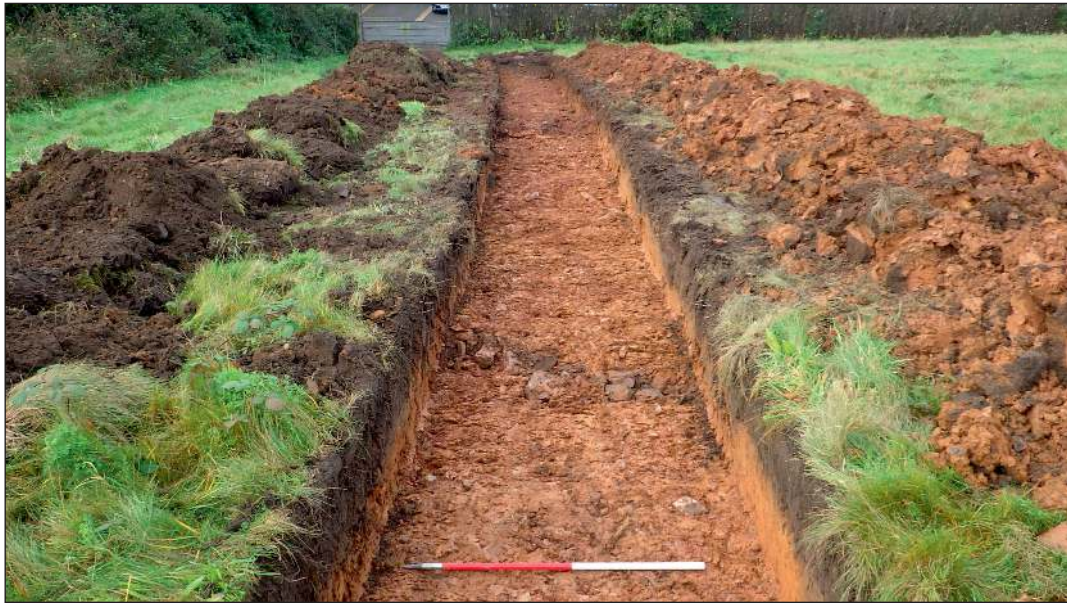
Plate 4: Trench 3 looking northwest (scale 1m)

Trench 3		Length 25m	Width 1.5m	Alignment NW-SE
Context	Description	Depth b.g.s	Interpretation	
300	Dark grey silty clay loam	0-0.38m	Topsoil	
301	Light reddish brown silty clay with occasional gravel pebbles	0.38-0.66m	Alluvial subsoil	
302	Light yellowish-red clay with abundant angular gravel and pebbles	0.66m+	Natural subsoil

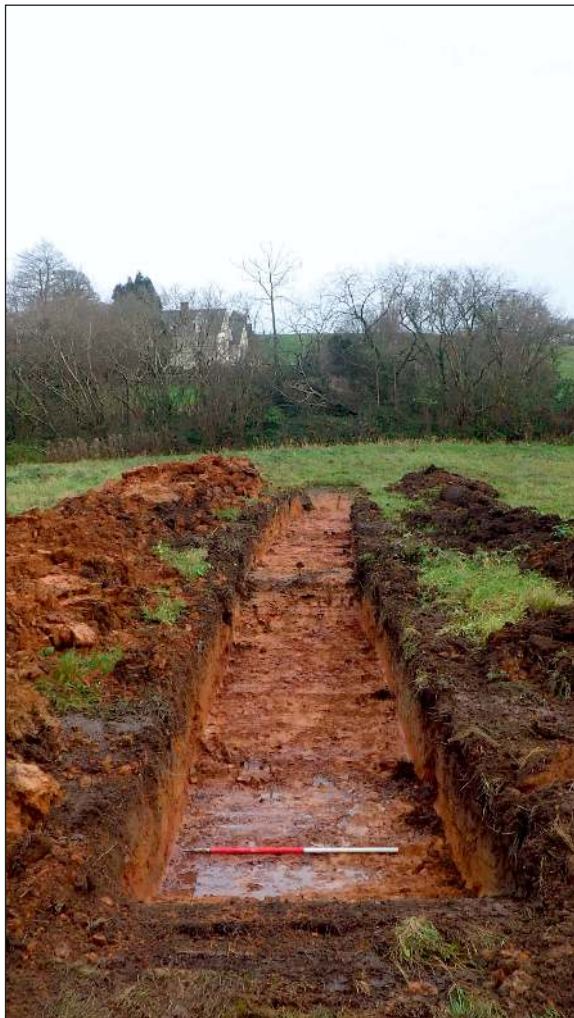
Plate 5: Trench 4 looking northeast (scale 1m)

Trench 4		Length 25m	Width 1.5m	Alignment E-W
Context	Description	Depth b.g.s	Interpretation	
400	Dark grey silty clay loam	0-0.25m	Topsoil	
401	Light reddish brown silty clay with occasional gravel pebbles	0.25m-0.8m	Alluvial subsoil	
402	Light yellowish-red clay with abundant angular gravel and pebbles	0.8m+	Natural subsoil

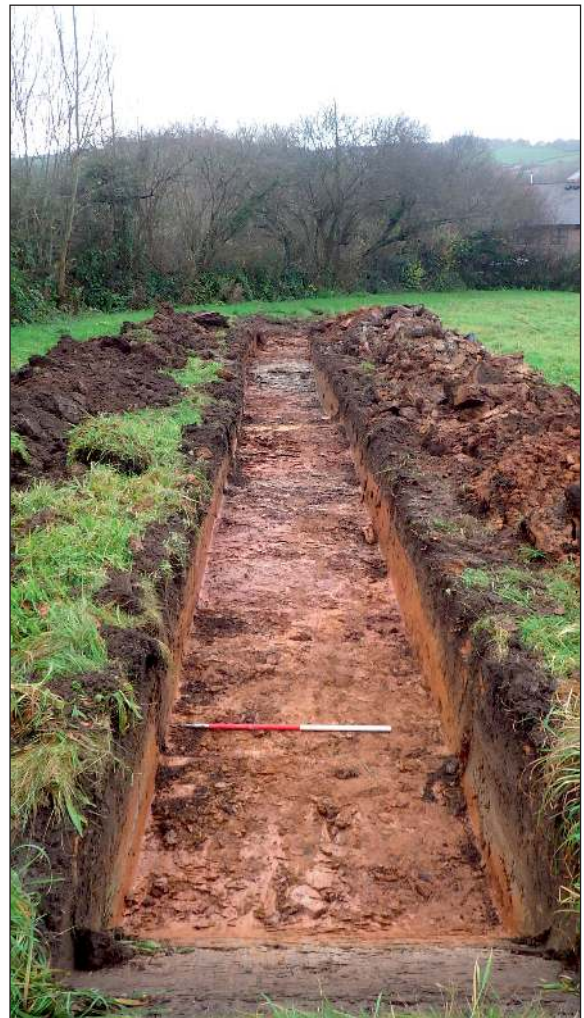
Plate 6: Trench 5 looking west (scale 1m)

Trench 5		Length 25m	Width 1.5m	Alignment E-W
Context	Description	Depth b.g.s	Interpretation	
500	Dark grey silty clay loam	0-0.35m	Topsoil	
501	Light reddish brown silty clay with occasional gravel pebbles	0.35m-0.7m	Alluvial subsoil	
502	Light yellowish-red clay with abundant angular gravel and pebbles	0.7m+	Natural subsoil
