THE SMITHY, BATTISBOROUGH CROSS, HOLBETON, DEVON

Results of historic building recording and an
archaeological watching brief

South Hams District Council planning reference
2850/17/FUL, condition 9

Document No: ACD2415/2/0

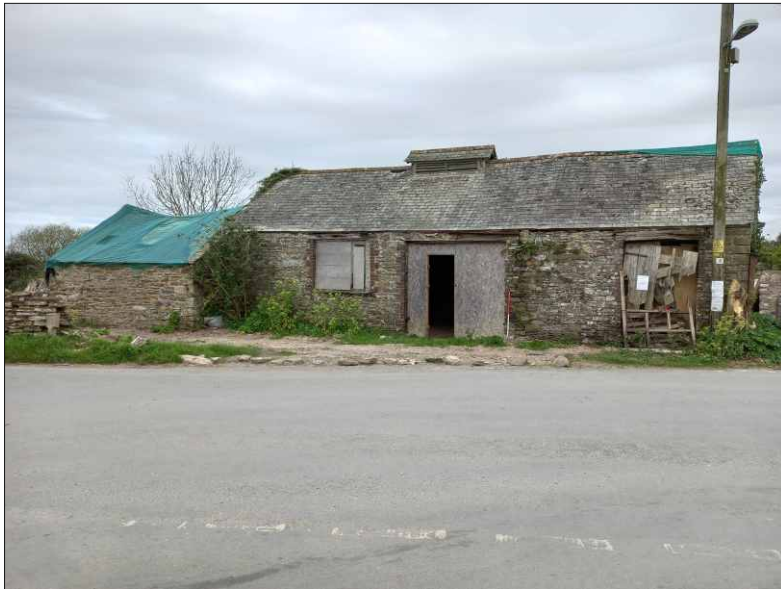
Plate 1: South elevation, looking northwest (1m scale)

5.1 The building is constructed of rubble stone laid in rough courses bonded with an off white lime mortar and has brick detailing around openings (Plate 1). It has a gabled slate roof with a central louvered vent, and a skylight on the north side. At the west end is a range formed by an extension that has partially collapsed.

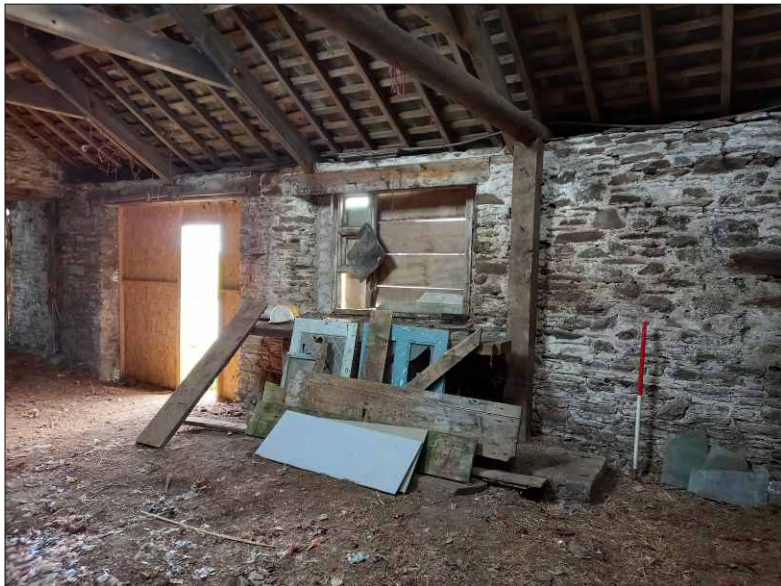
Plate 2: Internal view of south wall, showing the narrowed window, looking east (1m scale)

5.2 The south elevation features a window opening and two doorways. The larger of the two doorways is roughly in the centre of the wall and serves the west room. The eastern opening gives access to the east room; it is also wide and retains the remnants of a single plank and batten door fitted with plain strap hinges. The window opening has a wooden frame but no glass survives. There would have been a single pane to the west and three smaller panes set vertically to the east. Internally it can be seen that the opening has been narrowed on the east side with the insertion of concrete blocks (Plate 2). All the openings have large wooden lintels. The north elevation incorporates two window openings and a doorway (Plate 3). The doorway has been infilled with rubble stonework (Plate 4). The western window opening has

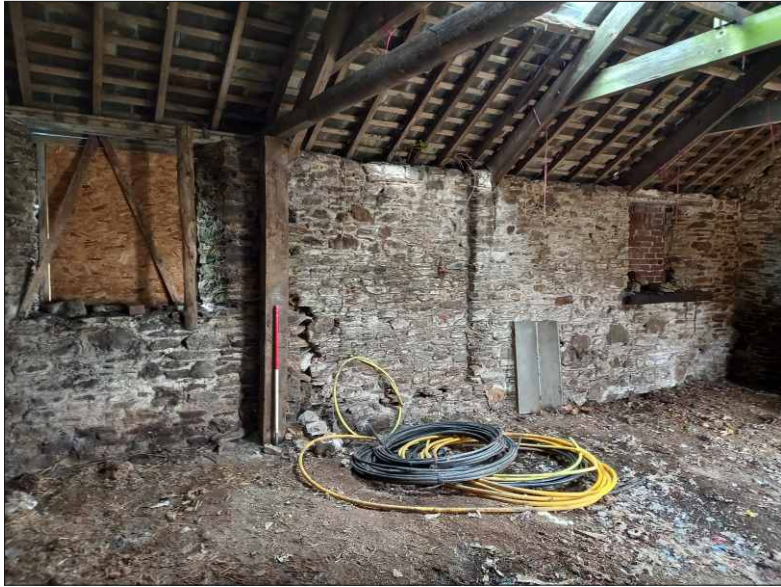
Plate 4: Internal view of north wall, showing blocked openings, looking north (1m scale)

a wooden pegged frame with four upper glass panes surviving, whilst the eastern window opening has been blocked up with brick.

- 7.3** The building was altered in the early-20th century, perhaps coinciding with the change of business activity, from smithing to carpentry, with a doorway and window being blocked in the north elevation. The west extension was altered and enlarged by removing its north wall and extending the west wall to the northern boundary of the property. This included a large doorway which was subsequently altered again in the late-20th century. In the late-20th century block partitions and feeding passages were added to the extension indicating livestock was being housed here during this period.

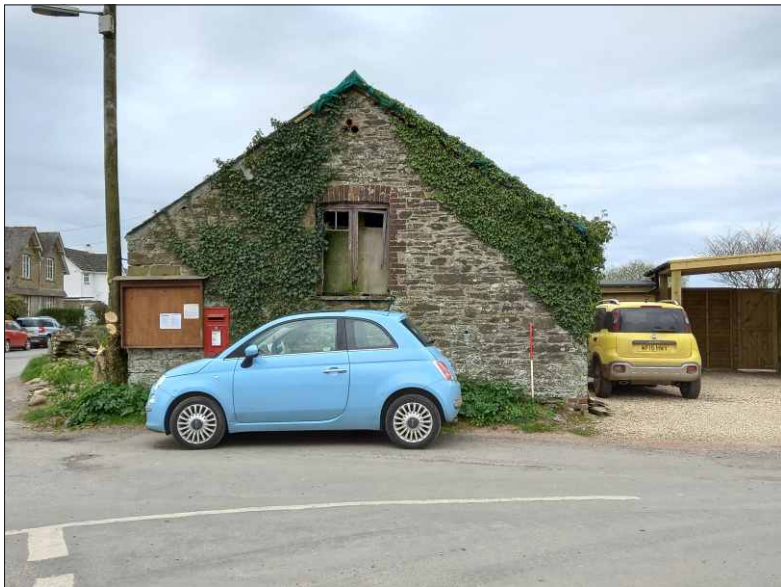
Plate 5: East elevation, looking southwest (1m scale)

- 5.3** The east elevation has built-in Royal Mail post-box and a single window opening with the remnants of a wooden pegged frame (Plate 5); no glass remains. Above this are three ceramic pipes set in the wall providing ventilation. The west elevation incorporates a single doorway with a pegged wooden frame and pintles to hang a door (Plate 6); the opening is located within rebuilt masonry associated with the extension. To the north of the door is a crack in the masonry. The upper part of the gable has been rendered. However, internally it can be seen that there is a set of ceramic pipes formerly providing ventilation, and matching those in the east elevation.

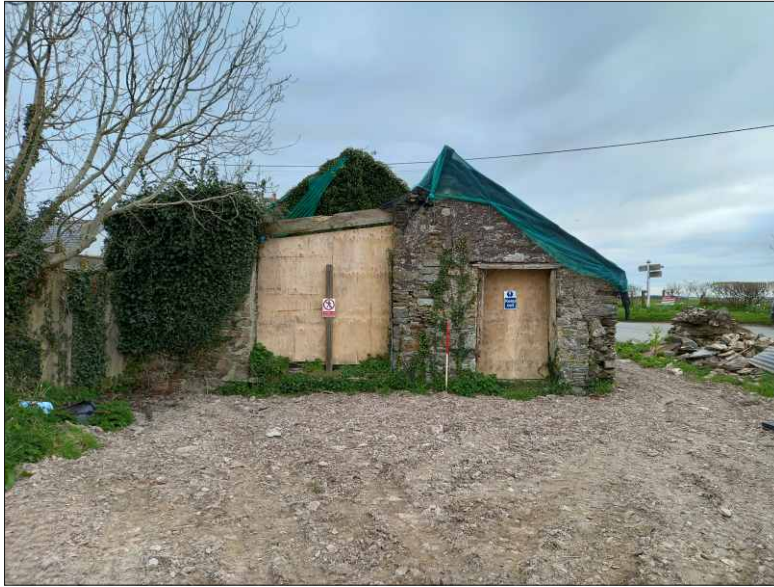
Plate 7: West elevation of the extension, looking northeast (1m scale)

- 5.4** The extension has partially collapsed and has no wall or roof structure to the north. The remaining walls are constructed of rubble stonework laid in rough courses with an off white lime mortar; the surviving southern pitch of the roof is covered with slates. In the west elevation are two door openings (Plate 7). The south opening has a wooden lintel and the remnants of a wooden frame but no door survives. The north opening is beyond the original line of the extension and is double width. A single vertical timber from a door frame survives on its south side. The opening has been altered and repaired with brick, blockwork and cement.

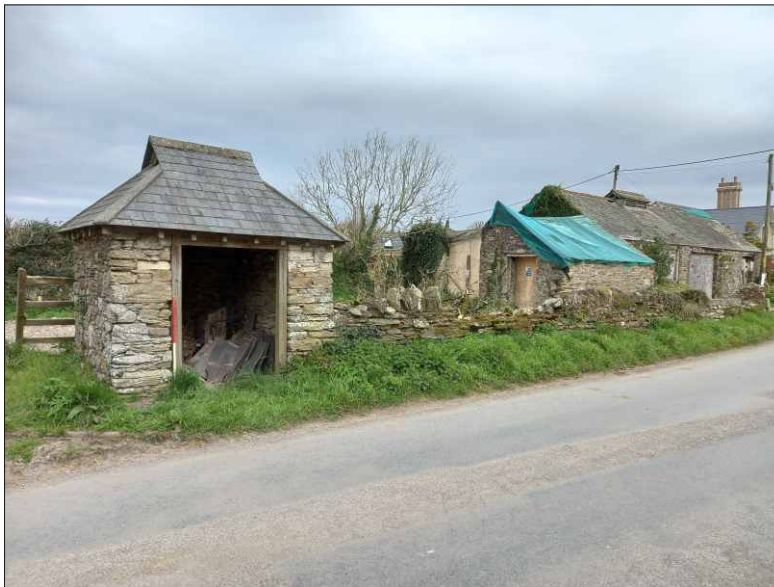
Plate 8: View of pump house and boundary wall, looking north (1m scale)

- 5.5** The plot to the west is bounded to the north by a stone wall of vertically set slate stone. Along the east end of the southern boundary is a rubble stone wall. This is in a very poor state of repair with areas of collapse. Some sections have the remnants of cock 'n' hen capping whilst another area has concrete capping. At the west end of the wall is a small pump house constructed of rubble stonework with a modern gabled slate roof (Plate 8). It has an entrance on the south side, onto the roadside verge, and covers a pump for the well located on the north side of the structure next to the boundary wall.

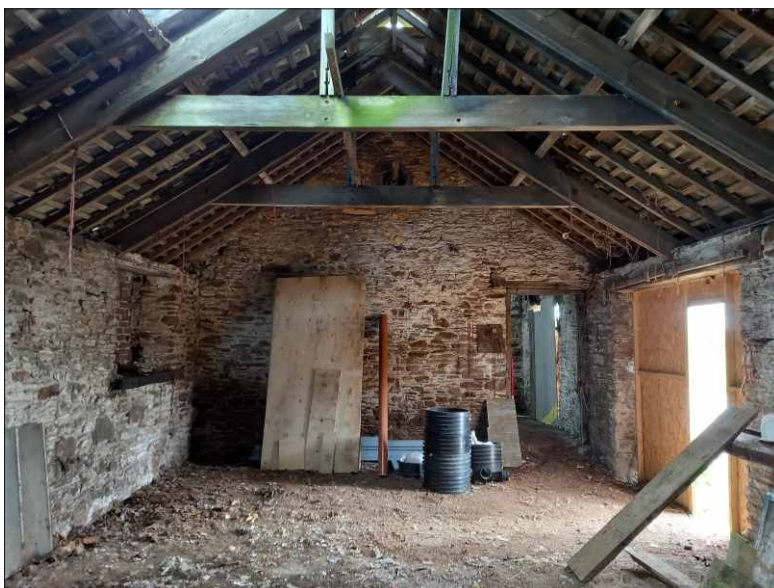
Plate 9: West room, looking northeast (1m scale)

- 5.6** The main body of the building is divided into two rooms by a primary rubble stone wall. In the upper part of the partition the end of an unhewn timber projects into the west room through a circular aperture. Below this various metal bars are set into the wall forming hooks. The larger area, the west room, has an earthen floor, and the roof is supported on three A-frame trusses with bolted applied collars (Plate 9). Two additional vertical timbers have been added above the collars of the eastern pair of trusses. Adjacent to the western truss is an additional horizontal beam at eaves level supported on vertical posts adjacent to the walls; it is structurally separate from the roof truss. The purlins are wedged in place on the back of the trusses with cleats and support the rafters and battens. The doorway in the north wall has an internal ledge above the current floor level. The reason for this is unclear. It does not appear to represent an earlier floor level as it is higher than the threshold to the south. The western window has an internal wooden ledge. In front of the window in the south wall is a wooden work bench. To its west set into the floor is a concrete base for a now-removed piece of machinery or motor.

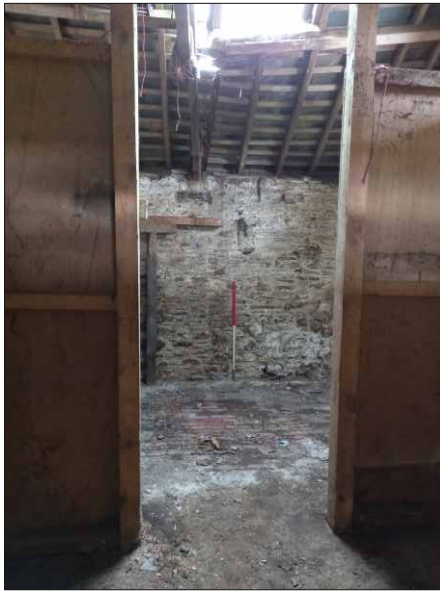
Plate 10: East room, looking northwest (1m scale)

- 5.7** At the south end of the partition wall is a doorway leading into the east room. The opening has brick step and a pegged wooden frame. The floor in this room is brick and there is a single truss of the same form as the in the west room. The area is divided by a wooden partition with some shelving to the north (Plate 10).

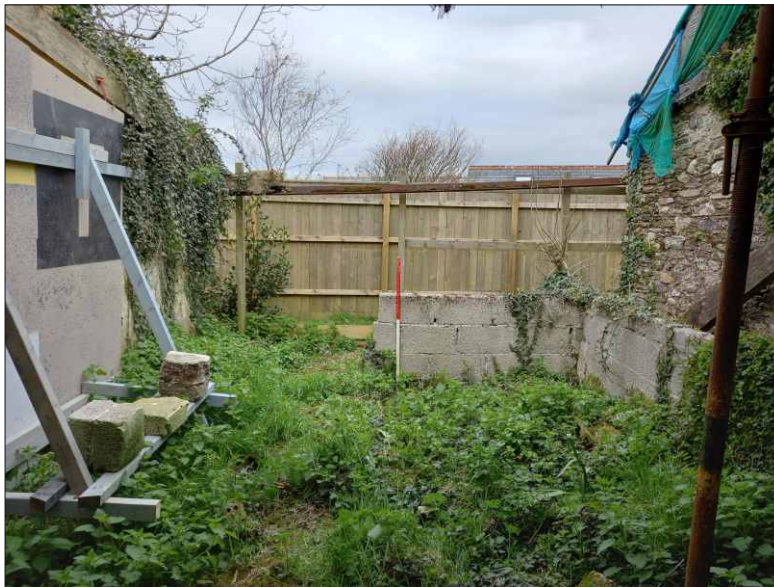
Plate 11: Animal pen in the extension, looking northwest (1m scale)

- 5.8** The extension, forming the western range, appears to have latterly housed an animal pen formed of concrete blocks; however, only the east, part of the north, and the base of the south walls remain (Plate 11). There appears to have been walkways to the south and west. The whole area contains building debris and vegetation.

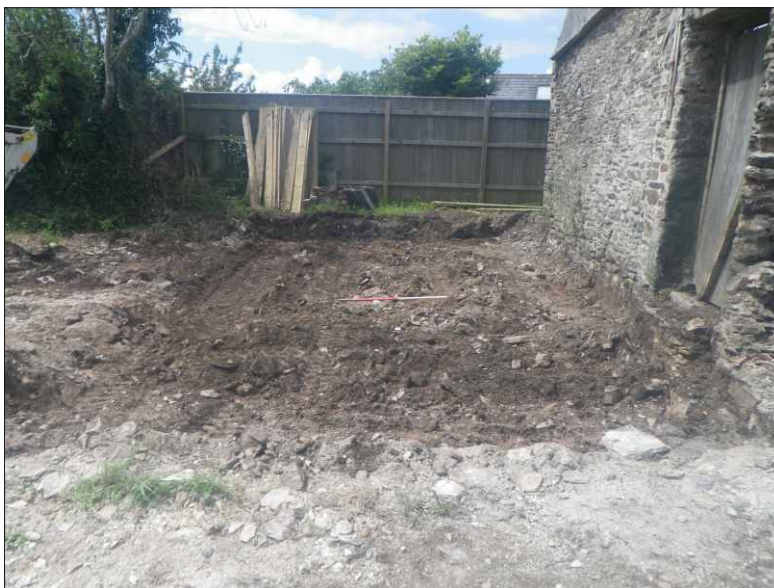
Plate 12: Area of watching brief in the area of the former western range, looking northwest (1m scale)

6.2 The monitoring of this area was conducted following the removal of the semi-derelict stone structure, modern animal pound and modern concrete slab. The groundworks comprised reduction of the level by 0.3m in an area measuring 7m long by 4m wide. Across the area was modern hardcore to a depth of at least 0.25m. In the south part of the area, located beneath the hardcore, was a deposit composed of mid greyish red clay with occasional sub-angular slate fragments. This was reduced to a depth of 0.05m. This deposit might represent the remains of an historic (19th-century) floor. No features or finds of archaeological interest were exposed.

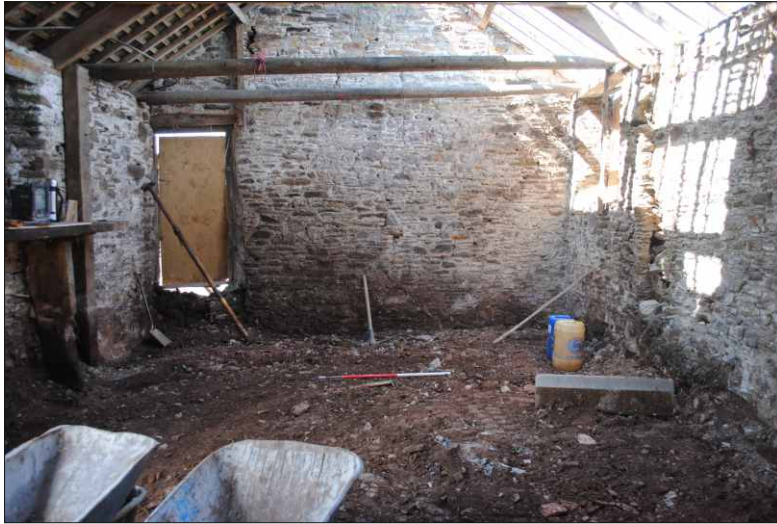
Plate 13: West room, following reduction of floor level, looking west (1m scale)

6.3 The groundworks in the west room comprised reducing the floor level by 0.5m. The material removed was consistently composed of loose dark brown silty loam which was full of modern detritus, particularly pieces of plastic animal feed bags. In the eastern half of the room natural subsoil, comprised of dark red silty clay with abundant sub-angular slate fragments, was exposed. No features, deposits or finds of archaeological interest were present.

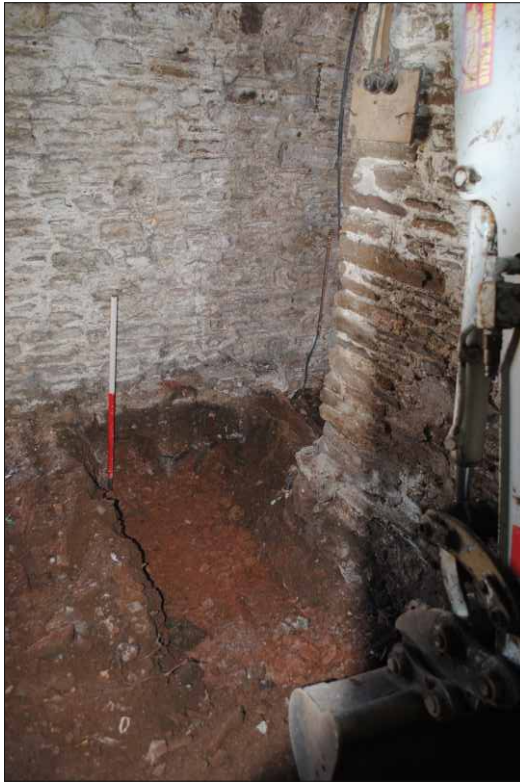
Plate 14: East room, exposed natural subsoil in the southwest corner of the room, looking southwest (1m scale)

6.4 The groundworks in the east room comprised reducing the floor level by 0.4m. The brick floor had previously been removed and the deposit removed was consistently composed of loose dark brown silty loam. Across the whole room natural subsoil comprised of dark red silty clay with abundant sub-angular slate fragments was exposed. No features, deposits or finds of archaeological interest were present.
