Vine Cottage, Swallowcliffe, Wiltshire, SP3 5NX:

Results of an archaeological watching brief

Document No. ACW1075/2/0

Date: September 2023

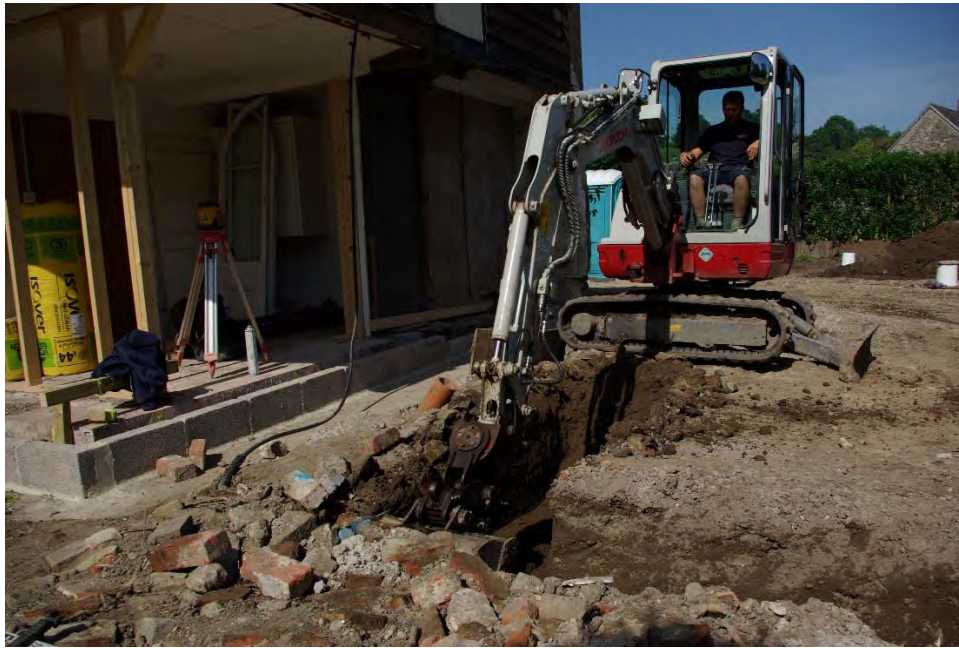
4.1 Two stages of archaeological monitoring were undertaken during May and June 2018. The initial stage involved the excavation of new foundations for the north-eastern part of the existing Vine Cottage (Plate 1). The ground floor walling was removed and new foundations excavated. The second stage involved monitoring the foundation groundworks for the new single-storey extension. This work was undertaken following the demolition of an early barn structure, whose position was slightly off-set to the north-east compared to the building that will replace it.

Plate 1: General view of groundworks

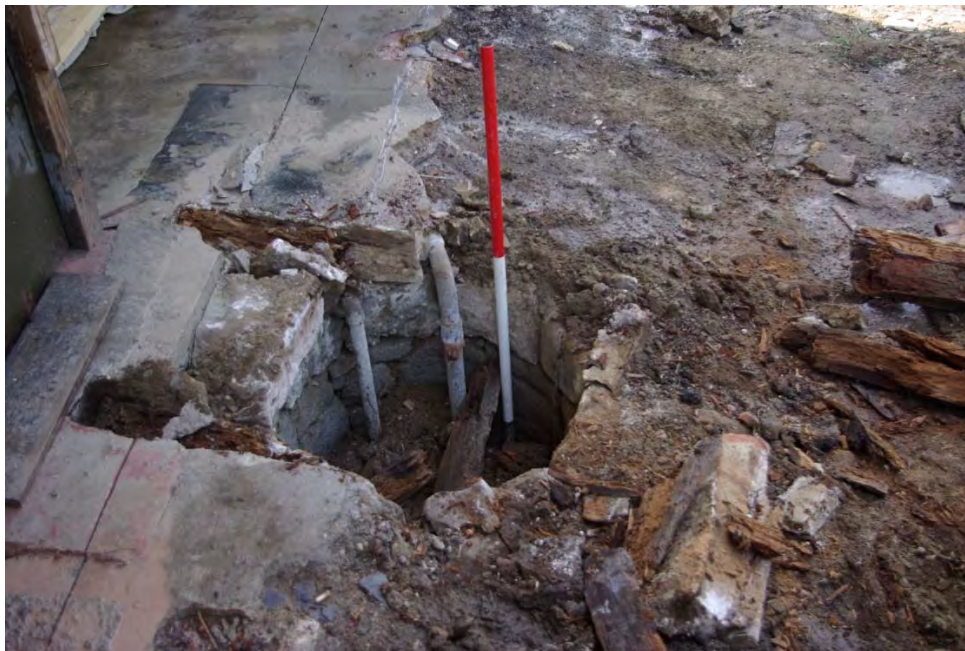
- 4.5** The northern foundation trench cut through a well, which was located between Vine Cottage and its associated barn, with the cottage foundations, unusually, extending around the well (Fig.1a and Plate 1). It is assumed that the well was positioned so that it could be used either from within the cottage, or from the barn. Prior to the groundworks, the well was still partially in use with pipes linking with the utility room in the cottage. The outer edge of the well was located c.2.5m from the north-west end of the foundation trench. The well was constructed from green sandstone blocks that were roughly cut, but with curved inner facing forming a circular internal diameter of 0.7m. The overall external diameter of the well was between 0.95 and 1.1m. There was no apparent construction cut for the well visible within the topsoil. One fill was recorded (context 106). This consisted of a very mixed deposit of green sandstone fragments, clay and mortar fragments. No finds were recovered from this deposit.

- 4.6** The excavation of the foundation trench resulted in the complete removal of the upper levels of the well to a depth of 1m. An iron water pipe, that was removed from the fill of the well, indicated that it reached a depth exceeding 3m.

Plate 2: Well prior to foundation trench excavation

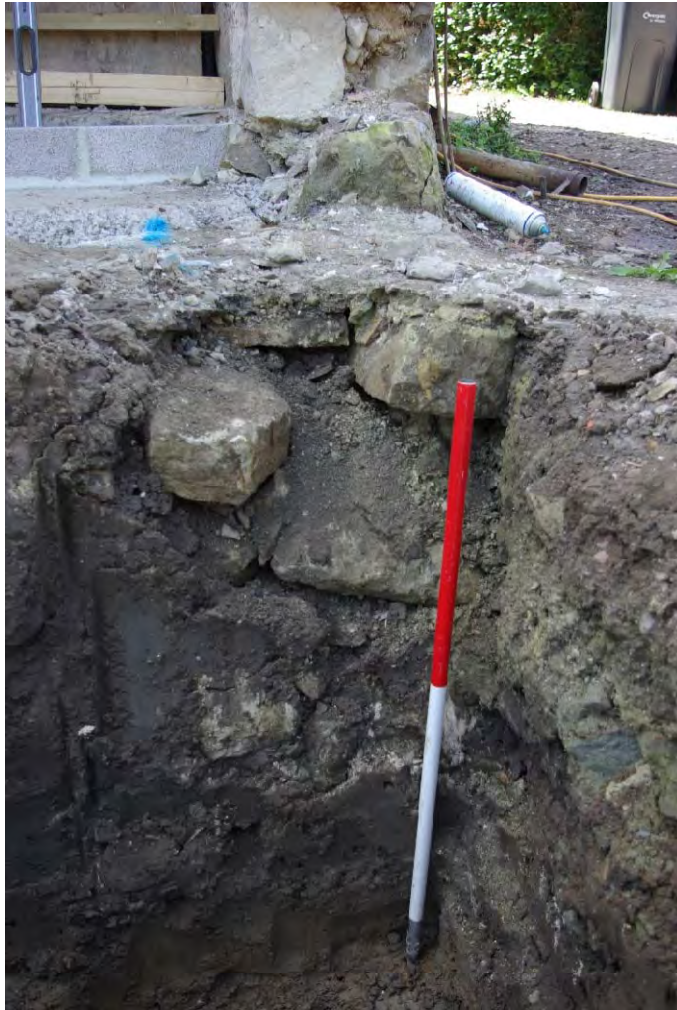
- 4.9** Part of the foundations to the earlier barn were exposed and removed during the excavation of the foundation trench. These consisted of rough blocks of green sand and a clayey mortar that extended for approximately 2m along the projected line of the old barn (Fig.1b and Plate 3). This evidence indicates that the barn foundations extended below the ground level where there were originally two double-door accesses to the building, as well as a fifth door that provided access to the utility room in the main cottage. Presumably these foundations were needed to hold upright posts that would have held hinges in place for the large barn doors, as well as supporting the roof structure itself.

**Plate 3: Foundations of demolished barn
(wall of cottage in background)**

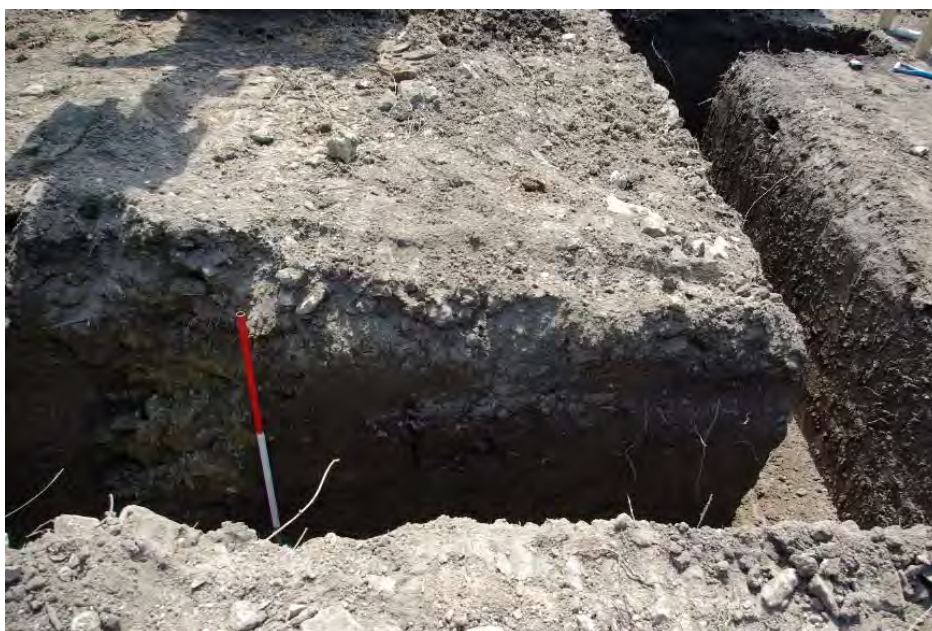
- 4.10** Within the north facing trench for the new extension were further pieces of sandstone. These appeared as a concentration of large rubble fragments bonded with clayey mortar material and occasional fragments of roof tile (context 203). The concentration of rubble was visible in both sides

of the foundation trench and measured approximately 0.8m in width, reaching a depth of c. 0.7m. It is very likely that this material represents parts of the foundation to the barn – probably part of the same foundation wall as described in paragraph 4.9 (see Fig.1c and Plate 4).

Plate 4: Foundations of demolished barn (north-western wall)
