# Land adjoining Ashill Village Hall, Ashill, Ilminster, Somerset:

Results of an archaeological trench evaluation

Document No: ACW1083/2/0

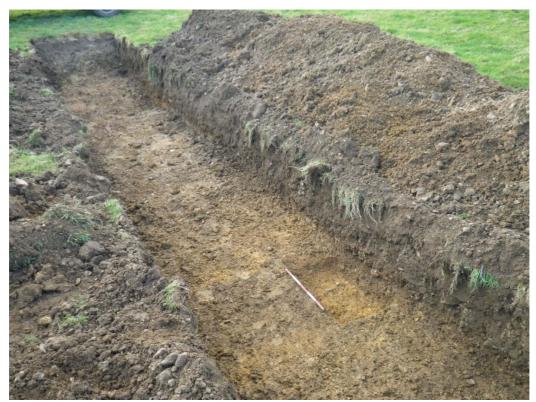
Plate 1: Trench 2, view of east-facing section of F203. View from the northeast, Scale 0.5m

Feature F203 (plate 1)

**5.5** This feature was linear in plan on an east to west alignment. It was 0.75m wide and had steep, concave edges and a flat base recorded to a depth of 0.25m. It contained a single fill (204), composed of mid grey-brown silty clay containing occasional sub angular and sub rounded stones and flint gravels. No finds were recovered from the fill of this feature. Feature F203 may represent the remnants of a field boundary or a form of land division. In addition, the profile and composition of F203 is comparable to feature F302, located in Trench 3 to the east, and together they may represent some form of land division or enclosure.

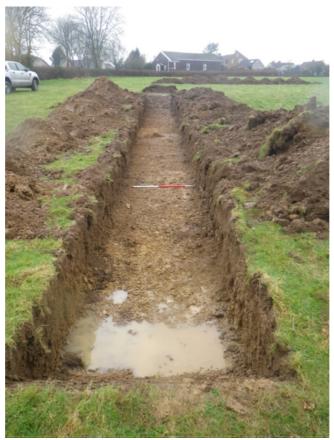
Plate 2: General view of Trench 3 with the village hall in the background. View from the east, scale 1m

Trench 3 (plan Fig. 2c; sections Fig. 2d-e, plate 2)

**5.6** This trench was aligned east to west, and was positioned on fairly flat ground, albeit with a very gentle slope to the east. Towards its western end the trench dissected an extant linear earthwork bank. A maximum depth of 700mm was excavated through topsoil and subsoil before a single linear feature was exposed cutting through the natural substratum. The recorded layer sequence is summarised in Table 3.

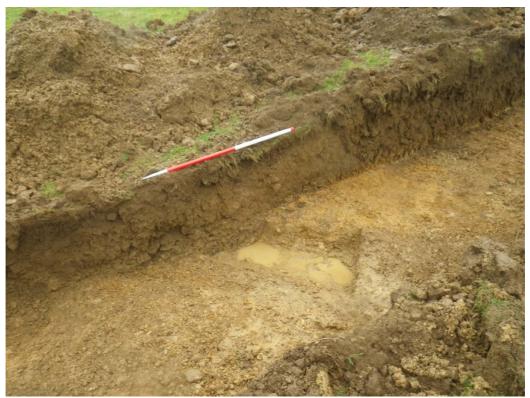
Plate 3: Trench 3, slot through linear feature F302. View from the northeast, scale 1m

Feature F303 (plate 3)

**5.7** This feature was linear in plan, on a north-west to south-east alignment, located approximately 6m from the western extent of the trench. It had a recorded width of between 0.65 and 0.80m with steep, concave edges and a flat base recorded to a depth of 0.25m. It contained a single fill (302), comprising a mid-brown silty clay. No finds were recovered from the fill of this feature. This feature represents the base of a field or hedge bank boundary and is possibly associated with the similarly aligned extent earthwork; evident at ground level. Its profile and composition suggests it may be contemporaneous with F202 in Trench 2, and thus, form part of a historic field enclosure.

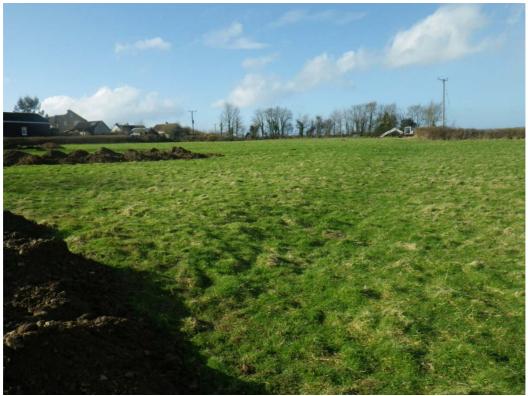
Plate 4: View of earthwork looking toward extant hedgerow. View from the southeast

# Extant Earthwork (plate 4)

**5.8** A transect 7.0m in length was positioned *c*. 2.50m north of Trench 3. Levels were then noted at 0.50m intervals so as to create a profile of the bank material which is visible as an earthwork in this portion of the site. The earthwork is on a clear north-west to south-east alignment and stands to height of approximately 0.60m. Aerial photographic analysis suggests this constitutes a continuation of a hedge bank boundary that formerly divided this land parcel (HER ref 38460). Historic mapping as far back as the 1880s continually show a

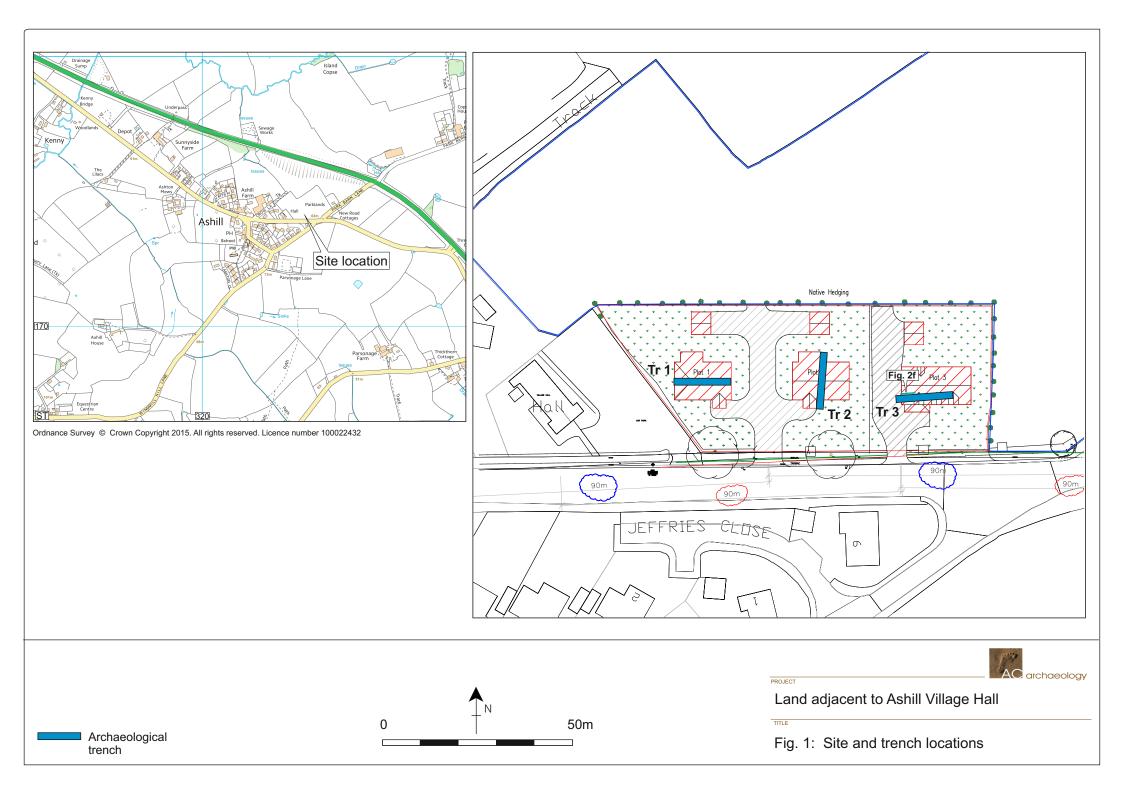
- **4.2** The investigations comprised the excavation of three trenches, totalling 45m in length, each 15m in length and 1.6m wide. The trenches were positioned on the ground using a Leica *Viva* GPS (Fig. 1). All site levels relate to Ordnance Datum.

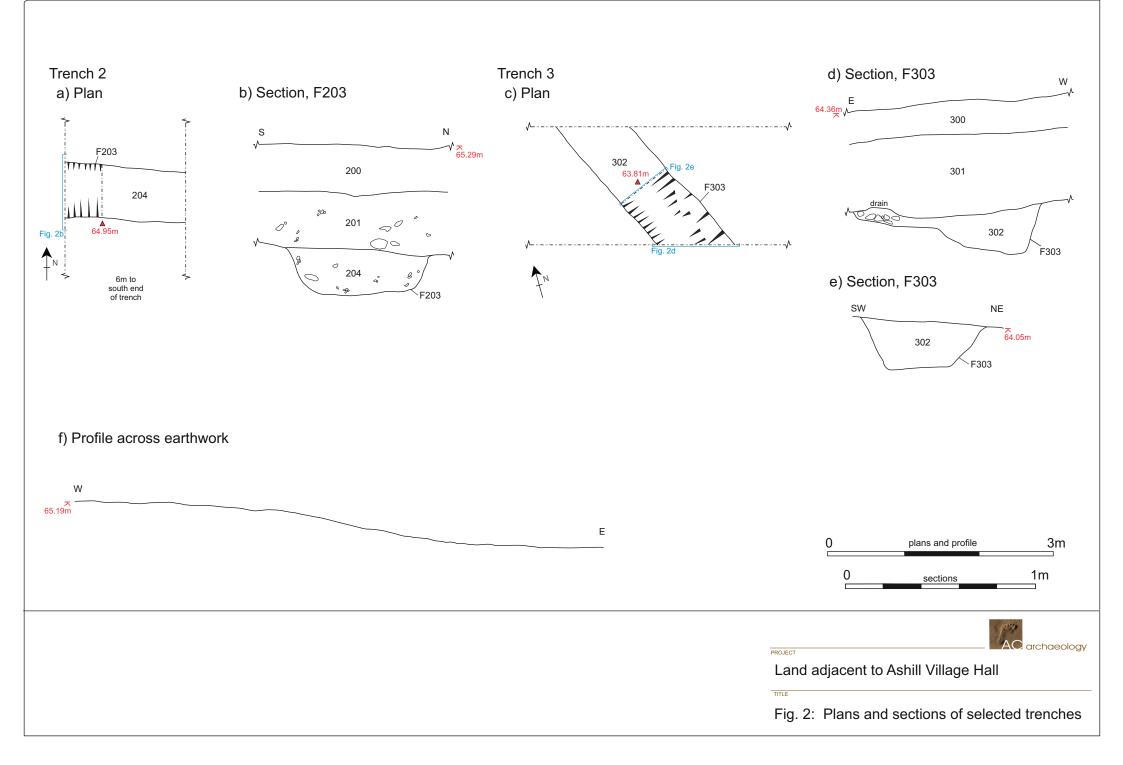
Trench 2 (plan Fig. 2a; section Fig. 2b)

**5.4** This trench was aligned north to south, and was positioned on ground sloping down very gently to the east. A maximum depth of 700mm was excavated through topsoil and subsoil before a single feature, comprising a linear ditch, was exposed cutting through the natural substratum. The linear feature may relate to a historic field boundary or land division. The recorded layer sequence is summarised in Table 2.
