Alderbury Hill House, Alderbury, Salisbury, Wiltshire:

Results of an archeological watching brief

Document No: ACW918/2/0

Date: June 2019

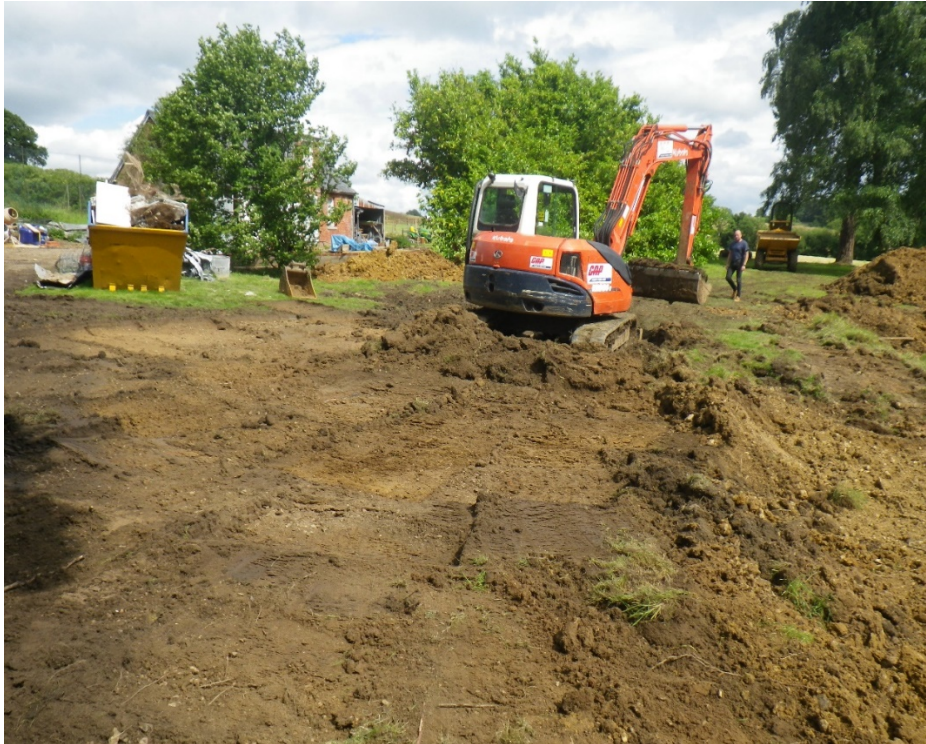
Plate 1: General view of groundworks

- 4.1 The existing house stands on levelled ground with the existing tennis court area also standing on land which was reduced and levelled prior to its construction. This activity is likely to have removed or disturbed any archaeological deposits that may have been present in these areas.
- 4.2 Limited topsoil stripping, in terms of depth, was undertaken across the site, reducing the potential for any archaeological deposits present to be revealed. Furthermore, it was evident

that large areas had previously been disturbed by earlier groundworks. Foundation trenches excavated for the new buildings revealed no evidence for any archaeological activity.

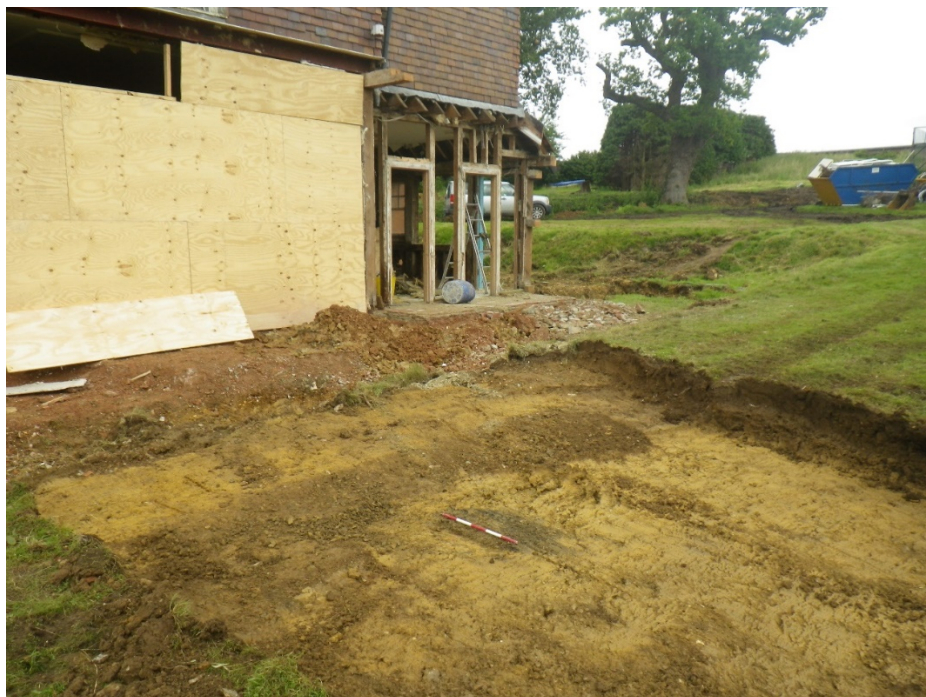
Plate 2: General view showing possible tree-throw feature

- 4.2** A shallow circular feature measuring c. 2.2m in diameter and 1.1m in depth was recorded approximately 10m to the south of the main house. It was composed of a dark grey brown silty loam, containing numerous fragments of charcoal. This feature appeared likely to represent a tree hollow.
