Fonthill Bishop Water Main Replacement, Wiltshire:

Results of a Programme of Archaeological Mitigation

Wessex Water project number: B0702

Document No: ACW1408/3/0

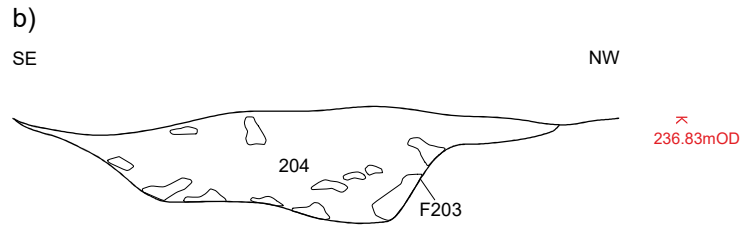
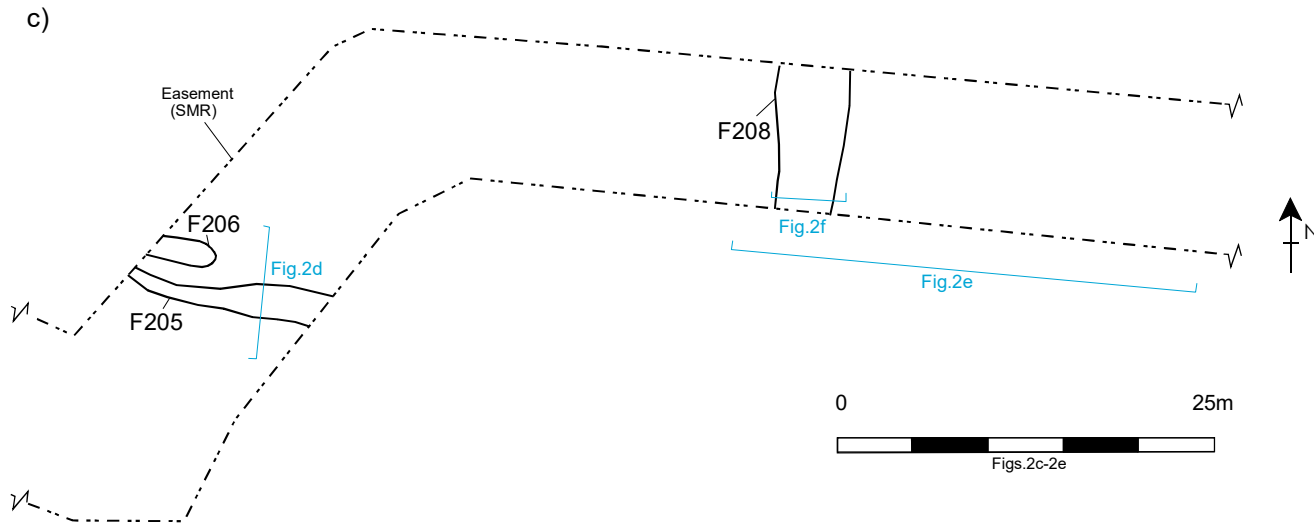
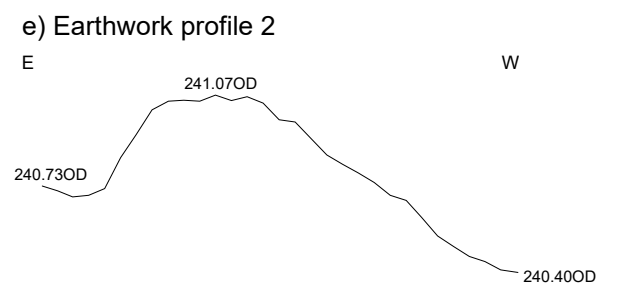
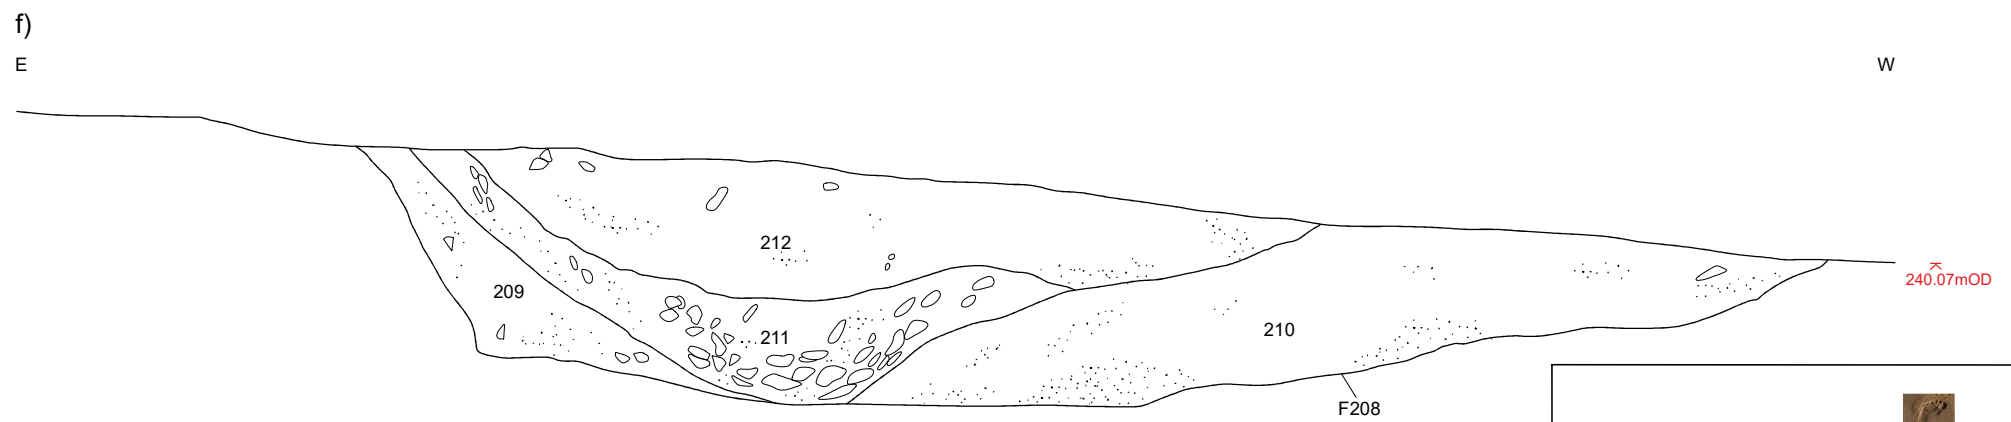
TITLE
Fig. 2: Plan and section drawings

Possible pit feature F203 (Plan Fig. 2.a, section Fig. 2.b)

6.6 An isolated, sub-circular, possible pit feature was recorded at the eastern extent of the SMR. It measured 0.76m x 0.67m, with a depth of 0.16m. It had moderately sloping sides and a concave base. It contained a single fill (204), comprising a mid-grey-brown sandy silt. No finds were recovered from this feature, and its function is unclear. However, it may have an arboreal or natural origin.

Stone bank 205 and linear ditch F206 (Plan Fig.2.c; profile Fig. 2.d, Plate 3)

6.7 Exposed adjacent to the remnant field boundary, this feature comprised an extent curvilinear bank or earthwork, aligned east to west. Visible for c. 13m, it had a height of c. 0.4m (see profile) and a maximum width of 2.2m. The bank material comprised sandy silts with coarse components, including compacted stone/limestone fragments (20-100mm in size). It is not clear if the source material itself originated from the truncated ditch (F206) to the immediate north. The base of the bank appeared to rest upon the natural substrate. Approximately 1.3m north of 205, feature F206 appeared to be an east to west aligned linear ditch with a width of 1.6m and a depth of 0.05m. Heavily truncated, probably as a result of historic ploughing, it was visible for 4.4m. This may have continued west and is likely to be associated with parallel bank 205 and ditch F208, located to the north-east. No dateable artefacts were recovered.

Ditch F208 (Plan Fig. 2.c; profile Fig. 2.e, section Fig. 2.f, Plate 4)

6.8 This feature appeared to form part of a curvilinear ditch, with a width of 4m and a depth of 0.65m. It was aligned north to south and located to the immediate west of a raised earthwork or bank. The ditch had a steep sloping profile, especially to the east, with an undulating base. It contained four fills (contexts 209 - 212), with contexts 211 and 212 potentially representing a later recut or modification. A prominent earthwork or bank was visible to the immediate east of the ditch, and although the relationship between this feature and the earthwork was not entirely clear, they are likely to be contemporaneous. The ditch is believed to be associated with F206 to the southwest and would have formed a curved or rectangular like enclosure, which continued to the north and west.

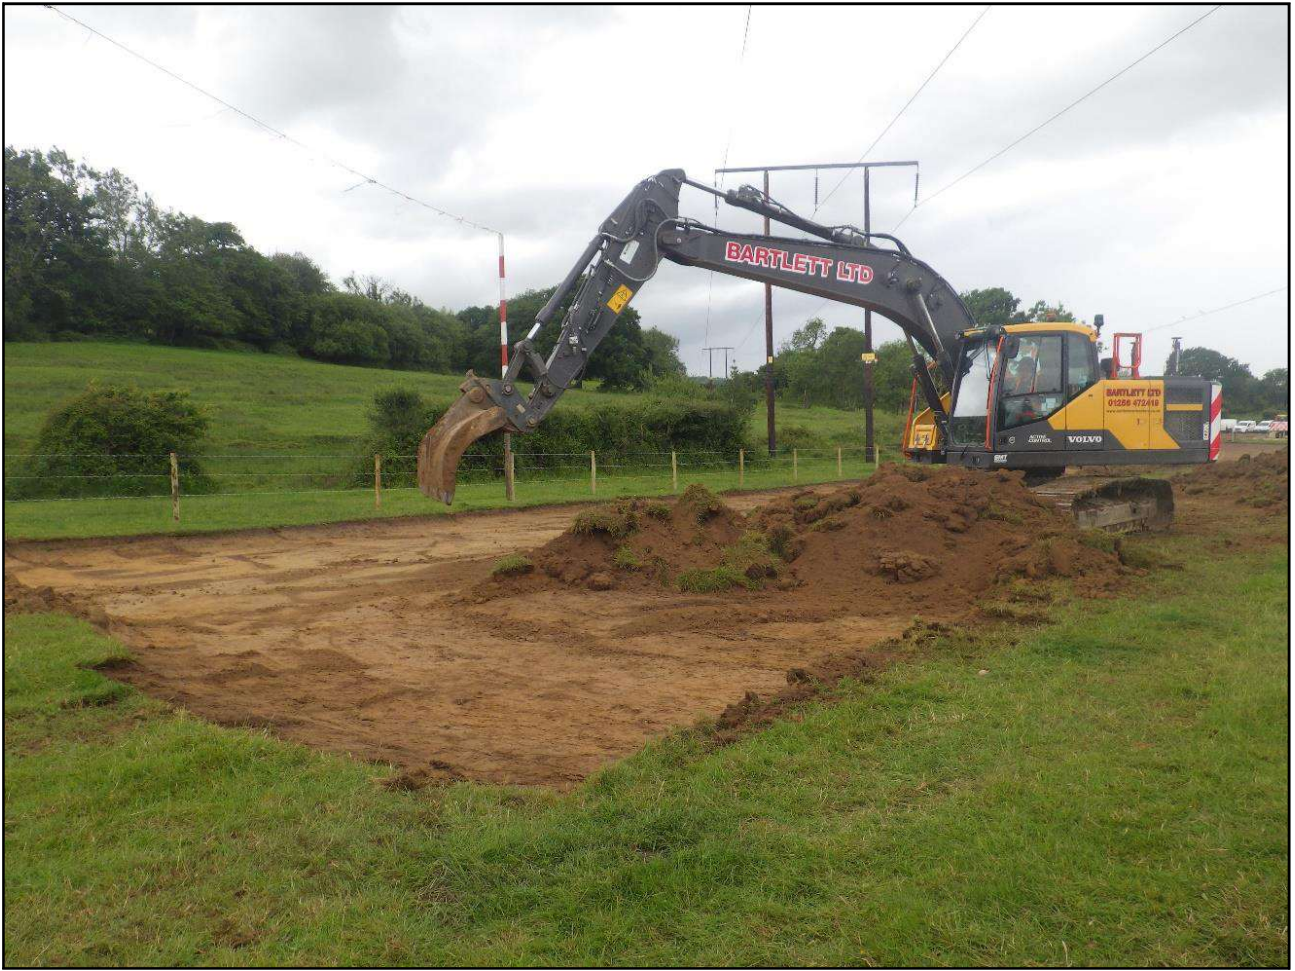
Plate 1: Working view of easement strip with earthworks in the background

- 6.2 An easement with a width of up to 15m was stripped of topsoil using a mechanical excavator with a toothless bucket (see Plate 1). The soil was subsequently stored in a bund to one side of the easement. The monitoring of turf and topsoil stripping for the majority of the route (and compounds) was limited to the depth of soil removal required by Wessex Water. Topsoil was removed to a depth not exceeding 300mm, revealing an underlying subsoil throughout much of the easement (see Plate 2). The natural bedrock was only intermittently observed during the strip. While no features of archaeological significance was recorded during this phase, a number of modern field boundaries and hedge banks were noted. Additionally, there was some evidence of agricultural activity including modern terracing.

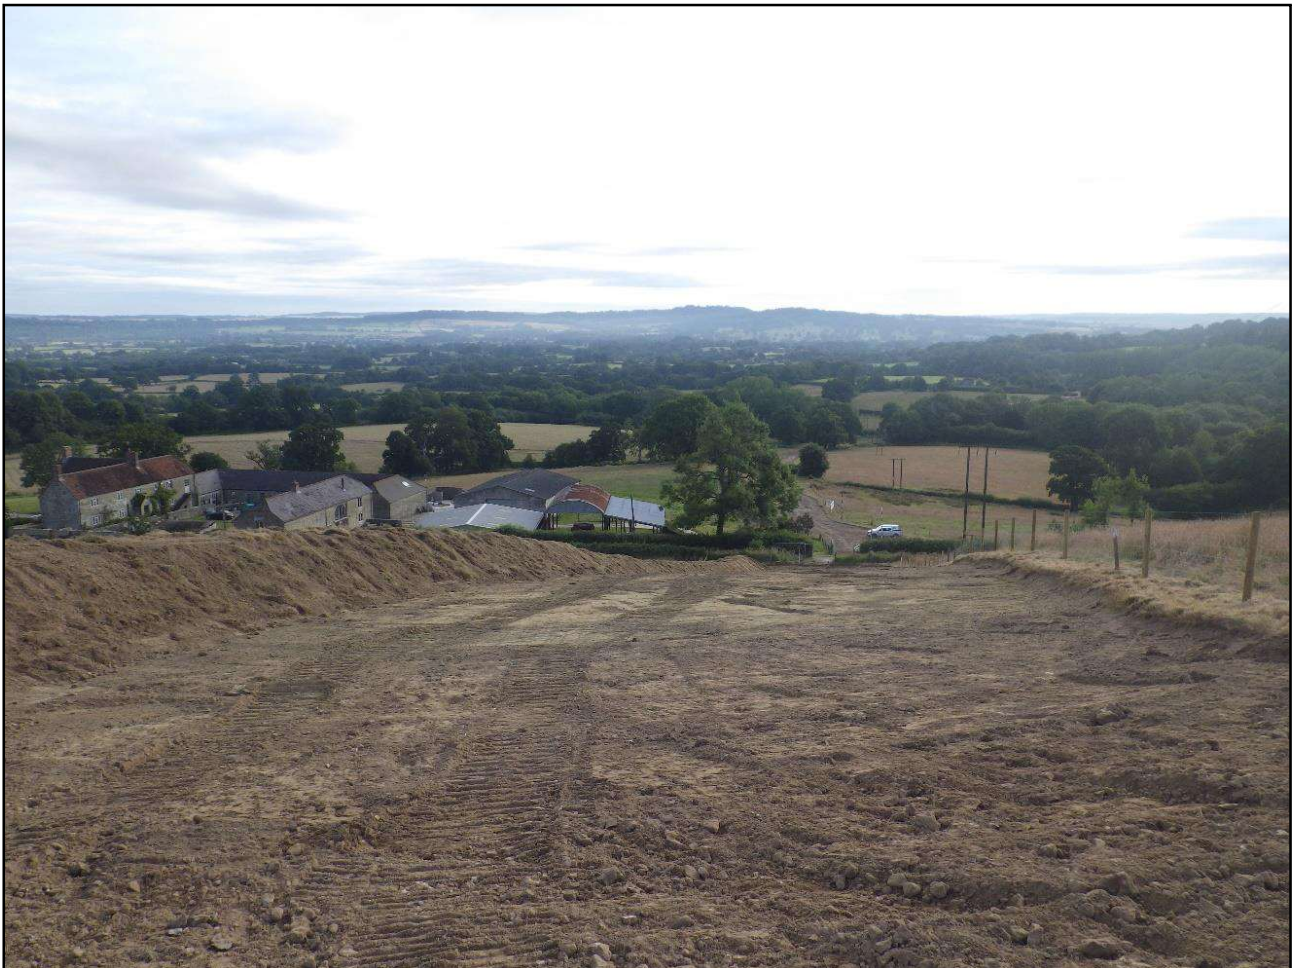
Plate 2: Completed easement strip. View from the south-west

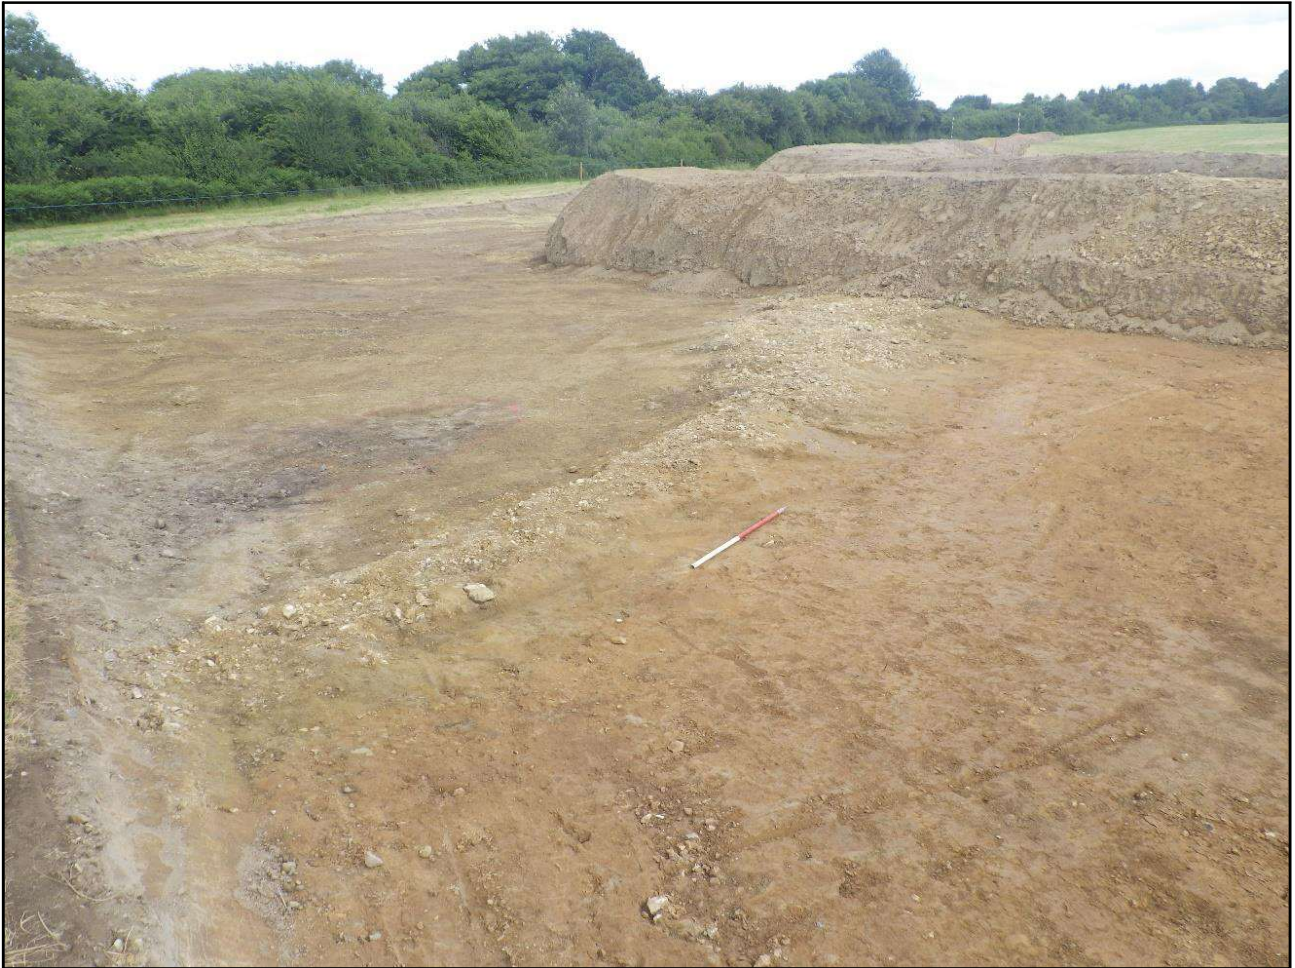
Plate 3: View of stone bank 205 and ditch F206. View from the south-west (scale 1m)

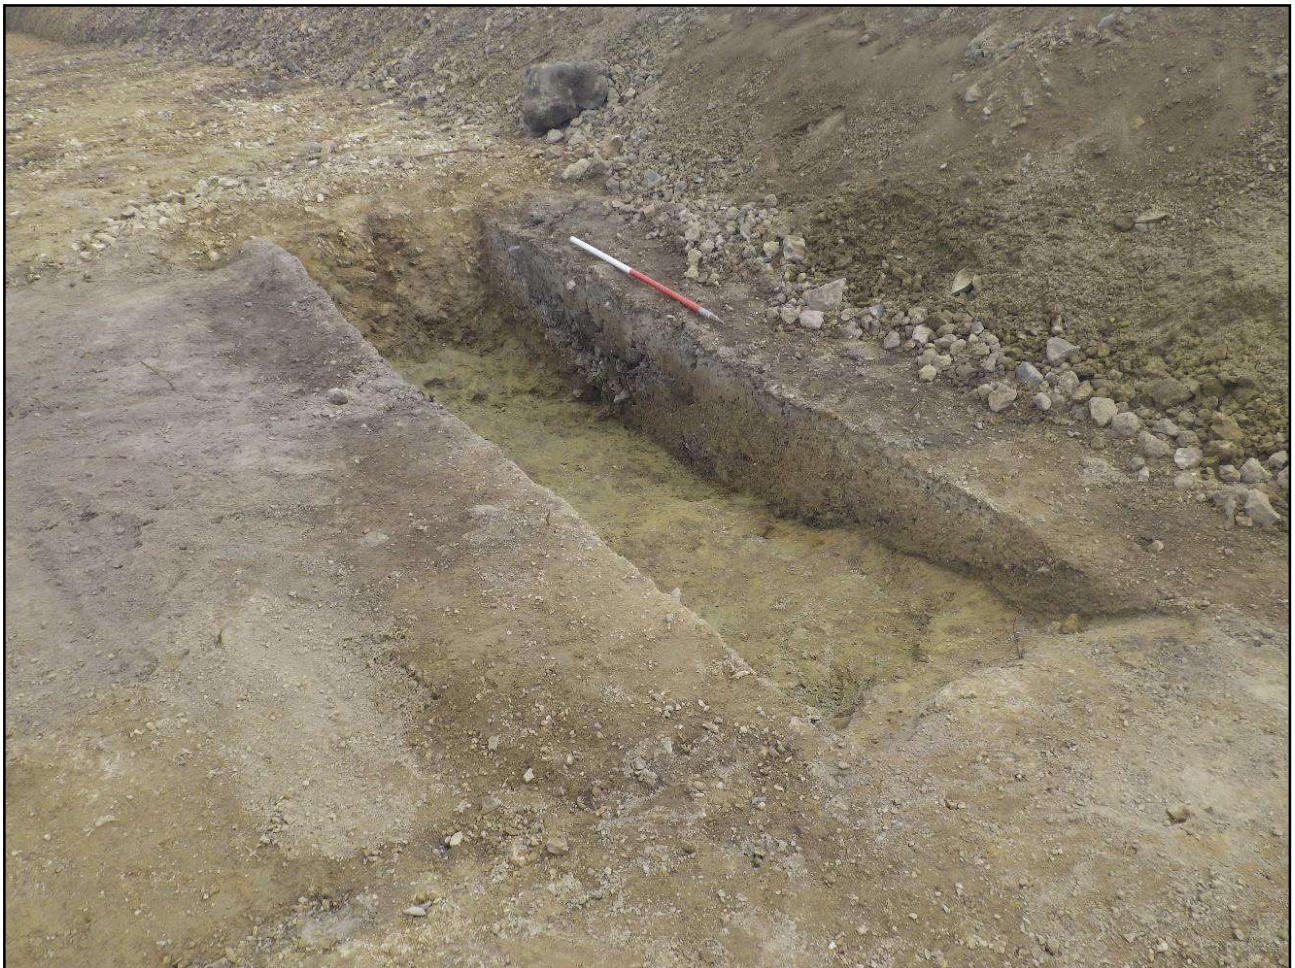
Plate 4: Oblique view of ditch F208. View from the north-west (scale 1m)
