FORMER HALLMARK CARS SITE, ST JOHNS HILL, WAREHAM, DORSET

Results of an archaeological watching brief

Document No: ACW966/2/0

Date: January 2017

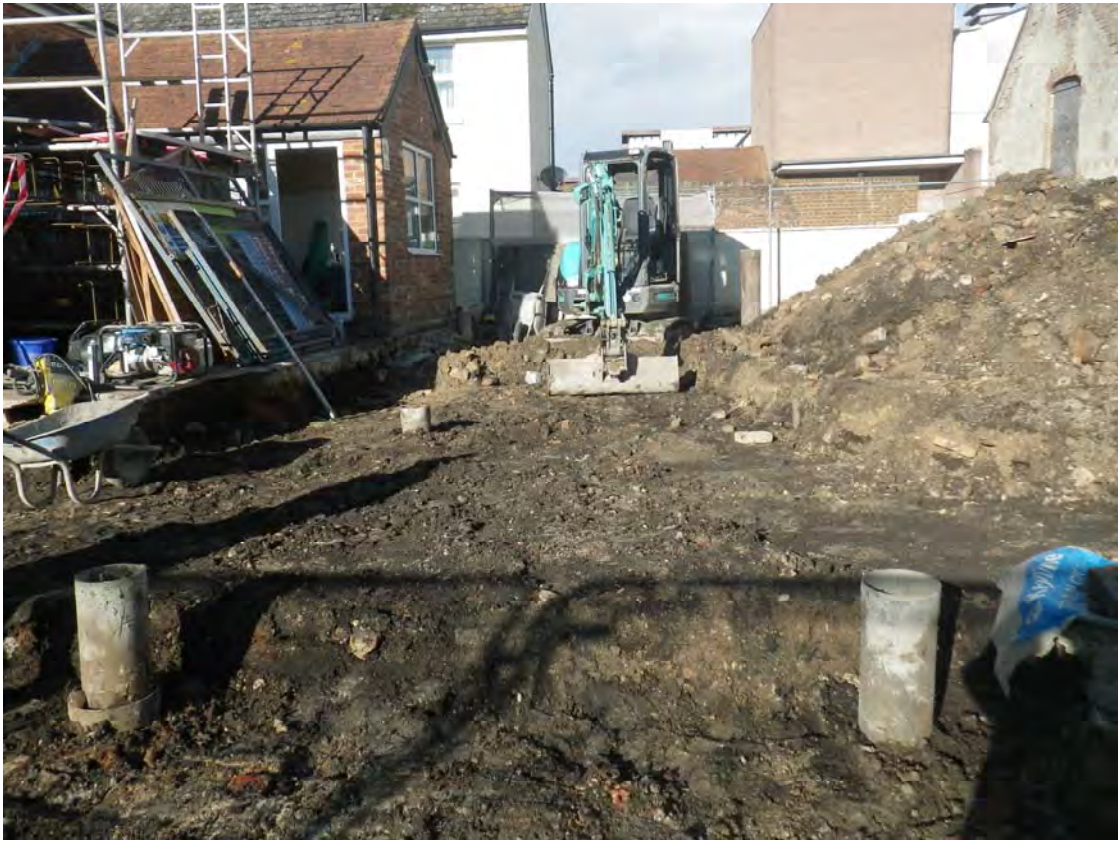
Plate 1: Reduction of levels within the northern portion of site, viewed from the south

- 4.2** Prior to the excavation of ring beams, supported on the piles, the development area was reduced to two different levels. To the south, the site was reduced by c.0.5m, while to the north; the ground level was reduced by only 0.3m (Plate 1). During this phase of groundworks, a brick structure, was revealed within the southeast extent of the site, and is believed to be the remains of a dovecote (Feature F103).

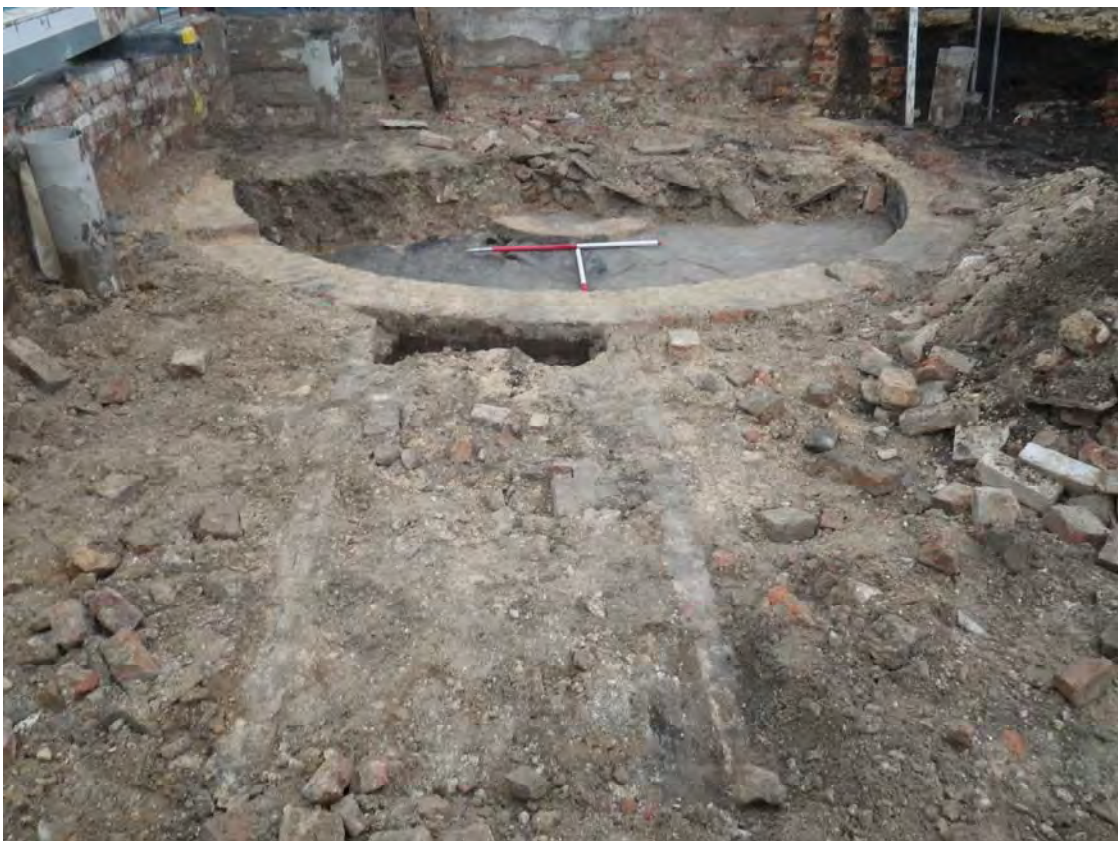
Plate 2: F107 (foreground) and F103, viewed from the east with two 1m scales

- 4.3** This structure comprised a 0.4m thick brick wall, in an English bond, laid in a circular fashion with a diameter of c. 4m. Within the interior of the structure, a series of limestone flagstones was laid forming a solid and relatively level floor (104) upon which an additional double skin of slightly curved bricks formed a circular plinth with a diameter of c.1m (F105). Within this was a ceramic tiled surface. The small central brick plinth may have supported a *potence* - a wooden frame supporting a ladder and occasionally occur with suspended floors or perching platforms (McCann, 1998). The in-fill of this feature comprised late post-medieval ceramic building material and refuse, such as glass, which suggests that this structure had gone out of use by the 19th century. This feature had been disturbed in part by the presence of an east-west aligned red brick wall, which most probably relates to the back wall of a row of 19th century structures (present on both the 1846 tithe map, and the 1889 ordnance survey map). A later brick wall, of similar construction and composition to that already outlined, had disturbed the feature to the northeast, while a portion of the eastern extent of the structure had been removed by the construction of the adjacent club building.

4.4 A probable pathway consisting of red brick edged block paving that had been substantially removed and damaged in places, was shown to abut the dovecot to the east. This is considered to be a garden feature and dates to the post-medieval period.

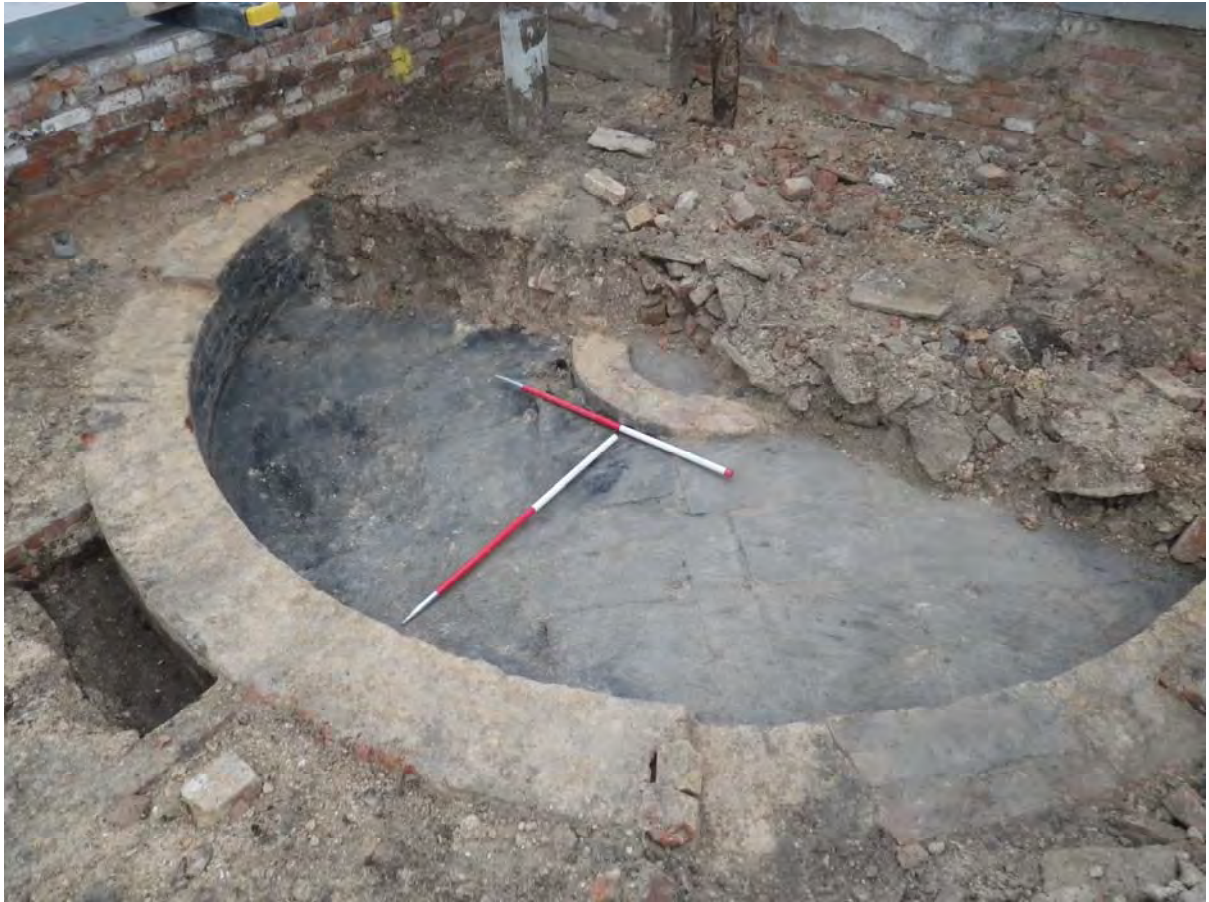
Plate 3: View of the interior of F103, from the northeast with two 1m scales
