Proposed enlargement of Coldharbour Lane Roundabout, Aylesford, Kent

Results of an archaeological trench
evaluation December 2020

Job No	CS096347		
Project	Coldharbour Lane Roundabout		
Location	Kent		
Title	Results of archaeological trench evaluation		
Document Ref	CLDHBR-CAP-EXX-00-RP-Z-0103	Issue / Revision	01
Originator	AC Archaeology Document No. ACW1171/4/0		
Date	15/12/2020		
Prepared by AC Archaeology	Vince Simmonds	Signature (for file)	VS
Checked by AC Archaeology	Peter Cox	Signature (for file)	PWC
Authorised by Capita	Kim Still	Signature (for file)	KAS

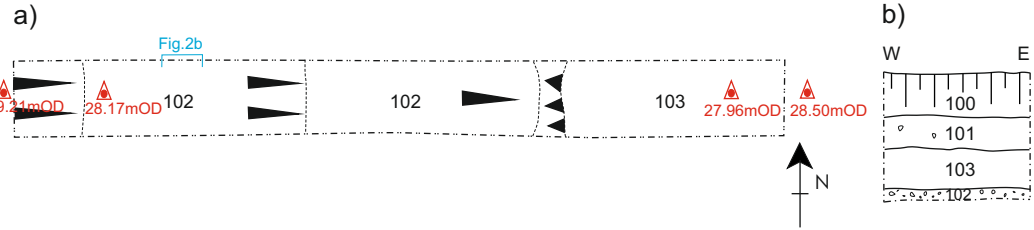
5.2 Trenches 1, 2 and 3, each contained a further subsoil representing a colluvial deposit (contexts 103, 203 & 303) and consisting of light brownish red, slightly clayey, silty fine sand. There were no apparent signs of reworking to suggest this is a placed deposit. This deposit is likely to be associated with an observed topographic feature consisting of a shallow valley that slopes down gradually to the northwest and southeast.

Trench 1		Length 21m	Width 1.5m	Alignment W-E
Context	Description	Thickness (mm)	Interpretation	
100	Brownish grey sandy loam	300	Topsoil	
101	Reddish grey-brown sandy silt with infrequent gravel	200-300	Subsoil	
102	Yellow and yellow-red sand and gravel	>100	Natural	
103	Light brownish red slightly clayey, silty fine sand	>300	Colluvium/hillwash

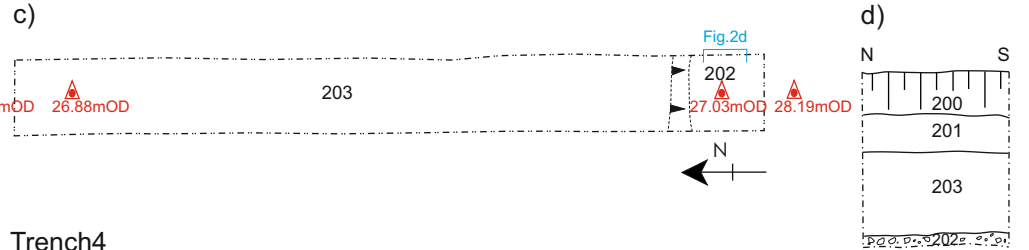
Trench 2		Length 20.5m	Width 1.5m	Alignment N-S
Context	Description	Thickness (mm)	Interpretation	
200	Brownish grey sandy loam	300	Topsoil	
201	Reddish grey-brown sandy silt with infrequent gravel	250-300	Subsoil	
202	Yellow and yellow-red sand and gravel	>100	Natural	
203	Light brownish red slightly clayey, silty fine sand	>600	Colluvium/hillwash

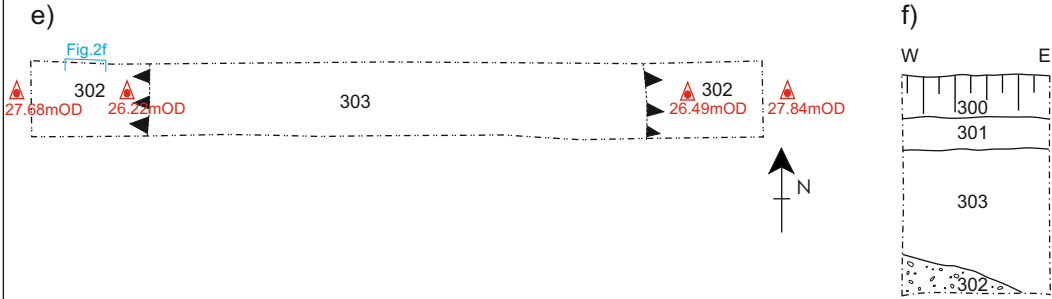
Trench 3		Length 20m	Width 1.5m	Alignment W-E
Context	Description	Thickness (mm)	Interpretation	
300	Brownish grey sandy loam	300	Topsoil	
301	Reddish grey-brown sandy silt with infrequent gravel	250-300	Subsoil	
302	Yellow and yellow-red sand and gravel	>250	Natural	
303	Light brownish red slightly clayey, silty fine sand	>1000	Colluvium/hillwash

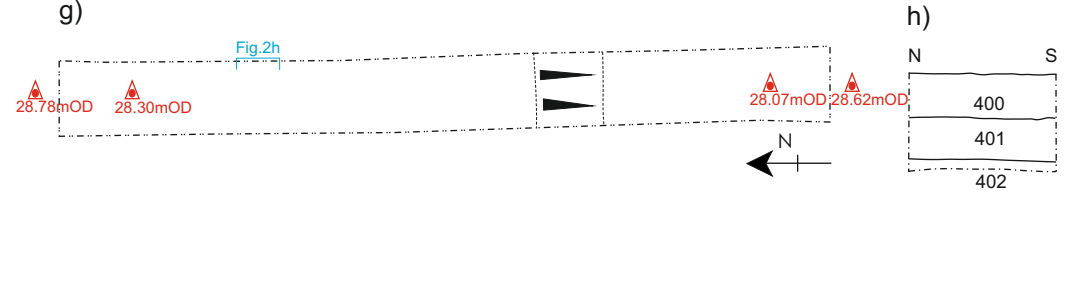
Trench 4		Length 21m	Width 1.5m	Alignment N-S
Context	Description	Thickness (mm)	Interpretation	
400	Brownish grey sandy loam	300	Topsoil	
401	Greyish yellow-red sandy silt with gravel	200-300	Subsoil	
402	Yellow and yellow-red sand and gravel	>100	Natural

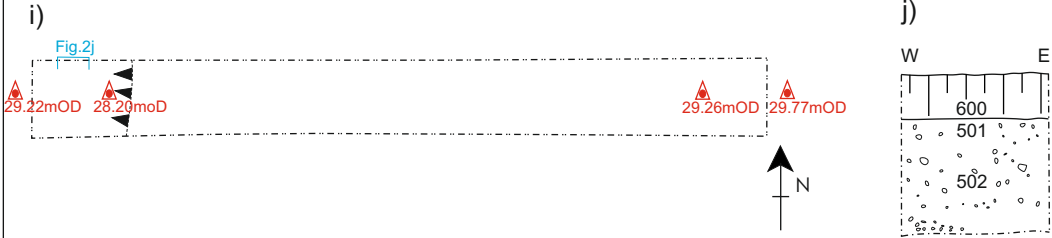
Trench 5		Length 20m	Width 1.5m	Alignment W-E
Context	Description	Thickness (mm)	Interpretation	
500	Brownish grey sandy loam	300	Topsoil	
501	Greyish yellow-red sandy silt with gravel	200-300	Subsoil	
502	Yellow and yellow-red sand and gravel	>500	Natural

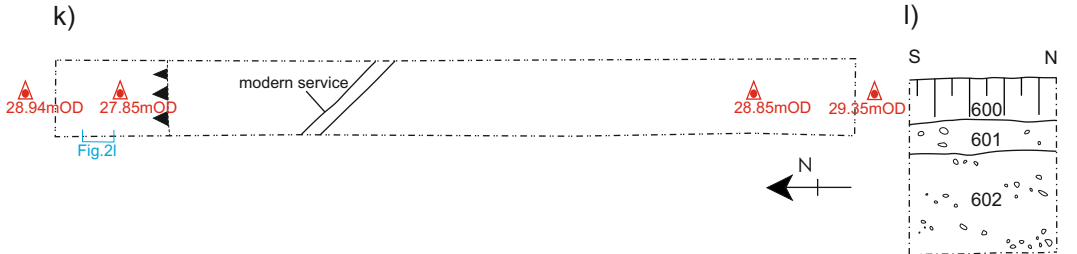
Trench 6		Length 22m	Width 1.5m	Alignment N-S
Context	Description	Thickness (mm)	Interpretation	
600	Brownish grey sandy loam	300	Topsoil	
601	Greyish yellow-red sandy silt with gravel	150-300	Subsoil	
602	Yellow and yellow-red sand and gravel	>700	Natural

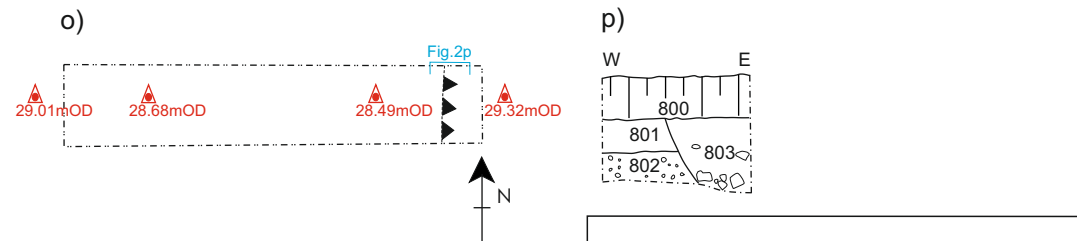
5.3 In addition to the above soil sequence, Trench 8 contained a partially exposed modern intrusive deposit (context 803), interpreted as being associated with the adjacent trunk road (Coldharbour Lane) construction works.

Trench 8		Length 10.7m	Width 1.5m	Alignment W-E
Context	Description	Thickness (mm)	Interpretation	
800	Brownish grey sandy loam	300	Topsoil	
801	Greyish yellow-red sandy silt with gravel	100-250	Subsoil	
802	Yellow and yellow-red sand and gravel	>200	Natural	
803	Brownish-grey sandy clayey silt with gravel and cobbles	>500	Modern dumping

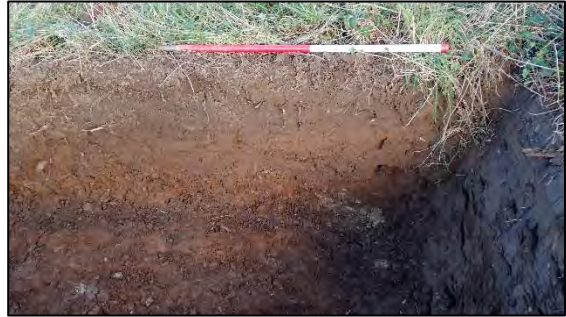
Plate 3: South-facing section at east end of Trench 8. Scale = 1m

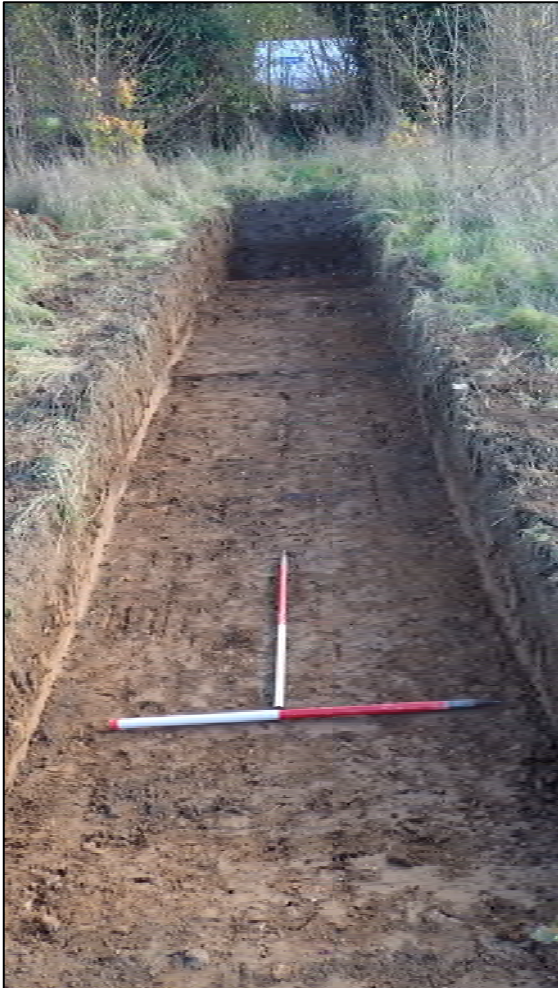
Plate 2: Overview of Trench 8, Coldharbour Lane in the background. Scale = 2x1m

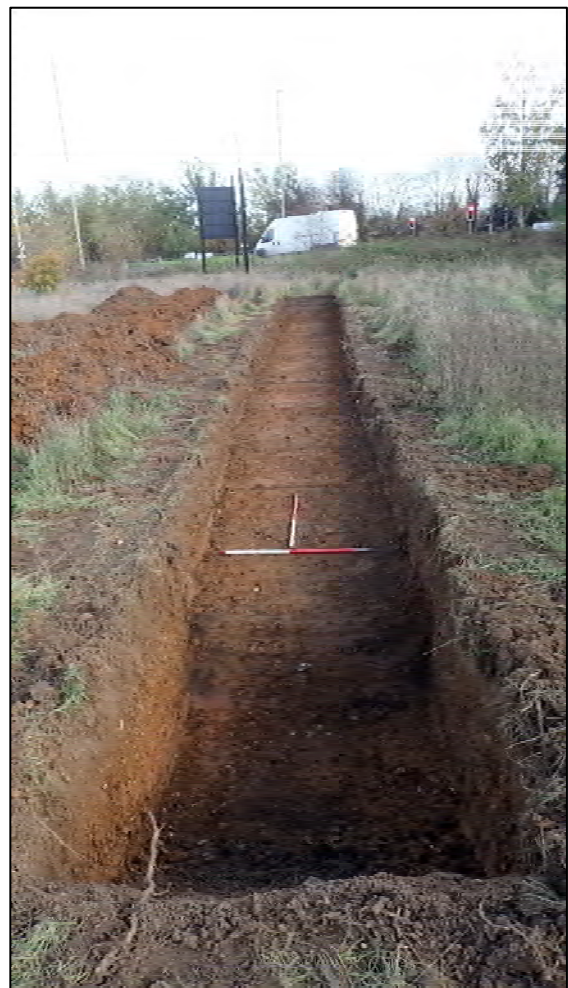
Plate 4: Overview of Trench 5, existing roundabout in background. Scale = 2x1m

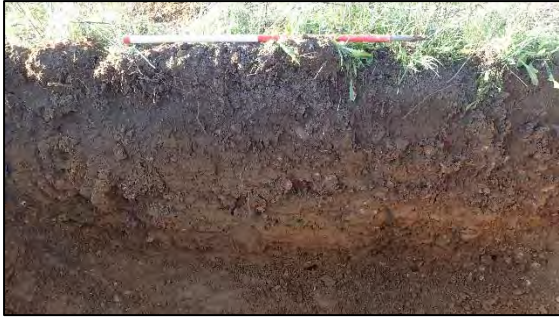
Plate 5: East-facing section at north end of Trench 6. Scale = 1m

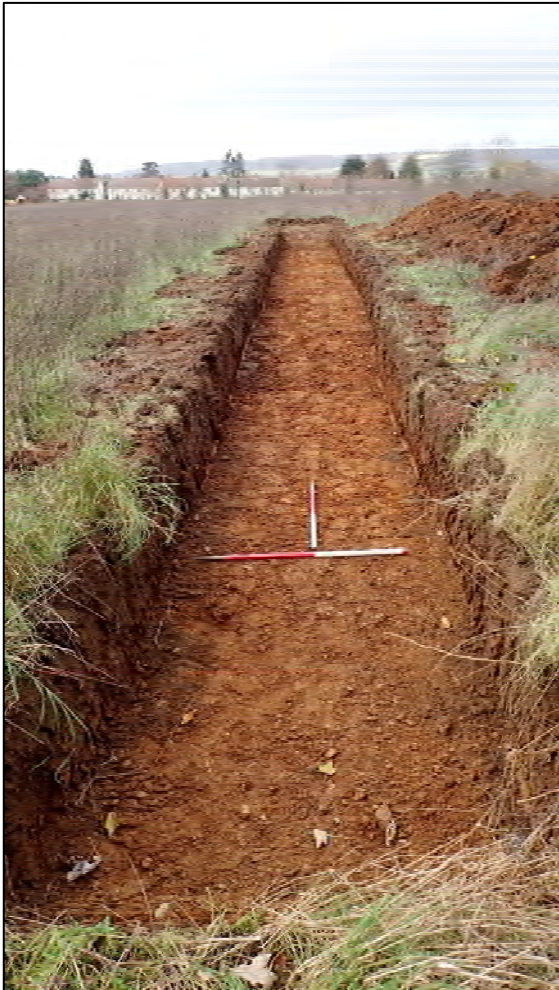
Plate 6: Overview of Trench 4. Scale = 2x1m

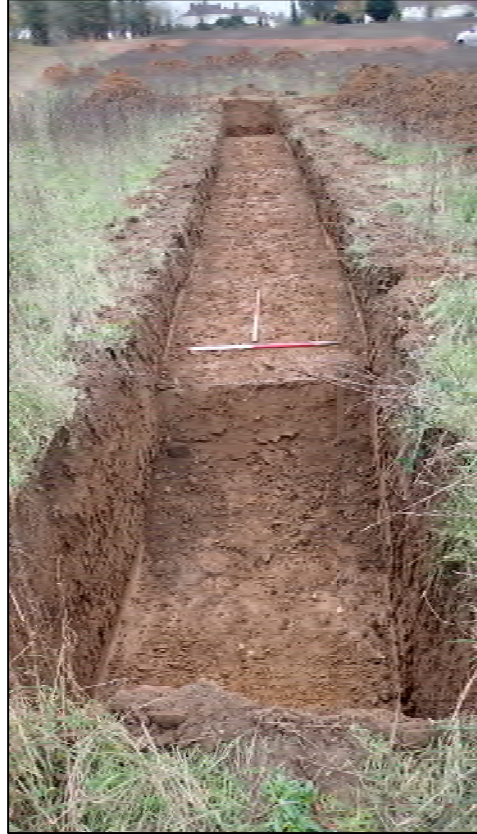
Plate 8: Overview of Trench 1, view from east. Scale = 2x1m

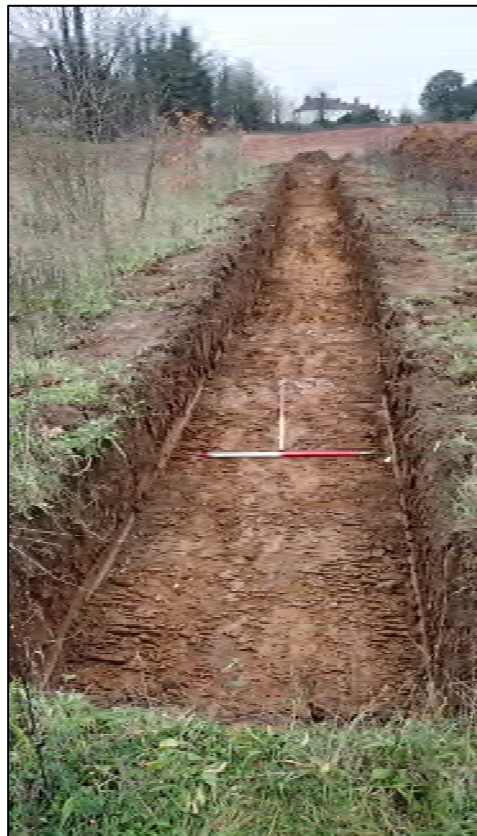
Plate 7: Overview of Trench 3, sondages at east and west ends. Scale = 2x1m
