# Installation of package sewage treatment plant and soakaway, Stonehenge Campsite, Berwick Road, Winterbourne Stoke, SP3 4TQ: Report on an archaeological watching brief

Document No: ACW1160/2/0

Date: January 2020

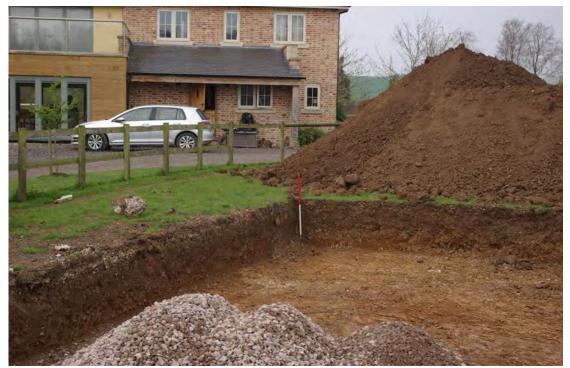
Plate1: Soak-away area

- 4.2 The soak-away area, measuring approximately 30m by 20m, was excavated on 15 April 2019 and contained largely made-ground, with mixed gravels and clays, sitting on chalk natural. The machine excavation stopped at the top of the chalk natural. This area had previously been the location of a poultry building which was demolished at some stage in the 1950s. It is likely that the made-ground was associated with this earlier land-use.
- 4.3 The southern part of the area did, however, contain some surviving natural stratigraphy. Approximately 0.40m of topsoil sealed a silty clay 0.30m in depth that overlay the chalk natural. There was no evidence for archaeological deposits within this area of undisturbed natural deposits.

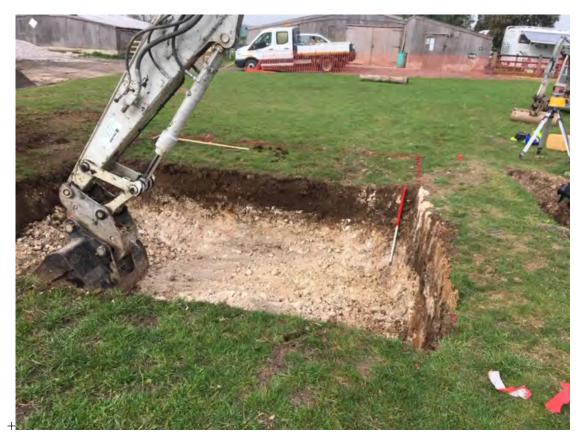
Plate 3: Excavation of sewage treatment plant area

The groundworks associated with installing a new treatment plant were monitored on 23 April 2019. The area measured approximately 3.5m by 3.5m. Monitoring ceased when the machine had dug to a depth of about 1.0m and when chalk natural was encountered. This area contained very mixed deposits. The east-facing section contained further evidence for made-ground which included topsoil with mixed deposits of gravel and chalk interspersed within this redeposited material. A band of original topsoil material was sealed by approximately 0.40m of this overburden. On the west facing section, there was less evidence for re-deposited material. A very dark brown topsoil ranging between 0.30 and 0.40m in depth sealed chalk natural. There was no evidence for sub-soils in this part of the site.

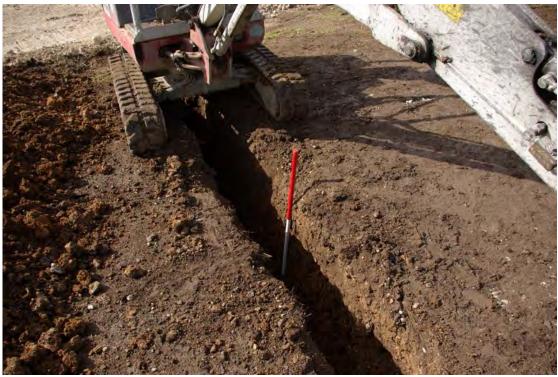
Plate 4: Pipe trench linking soak-away with treatment plant

4.5 The pipe trench that connected the sewage treatment plant with the soak-away was approximately 30m in length. The trenching was monitored on 25 and 26 April 2019. A c.0.30m wide trench was excavated to a depth of approximately 0.60m. The trenching contained further evidence for madeground with bands of gravel within the top-soil.
