Mill Farm, Teffont Evias, Salisbury, Wiltshire:
Results of a Programme of Archaeological Investigations

Document No: ACW1476/3/0

Date: May 2023

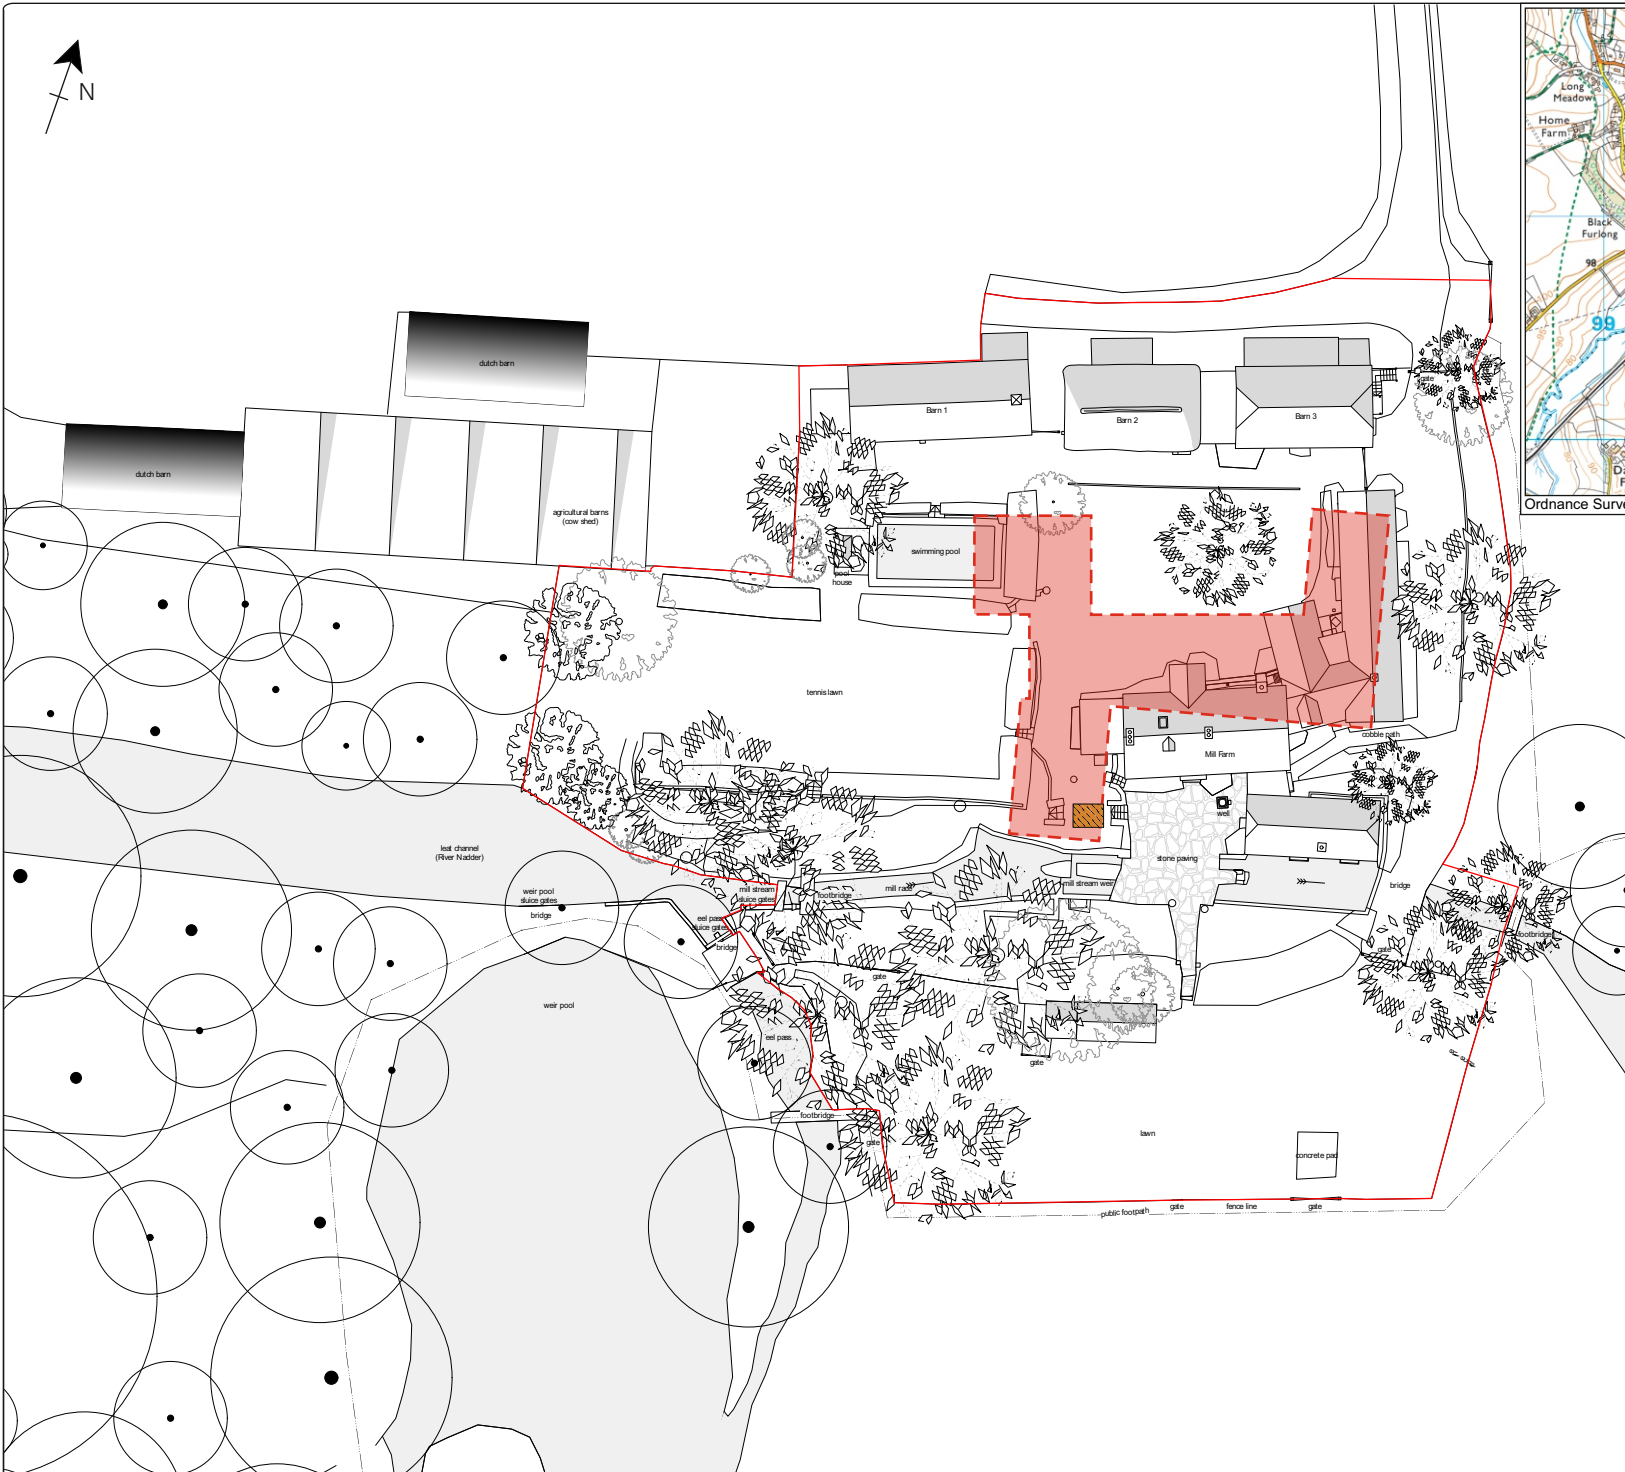
Fig. 1: Site location showing area of trial pit and watching brief

- 1.1 This document sets out the results of a programme of archaeological recording undertaken prior to and during the demolition of an existing dwelling and ancillary building and during the groundworks associated with the replacement dwelling, together with associated hard and soft landscaping at Mill Farm, Teffont Evias, Salisbury, Wiltshire, SP3 5RP (centred on NGR 400042 130643). The site location is shown in Fig. 1.

Figure 1: Site Location and Details of Archaeological Investigations

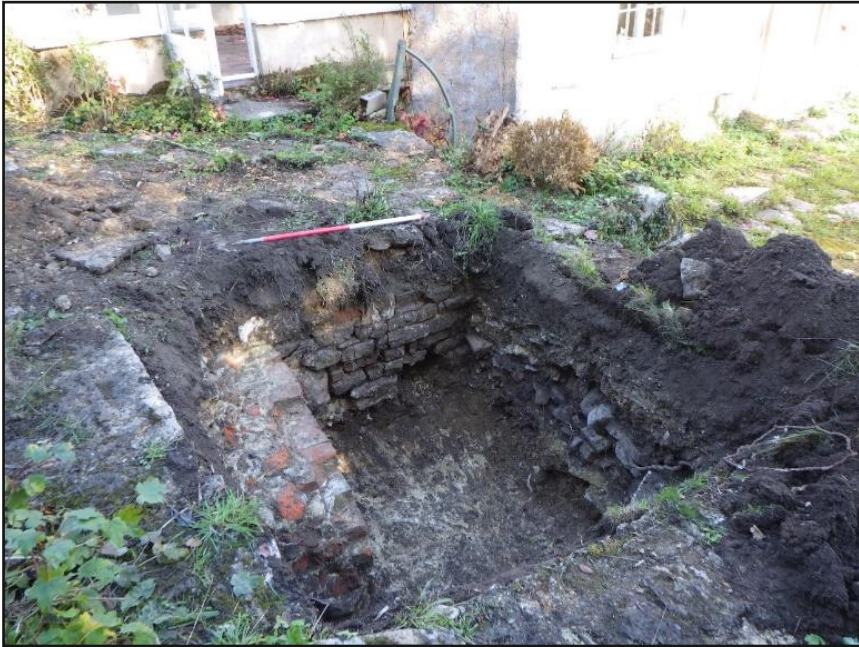
- 4.3** This investigation involved the excavation of a 2m² trial pit to identify any historic building remains or structures that may survive below current ground level. A maximum depth of 1.3m was reached before encountering the natural geology (**Plate 1**). A basic recording of the structural elements and their general characteristics was subsequently undertaken. However, additional recording was not possible due to the depth of the excavation (without shoring) and the instability of one of the exposed walls, preventing immediate access. Some metal fixings associated with the structure was noted and most likely relates to mechanical components.

Plate 1: Oblique view of excavated trial pit. View from the south-west (scale 1m)

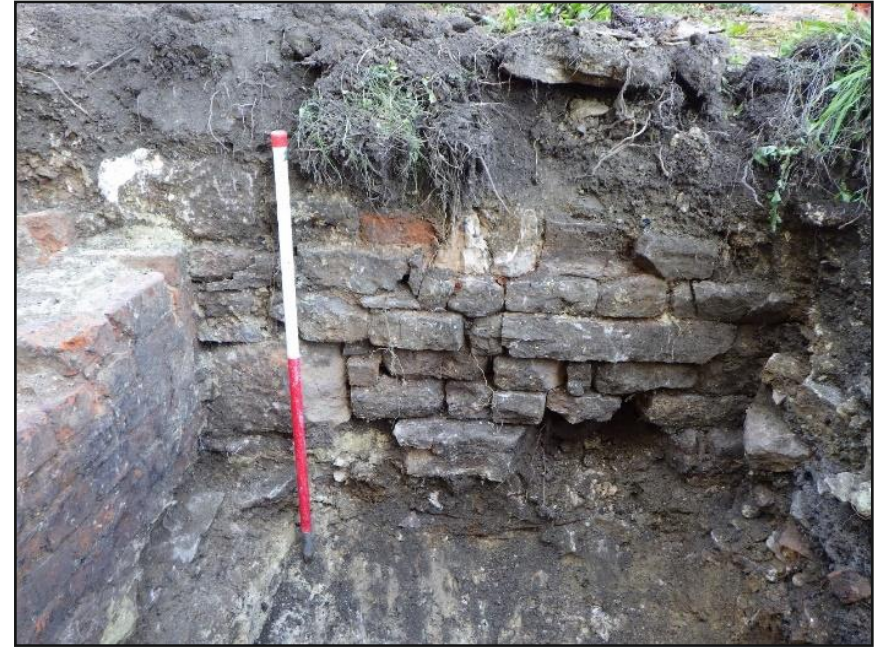
- 4.4** The south facing section highlighted a 1.53m length of stone wall (S103) comprising randomly coursed limestone blocks, with no evident bonding material (**Plate 2**). The wall was east to west aligned with an overall height of 0.73m and appeared to abut a red-brick wall to the west. It continued to the east as a remaining part of a stepped garden wall, probably dating to the twentieth century.

Plate 2: South facing section showing wall S103 (scale 1m)

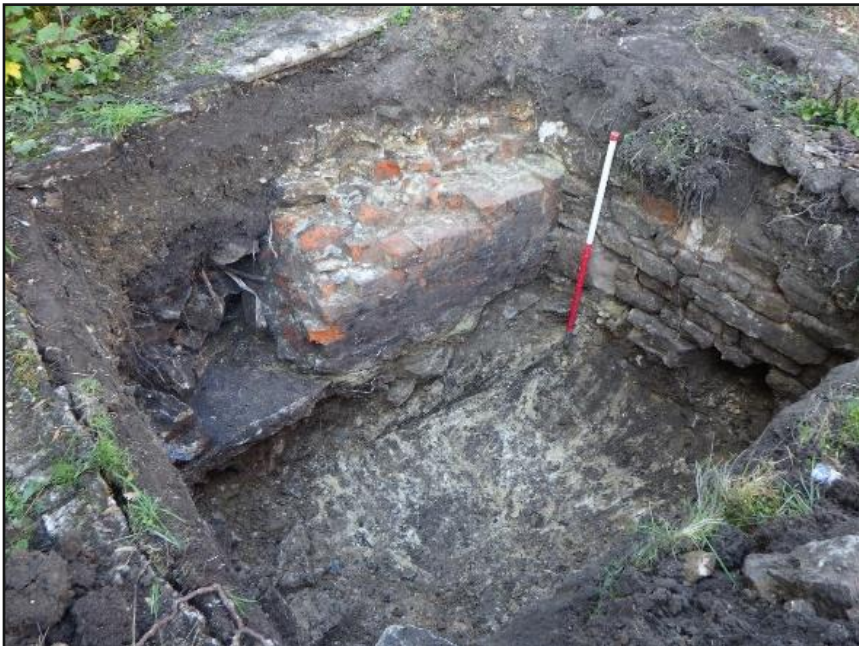
- 4.5** The east facing section comprised a 1.25m length of red-brick walling (S104), which was 0.52m deep and had a height of 0.82m (**Plate 3**). Although fragmented, the bricks were laid head and stretcher followed by 3 courses of head (on end). This north to south aligned portion of wall was bonded by OPC (cement) and most likely continued to the north and west. A void to its immediate south comprised loosened rubble stone and metal fixings, including a thread that may have formed a mechanical element. These elements may have formed structural components relating to the final phase of the mill prior to its destruction in a fire in 1904.

Plate 3: Oblique view of east facing section showing wall S104 (scale 1m)

6.1 The archaeological investigation has allowed for the partial recording of structural elements with a probable association with Mill Farm and its history. These structural elements, particularly S104 and S105, may represent historic remnants of the mill and its workings prior to the fire in 1904.

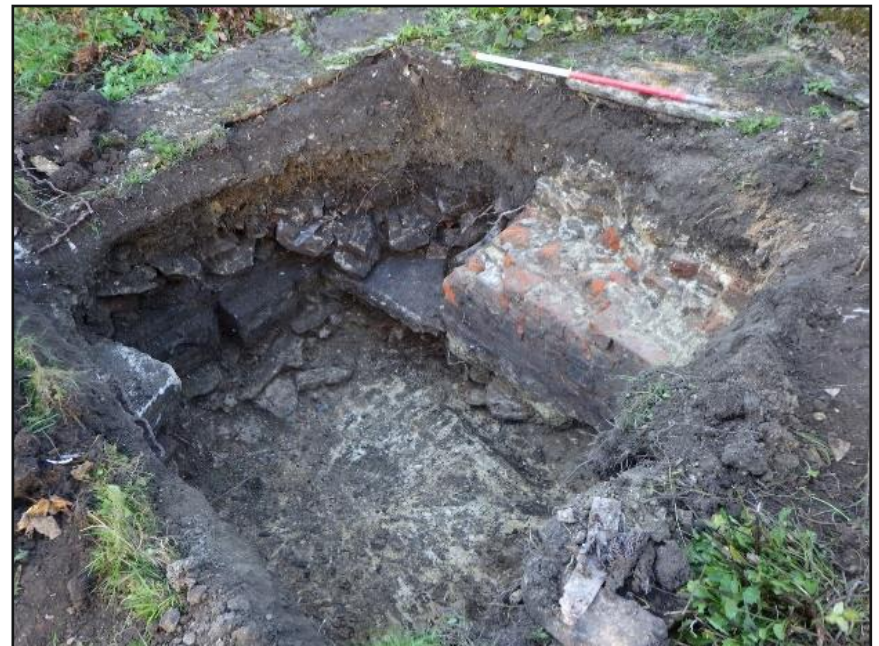
4.6 To the south and southwest of S104 a stone base (S105) was also recorded in section. It comprised a series of large, rectangular limestone blocks up to 0.4m thick, with no apparent bonding material (**Plate 4**). While its relationship to S104 was not entirely clear, it may be contemporaneous and formed the primary element to additional structural or mechanical elements related to a late phase of the former mill. In the north facing section this stone base was overlaid by a backfill deposit comprising rubble stone (101), most likely formed as a result of destruction and subsequent infilling.

Plate 4: Oblique view of north facing section showing base S105 (scale 1m)

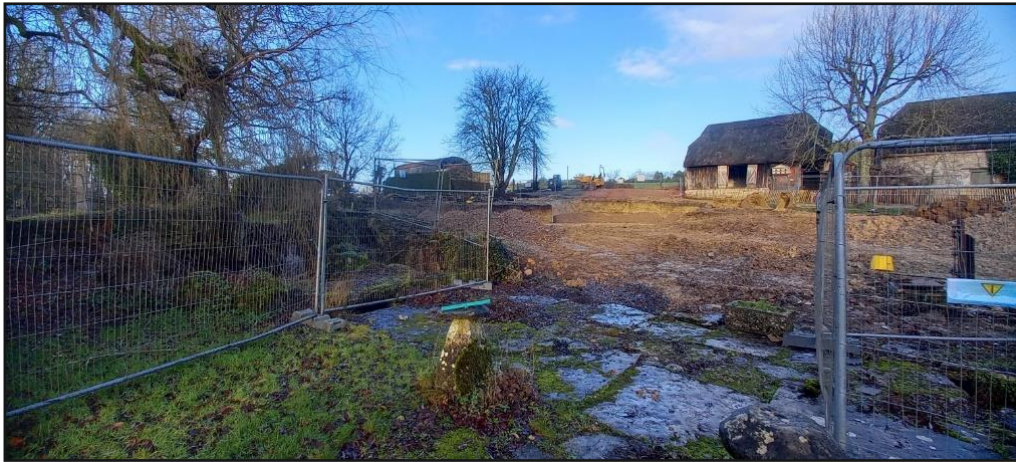
4.7 Archaeological monitoring of the site was undertaken between January and April 2023. This involved the monitoring of areas where the reduction of ground levels was taking place. With the exception of a feature representing a probable tree throw (revealed in section), only the natural sub-strata was revealed. No evidence for any structures associated with the former mills or any other archaeological deposits were present across the site. The stratigraphic sequence encountered during the monitoring is described in Table 2.

Plate 5: General view of site

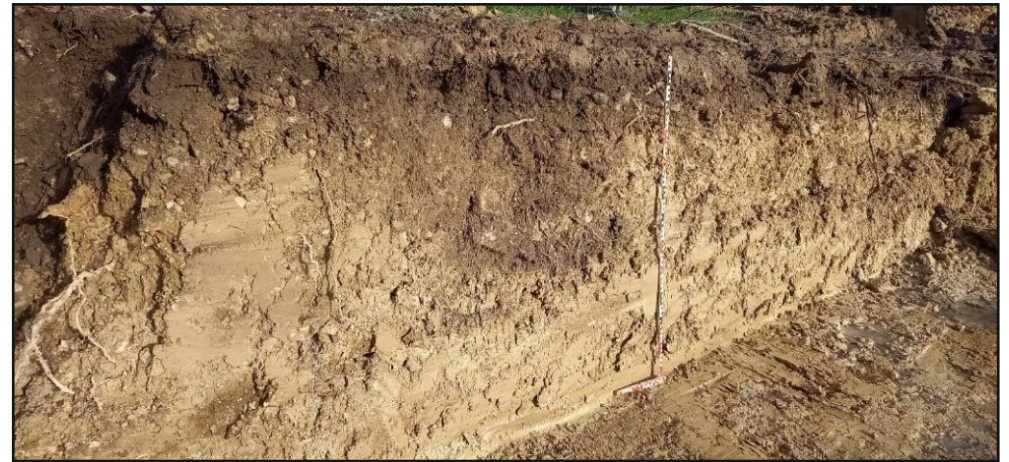
Plate 6: Possible Feature F103 (scale 2m)

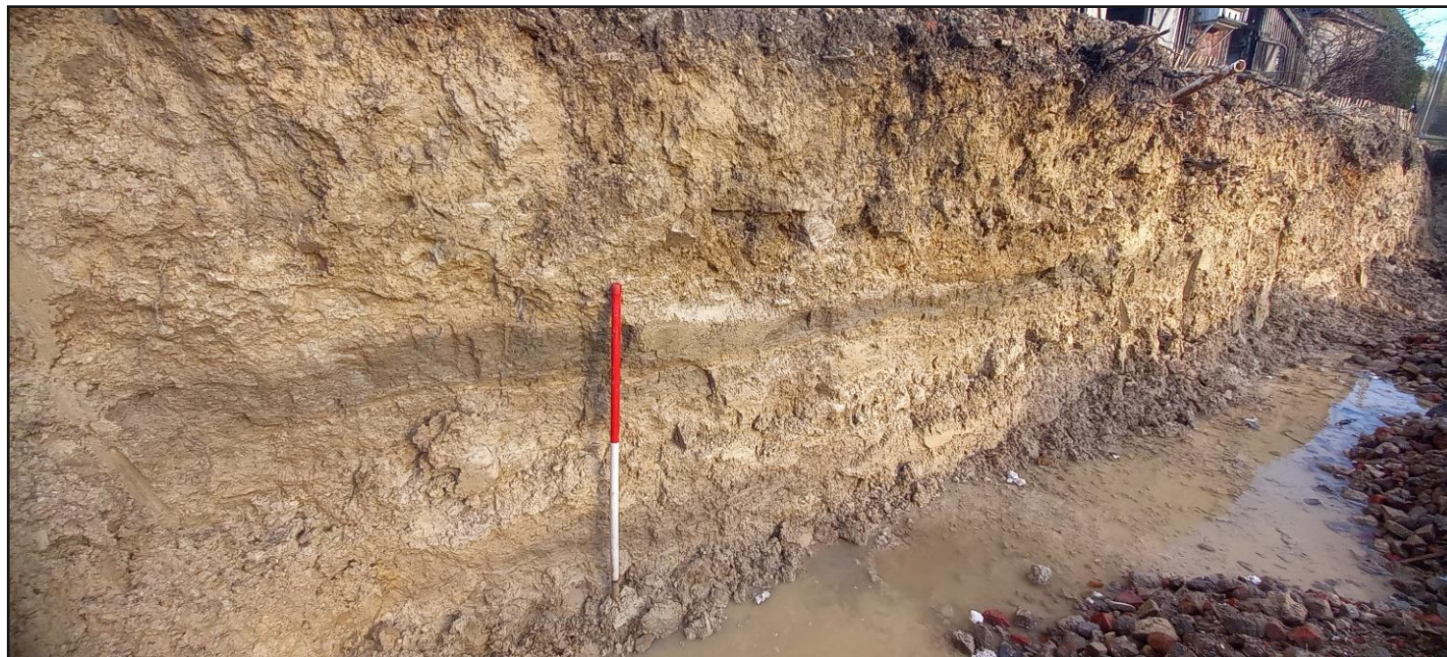
Context Number	Description	Depth	Interpretation
200	Mixed dark brown silty clay	0-100mm	Modern overburden / disturbed topsoil
201	Grey-brown loamy silty clay	100 - 300mm	Topsoil
202	Off-white 'marly' silt-clay	-	Natural sub-strata

Plate 7: General view of stratigraphy (scale 1m)
