Land at Britford depot and paddock, Britford, Wiltshire

Results of archaeological evaluation

Document No: ACW581/2/0

LAND AT BRITFORD DEPOT AND Paddock, BRITFORD, WILTSHIRE (NGR: SU159282) Results of Trench Evaluation

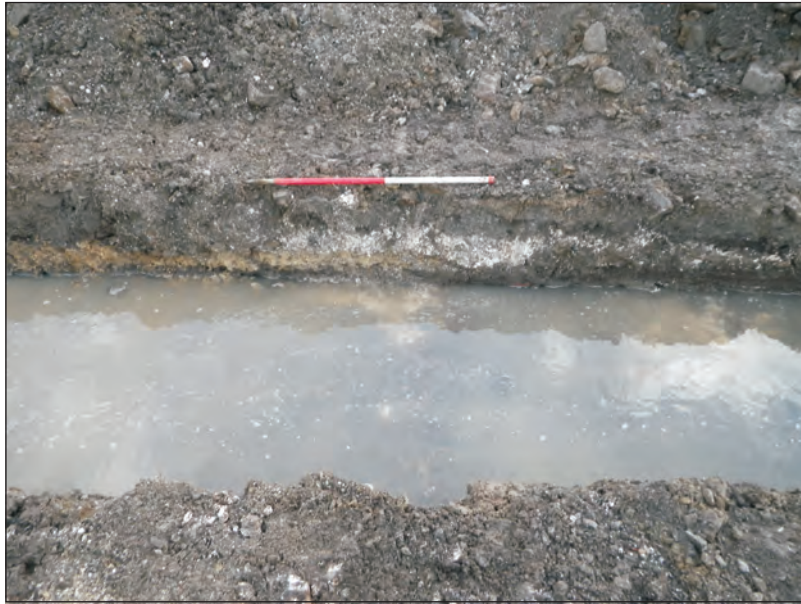
Plate 1: Trench 1, view from the north (scale 1m)

Trench 1 (Plate 1)

- 5.2** Trench 1 was aligned east-west. Mixed aggregates (100) and modern made ground was noted in the upper layers (101) and natural grey-brown river gravel (102) overlying chalk was encountered at a depth of c. 0.6-0.65m below the current ground level (45.35m aOD).

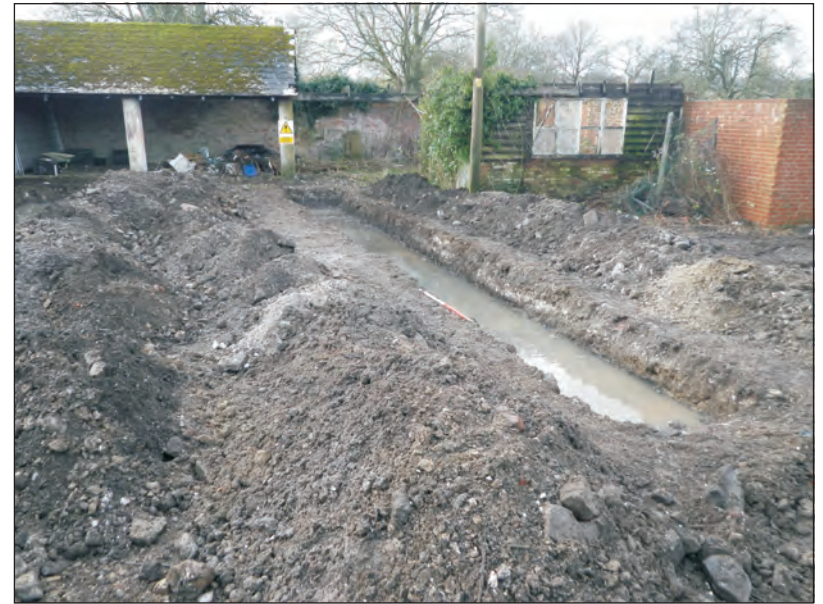
Plate 2: Trench 2, view from the north (scale 1m)

Trench 2 (Plate 2)

- 5.3** Trench 2 was aligned east-west, and a series of mixed and disturbed deposits (200 and 201) were noted overlying natural grey-brown river gravel at a depth of 0.45-0.5m from the top of the trench (45.5m aOD).
