Land off Furge Lane, Henstridge, South Somerset

Results of an archaeological evaluation

Document No: ACW1128/2/0

Results of an archaeological evaluation by trial trenching

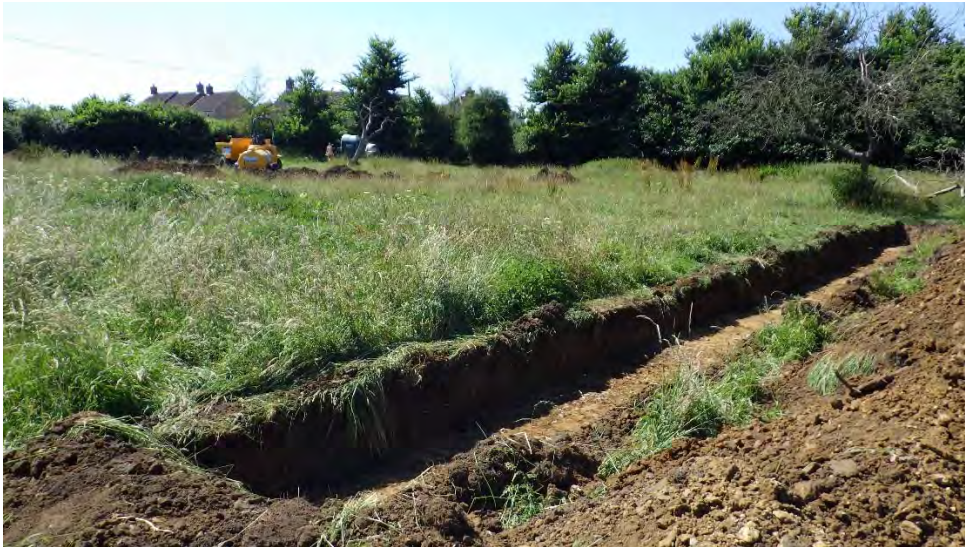
Plate 1: General view of site with Trench 4 in the foreground. View from the southeast

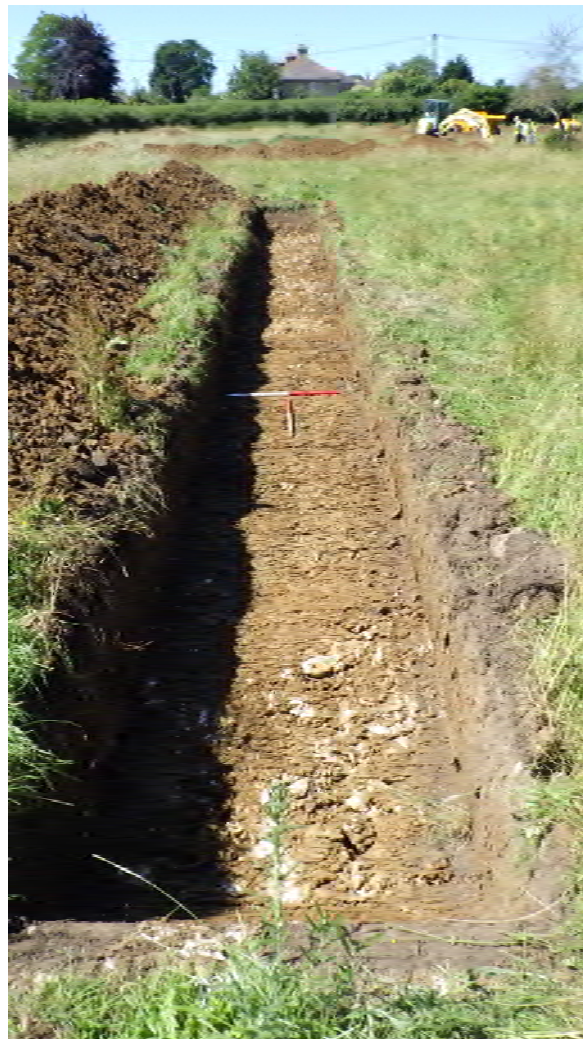
- 5.3** Subsoil was evident throughout the evaluation trenches, with a noticeably greater depth recorded in Trenches 5 and 6. This is attributed to the gradual slope of the land towards the east, with the resultant increased depth in subsurface soils.

Plate 2: View of Trench 5 from the northeast. Scale 2 x 1m

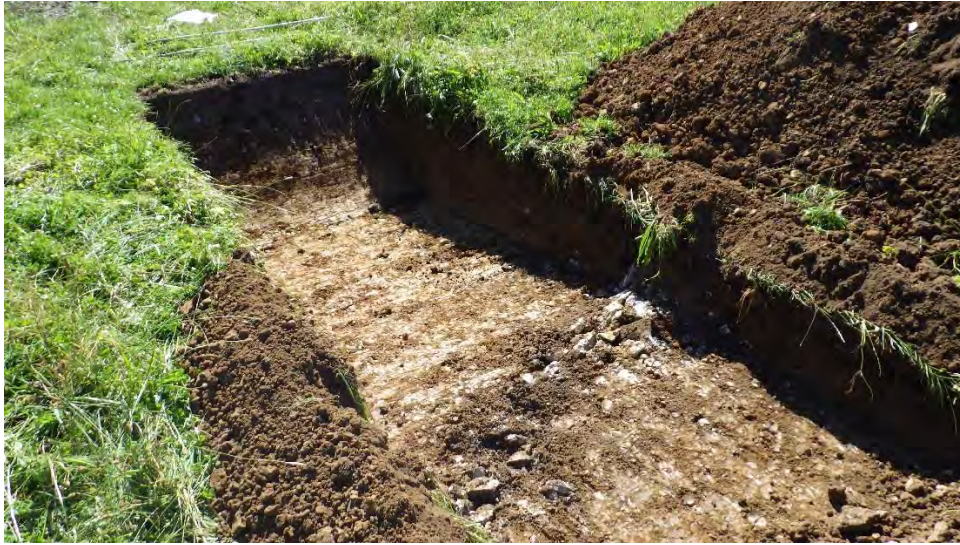
- 5.2** Several irregular features were investigated, noticeably in Trench 4 and Trench 6. In Trench 4 two parallel linear features, located towards the south-southeast end of the trench, were investigated but not found to be archaeological in origin. In Trench 6 a limestone filled 'French' drain was noted approximately 2.8m from the east end of the trench. This probable field drain was aligned north to south and cut into the subsoil (**Plate 3**). In addition, 3.6m to the west of the drain was a sub circular pit-like feature, F603. This pit feature had a maximum diameter of 0.5m and was 0.3m deep. It had a single fill, comprising dark grey-brown silty clay, which contained modern debris such as brick, glass and metal fragments (**Plate 4**). It is thought to be 20th century in origin and may relate to agricultural activity on the site; similar debris and disturbance was noted in the topsoil in a number of the other trenches during the site investigation. Feature F603 is of limited archaeological value.

Plate 3: Oblique view of limestone drain in Trench 6. View from the north

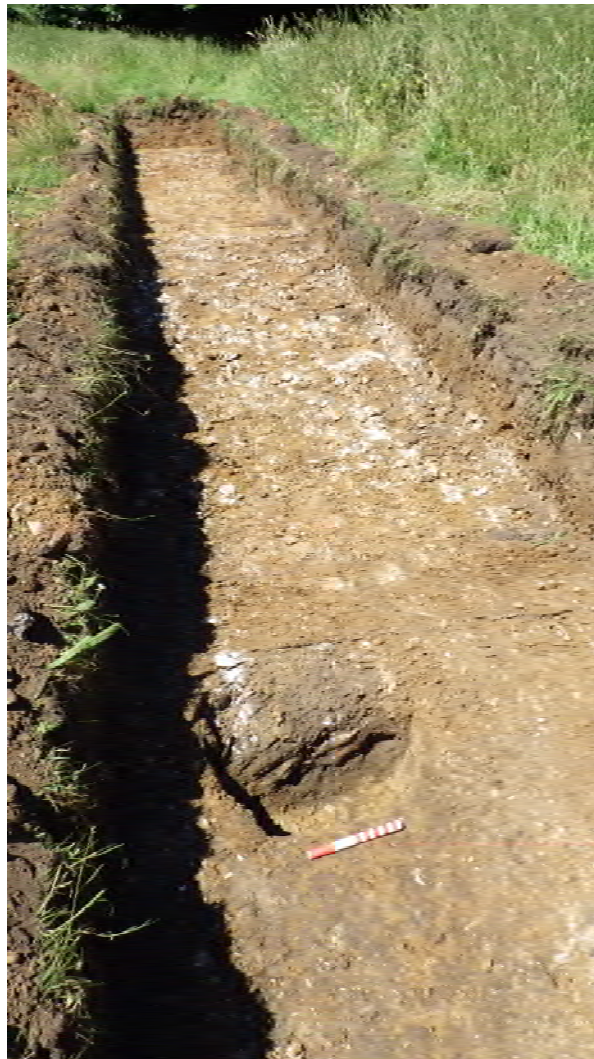
Plate 4: View of Trench 6 with pit F603. View from the east. Scale 0.2m

601	Mid yellow-brown silt with clay. Friable with rare limestone frags and stones	250-550	Subsoil
602	Mottled mid yellow-brown clay with silt with common limestone/brash	+550	Natural geology
F603	Sub circular 'pit' feature, filled with dark grey-brown silty clay with CBM	300	Modern 'pit'

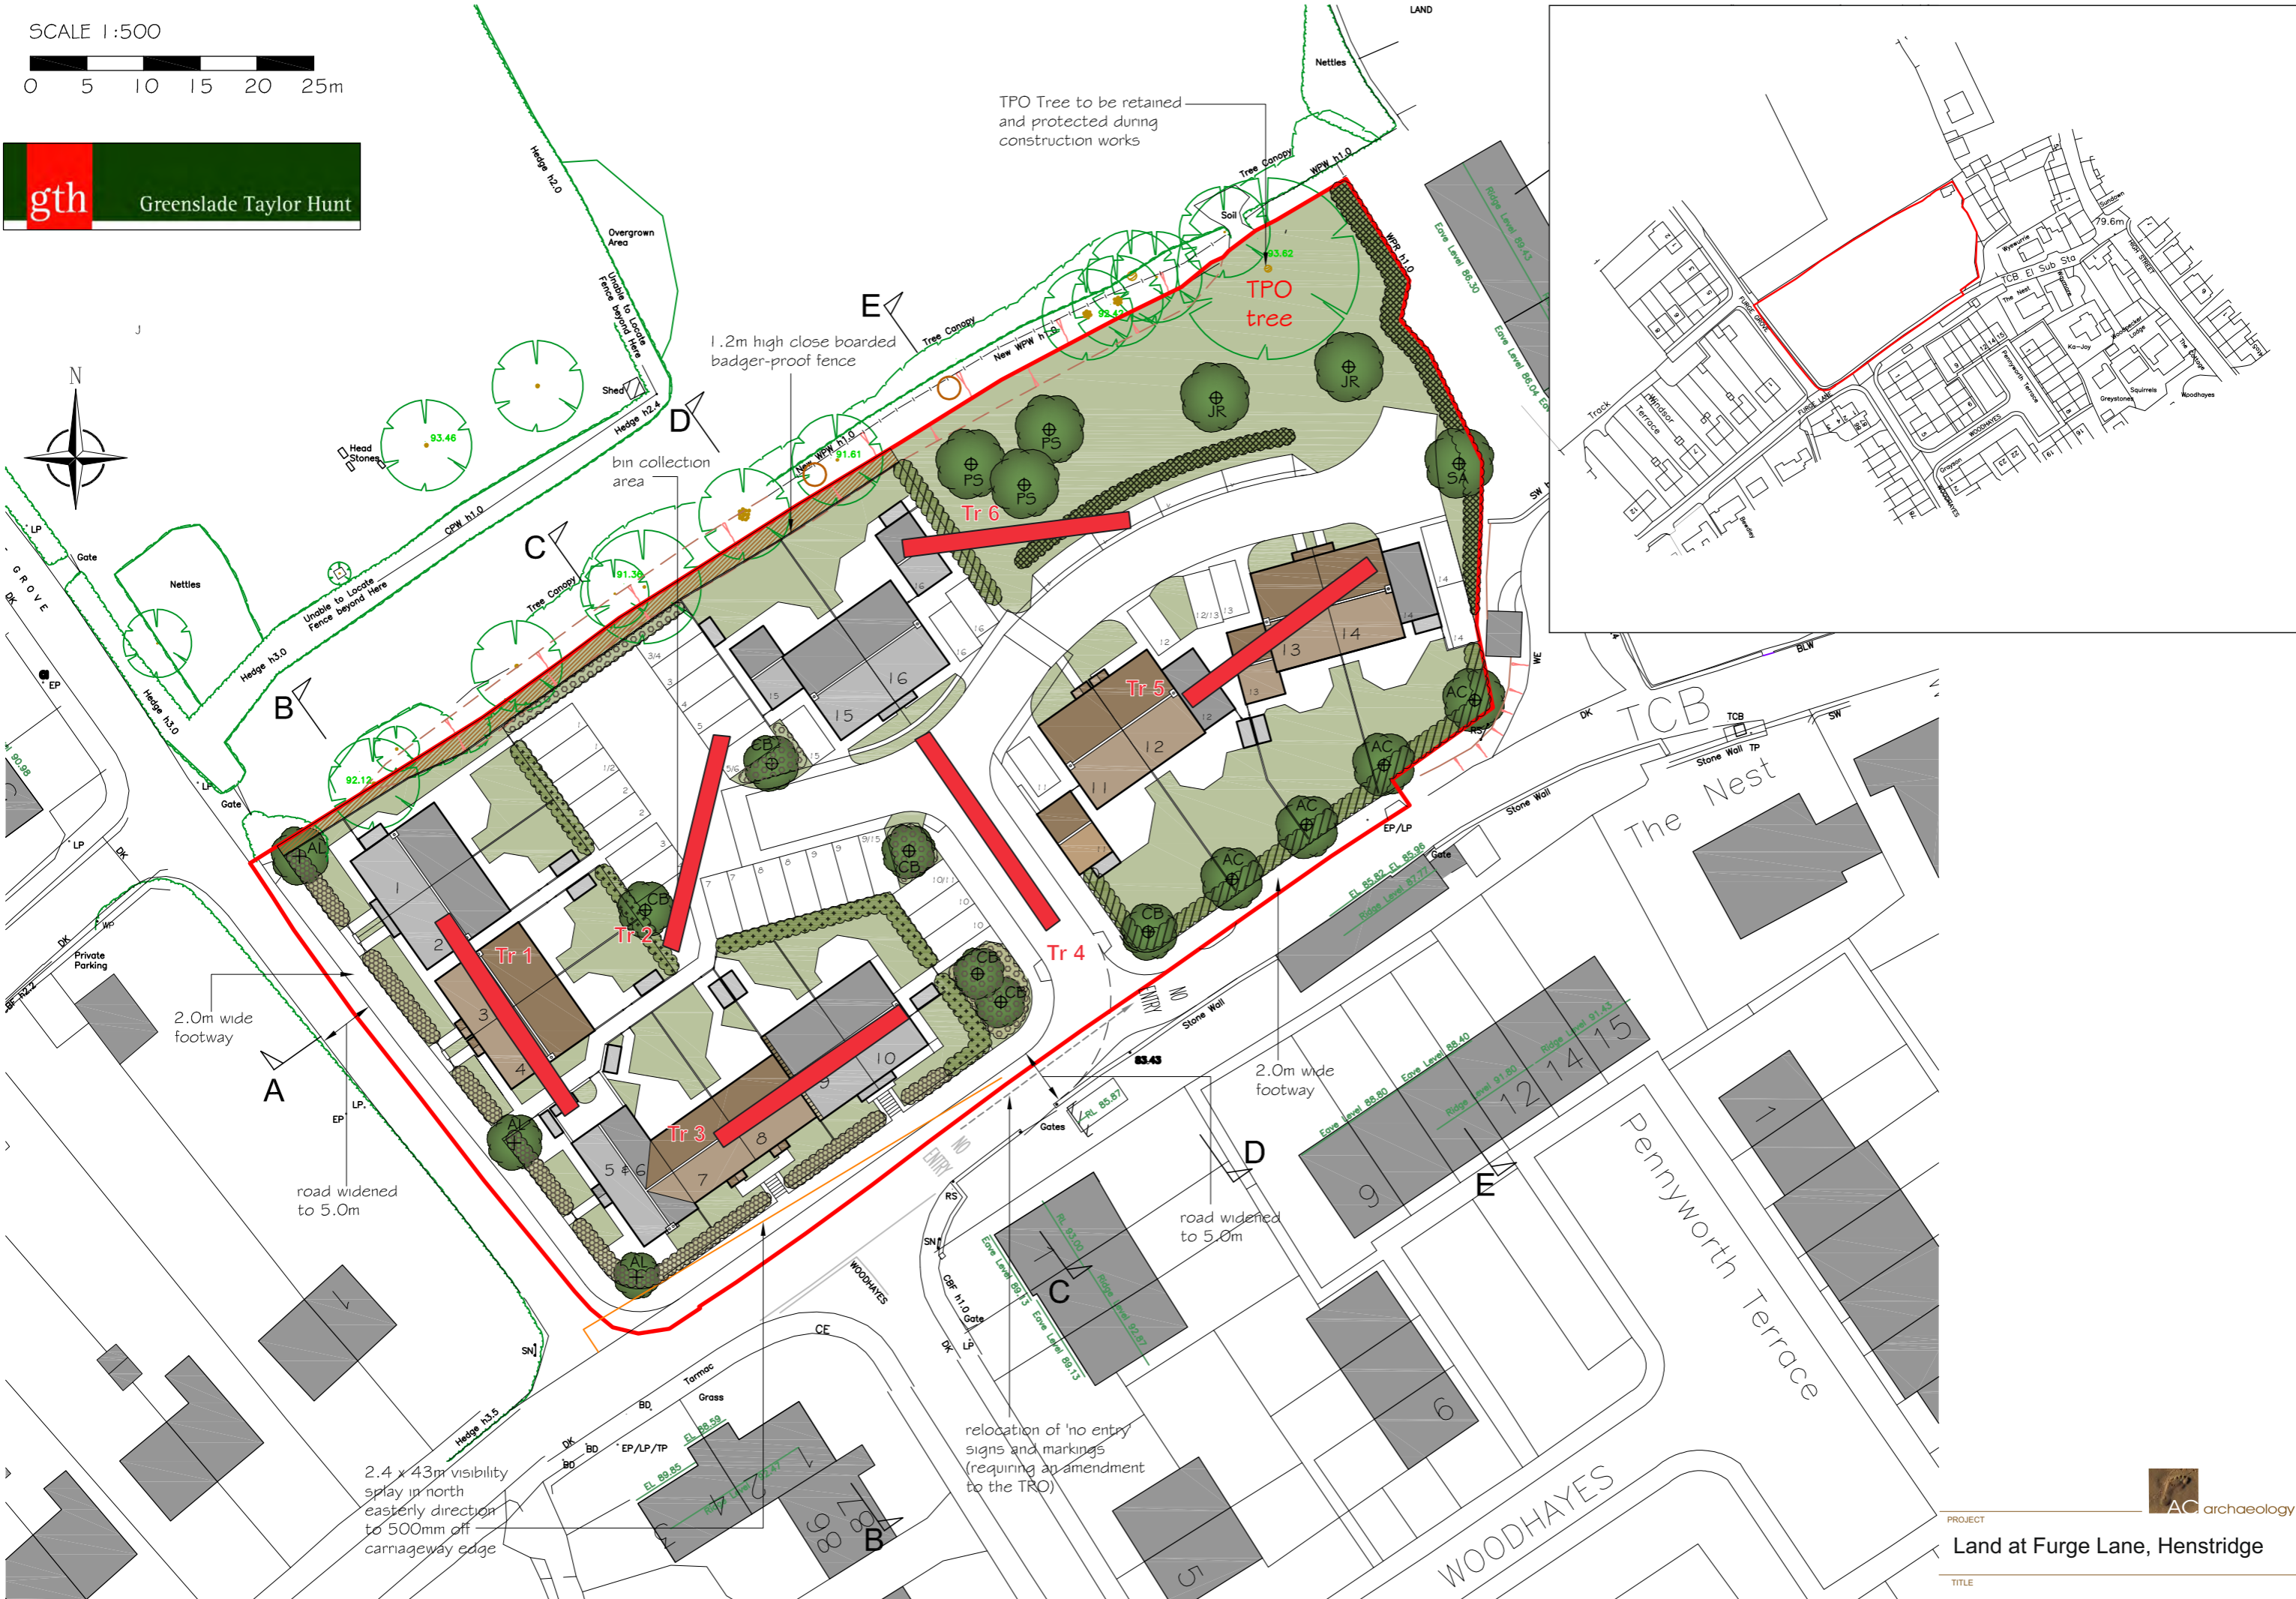
SCALE 1:500
0 5 10 15 20 25m

- 1.1 This report sets out the results of an archaeological evaluation relating to land off Furge Lane, Henstridge, Somerset. The site location and trench positions are included in Fig.1.

- 4.1 The evaluation was undertaken in accordance with a project design for archaeological evaluation, prepared by AC archaeology (Trott 2018), which was submitted to and approved by the SWHTSHEO, prior to commencement.
- 4.2 The investigation comprised the machine excavation of six trenches (a total of 320m² in area) with each trench being 1.6m wide and 20m in length. Each trench was positioned to understand the nature of the archaeological resource and amounts to a c. 4% sample of the site. Trenches were positioned on the ground using a survey grade GNSS instrument with a horizontal precision of c. 20mm (see Fig. 1).
